## Compliance Assessment Report CAR\_NRW0049601

**Permit being assessed:** AN0401901

For: RYDER CUP CLUBHOUSE CELTIC MANOR, held by THE CELTIC MANOR RESORT LIMITED

**Type of assessment carried out:** Site Inspection, Reason: Routine.

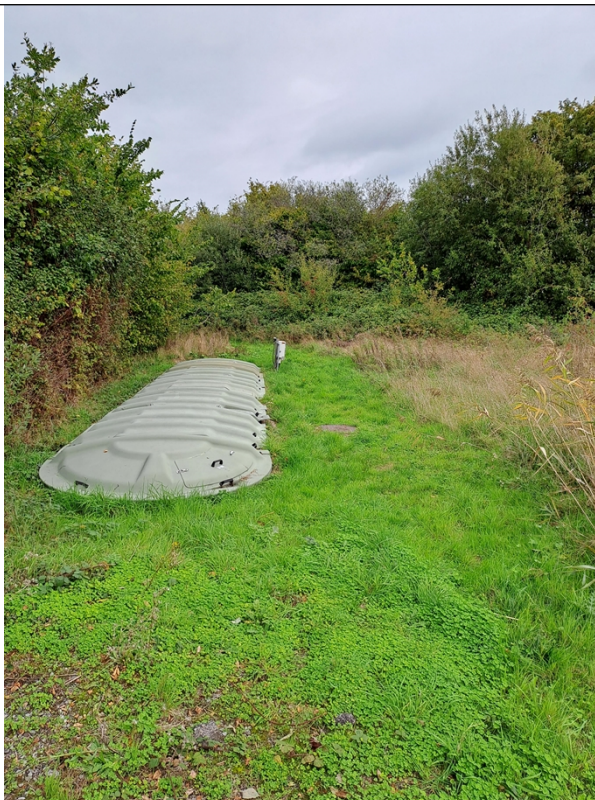
General site conditions were good at the time of the visit with good access to all permitted components and no obstructions or restrictions present. An overview of the site can be seen in Figure 1.

Figure 1: General site conditions as observed during the visit.

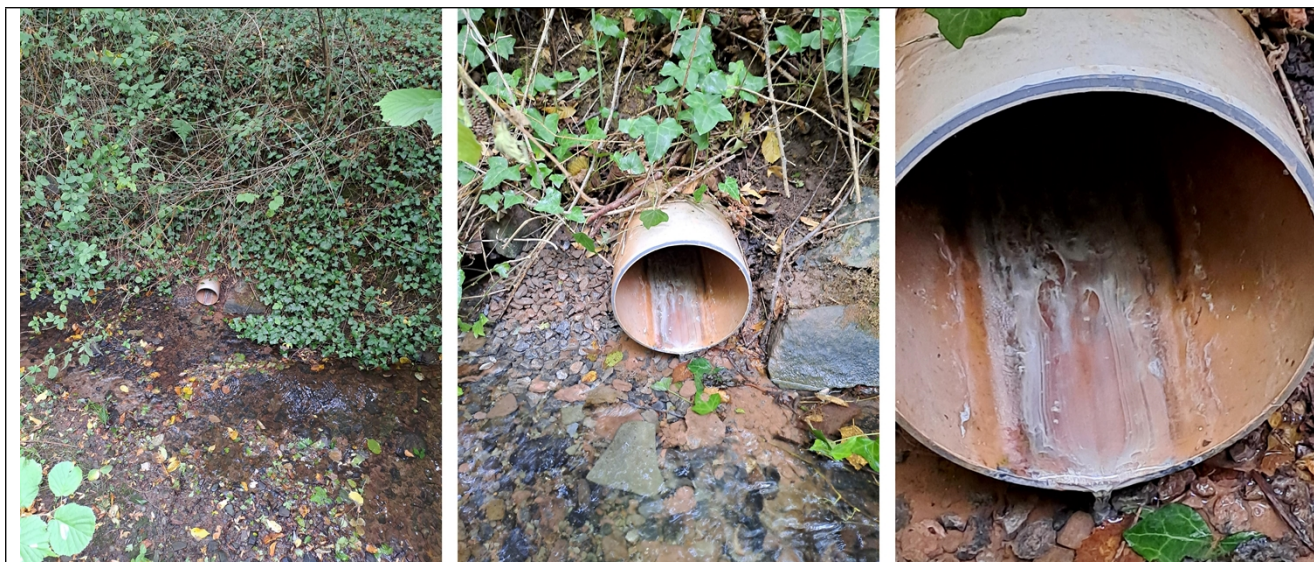
We first inspected the discharge point which was located at ST356391336; while not in the exact location stipulated in the permit it is within 8m of the listed point and does not pose any risk of being miss-identified. As such I am happy that the location is compliant. The discharge itself was very minimal at the time of the visit. There was minor staining on the outfall pipe but the effluent was clear and there was no fungus present around the pipe or downstream. I am happy that the discharge is not posing any environmental risk. As noted above, there were no access issues and there were steps down to the watercourse to facilitate any sampling required. These observations are evidenced in Figure 2.

Figure 2: The discharge/sample point as observed during the visit.

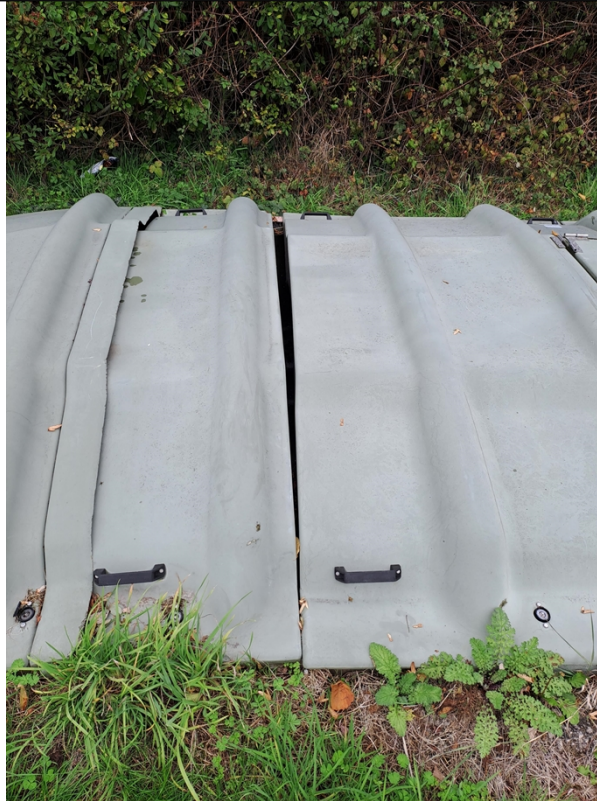
The treatment system itself appeared to generally be in a good condition. All covers were in place and there were no major defect present. A small gap was present in one of the covers (Figure 3), to which SW explained that the general maintenance operators may have failed to replace the chamber covers correctly during their last visit. SW replaced the cover immediately, but I have added an advisory note below to ensure all covers are returned as designed to ensure no water ingress can occur which may overwhelm the system or even cause flooding.

Figure 3: The treatment system with a small gap in the cover as observed during the visit.

1. Ensure all chamber covers are replaced correctly after routine maintenance to restrict water ingress into the system.

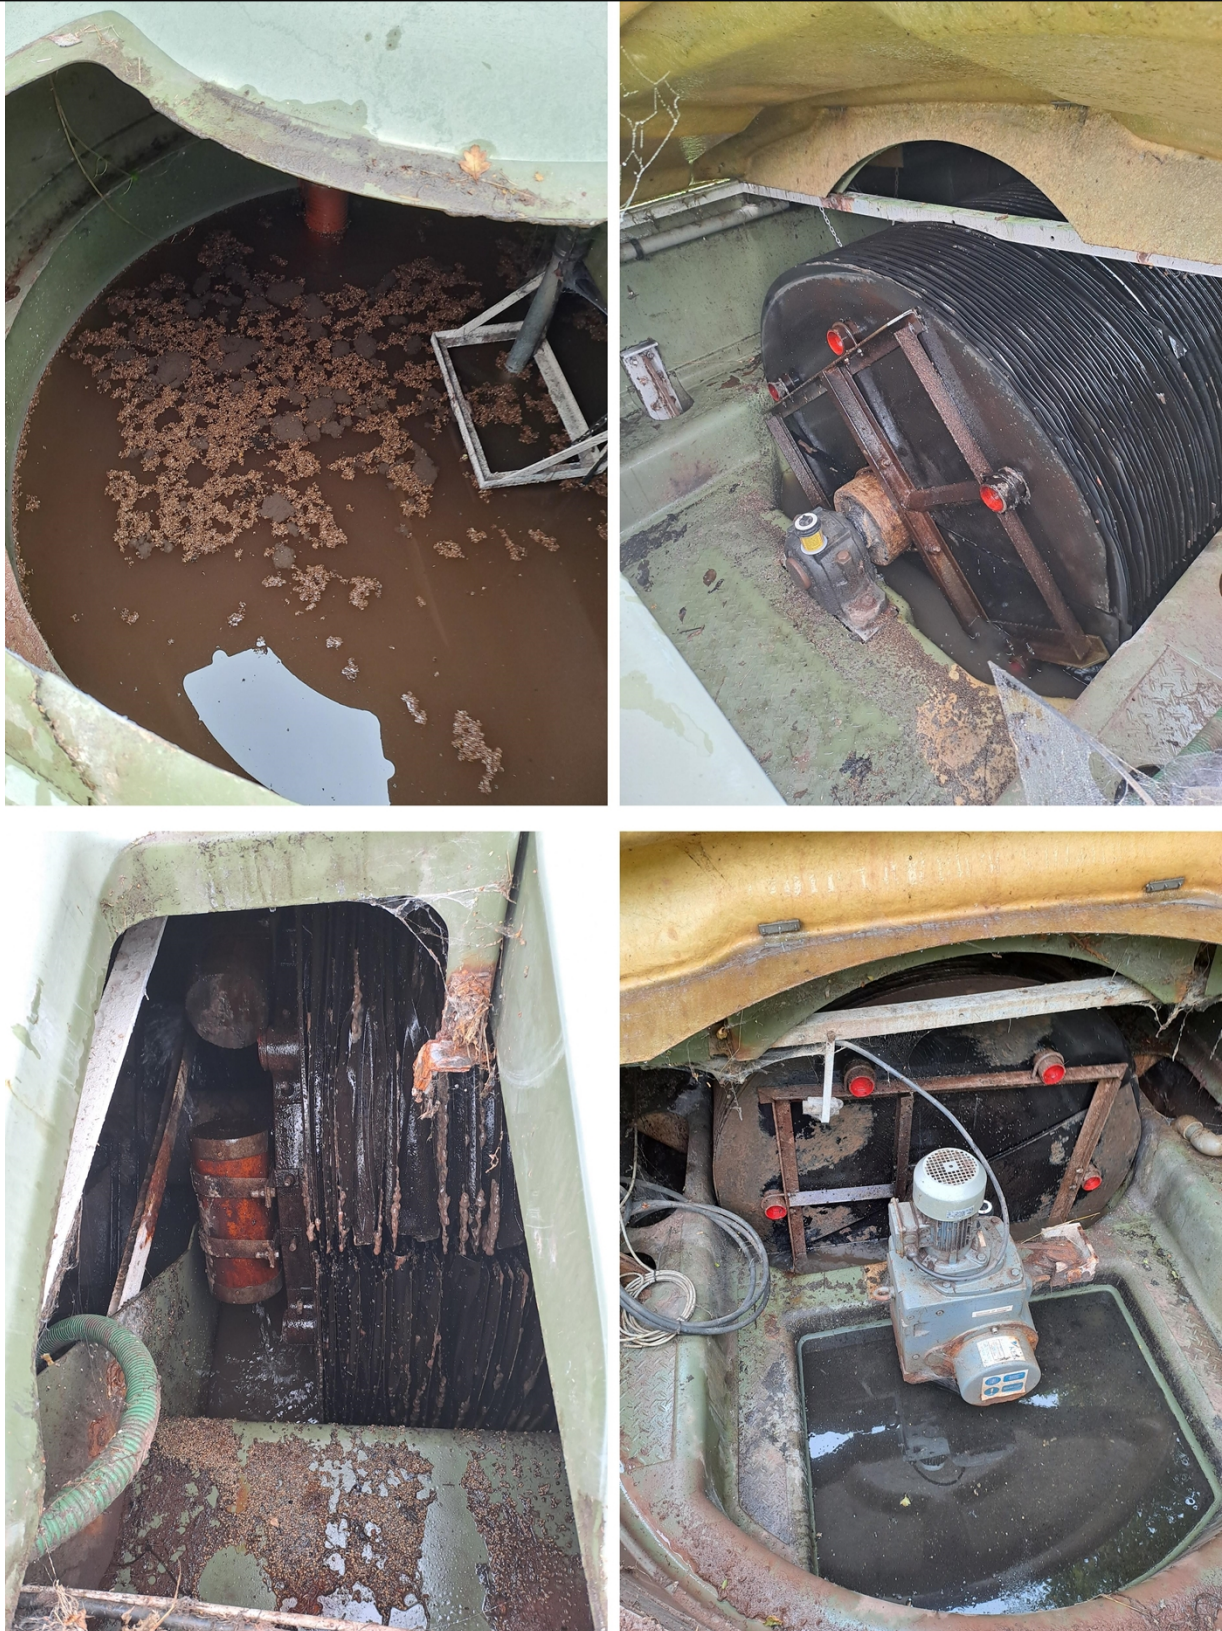
Each system chamber was lifted in sequence and an assessment made on its function and effectiveness. The observations made are as follows:

1. Primary effluent/settlement chamber - As expected, no defects in the chamber walls observed and not overly full, with sufficient volume remaining before next de-sludge is required.
2. Filter and aeration chambers (x2) – Filters were in operation and clear of excessive debris. There was good aeration and no significant solids carry over from the settlement chamber.
3. Final effluent chamber – The effluent was clear with no trace of solids carry over and there was no noxious or prominent odours present.

No concerns noted. Evidence of the above observations can be seen in Figure 4.

Figure 4: The treatment system chamber as observed during the visit.

From top to bottom, left to right: Primary/settlement chamber, Filter and aeration chambers (x2), Final effluent chamber.

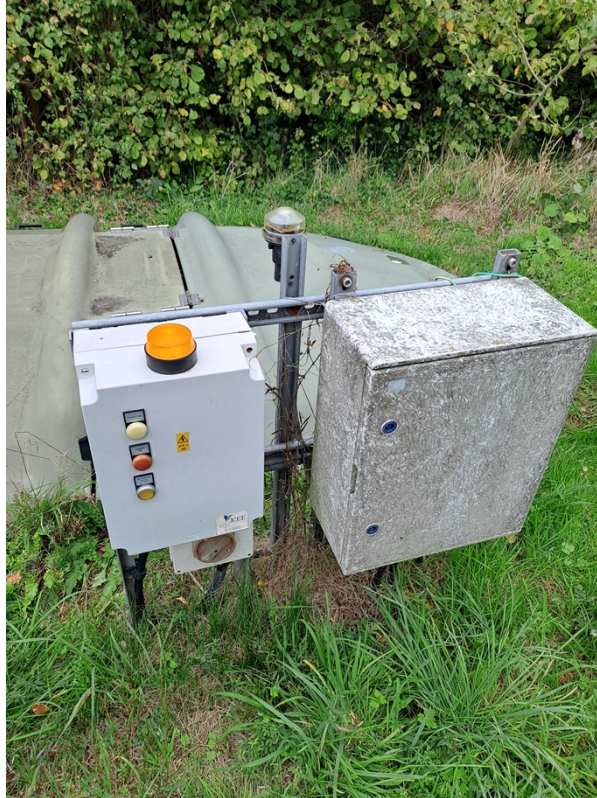
The small control box for the system was observed (Figure 5). There was no damage present and there was an isolator in place. This is appropriate for the size and nature of the system. No concerns raised.

Figure 5: The control box as observed during the visit.
