Compliance Assessment Report CAR_NRW0049814

Permit being assessed: BP0228201

For: ABERYSTWYTH STW GLANYRAFON, held by DWR CYMRU CYFYNGEDIG

Type of assessment carried out: Site Inspection, Reason: Routine.

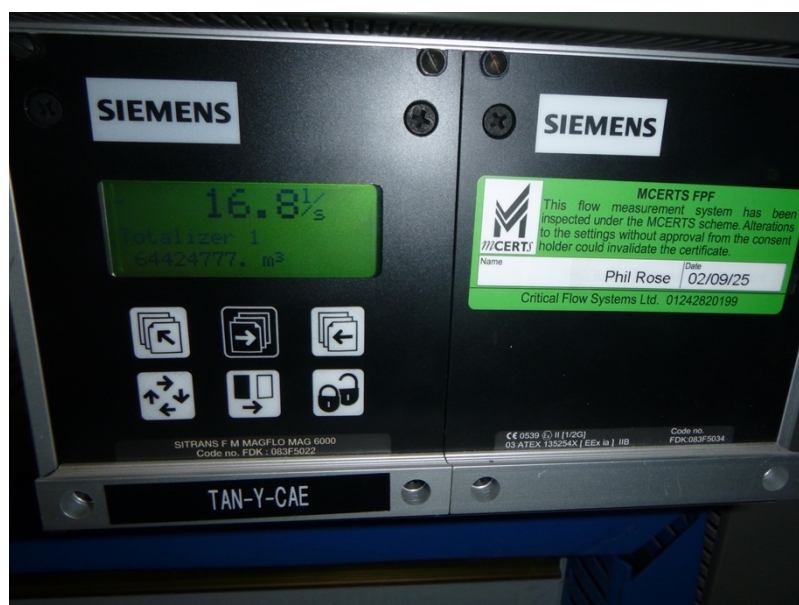
Sewage arrives at Aberystwyth STW from Tan y Cae and Bow Street Sewage Pumping Stations (SPS). An MCERTS flow passed forward (FPF) meter at Aberystwyth STW measures the amount of flow arriving from Tan y Cae SPS. The flow meter's visual display can be viewed within the site's control room as shown in photograph 1 below. At the time of the site inspection, 16.8l/s was being passed forward from Tan y Cae SPS to Aberystwyth STW. The MCERTS certification for the meter was last renewed on the 02 September 2025. The FPF meter for Bow Street SPS is located at Bow Street SPS rather than Aberystwyth STW.

Photograph 1: Visual display for Tan y Cae SPS MCERTS FPF meter

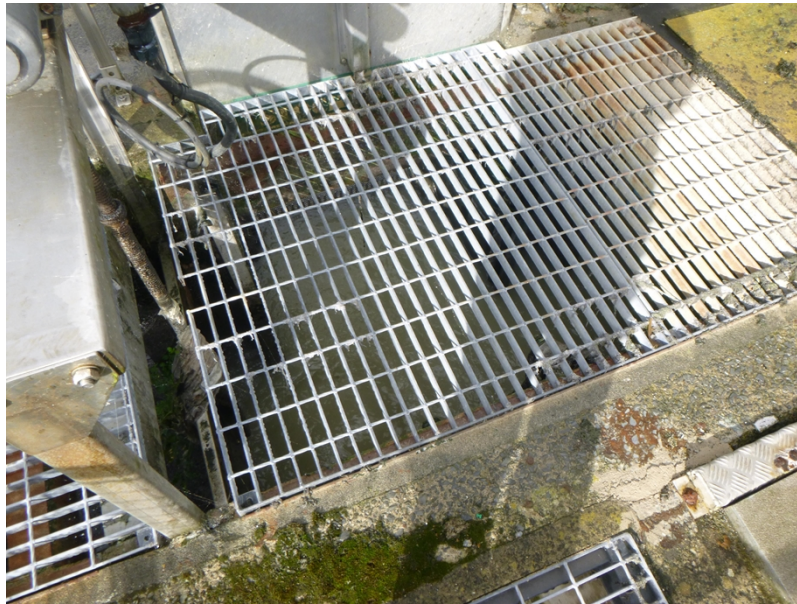
Aberystwyth STW's inlet is shown in photograph 2 below. A representative sample of the influent may be obtained at this location as required by condition U4(a) of the Urban Waste Water Treatment Regulations (UWWTR). The sample point is however not appropriately labelled as required by condition U4(a). A category 4 non-compliance has therefore been recorded above for a non-compliance that cannot foreseeably have any impact on the environment, people and/or property. To rectify this non-compliance, NRW ask DCWW to ensure that the Urban Waste Water Treatment Directive (UWWTD) crude sewage sampling point at Aberystwyth STW is appropriately labelled by no later than the **31 December 2025**.

Photograph 2: Aberystwyth STW inlet and UWWTD crude sewage sampling point

Criteria	Action needed	Complete by
WQ-B2	Ensure that the UWWTD crude sewage sampling point at Aberystwyth STW is appropriately labelled.	31/12/2025
WQ-B2	Fix leak in pump which pumps sludge from the primary settlement tanks.	31/12/2025

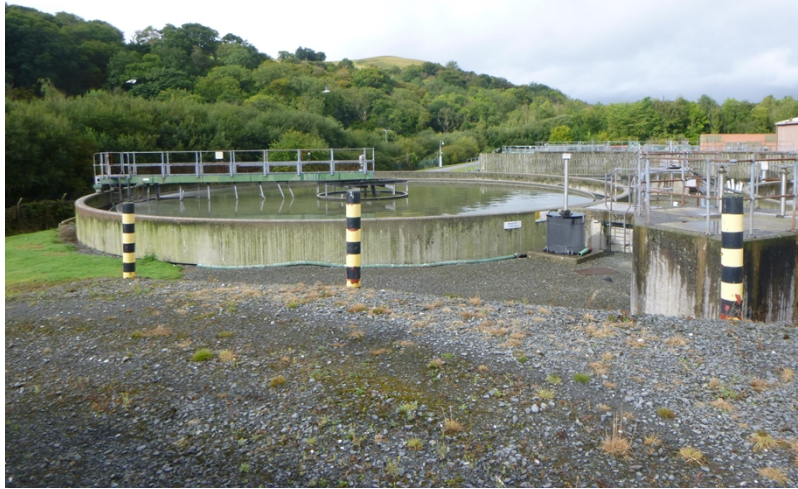
After passing the inlet, flows at Aberystwyth STW are screened by two inlet screens with automatic wipers. Flows then enter grit classification tanks for the removal of grit. Following screening and grit classification, flows enter two primary settlement tanks, one of which is shown in photograph 3 below. Sludge pumped from the primary settlement tanks undergoes centrifugation to remove the liquid fraction. The liquid fraction is returned to the inlet for treatment whilst the solid fraction, or cake, is transported from site to be anaerobically digested. At the time of the site inspection, a small leak was evident within the pump pumping sludge from the primary settlement tanks as shown in photograph 4 below. Although the leak did not appear to be having an environmental impact, DCWW are asked to fix the leak by the **31 December 2025**.

Photograph 3: One of two primary settlement tanks

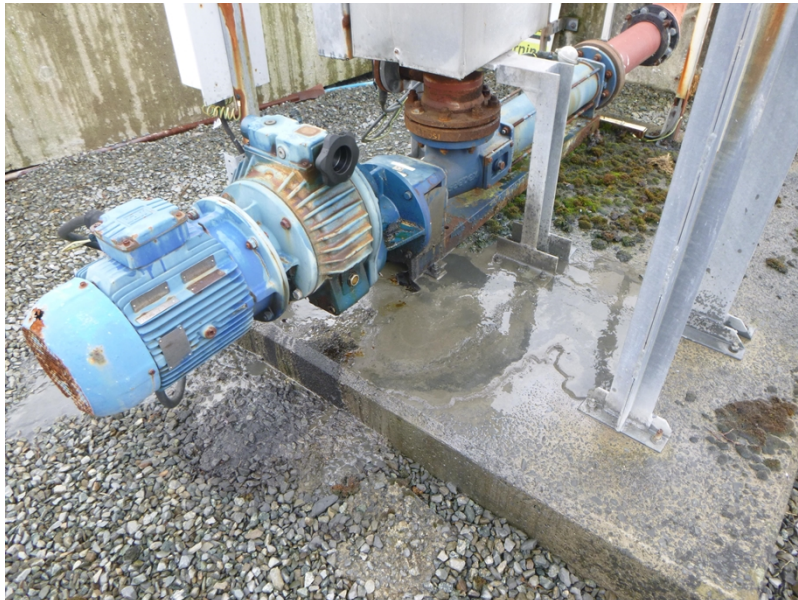
Photograph 4: Small leak evident in sludge pump

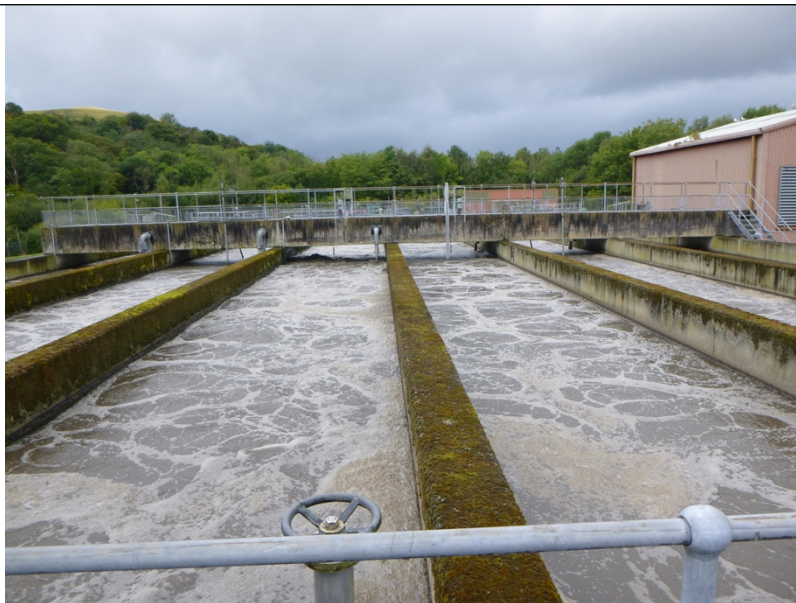
Flows exiting the primary settlement tanks enter two aeration lanes as shown in photograph 5 below. Immediately before doing so, flows pass an anoxic zone to starve the microbes before they enter the oxygen enriched environment of the aeration lanes. This improves the effectiveness of this part of the treatment process.

Photograph 5: Aeration lanes

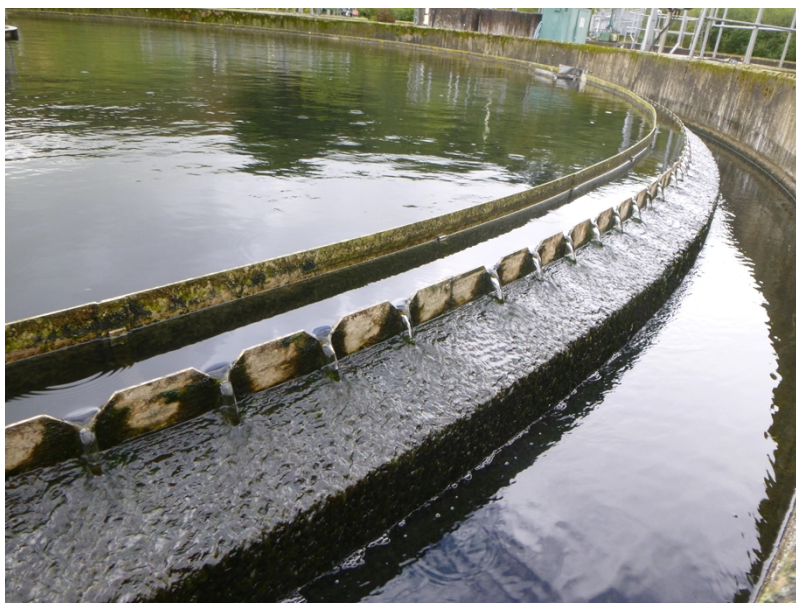
Flows exiting the aeration lanes enter three final settlement tanks. One final settlement tank is larger in size, with the other two being equal in size (approximately 20-20-60 split). Photograph 6 below shows flows discharging from one of the three final settlement tanks. Flows from the final settlement tanks combine prior to UV dosing.

Photograph 6: Discharge from one of three final settlement tanks

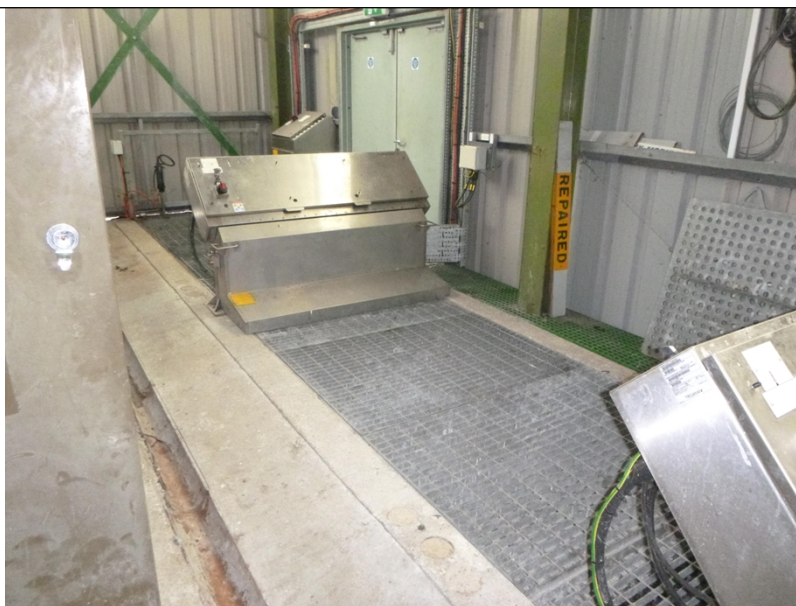
Two UV banks exist at Aberystwyth STW, one of which is shown in photograph 7 below. The UV banks have automatic cleaning systems. In accordance with condition 28 of permit BP0228201, a fixed standby generator with accompanying fuel tank is located on site to ensure that the UV plant continues to receive power in the event of an external power supply failure.

Photograph 7: One of two UV banks

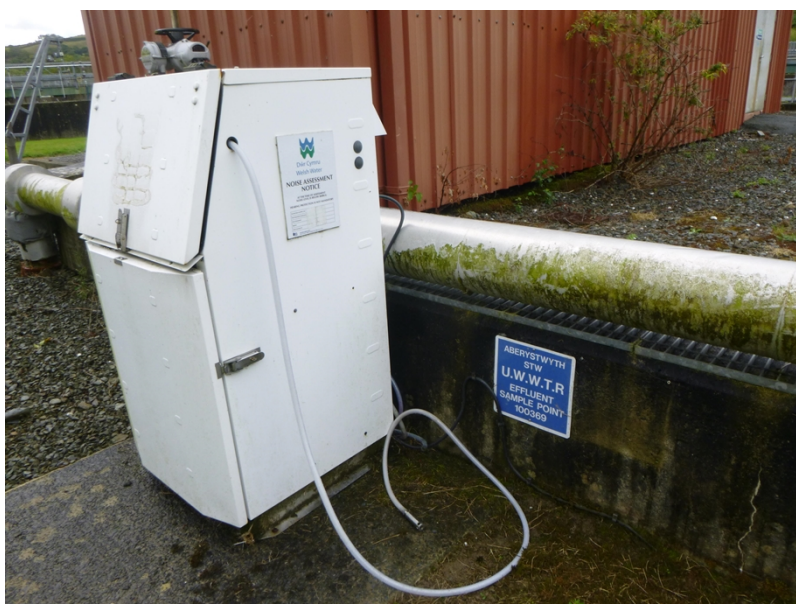
Following UV dosing, flows pass an appropriately labelled UWWTR effluent sample point as required by condition U4(b). The UWWTR effluent sample point is shown in photograph 8 below. An ammonia reader and MCERTS flow meter also exist at this location. The visual display for the flow meter can be found inside the site's control room as shown in photograph 9 below. The MCERTS meter was last verified on the 05 April 2022. At the time of the inspection, 151l/s appeared to be passing the UWWTR effluent sample point. This is compliant with condition 7 of the permit which states that *"the rate of discharge shall not exceed 290 litres per second"*.

Photograph 8: UWWTR effluent sample point

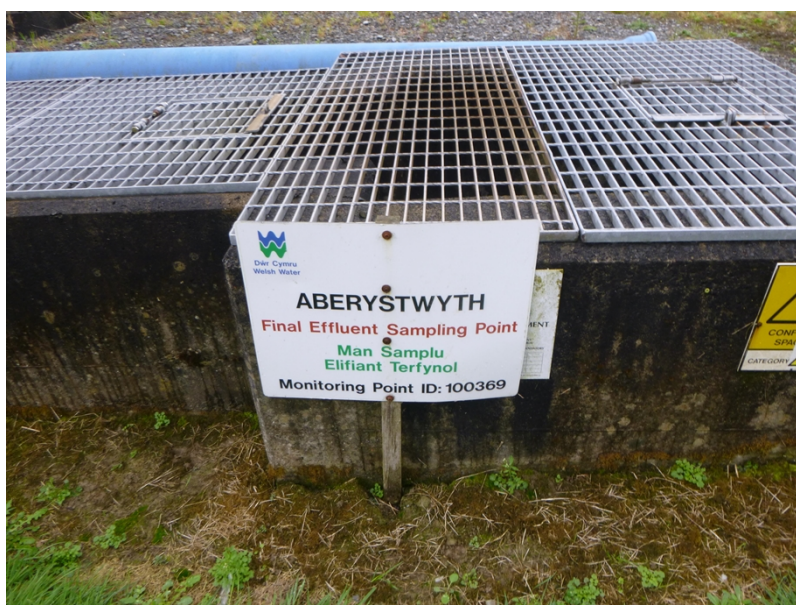
Immediately after passing the UWWTR effluent sample point, final effluent passes an appropriately labelled final effluent sampling point as required by condition 4 of the permit. The final effluent sampling point is shown in photograph 10 below. Final effluent appeared clear at the time of the inspection with no significant trace of visible oil or grease.

*Photograph 10: Final effluent sampling point*
