Compliance Assessment Report CAR_NRW0049846

Permit being assessed: YP3937SH.

For: Amex Park, **held by:** Mekatek Limited

Type of assessment: Site Inspection,

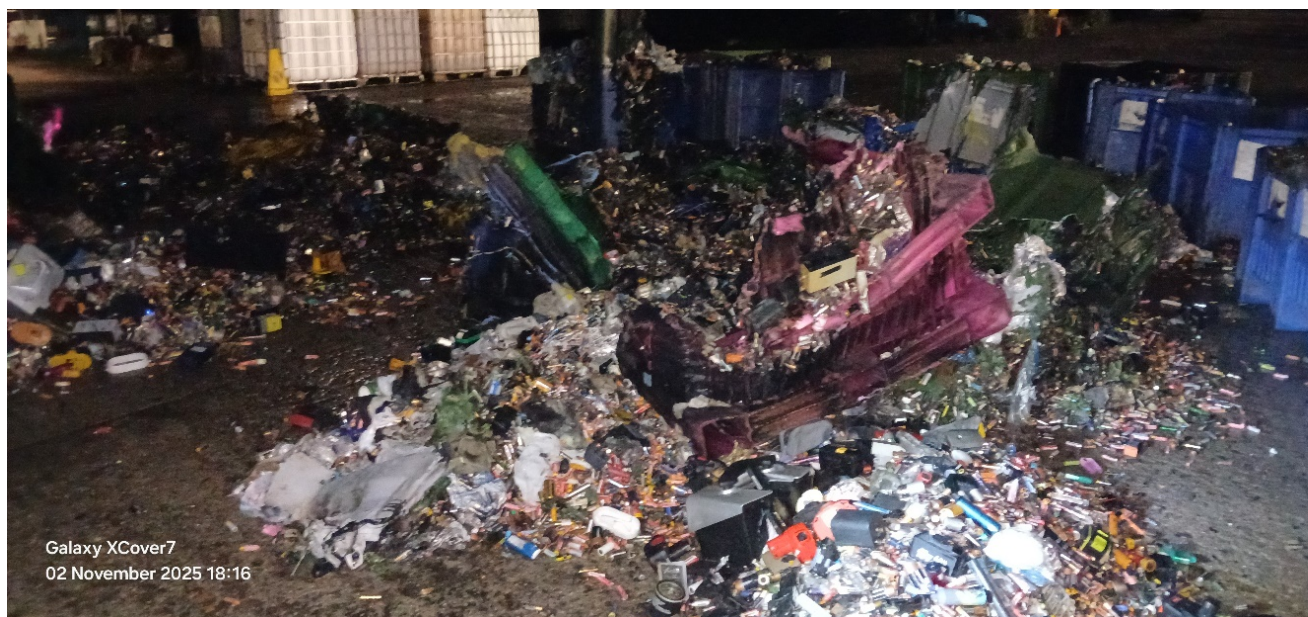
Following extinguishment, and on the advice of the FRS, the fire-affected material was relocated from the building to an open area of the yard. This area is surfaced with impermeable concrete and benefits from sealed drainage infrastructure (see Image 1). The FRS continued to cool the material using fire hoses and maintained a fire watch to monitor for potential reignition.

Image 1 - Taken at 18:16 on 2 November 2025, showing fire-affected materials relocated from the transfer station and stored on an impermeable surface within the yard.

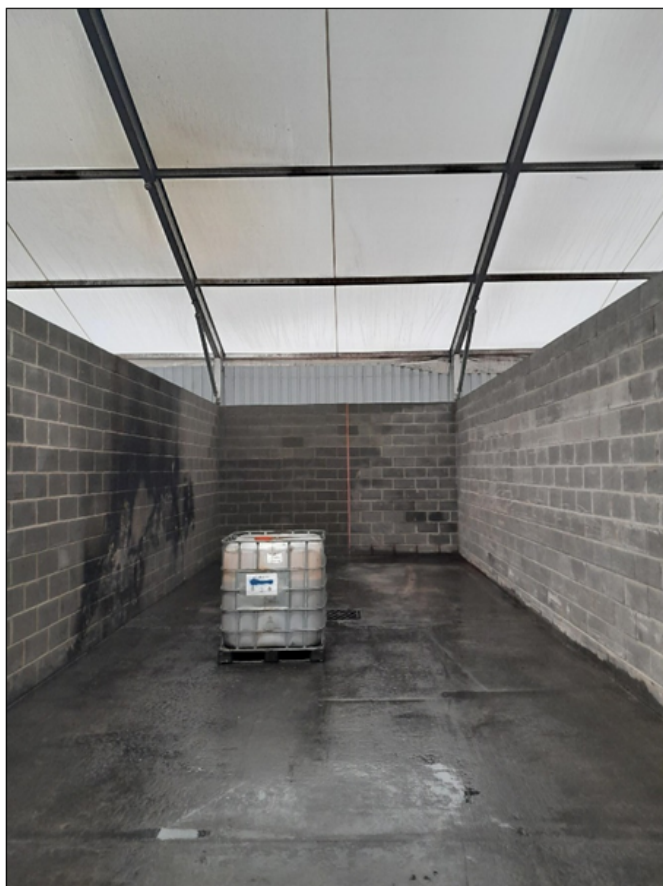
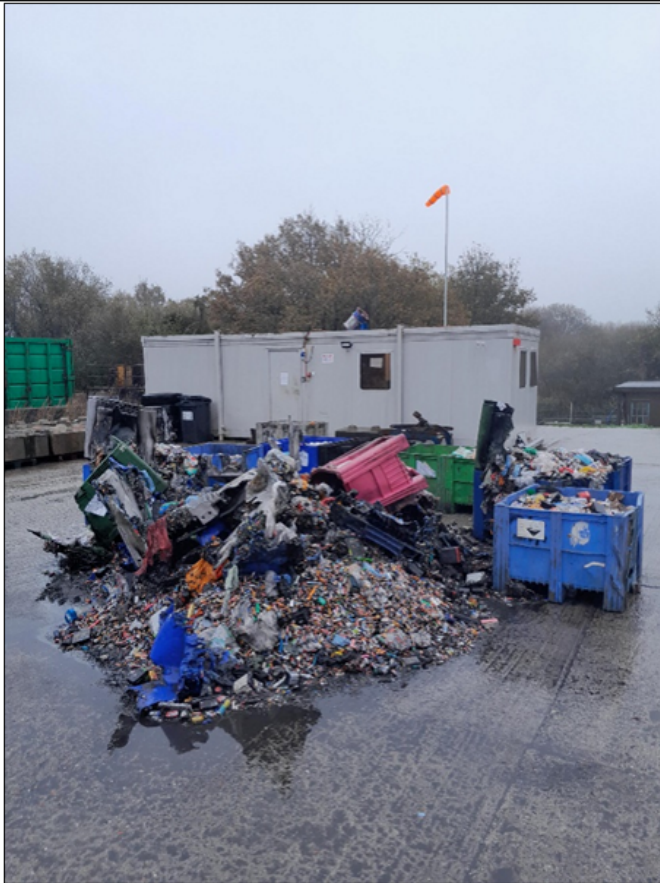
NRW officers proceeded to inspect the transfer station area and observed the fire-affected material that had been relocated to the yard, as shown in Image 4. The fire had been contained within a single storage bay inside the transfer station building. At the time of inspection, the bay had been cleared of all material, and the slot drain - previously pumped appeared to be unblocked. The building is equipped with fire-retardant roofing, which showed no visible damage. Scorch marks were present on one wall of the containment bay, but structural damage was limited to that area.

Images 3 and 4, taken at 9:45am on 3 November 2025, showing the containment bay within the transfer station building where the fire originated, and the fire-affected material relocated outside the unit and stored on an impermeable surface equipped with sealed drainage.

While firewater generated during the incident was effectively contained within the site's sealed drainage system, **unauthorised emissions to air** occurred due to smoke released during the combustion of lithium batteries and the plastic containers housing them. These emissions had the potential to cause environmental pollution, given the nature and composition of the materials involved.

1. **Provide NRW with the laboratory analysis results for the firewater captured in Tank 4 of the ETP.**
This will inform whether the material can be treated and discharged in accordance with the site's permit conditions.
2. **Conduct an investigation into the cause of the fire and submit a summary of findings to NRW.**
This should include any relevant CCTV footage, operational records, and contributing factors identified.
3. **Review the current Fire Prevention and Mitigation Plan (QP84) to ensure it reflects the latest NRW guidance, particularly regarding the storage and management of lithium and lithium-ion batteries.**
Any updates should be submitted to NRW for review.
