## Compliance Assessment Report CAR\_NRW0049761

**Permit being assessed:** DB3495CT

For: Microsoft, held by John Paul Construction

**Type of assessment carried out:** Site Inspection, Reason: Routine.

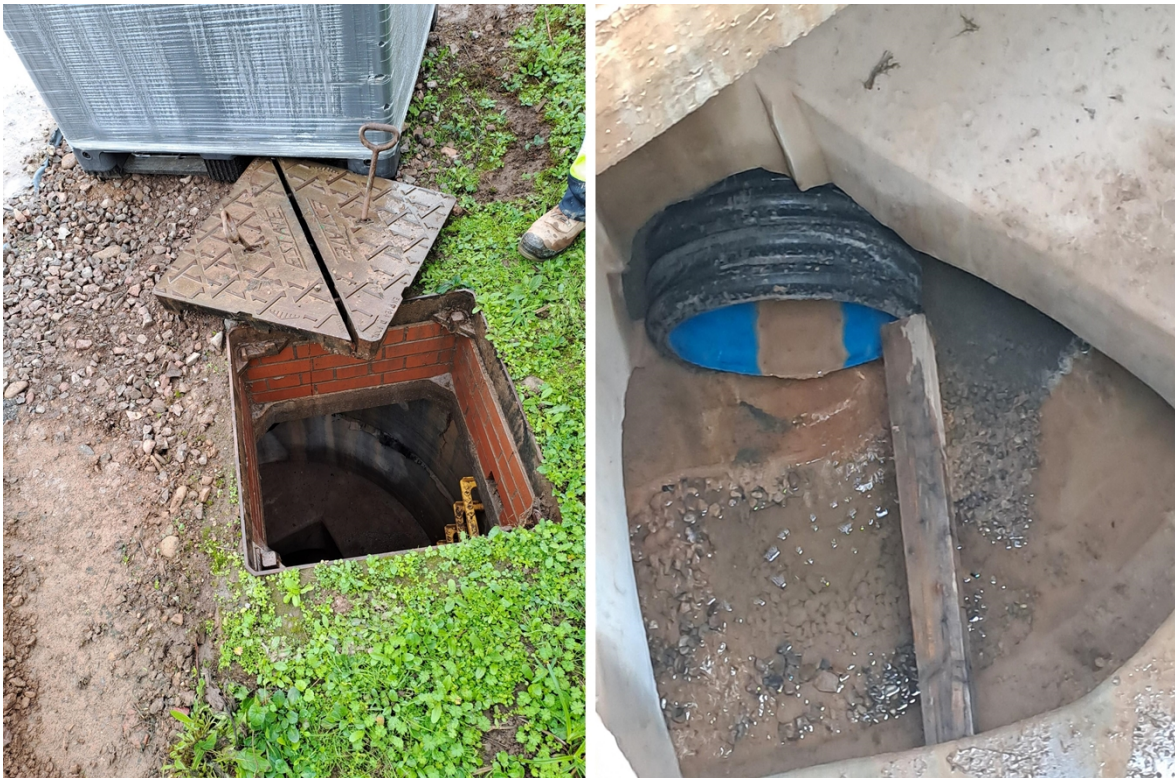
The effluent sample point was observed first and recorded to be located at ST2788583931 (measured using an on-site GPS). This reading is within 11m of the listed permitted location and as such is within the acceptable discrepancy meaning it is compliant. On

lifting the chamber cover, the discharge at the time of the visit was clear of any visible pollutants.

There appeared to be a large piece of timber within the chamber which I noted whilst reviewing the collected evidence after the visit. While not noted on site, I request that this item be removed as a priority to ensure it does not pose a restriction risk or damage any infrastructure which could lead to a non-compliance related to the discharge. This is actioned below.

While there was some accumulated sediments and aggregate within the chamber, this does not necessarily mean that a non-compliant discharge has occurred and is likely to represent an accumulation of solids over an extended period of time. As a precautionary measure, an advisory comment has been added to undertake periodic reviews of the chamber's condition and initiate a cleaning regime if required to ensure the accumulated solids do not pose a risk in future or restrict flows through the system. These observations can be seen in Figure 1.

Figure 1: The effluent sample point as observed during the visit.

3. Remove the piece of timer observed within the effluent sample point chamber.

1. Undertake periodic reviews of the effluent sample point chamber condition and initiate a cleaning regime if required to ensure the accumulated solids do not pose a

pollution risk or restrict flows through the system.

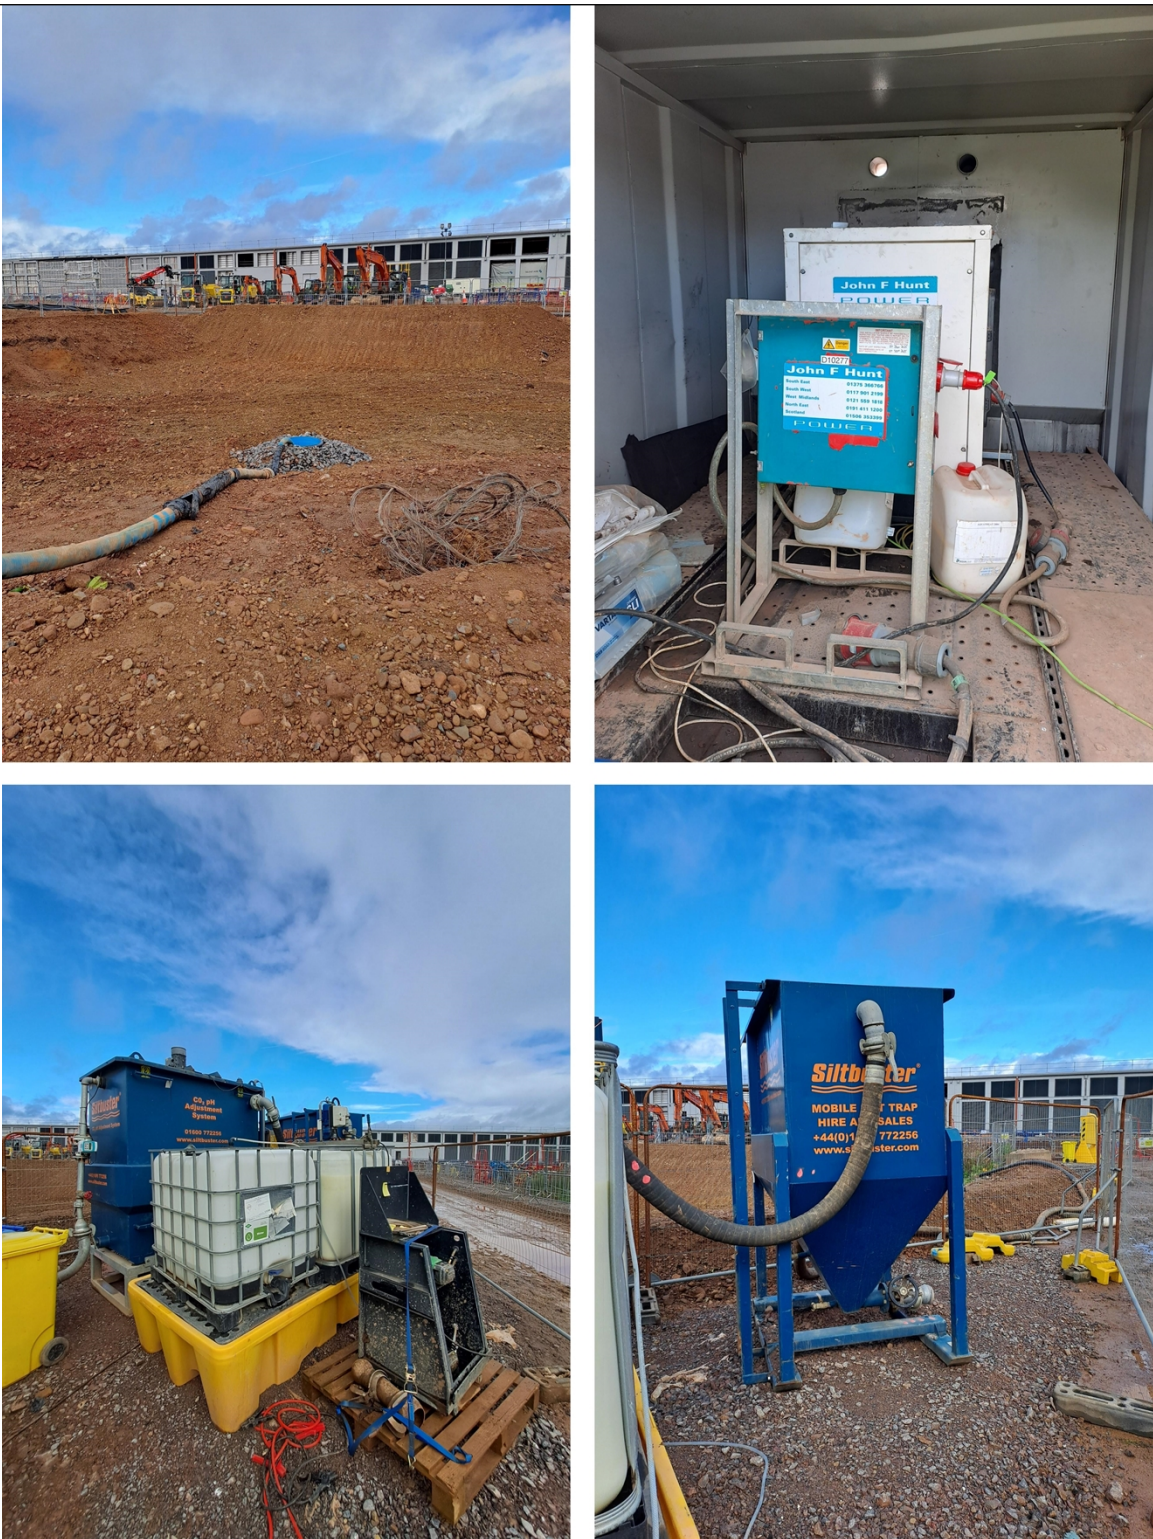
The treatment system and settlement pond were observed, composing of a generator, dosing system and Siltbuster. The system was not in use at the time of the visit, so I requested information on the frequency of usage since it was installed, although I understand that it is dependant on rainfall which during the six months prior to the visit was lower than average. Overall the system seemed to be managed appropriately, with no excessive build up of material and requisite mitigation measures (bundling, spill kits etc) in place. I requested an example of maintenance records for the system to be shared as evidence of appropriate management. This is outlined below. These observations are evidenced in Figure 3.

Figure 3: The treatment system infrastructure as observed during the visit.

4. Confirm the frequency of the treatment system's use since it was installed (rainfall dependant).

5. Provide an example of maintenance records for the treatment system as evidence of appropriate management.
