Compliance Assessment Report CAR_NRW0049919

Permit being assessed: NP3894FK.

For: Point Of Ayr Treatment Facility, **held by:** Delyn Metals Ltd

Type of assessment: Site Inspection,

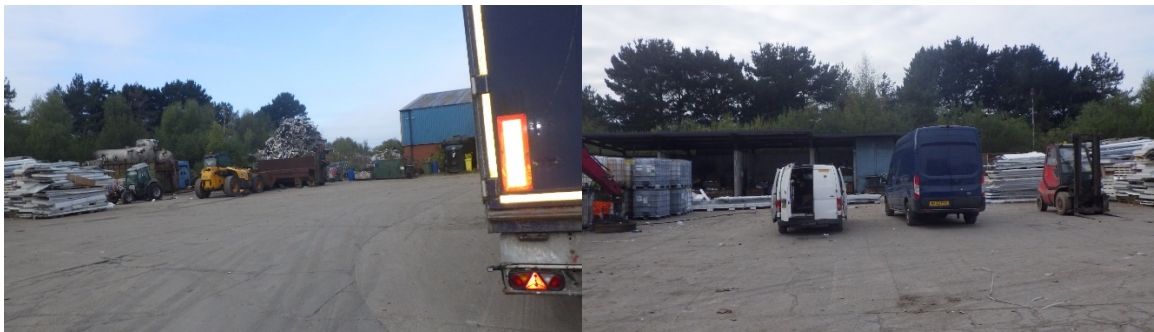
The officers saw some improvement in this area, with some panels stored close to the WEEE storage area.

The storage of the insulation panels was discussed during the last visit. The area where the panels were stored is not included in the site plan and therefore a breach of the condition 1.1.1 which states: "No waste management operations shall be authorised by this licence unless, 1 specified in and undertaken in accordance with the limitation in the following table. Table 1.1. Specified waste management operations – Storage The storage of waste shall be restricted to the areas identified for this purpose and outlined in red on site plan reference No. DELYN/PDA/002 16092006.

This breach has been assigned a **CCS3 score**.

Panels stored on site

Action: Please ensure waste is stored in compliance with the site permit. Please comply by the **28th November 2025**

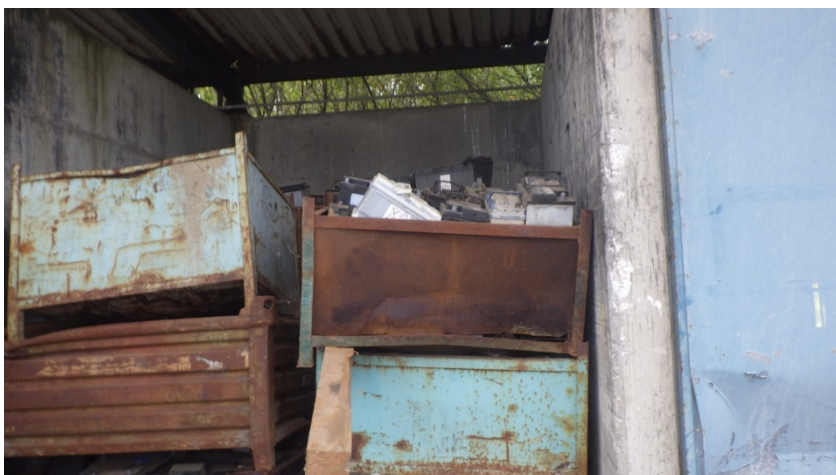
The batteries storage remains non-compliant.

Officers checked the containers which appeared unsuitable.

They were not acid-resistant with some of them clearly corroded and perforated in places. Please see the photos below.

Batteries stored in corroded containers

Table 4.4 b) v) states: “Lead acid batteries shall be stored in containers with impermeable, acid resistant base and a lid to prevent ingress of surface water”.

Action: Please ensure the batteries are stored in compliance with the site permit. Please comply by the **28th November 2025**.

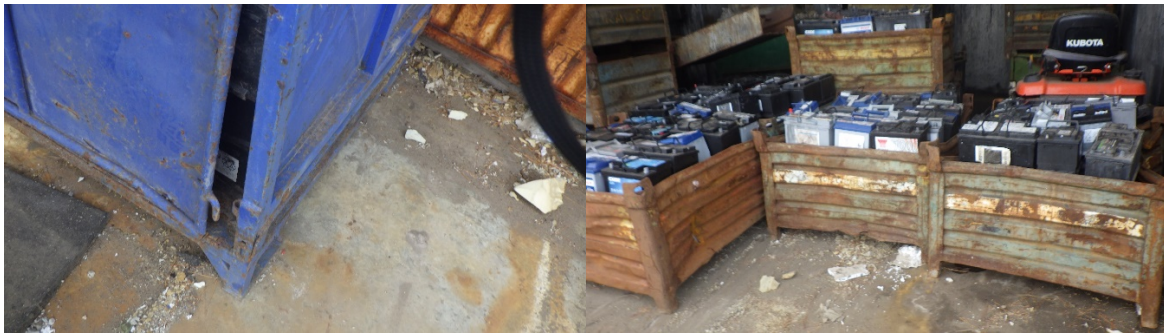
**Batteries stored in unsuitable metals containers**

This breach has been assigned a **consolidated CCS3 score**.

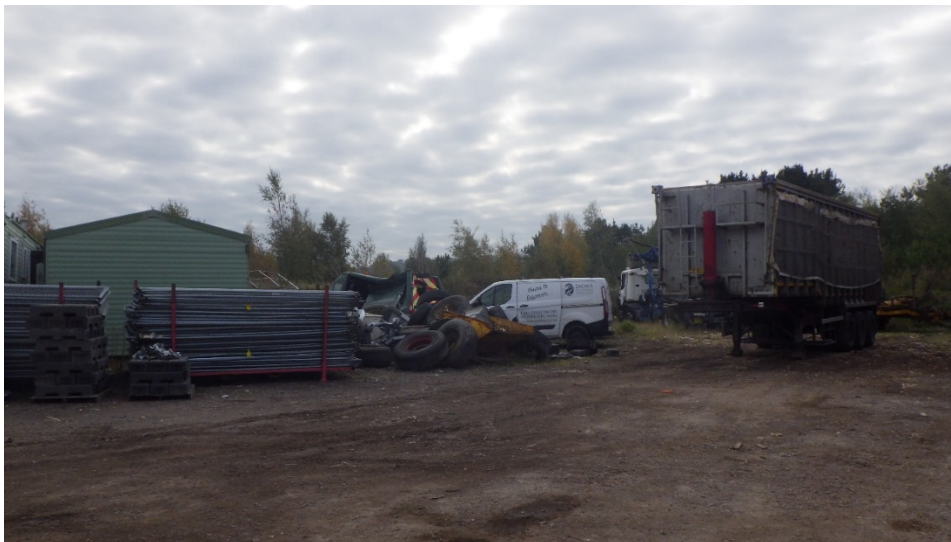
The storage of tyres on site remains non-compliant with the site plan.

Officers noticed tyres being stored around the site, including on permeable ground in the same location where they had been stored at the time of previous inspection, which resulted in a C3 non-compliance score. Please see photos below.

Tyres stored on the ground, same location as during the last site inspection

Once removed from vehicles, these waste types shall be stored **in separately designated areas** provided with an **impermeable pavement and sealed drainage** in accordance with condition 2.1

Tyres shall be stored in **stable stacks** with individual capacities of no greater than 50 cubic metres and to a height of no greater than 3 metres. Individual tyre stacks shall not be stored within 6 metres of each other. Individual tyre stacks shall not be stored within 15 metres of the site boundary or building. Tyre stacks shall not be located within 10 metres of any area used for flame cutting operations”.

Action: Please ensure the tyres are stored in compliance with the site permit. Please comply by the **28th November 2025**.

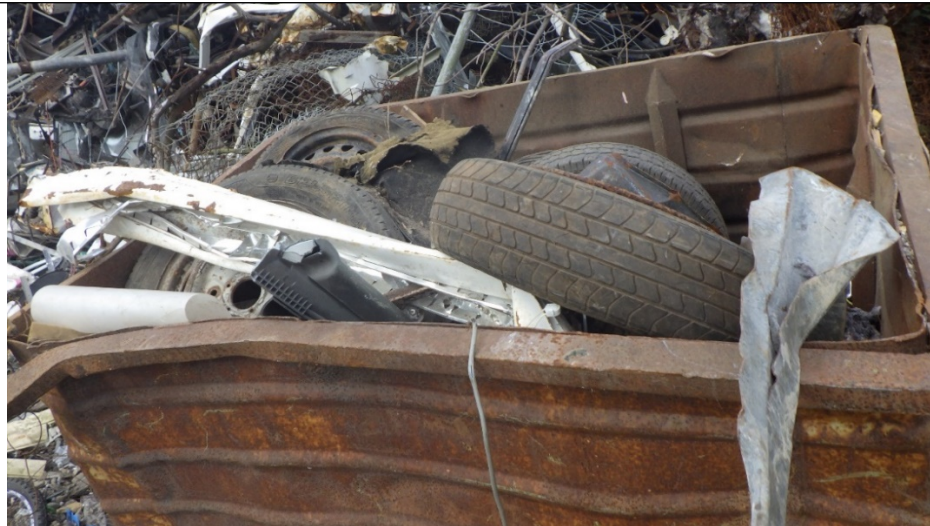
Tyres stored mixed with other waste in a metal container.

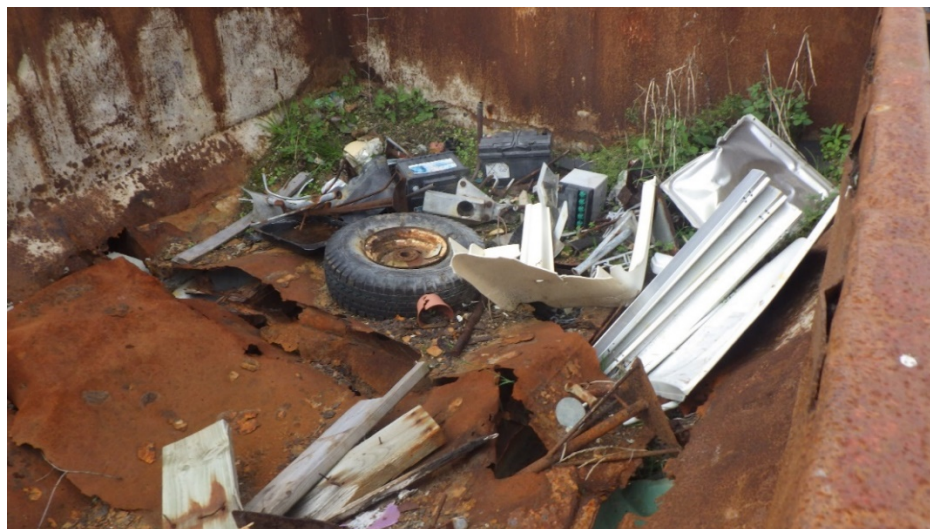
Tyre stored in corroded metal container mixed with several batteries

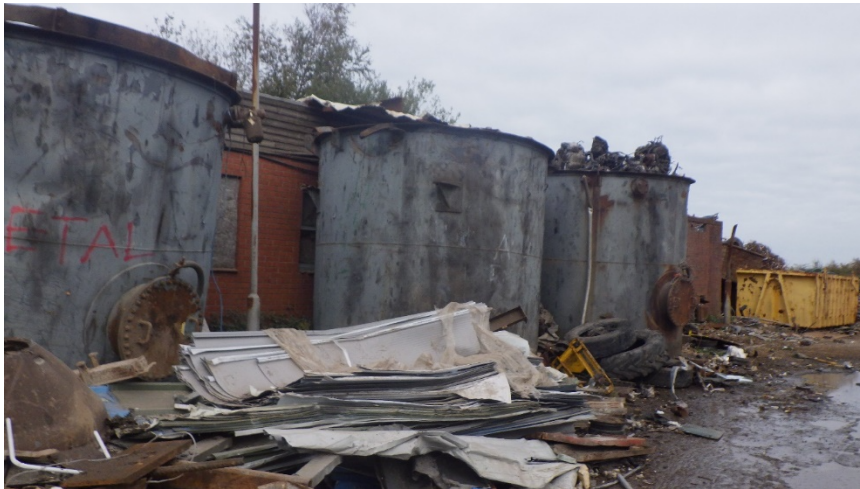
The storage of oil contaminated parts remains non-compliant and have been discussed with the management on a number of occasions.

The majority of oily part seen during the inspection were seen in upright metal containers. The containers were not weatherproof and did not have a cover. This has been raised with the manager during this and previous inspections.

It is noted that the site management has ordered more suitable covers. **Table 4.4 (b)** states that oil contaminated parts are to be stored within dedicated appropriate containers which are fit for purpose. The containers are to be clearly and unambiguously labelled regarding their content.

This storage arrangement is in breach of the afore-mentioned condition and has been assigned a **consolidated C3 score**.

Action: Please ensure the oily parts are stored in compliance with the site permit. Please comply by the **28th November 2025**.

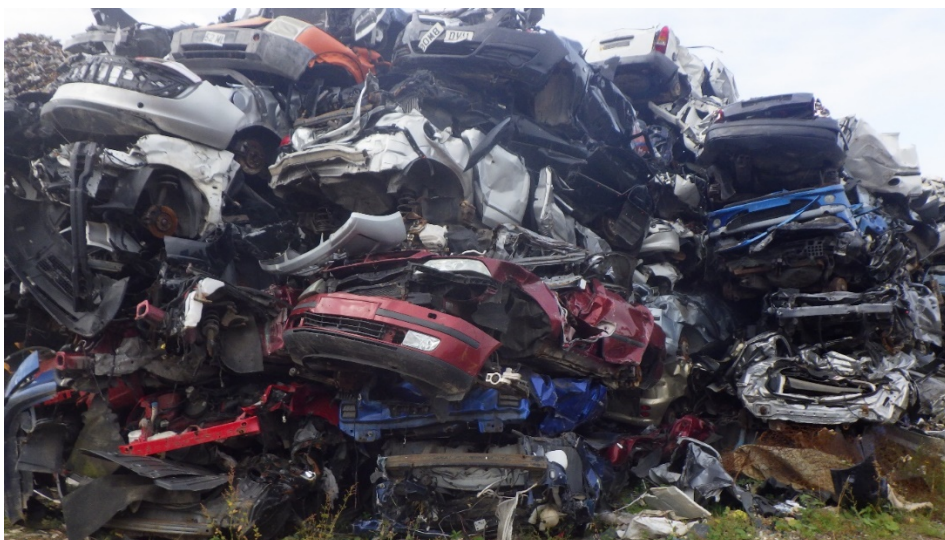
The storage of ELVs on site remains non-compliant with the site plan.

ELVS stored at the back of the storage pile opposite the office

The area at the back of the site office is shown as an ELV process area, on the original site plan. The updated site plan describes the storage area for depolluted, baled ELVs as being next to the interceptor.

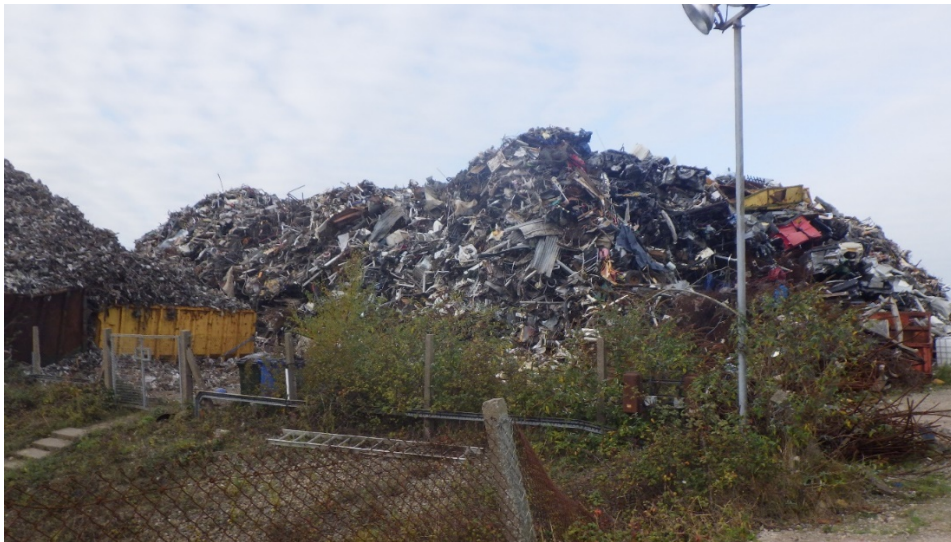
ELVs mixed with metal stored on site

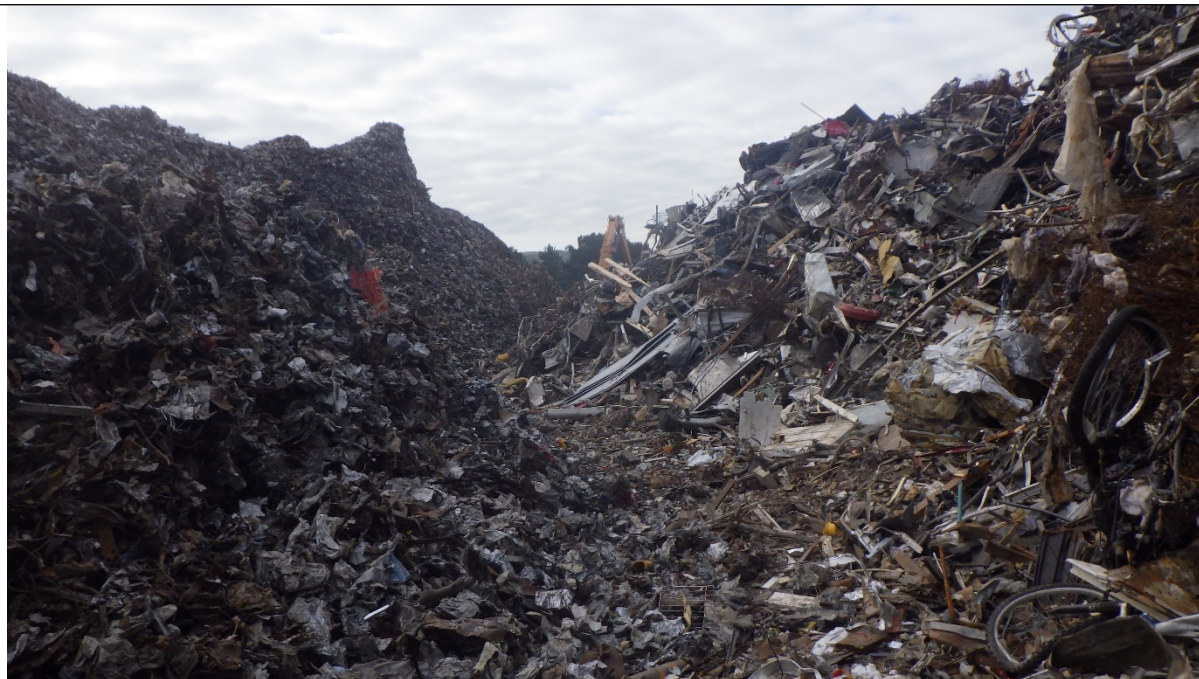
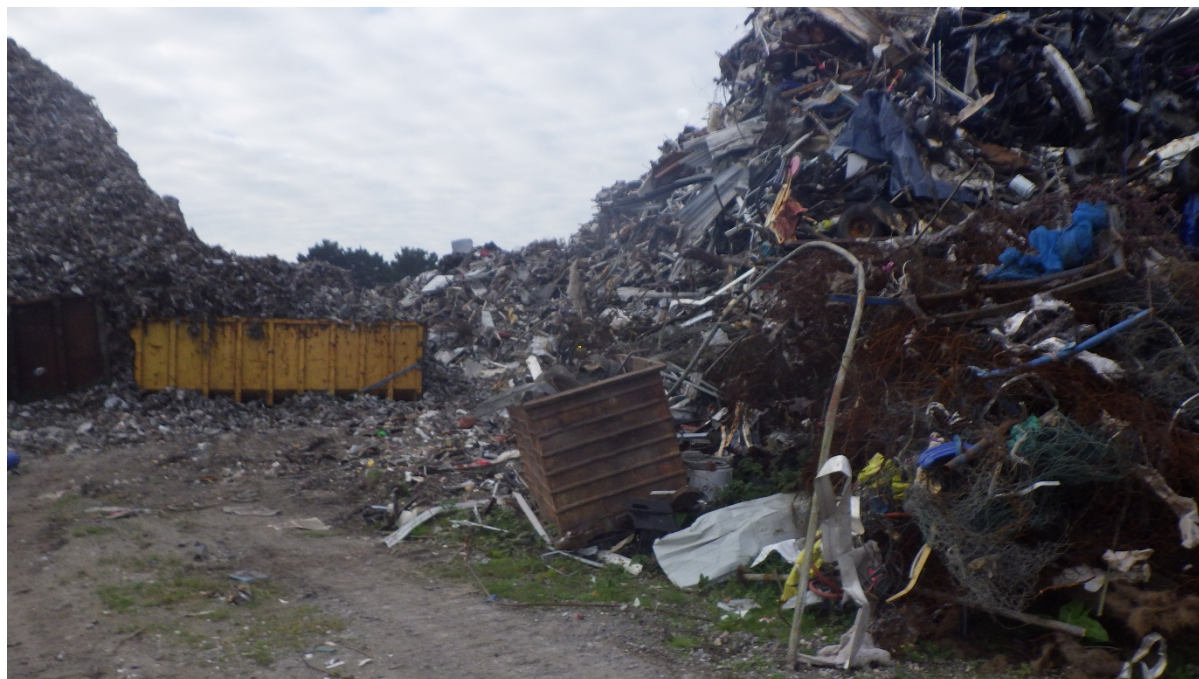
As NRW officers walked around the site it was noted that one of the paths was still completely blocked by waste.

The arrangements are not as described in the current Working plan and are also a hazard should an emergency situation arise on site. This issue was discussed with the site manager and an immediate action is required to ensure emergency services have access to all parts of the site should they deal with an emergency situation i.e. fire.

This breach has been assigned a **consolidated C3 score**.

Path blocked by waste

Action: Remove waste blocking the path by the **14th November 2025** and provide photographic evidence to NRW

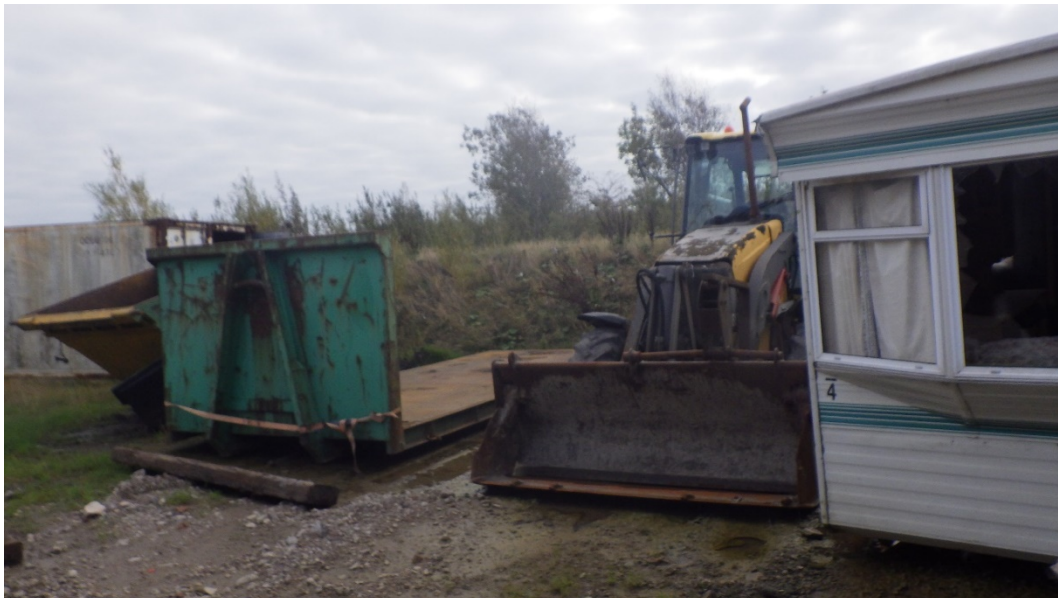
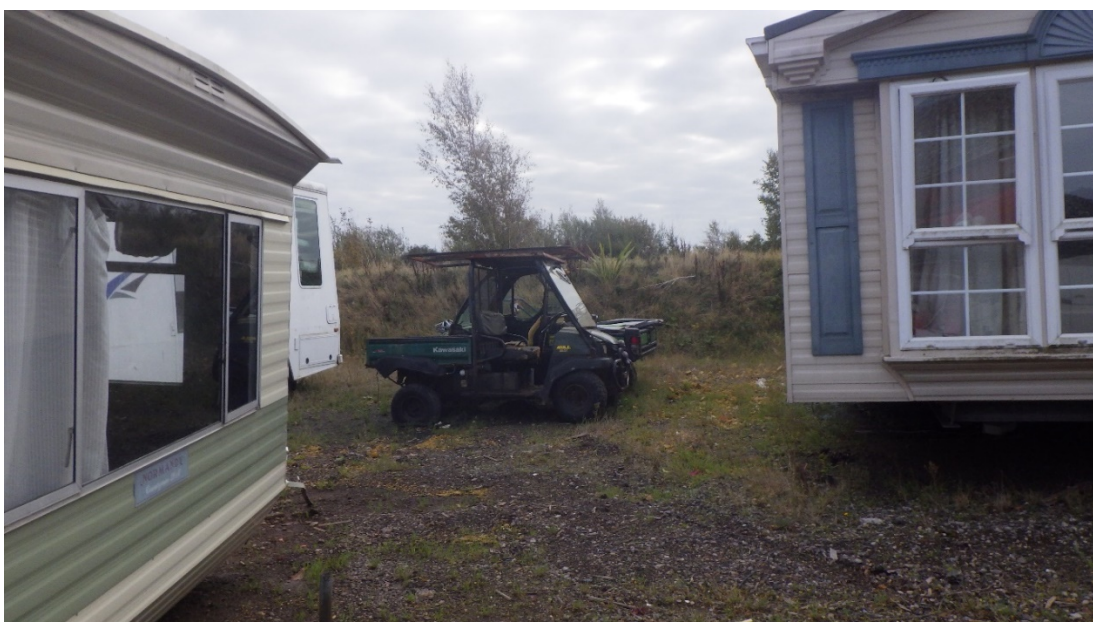
The deposit of trommel fines and using them as material to build a bund on site is a breach of permit

condition 1.1.1.

Keeping the trommel fines at the current location on site constitutes an illegal deposit. As a result a **CCS3 score** has been assigned for this breach.

Bund created using trommel fines**Hardstanding surfaces**

Action: Remove all trommel fines, used to create the bund, from site and provide duty of care documents for the removal. Please comply by the **28th of February 2026**.

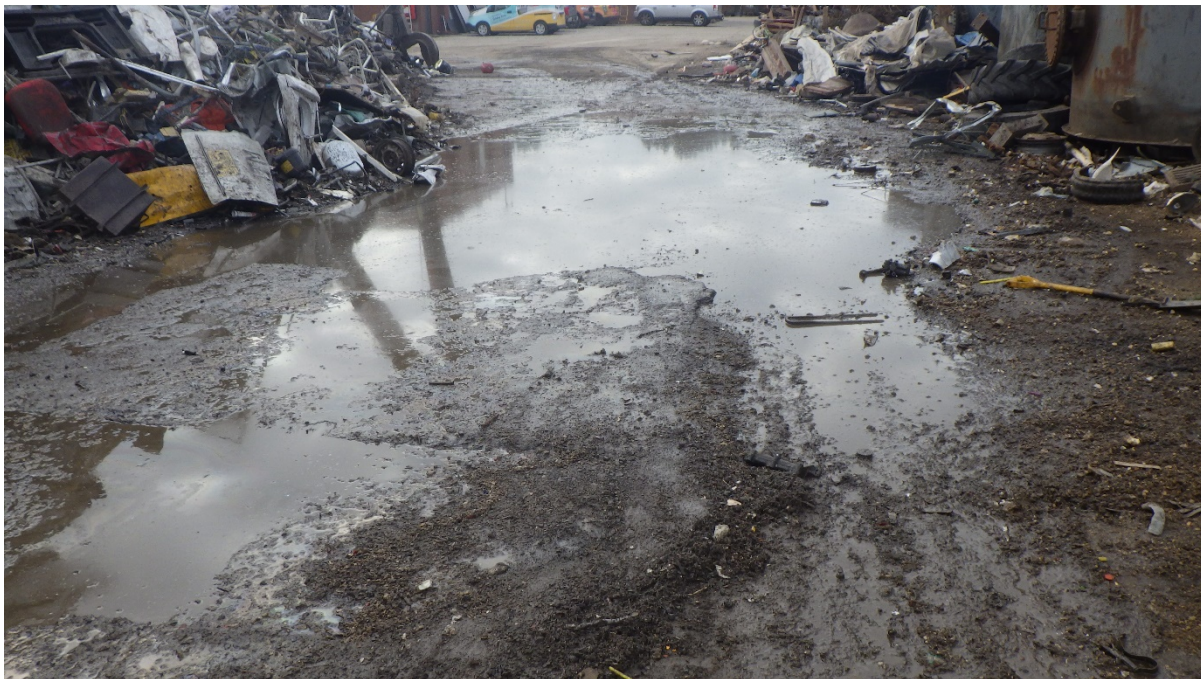
During this site inspection it transpired that the surfaces remain uneven, cracked and filled with standing water after rainfall. This is a potential pathway for pollution from the waste stored on site. There was visible oily film on top of the standing water.

Standing water, storage areas

- iii. shall not be subject to rutting by vehicles even when wet
- iv. shall have sufficient durability to allow cleaning for example by scraping
- v. **shall remain free of standing water.**

This breach has been assigned a **CCS3 score**.

Action: Please ensure all surfaces are maintained, kept in good condition and in compliance with the site permit. Please comply by the **28th November 2025**.

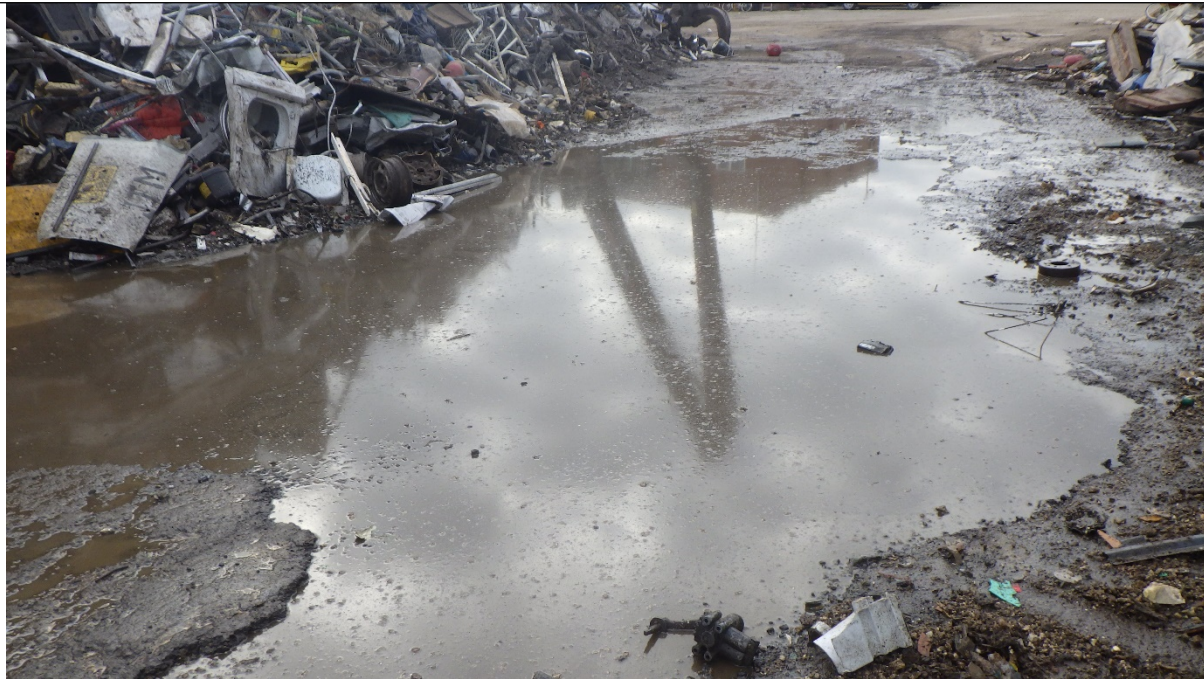
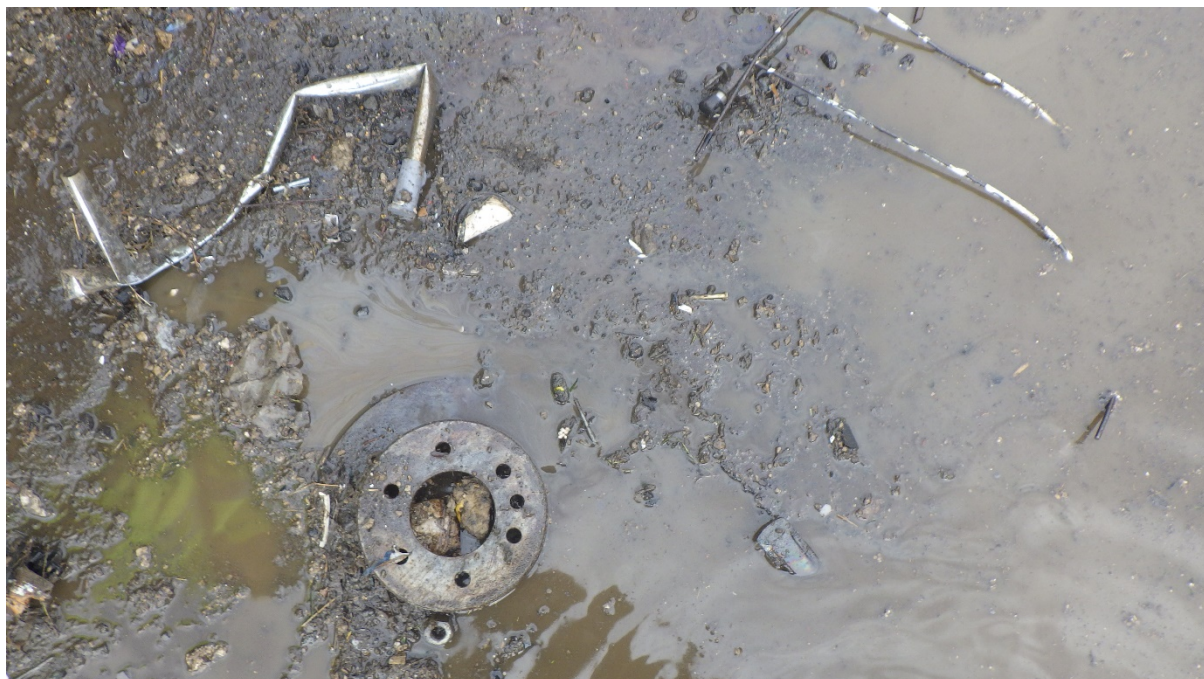
Standing water with oily film visible

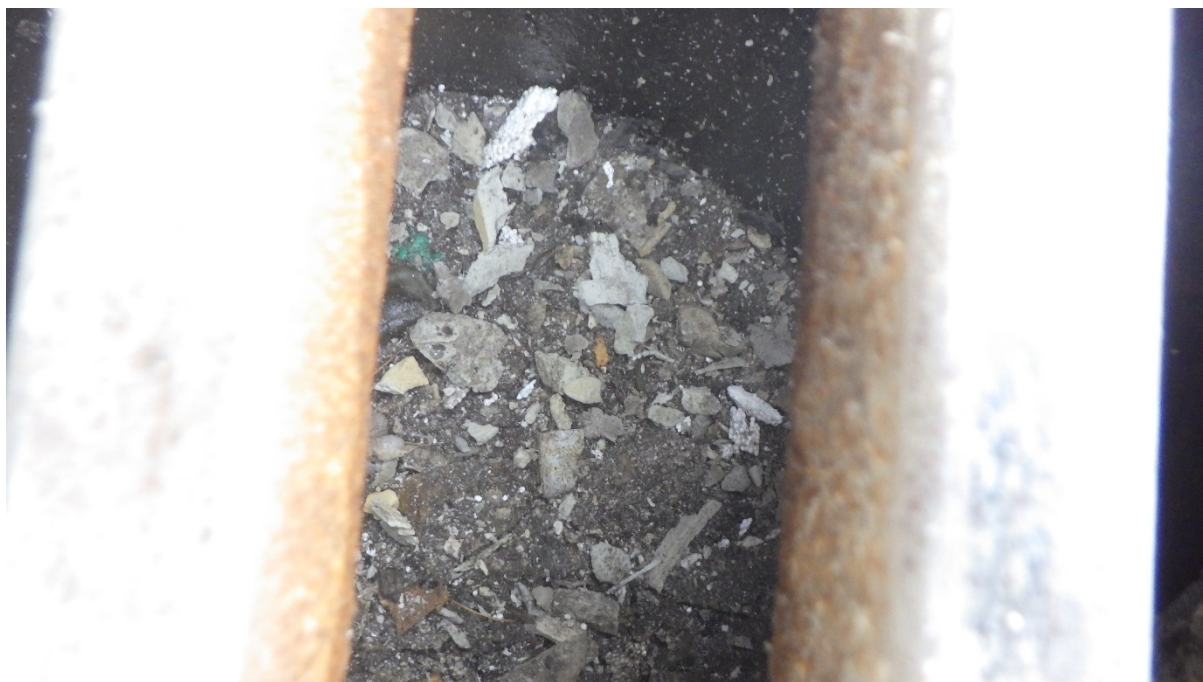
During the last inspection blocked drains were discussed with the site manager. An action was requested to check and clear the drains, which was to be carried out by an external company. During this site inspection the drains appeared to have a lot of residue, including pieces of foam.

Residue at the bottom of surface drain.

Action: Please provide evidence to NRW of the last maintenance of the surface water drains. Please comply by Friday the **14th of November 2025**.

Please ensure the drainage system is clear of debris and compliant with the permit section **5.3.1.2**.

Should the drainage system appear blocked the issue should be rectified without delay.

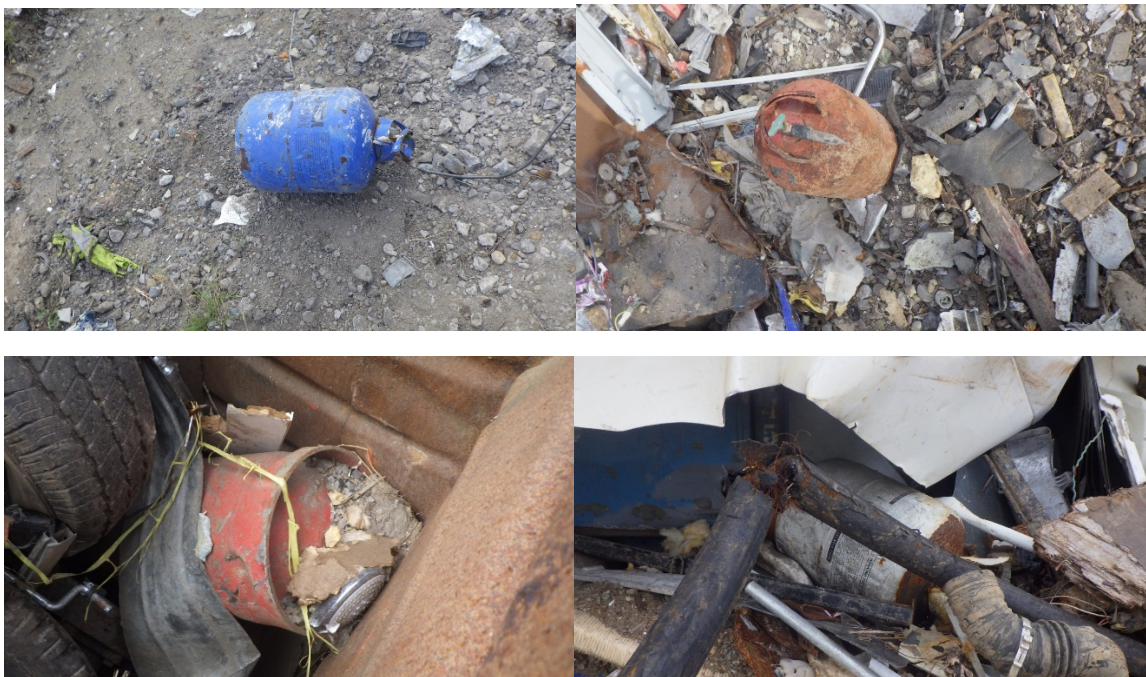
Fire extinguishers were seen amongst other waste metal on site, in a corroded container and also on the ground.

This waste type (EWC code 16-05-05 Gases in pressurised containers) is not on the list of wastes that can be, accepted on site. This breach has been assigned a **CCS3 score**.

Pressurised gas containers dotted around the site

Action: Please ensure your acceptance procedures are adhered to and all non-conforming waste is separated from other waste streams. Please ensure all pressurised gas containers are kept in the quarantine area in an upright lockable cage. **For immediate compliance.**

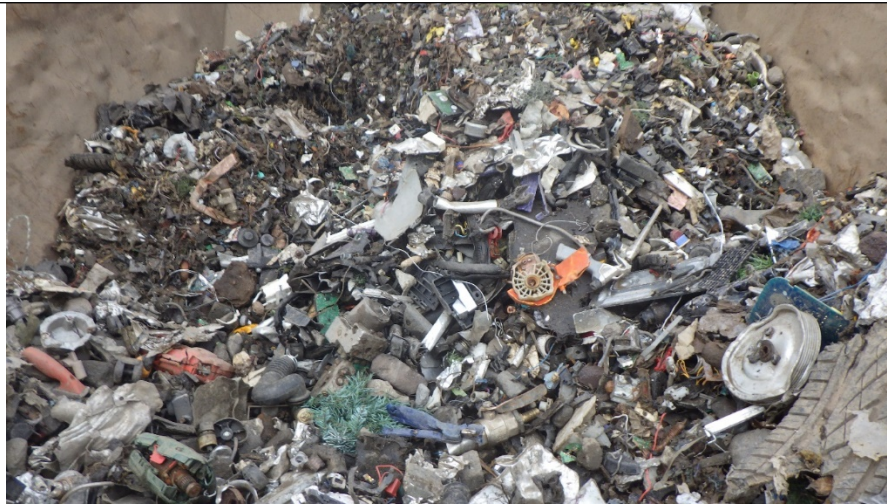
As officers walked around the site they noted several circuit boards were present mixed with a large pile of shredded waste. The manager stated that shredded metals are separated into ferrous and non-ferrous metals on site and pointed to a metal container which contained a mixture of shredded metals, including printed circuit boards (PCB)

Mixed shredded metals including PCBs

Action: Please provide evidence of the waste seen on site (PCBs) not containing hazardous components so they can be stored and treated as non-hazardous. Please comply by the **31st of November 2025**.

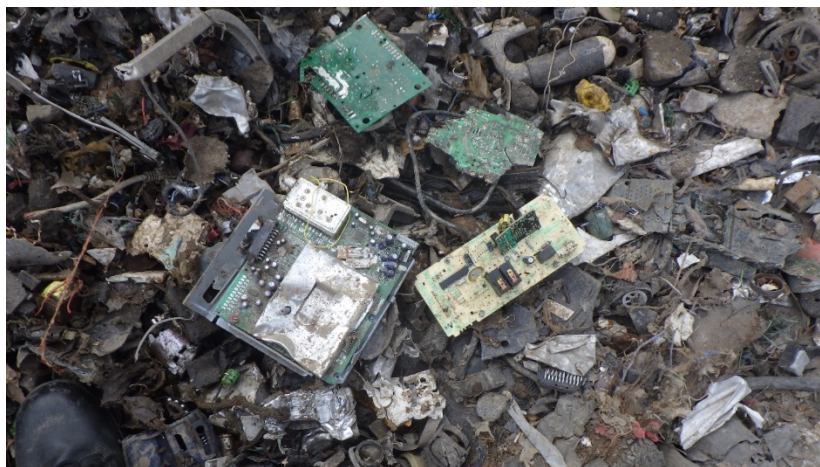
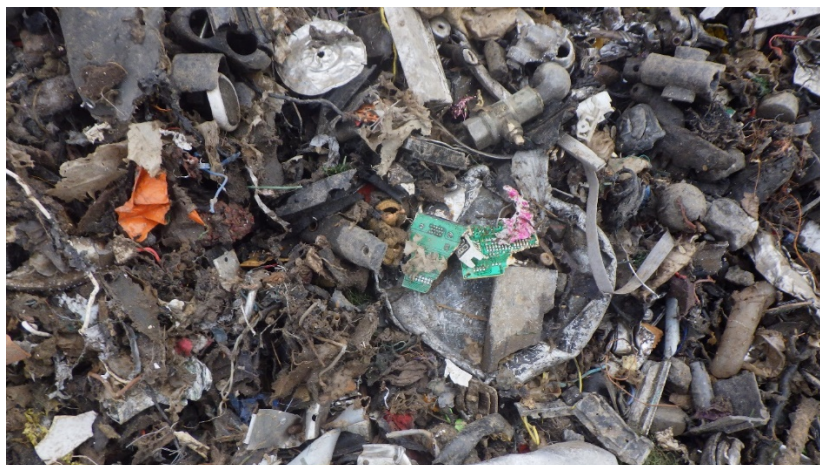
Circuit boards mixed with waste in the large storage area

“ Batteries, PCBs/PCTs containing capacitors and other hazardous waste must be stored in dedicated, labelled appropriate containers”.
