Compliance Assessment Report CAR_NRW0049764

For: SPS At Corporation Road Liswerry, held by DWR CYMRU CYFYNGEDIG

Type of assessment carried out: Site Inspection, Reason: Routine.

Site Visit Report

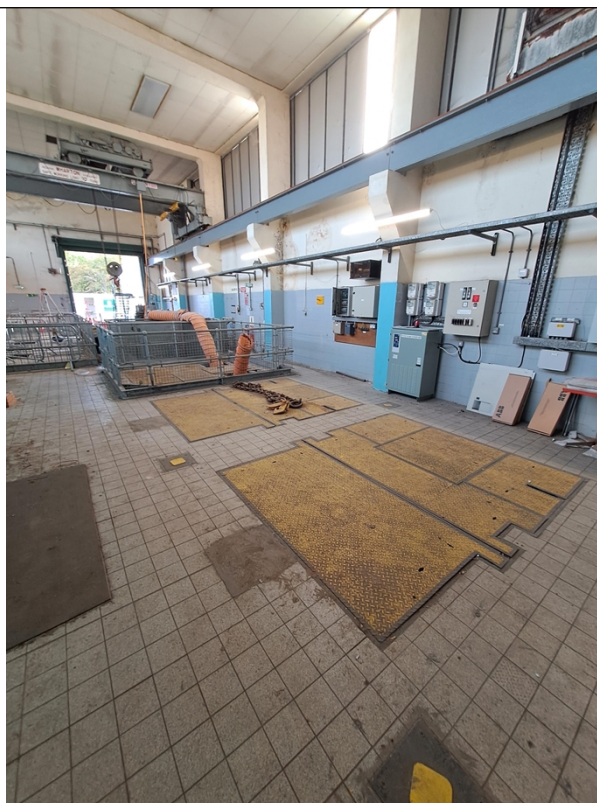
I commenced my inspection in the site control hall. General conditions were adequate, with access slightly hindered by the physical and health and safety restrictions posed by the ongoing repair works. However, this did not overly hinder the inspection. Figure 1 shows the conditions observed at the time of the visit.

Figure 1 – Control hall conditions at the time of the visit.

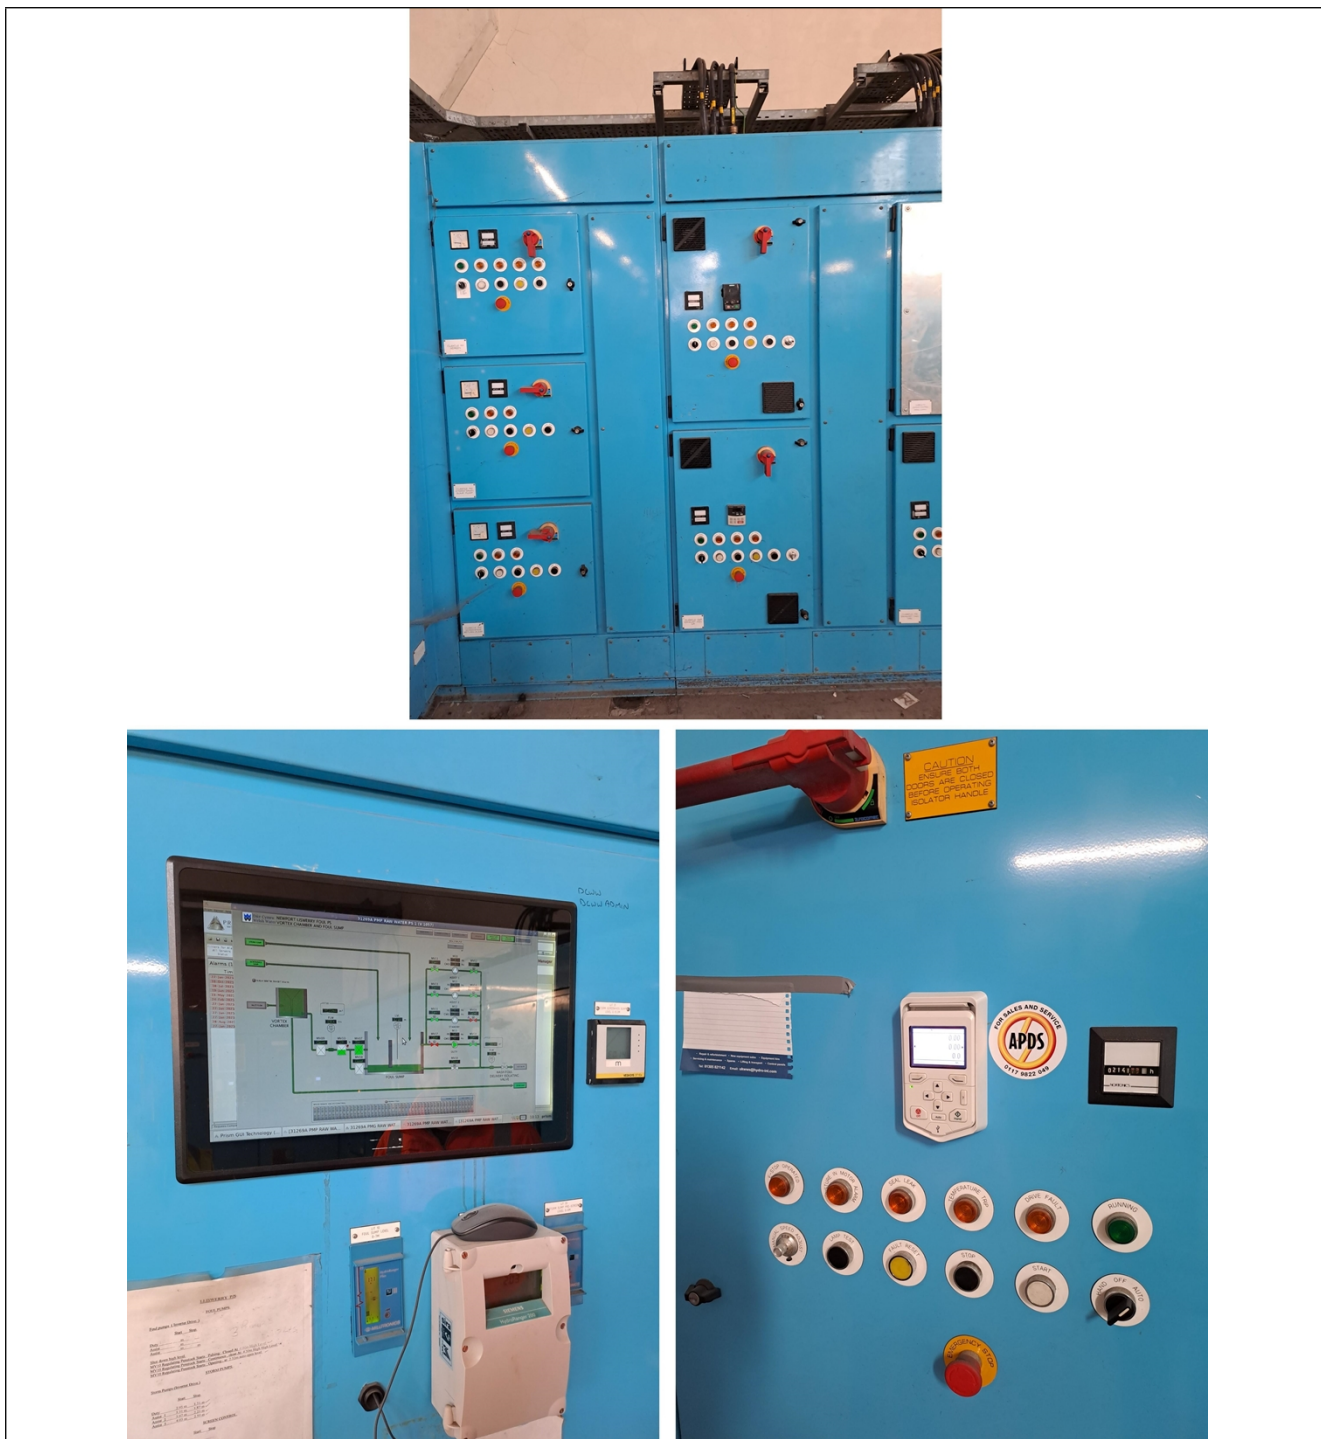
All control panels were clean and dry with no cracks or condensation present. The digital readouts were operational and working as designed, displaying all required recording and monitoring data. An emergency stop function is in place. These observations are evidenced in Figure 2.

Figure 2 – The control panels and readouts as observed during the visit.

Regarding monitoring and data recording, SB stated that flow rate and EDM are monitored with data displayed in real time of the readouts (Figure 2) and via telemetry. The alarms themselves were noted to be on a 4 year maintenance regime, although SB did not have information on the most recent maintenance undertaken on them. I have actioned that this

5. Provide details with evidence on the most recent telemetry and sensor maintenance undertaken on.

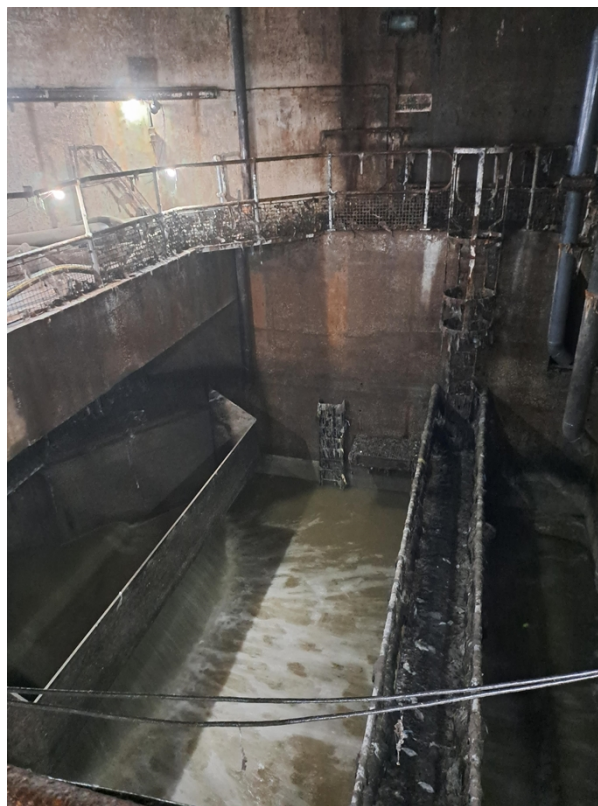
The wet well was observed to be in a good condition with no cracks or corrosion present. SB explained that the top level alarm is set at ~5m, with a full capacity of ~7m. However, the system is calibrated to start pumping when the level reaches 2.5m. EDM data will confirm the frequency of these events. Regarding maintenance, SB noted that a full clean of the well will be undertaken in Summer 2026, with a top clean scheduled for early (“after the new year”) 2026. The conditions outlined above are observed in Figure 3.

Figure 3 – The wet well as observed during the visit.

1. Inform NRW when the wet well cleanse and clean are completed, with evidence of conditions.

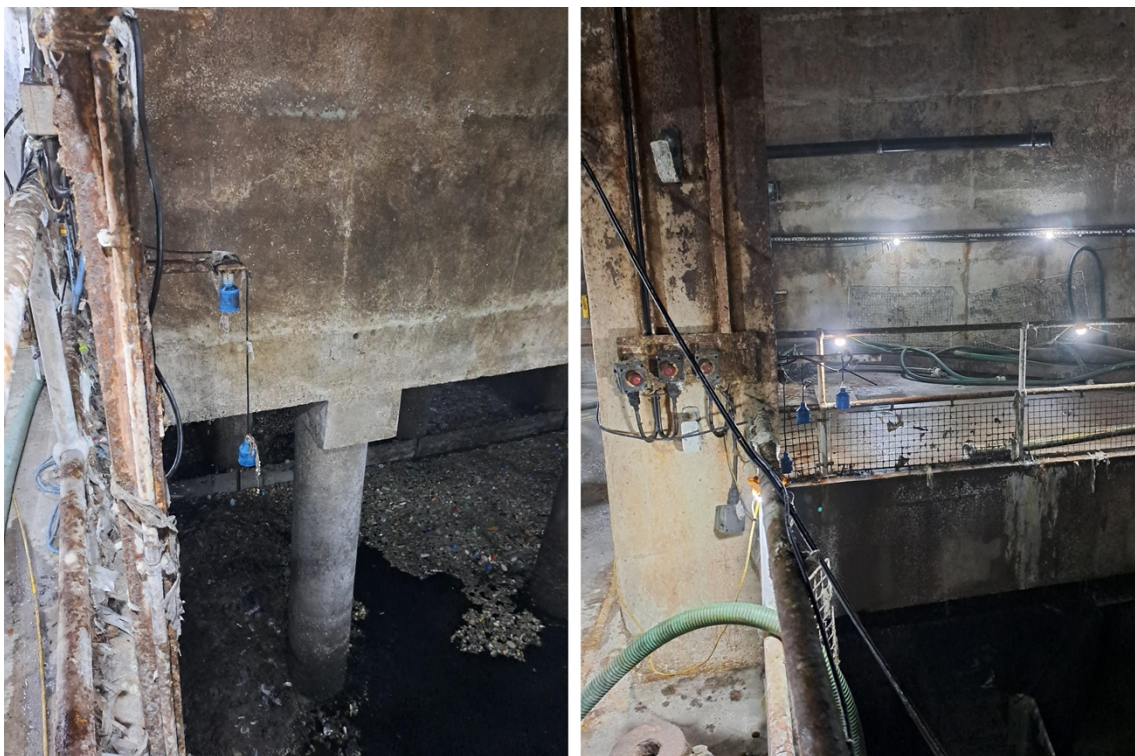
The level sensors and EDM monitors were observed to be in place and clear of debris or damage. This is seen in Figure 4.

Figure 4 – Level sensor and EDM monitor heads as observed during the visit.

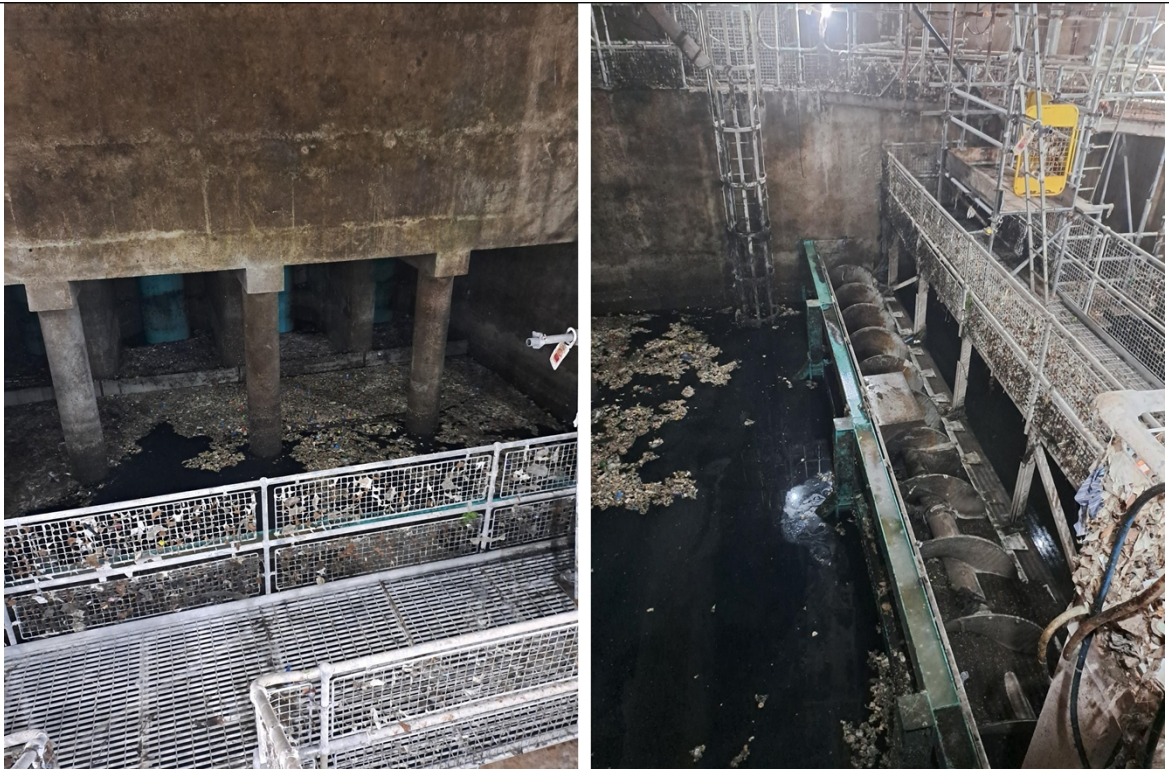
The screen was observed to be removing debris prior to onward flow with the majority of solids being held within the tank (Figure 5). While no excessive solids were observed to be passing forward at the time of the visit, there was a large amount of rag and debris caught in the safety rails throughout the chamber, indicating very high flows which may have overtopped the screen and top level of the wet well. EDM data will evidence these events. These areas (as observed in Figure 6) should be included in any cleaning scheduled in 2026.

Figure 5 – The screen as observed during the visit.

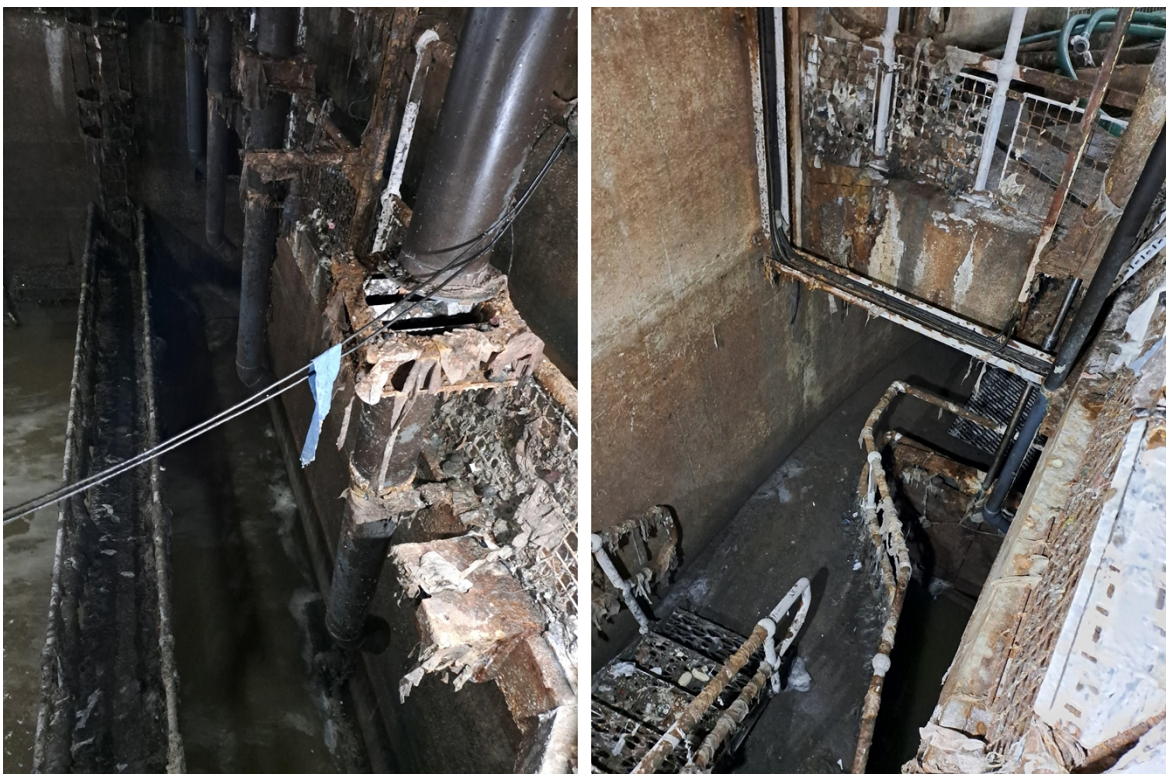
Figure 6 – The rag build up as observed during the visit.

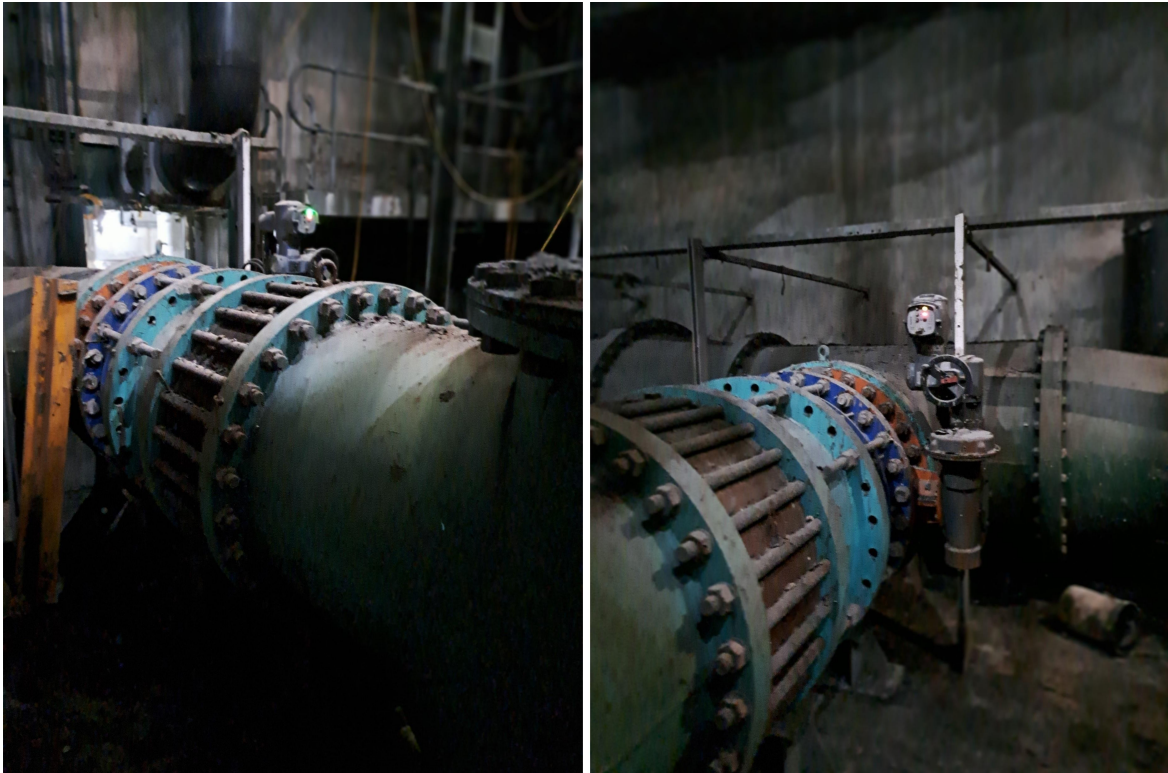
The valves were observed and appear to be in a good condition with no excessive

corrosion present. This is evidenced in Figure 7.

Figure 7 – The valves as observed during the visit.

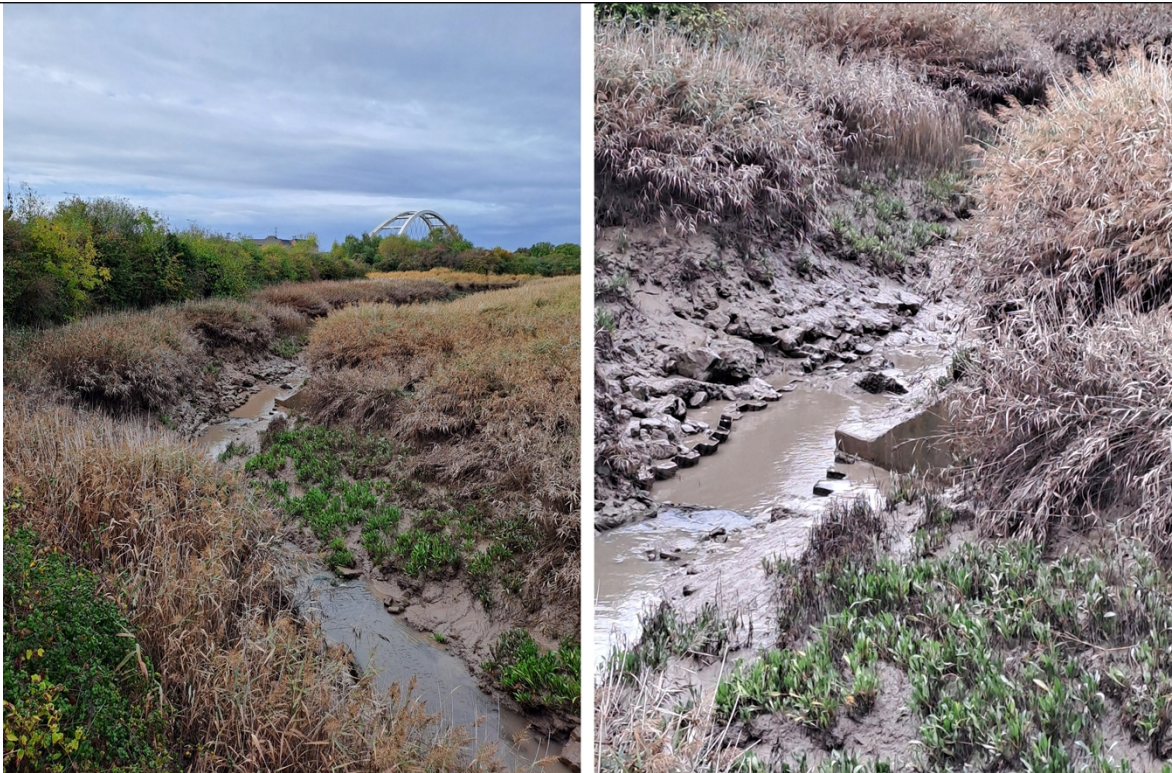
We then proceeded to the consented outfall/discharge point. On previous visits DCWW were unable to confirm where the discharge point was located. However, by using drones, the location has now been confirmed and is situated in the correct place consistent with the permit (ST3294487020). While the outfall was visible (to an extent) from the main road (as seen in Figure 8) access to it is limited due to the estuarine nature of its location. As a result, an assessment of its condition could not be undertaken at the time of the visit. SB noted that DCWW will provide the drone images that they captured showing the outfall condition as evidence of compliance. This has been actioned below.

Figure 8 – The outfall as observed during the visit.

8. Provide NRW with the drone photos of the outfall as evidence of its condition and compliance.
