Compliance Assessment Report CAR_NRW0049765

Permit being assessed: AN0031501

For: Pill South B Pumping Station, held by DWR CYMRU CYFYNGEDIG

Type of assessment carried out: Site Inspection, Reason: Routine.

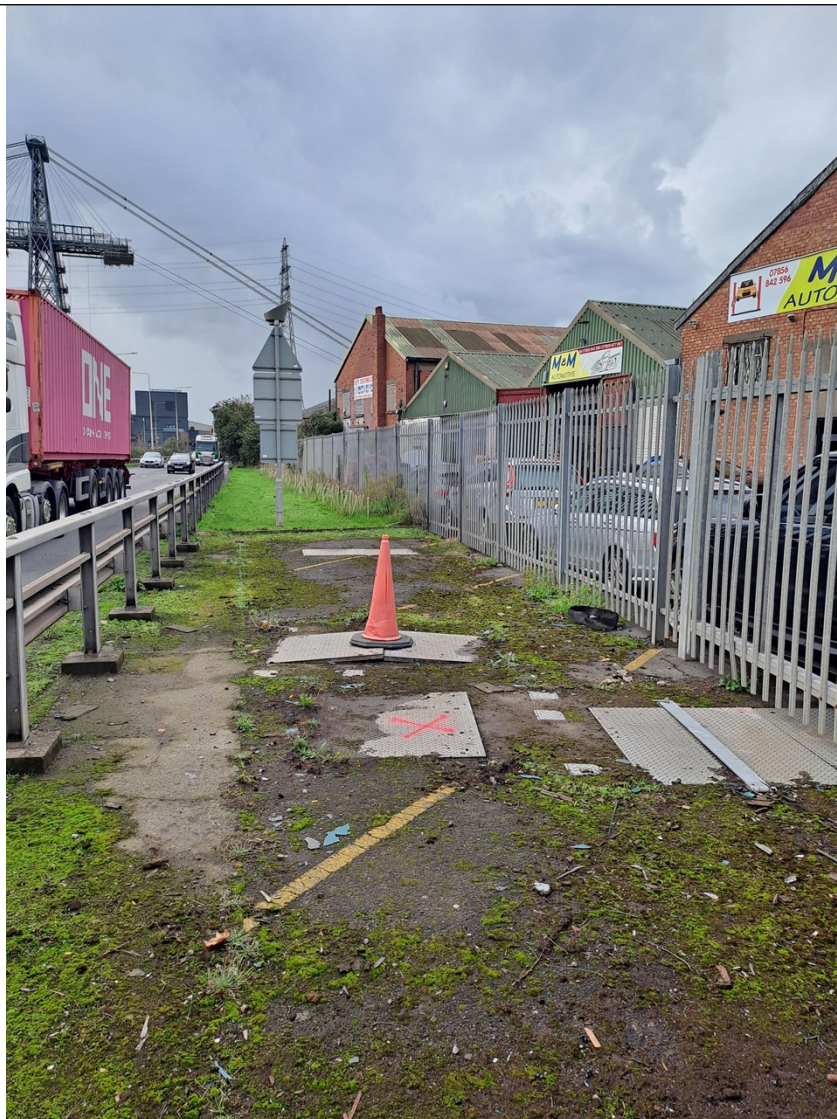
General site conditions were adequate at the time of the visit. Despite the access issues outlined above, we experienced no issues gaining entry to the site. However, the site compound appeared slightly unkempt, with slippery moss present throughout and various items of waste present. I have issued an advisory comment to undertake a tidy up of the site. One significant issue observed was a chamber that was not able to be closed or locked, with a traffic cone placed on top to keep it shut. This not only raises concerns regarding water ingress but also a health and safety hazard for anyone present on site, particularly as there was also no safety grate present. While SB stated that this was on a maintenance list to be completed, I have added an action to undertake the required work to rectify the issue and an advisory to assess any further health and safety requirements on site. These observations are evidenced in Figure 2.

Figure 2 – General site conditions as observed during the visit

2. Review the H&S measures in place regarding chamber access and protections for

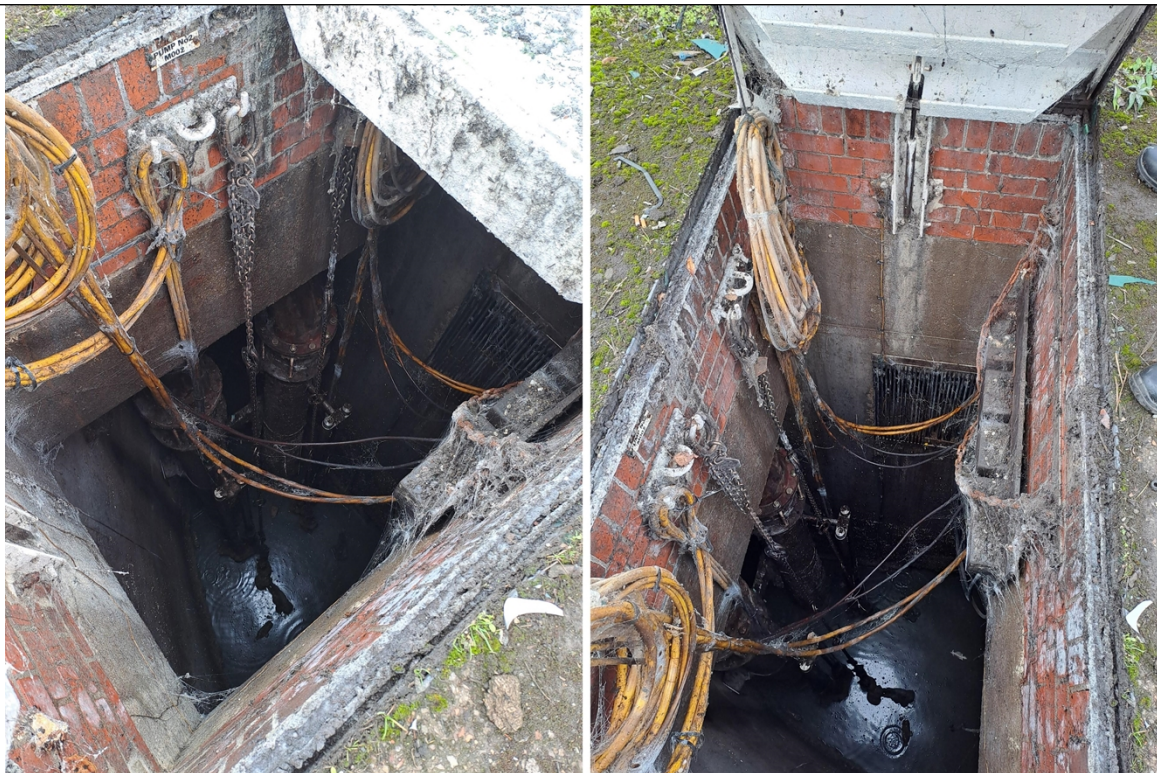
Regarding operational infrastructure, the wet well was observed and the condition appeared appropriate with no major cracks or defects seen and no significant corrosion present. No noxious odours were present. When queried on cleaning the schedule, SB stated they did not know the current arrangements but would confirm it with me at a later date. I have listed this as an action below. The condition of the wet well can be seen in Figure 3.

Figure 3 – The wet well as observed during the visit.

2. Confirm the current cleaning schedule of the wet well and the last time this was conducted.

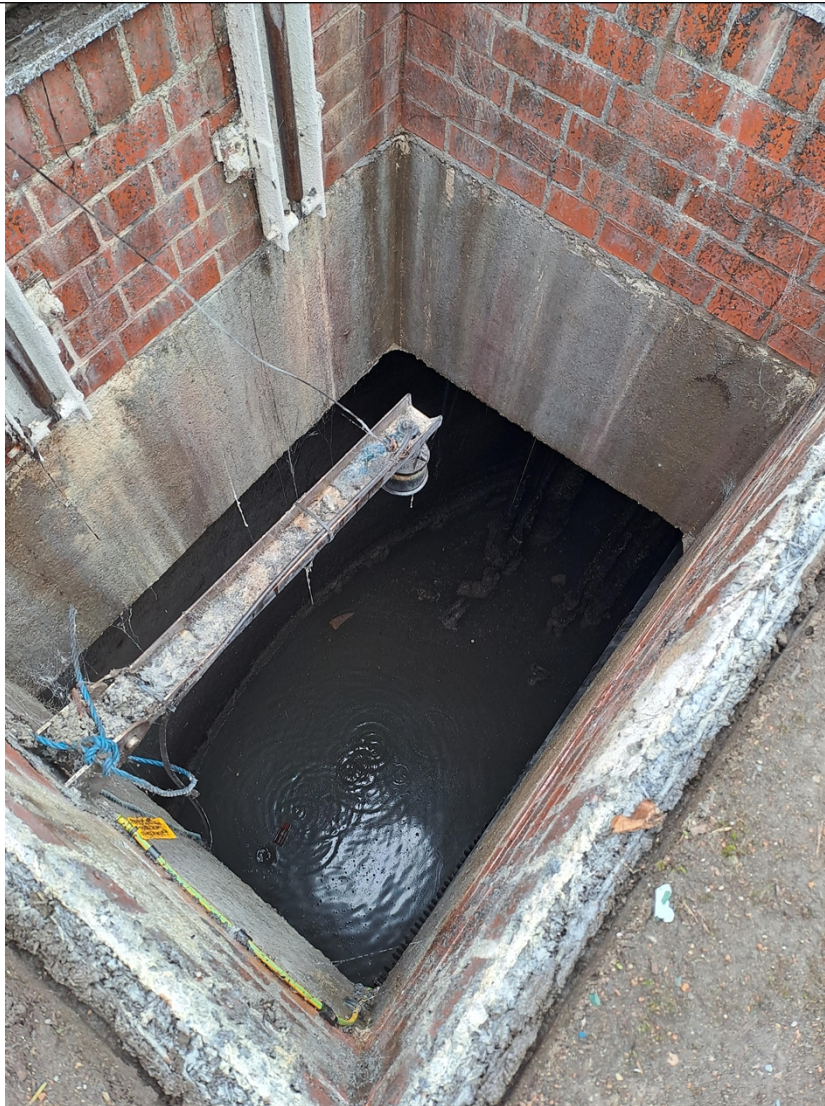
The telemetry sensors were observed and seen to be clean, with all infrastructure in a good condition, as seen in Figure 4. The servicing and maintenance was queried, of which SB noted that this could be communicated via email (actioned below). It was stated that EDM and flow are recorded on site, so I have also requested some data as evidence of operation and overflow events.

Figure 4 – The telemetry sensor as observed at the time of the visit.

4. Provide information of the most recent sensor (EDM and level) servicing, calibration and maintenance as evidence of effective operation.

5. Supply NRW with flow data and overflow events for the 12 month period prior to the site inspection (October 2024-October 2025).

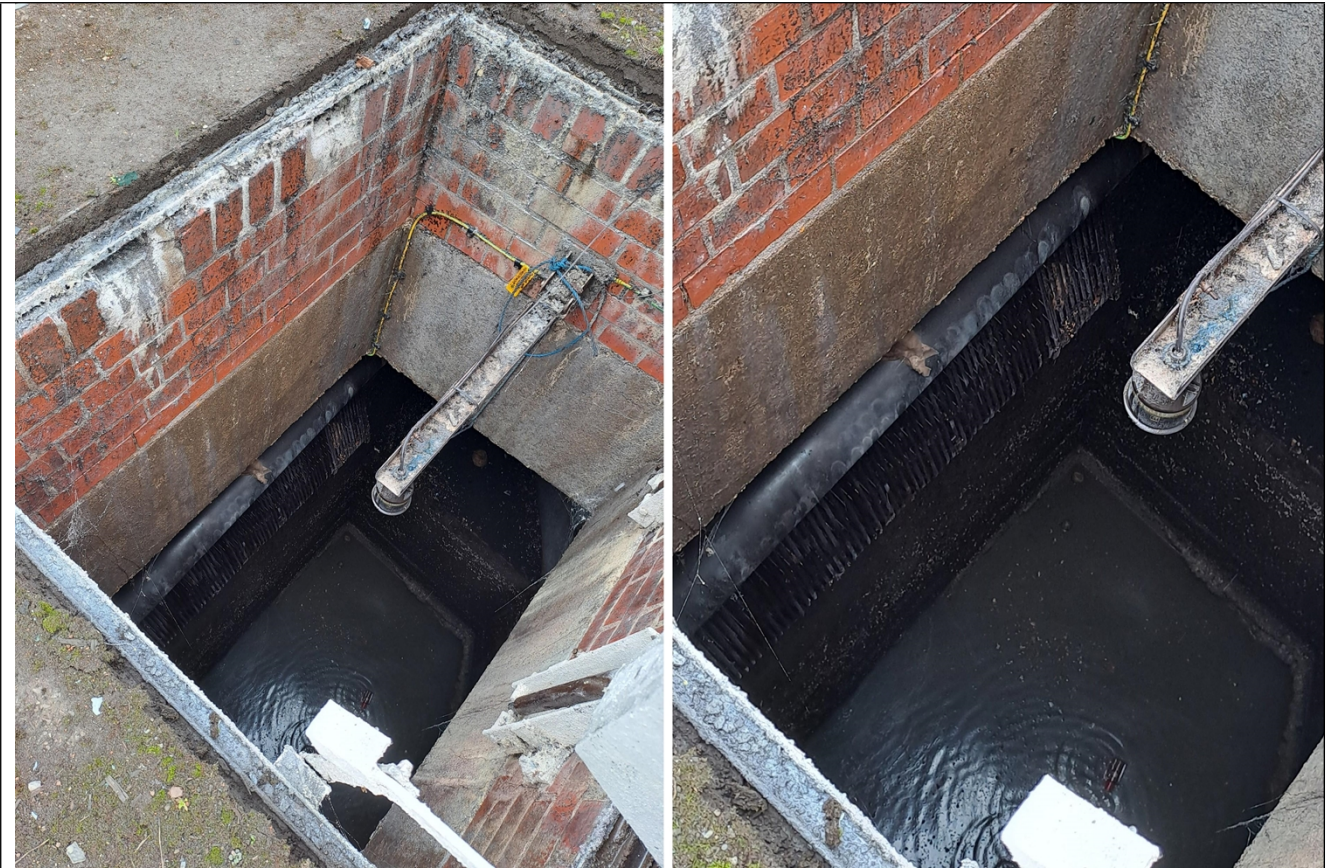
As noted above, SB stated that there were no screens present at this site, having been removed ~15 years ago. This is concerning as the provision of a screen is a key permit condition (under S3.3) of the storm sewage discharge settings. However, on observing the photographic evidence collected during this visit, I note the presence of what appears to be a screen within two separate chambers on site, as seen in the wet well (Figure 3 above) and in the monitoring chamber seen in Figure 5 below. I request that DCWW confirm if the site possesses screens as per the requirements of the permit, identify what the infrastructure observed is if they are not screens and justification as to why the screens were removed. Further discussions with NRW senior officers and permitting team may be required to resolve this issue. I have not scored this as a breach at this time until further evidence is supplied.

Figure 5 – Apparent presence of a screen within the monitoring chamber prior to discharge, as observed during the visit.

6. Confirm if the site possesses screens as per the requirements of the permit, identify what the infrastructure observed is if not screens and justification as to why the screens were removed.

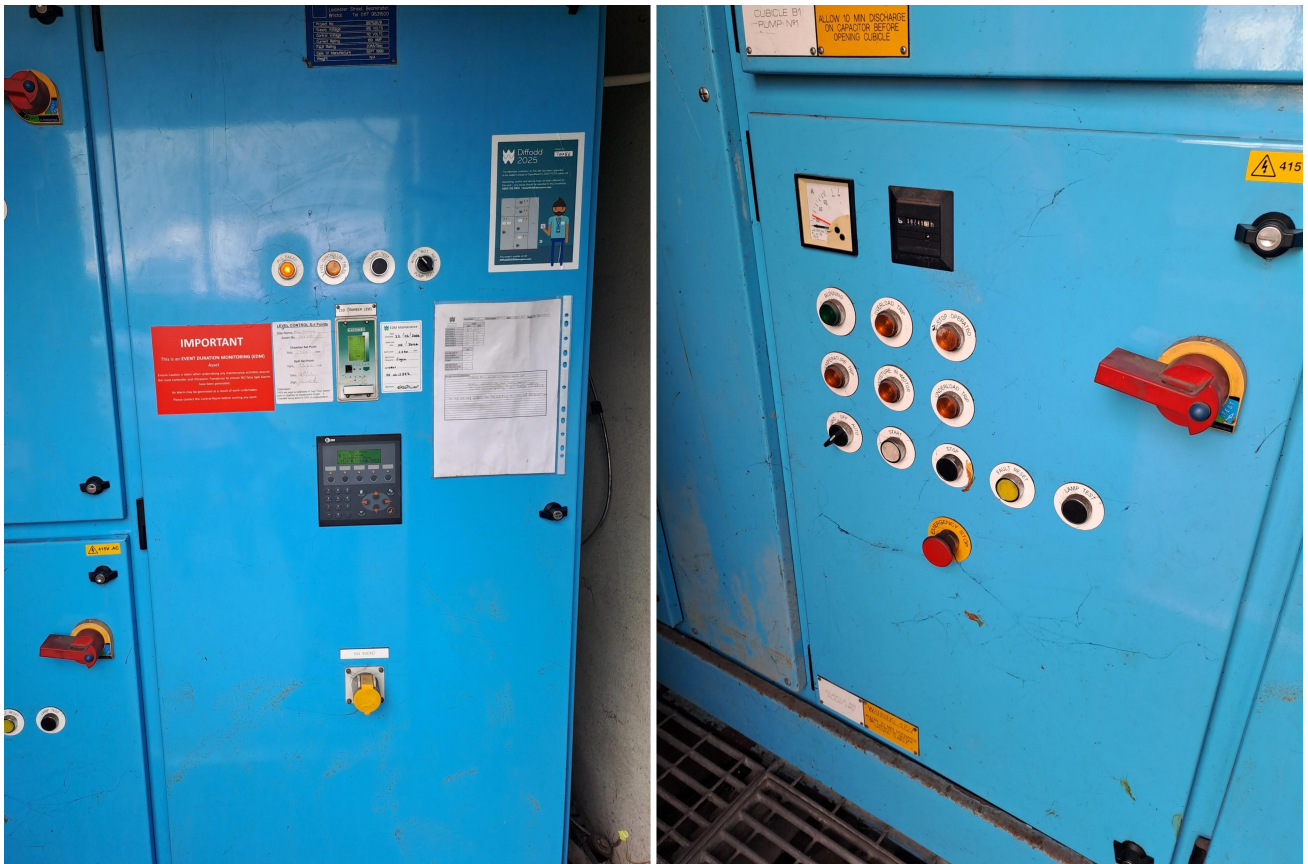
The control room and panels were inspected and were found to be clean and dry with no cracks or condensation present. An emergency stop function was present and a backup generator can be installed on site via hard wiring. These observations can be seen in Figure 6. The site log book was observed which appeared to be updated regularly with routine and non-routine maintenance both recorded. There were several pump failures noted due to power dips in the area but these issues were resolved promptly and the

system has not been offline for a prolonged period. No concerns were noted.

Figure 6 – The control panel as observed during the visit.
