Compliance Assessment Report CAR_NRW0049767

Permit being assessed: AN0389101

For: HIGH CROSS ROAD ROGERSTONE, held by NEWBRIDGE ESTATES

Site Visit Report

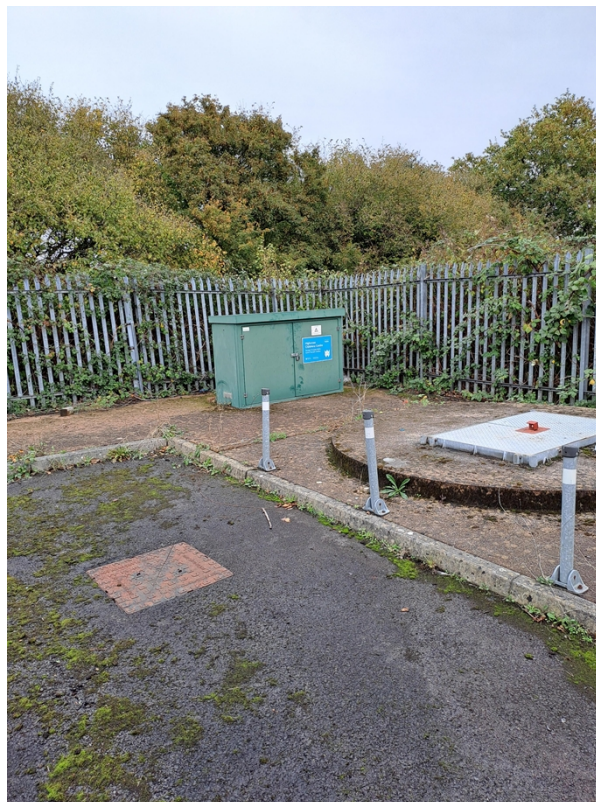
Figure 1 – The general site condition as observed during the visit.

General site conditions were good with the compound being secured by a fence and all appropriate signage was in place. The compound was clear of any obstructions, all covers and grates were intact and safe, and there was no difficulty in accessing any of the infrastructure. This is seen in Figure 1.

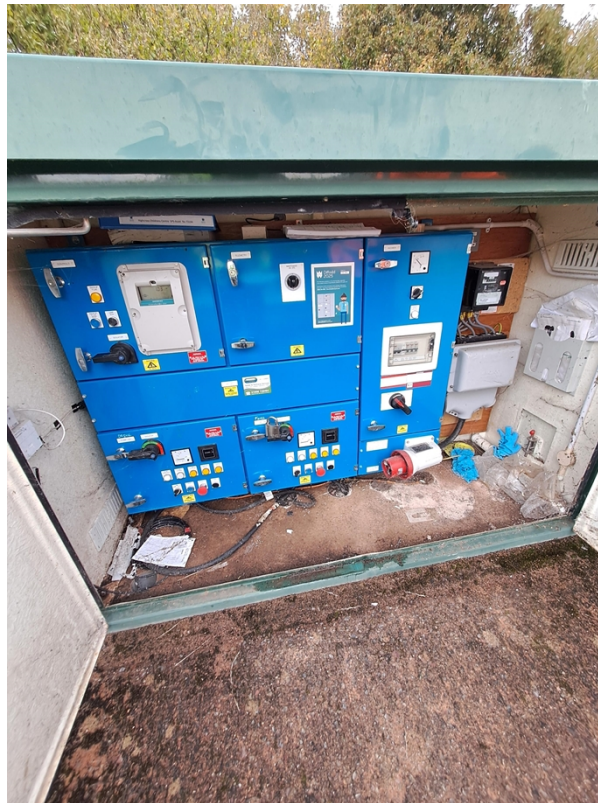
Figure 2 – The control box as observed during the visit.

The control box was inspected and observed to be clean and dry with no condensation or cracks present. There was an emergency stop function in place as well as a plug in point for a backup generator. All displays and readouts were clear and working as designed, with SB noting that this asset was a part of the Diffodd scheme to upgrade and improve the remote monitoring at the site. These observations are evidenced in Figure 2.

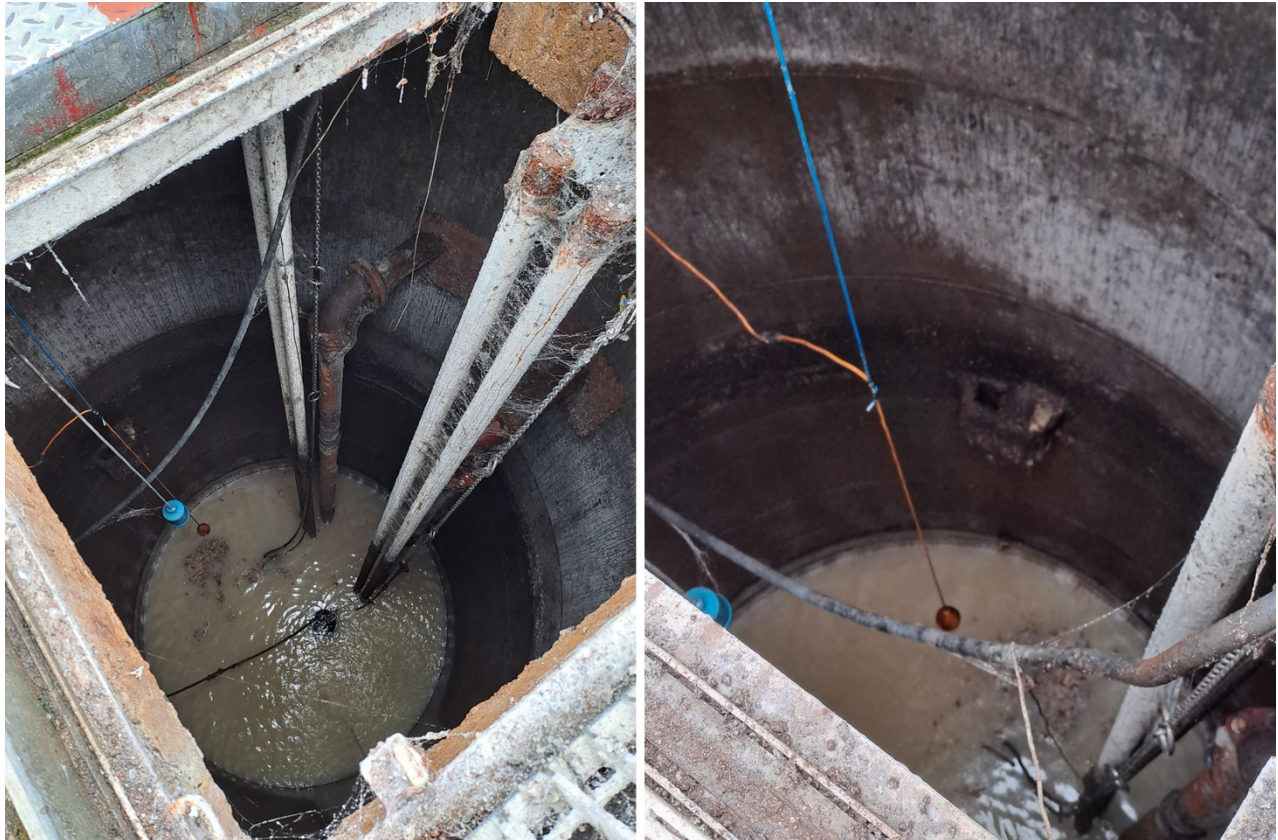
Figure 3 – The wet well conditions as observed during the visit.

The wet well was inspected and appeared to be in a good condition structurally, with no cracks or defects present. However, some minor corrosion is present on the metal components, raising concerns on the long term integrity of the asset. An advisory comment has been listed to assess this to ensure continued operational effectiveness. Additionally, there were some deposits present within the chamber and particularly on the 10mm bar screen for the EO, with a slight residual odour as a result. Please see Figure 3

for evidence to support these observations. I have actioned that a clean should be undertaken to address this due to the risk of flows being impacted by this restriction, potentially leading to flooding at the site. SB informed me that the asset is on a 12 month cleaning regime with the last clean completed on the 20/05/2025. I also requested that SB confirm the storage capacity of the site as it was not known at the time of the visit.

Left: The wet well in its entirety; Right: The outlet screen with deposits buildup present

3. Undertake a wet well clean, focusing on removing deposits from the chamber walls as the bar screen.

1. Assess the corrosion present on the metal components within the wet well and upgrade as necessary to ensure continued operational effectiveness.

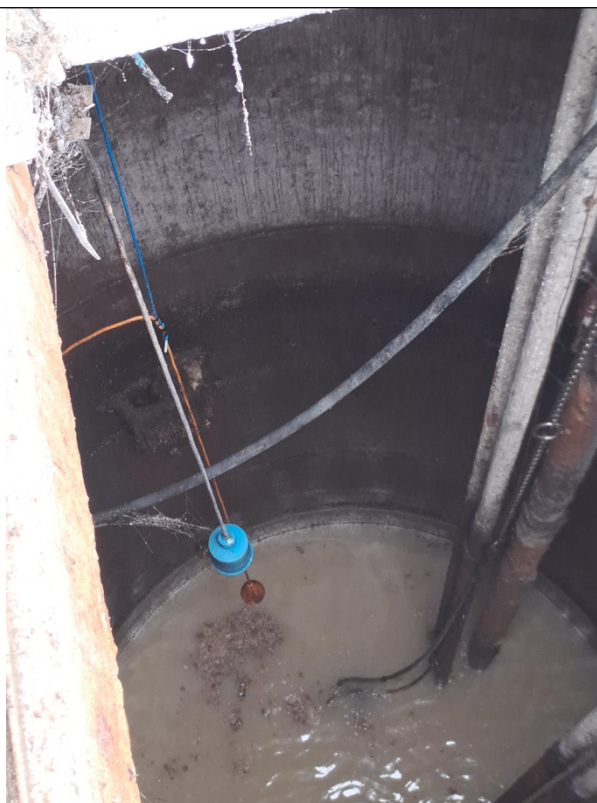
Figure 4 – The telemetry sensor heads as observed during the visit.

There is a telemetry system in place at the site, with EDM and high level recorded. The sensors were observed to be clean and working as designed (Figure 4), with SB showing the data recorded on their phone during the visit. I have requested an example of this data for the site to show flow rates and overflow events to ensure compliance, please see the actions list below. Additionally, I requested the maintenance schedule and calibration records for the system as evidence of appropriate management and operation.

5. Provide an example of telemetry data (EDM and flow recording) for the 12 months prior to the visit (October 2024 - October 2025).

6. Confirm the telemetry maintenance schedule and calibration records.

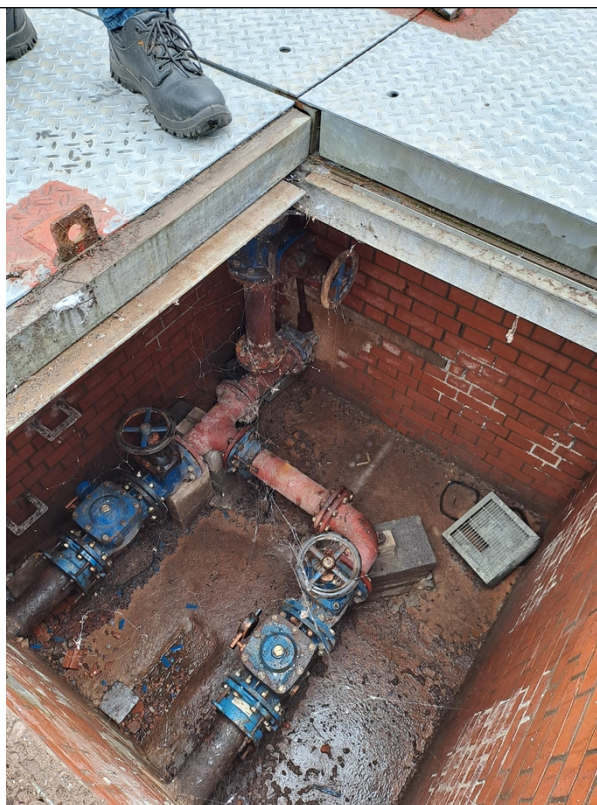
Figure 5 – The valve chamber as observed during the visit.

The valve chamber was secure and accessible, with all internal infrastructure in a good operational condition. However, I was unable to observe a tanker point to be used in the event of inoperable periods. As such I have requested that confirmation and evidence of a tanker point be provided. These observations are seen in Figure 5.

7. Confirm, with evidence, the location of a tanker point for the SPS.

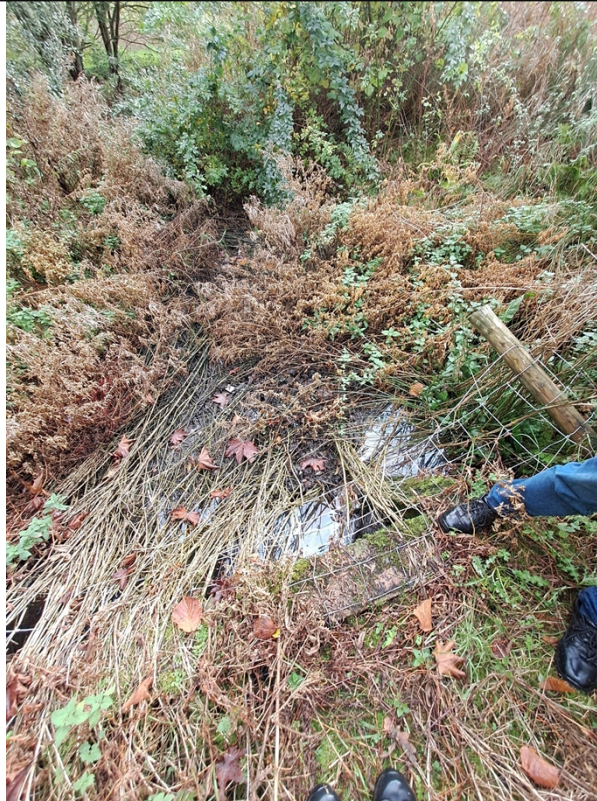
Figure 7 – The headwall located at ST2831088173, within 10m of the suspected discharge point as it appears on the NRW mapping system.

Gaining access via the adjacent fields (which involved restricted access and climbing over a boundary fence), SB and I followed the line of the EO overland to the suspected discharge point. On arrival, a headwall was found at ST2831088173 discharging to a wet, marshy area which is presumably connected to a pond at ST2844088112 and thus the wider water environment. This headwall is seen in Figure 7.

Through discussions with SB, an agreement was reached where DCWW will attempt to gain access to the listed sample point at ST2819188273 through vegetation clearance. This lack of access has been breached in this report, with the clearance work actioned below. Additionally, DCWW will improve access to the discharge point identified at ST2831088173 in this visit and vary the permit to reflect the reality of the drainage layout on site. This is actioned below.

8. Improve access to the discharge point identified at ST2831088173.

9. Apply for a permit variation to change the discharge point to ST2831088173.
