SITE REPORT

SITE: The Willows, Barecroft Common, Magor, Monmouthshire. NP26 3EB

PROBLEM: Site Visit and Tank Inspection

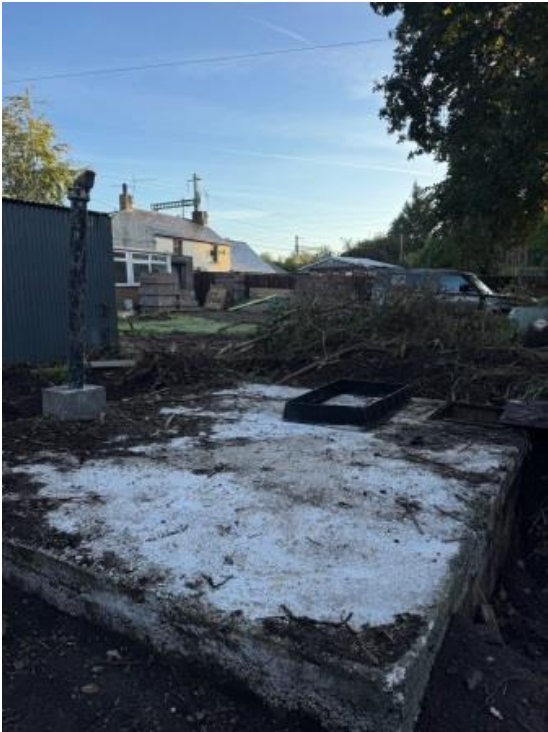
The cesspit tank is a Brick/Block built type septic tank and predates 1983 and the introduction of building regulations. The tank is a single chamber with one access cover. The tank is 3.2m long x 3m wide x 1.5m deep (Below invert) giving a capacity of around 14.4m³. The tank is a holding tank with no outlet. The tank was emptied in February and the property has been empty since then. On the day of inspection the tank was nearly full of water and from what can be seen appears to have groundwater and or surface water ingress. This means that the tank as inspected would be classified as a failing system.

Pic 2 Cesspit Tank

The ground on site is of a clay type soil and the water table is approx. 1m below ground level. This means that the site would not be suitable for a conventional drainage field. There is a running watercourse/Reen at the front of the property. I would propose installing a high quality sewage treatment plant and discharge to the running watercourse. I would recommend installing the Graf One2Clean sewage treatment plant which is a SBR type plant with a high quality effluent standard after treatment. I believe this would be betterment to the failing system already in place. This would of course be subject to NRW approval.

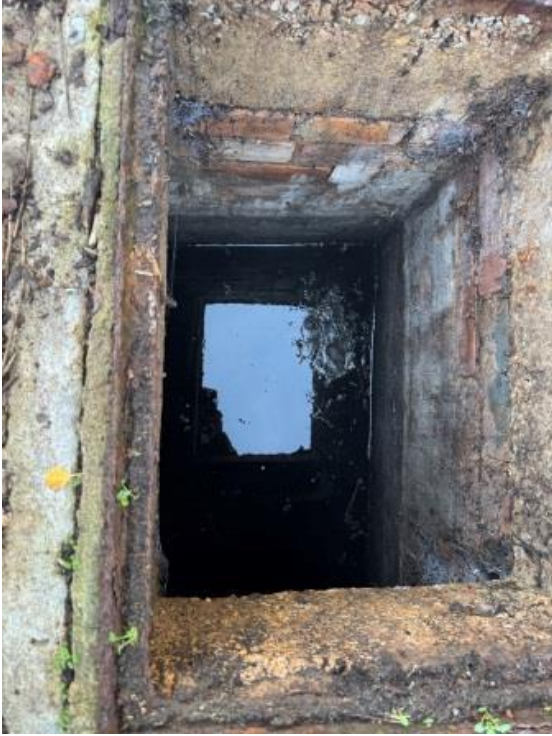
Pic 3 Picture of Water inside Cesspit Tank (Signs of water ingress)

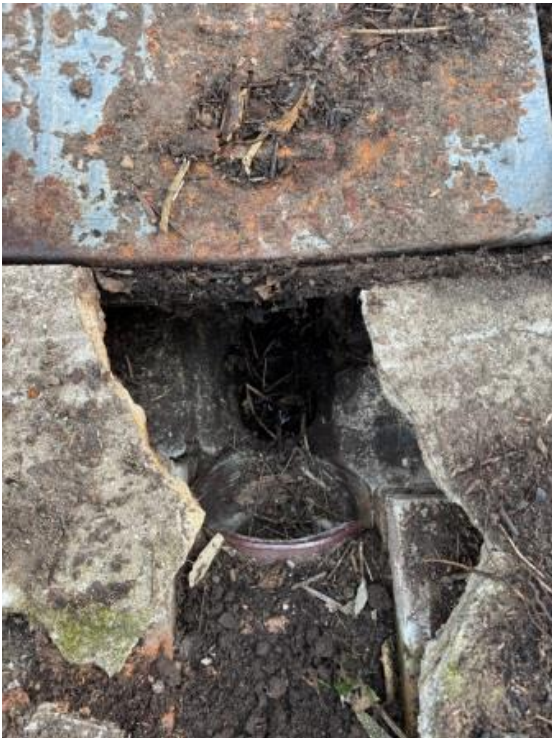
The foul drainage runs from the rear of the property through a manhole chamber to a cesspit tank located in the front garden.

Pic 4 Inlet Pipework to Cesspit Tank

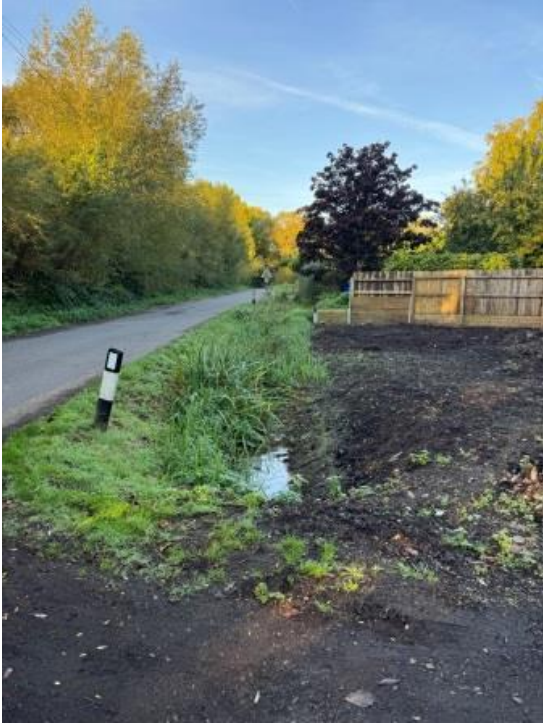
Pic 5 Running Watercourse to front of property.
