**Rhydlanfair Weir  
Archaeological Recording**

**Commissioned by  
Dr Liam Whitmore,  
North Wales Rivers Trust**

**Analysis by  
I.P. Brooks  
Engineering Archaeological Services Ltd  
*EAS Client Report 2024/15***

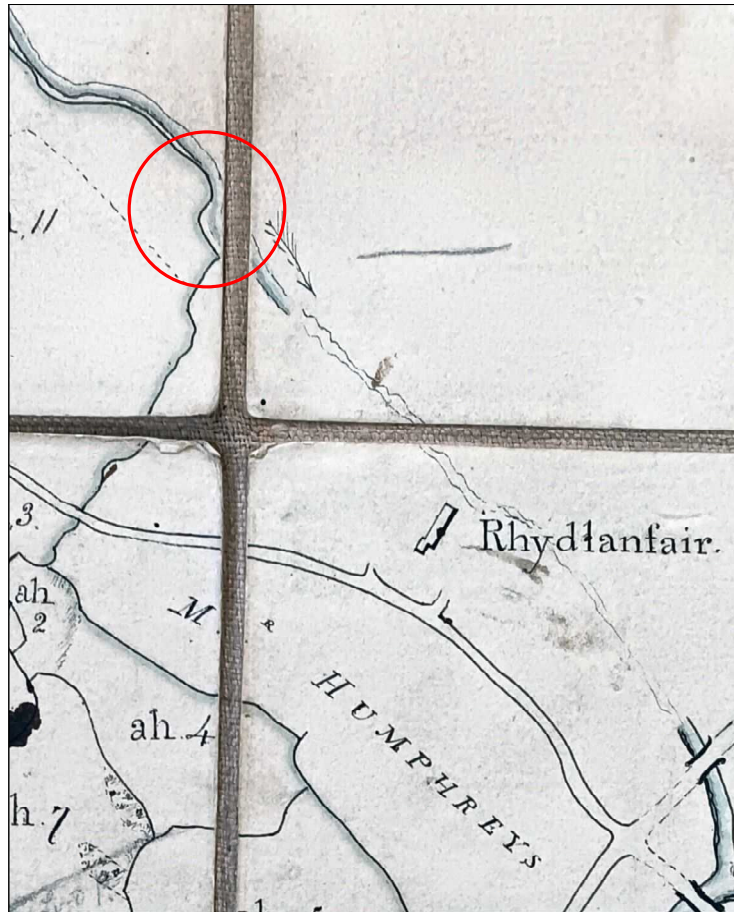
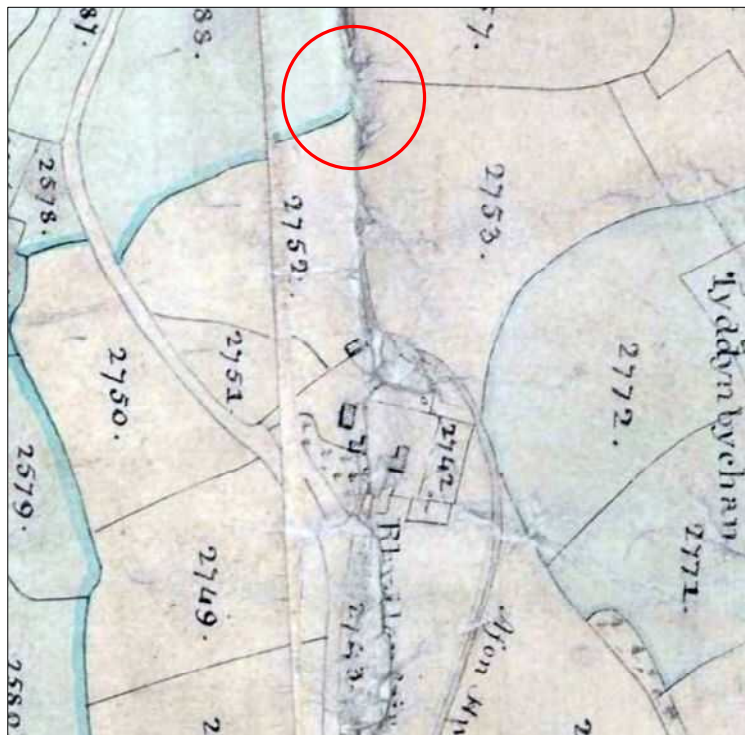
Figure 3: Historic Mapping  
Rescaled to 1:5,000 (approximately)

The earliest map evidence located is the 1813 Voelas Estate map (Figure 3) (National Library Voelas 287). Although Rhydlanfair is outside the Voelas Estate it has a common border along the Afon Iwrch. The weir is not marked, although the bend in the river is clearly marked. This is a feature, however, is not shown on either the Tithe map of 1839 (Figure 3), nor the 1867 map from a conveyance document (Figure 4). At the time of the tithe map the land was owned by John Jones and occupied by his daughter Anne, although by the time of the conveyance, to the Penrhyn Estate in 1867 (Bangor University, PENRA/2634) it was owned by Anne Jones herself. Rhydlanfair was bought for £6250,

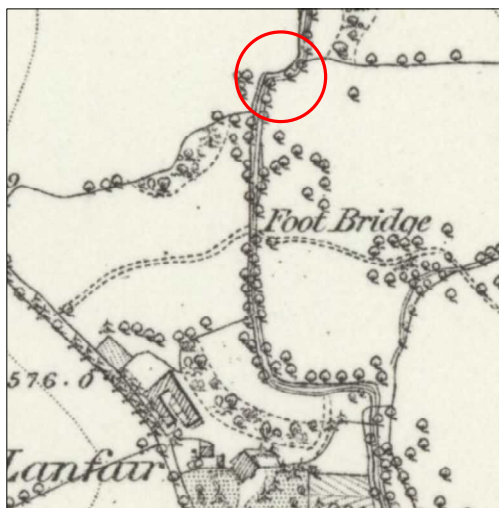
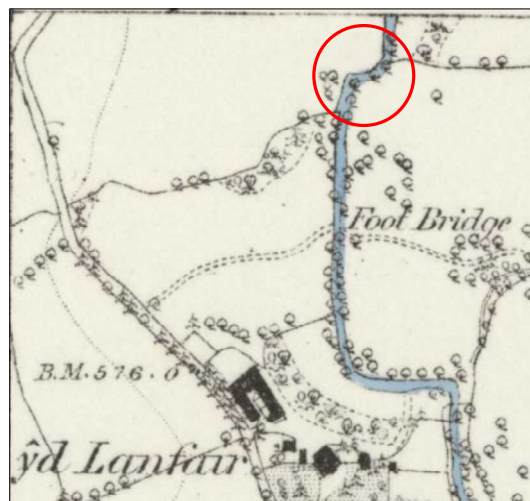
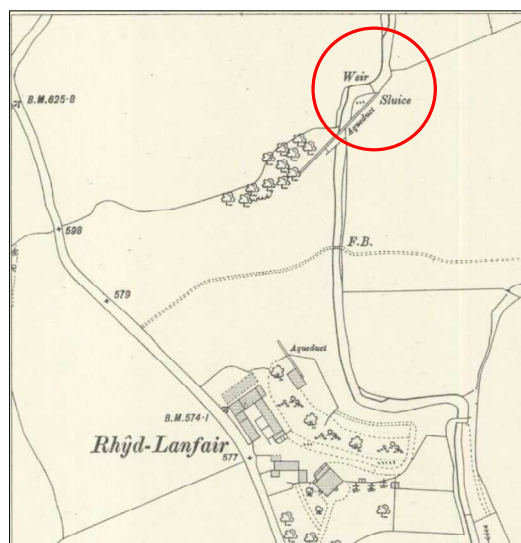
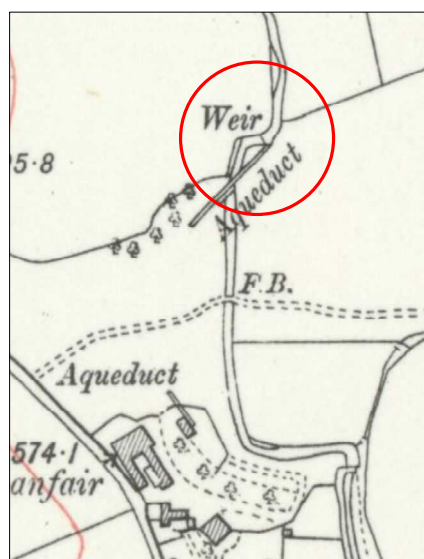
Figure 5: Historic Ordnance Survey Maps 1880 - 1915  
Re-scaled to approximately 1:5,000

The Ordnance Survey mapping published between 1880 and 1888 (Figure 5) does not mark the weir or any associated features. However, the map published in 1900 (surveyed in 1899) is the earliest map to mark the weir and an associated aqueduct. This aqueduct runs to the south west, where it crosses the Afon Iwrch, ending in a small copse. Since the 1888 map was surveyed between 1875 to 1887 it is likely that the weir was constructed in the 1890's.

There is remarkably little change in the Ordnance Survey mapping published between 1900 and 1964 (Figures 5 and 6). With both the weir and its associated aqueduct being shown. It is not clear what the aqueduct is leading to. The mapping suggests the aqueduct stops at a point approximately 75 m south west of the weir in an area that is known to contain a quarry (NT

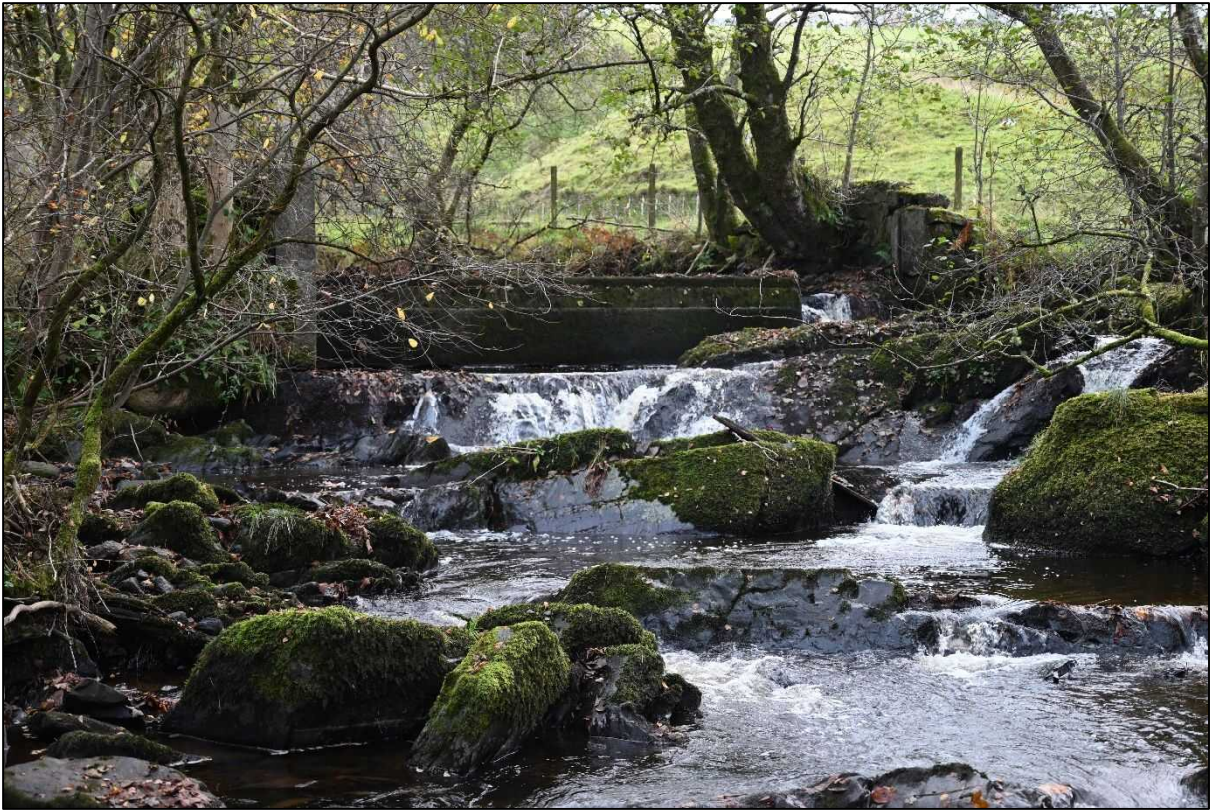
Plate 1: The weir, looking east

The weir was visited on 6/11/2025 to record the structure. The weir sits at the top of a cascade (Plate 1) with relatively smooth water above (Plate 2) caused by the damming effect of the weir. The weir, itself is a concrete block with a shaped top (Plates 3 and 4) running largely across the river, but with a gap, approximately 1.5 m wide at its southern end. This gap was occupied by a sluice, as is shown by the slot in the stone block marking the southern bank (Plate 5). The weir is at least 1 m high and 0.60 m thick, whilst the cascade, below is in the region of 1.85 m high.

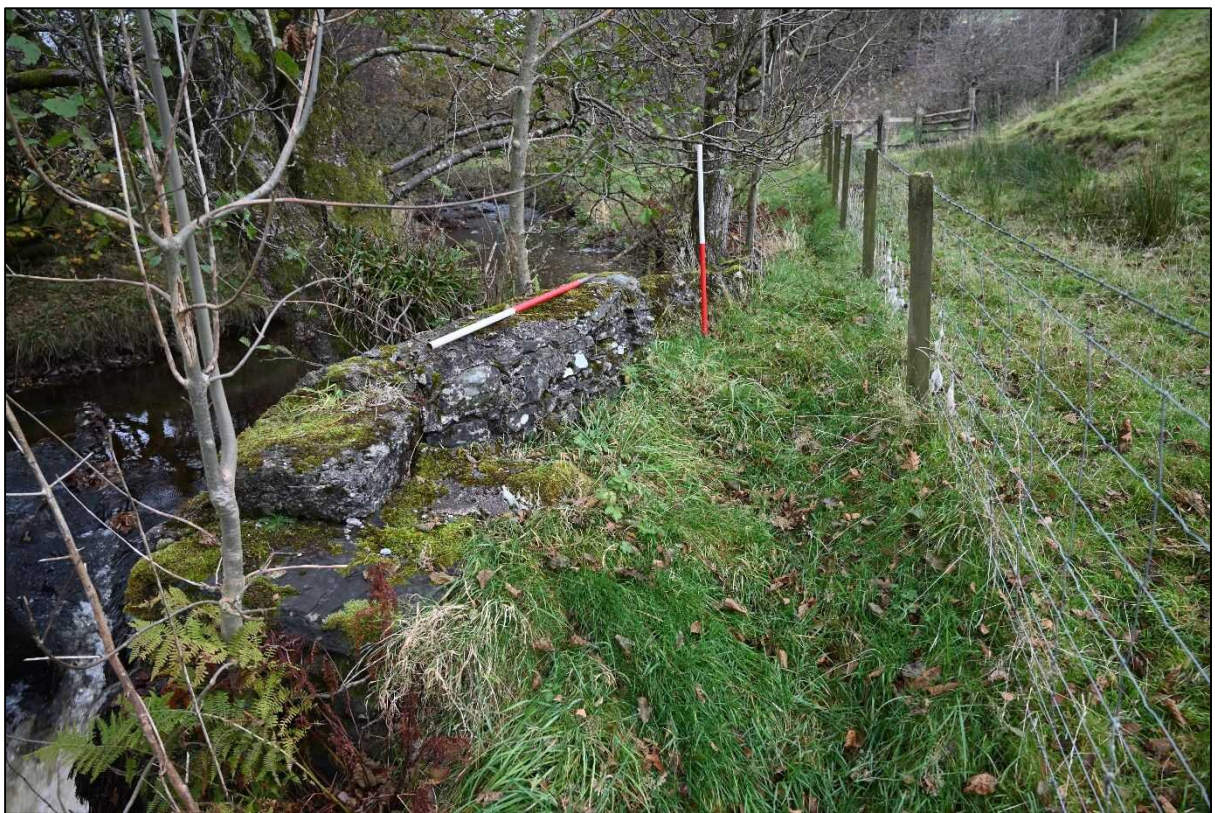
Plate 6: Southern head wall, looking NE

The block with the slot for the sluice forms the western end of a revetting wall along the river bank (Plate 6). For about 2 m this wall is of mortared stone, however, beyond this point, for approximately 2.8 m to the north east, this is replaced with a dry-stone wall with a concrete outer facing. The block containing the slot for the sluice (Plate 7) is well built of stone slabs and has a slate cap.

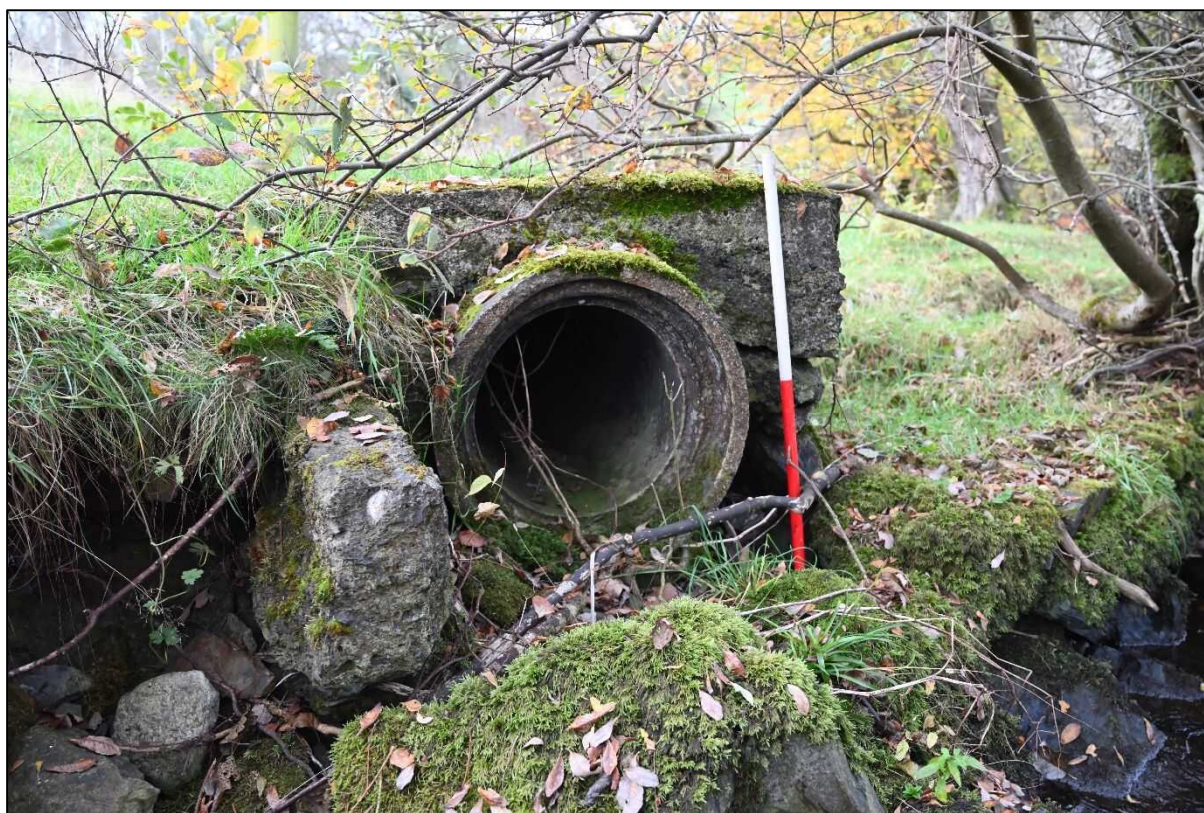
Plate 8: End of the pipe in the aqueduct, looking SW

Also on the southern bank of the river is the end of the aqueduct, consisting of a concrete pipe (Plate 8) buried within an earthen bank with a drystone revetting along its north western face (Plate 9). The pipe is 570 mm in diameter (internal diameter 450 mm) and is buried within a linear bank which is 1.3 m wide and up to 4.5 m wide. Nearby there is a cut platform on the river bank (Plate 10) which has a concrete floor, at least along the edge nearest to the river. This platform is roughly “D” shaped and is 3.4 x 3.4 m in size.

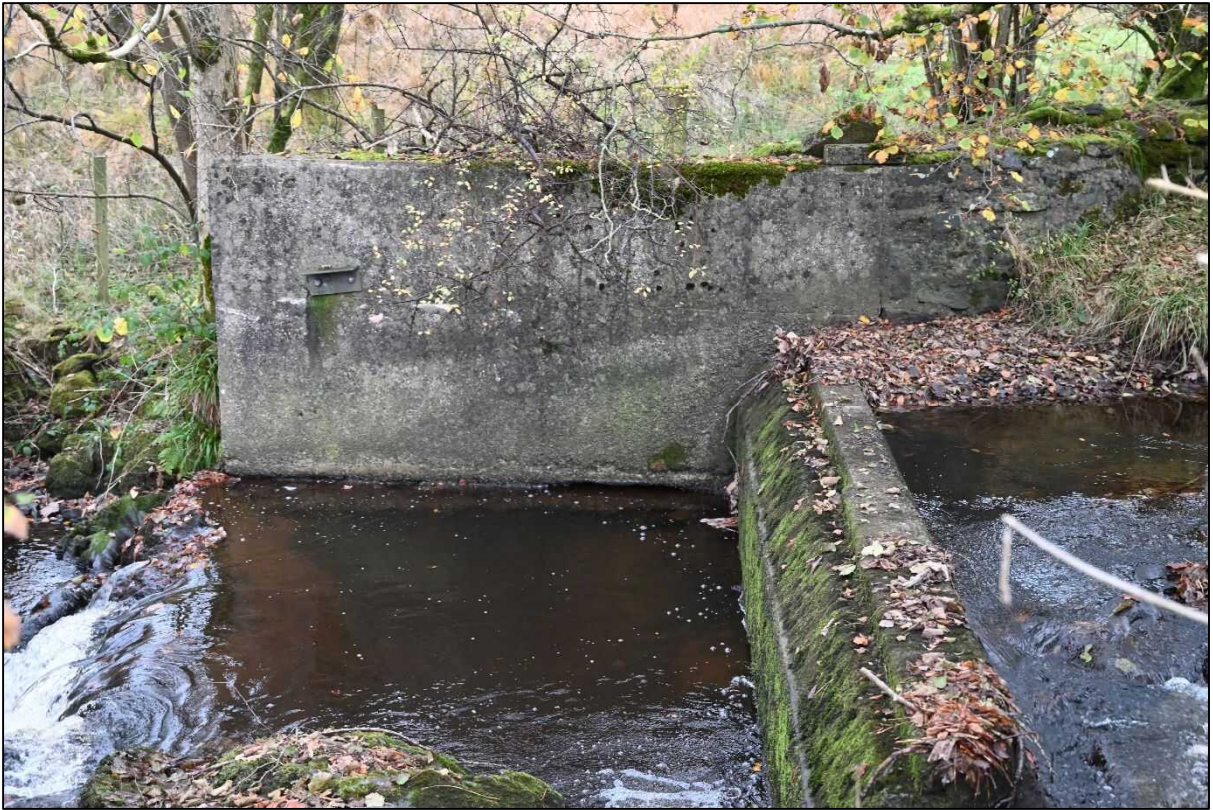
Plate 11: Northern concrete head wall

On the northern bank, the edge of the river is marked by a concrete head wall (Plate 11) which runs for 3.90 m and is 0.30 m thick (Plate 14). This is offset from the line of the weir with only 0.30 m of the wall protruding on the eastern side of the weir, whilst downstream it runs for approximately 3.0 m. There are two eye bolts fixed into the concrete wall (Plate 12) and a metal flange (Plate 11), all at the relatively high level on the wall. It is uncertain what the function of these fittings was. There are also at least two iron plates on top of the wall (Plate 13) whose function is also unknown. Behind the concrete wall is a wide, dry-stone bank, which is approximately 0.80 m thick and runs for approximately 8.1 m along the bank of the river (Plate 15). Filling the gap between the end of the concrete wall and the point where the stone bank meets the river bank is a short length of mortared stone walling approximately 2 m long and 0.50 m thick (Plate 16).

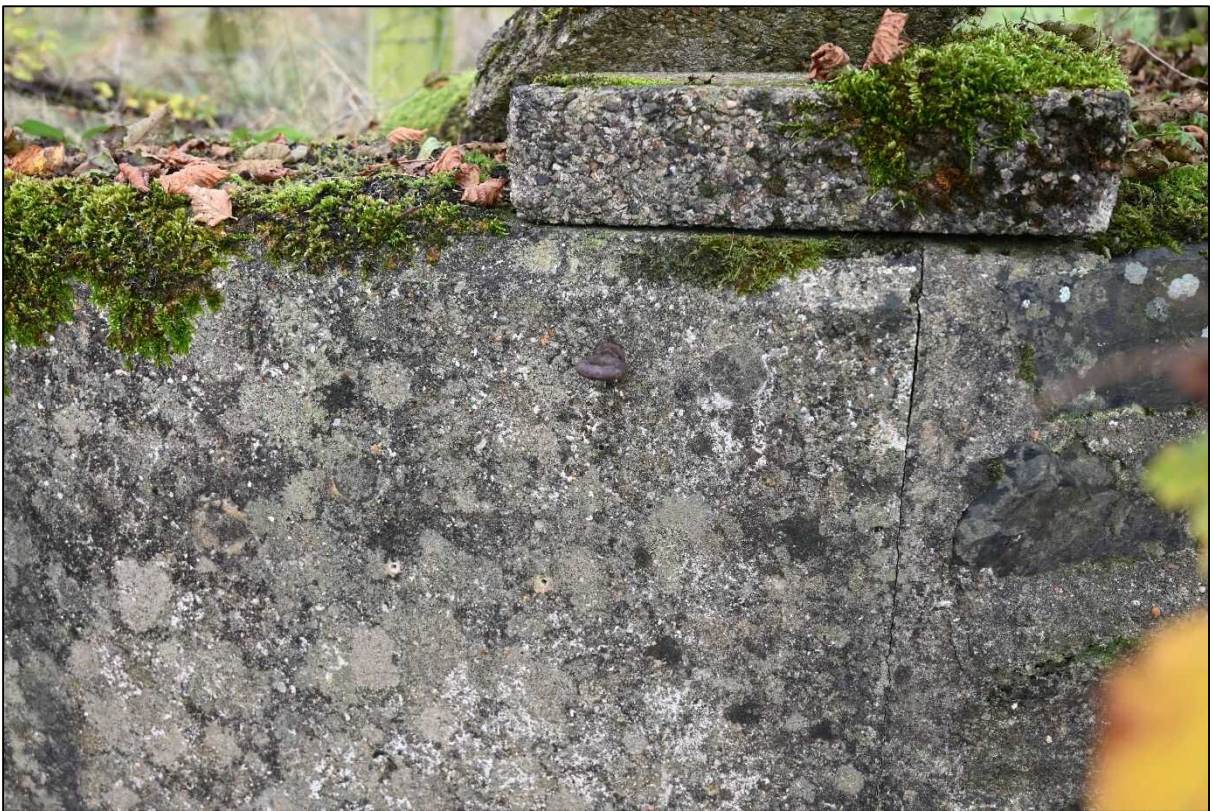
Plate 12: Eye bolt in the eastern end of the northern head wall

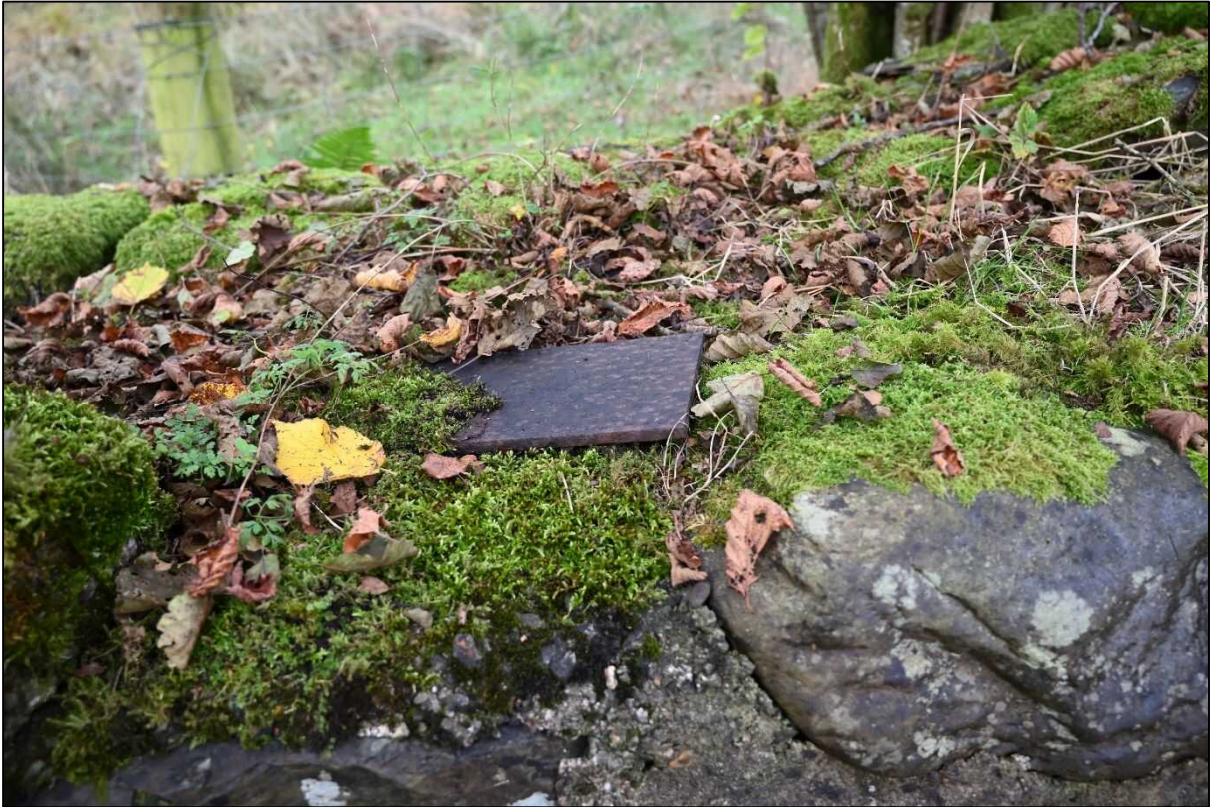
Plate 13: Iron plate on top of the northern head wall

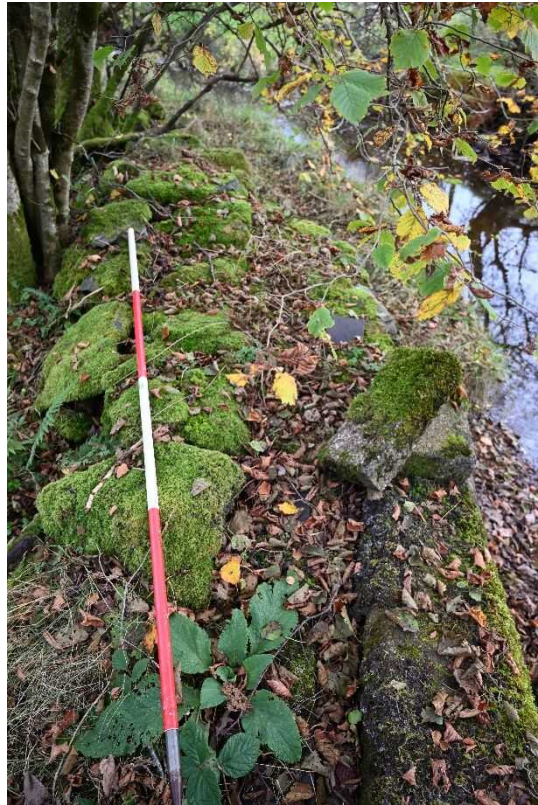
Plate 15: Stone bank behind the concrete head wall on the northern side of the river

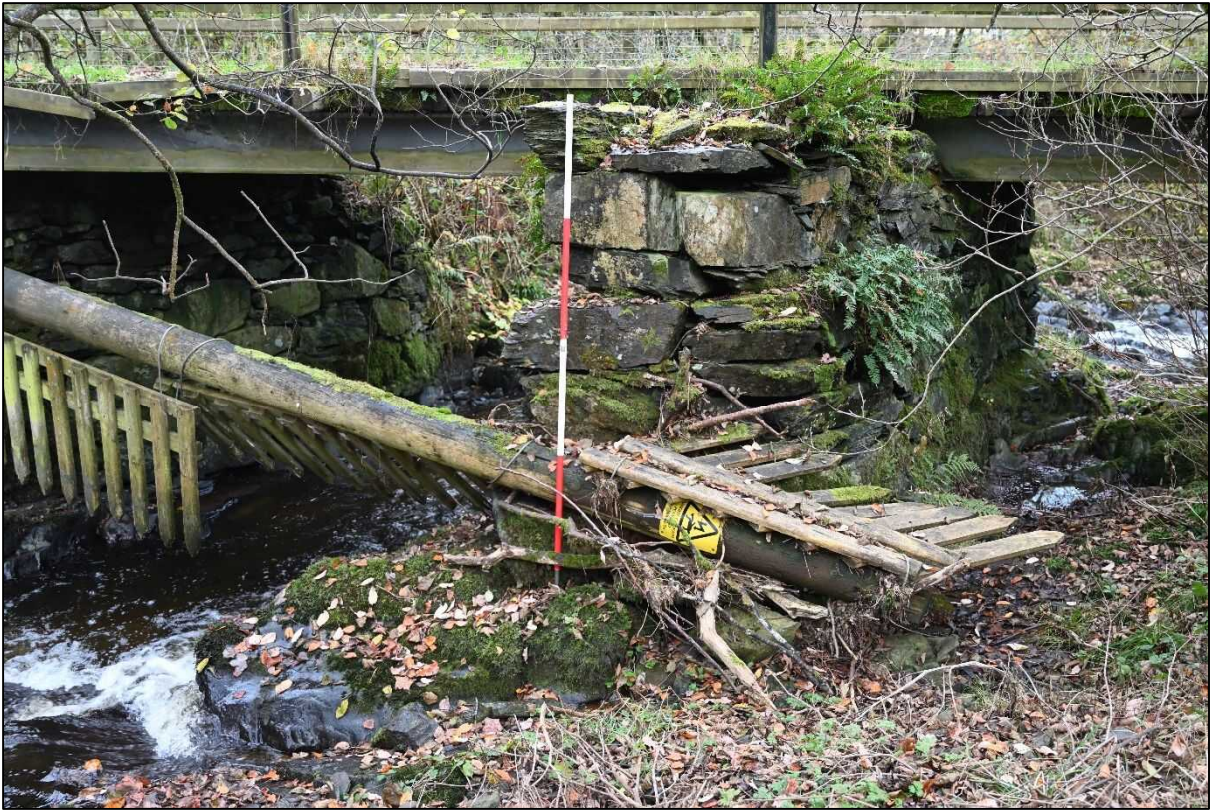
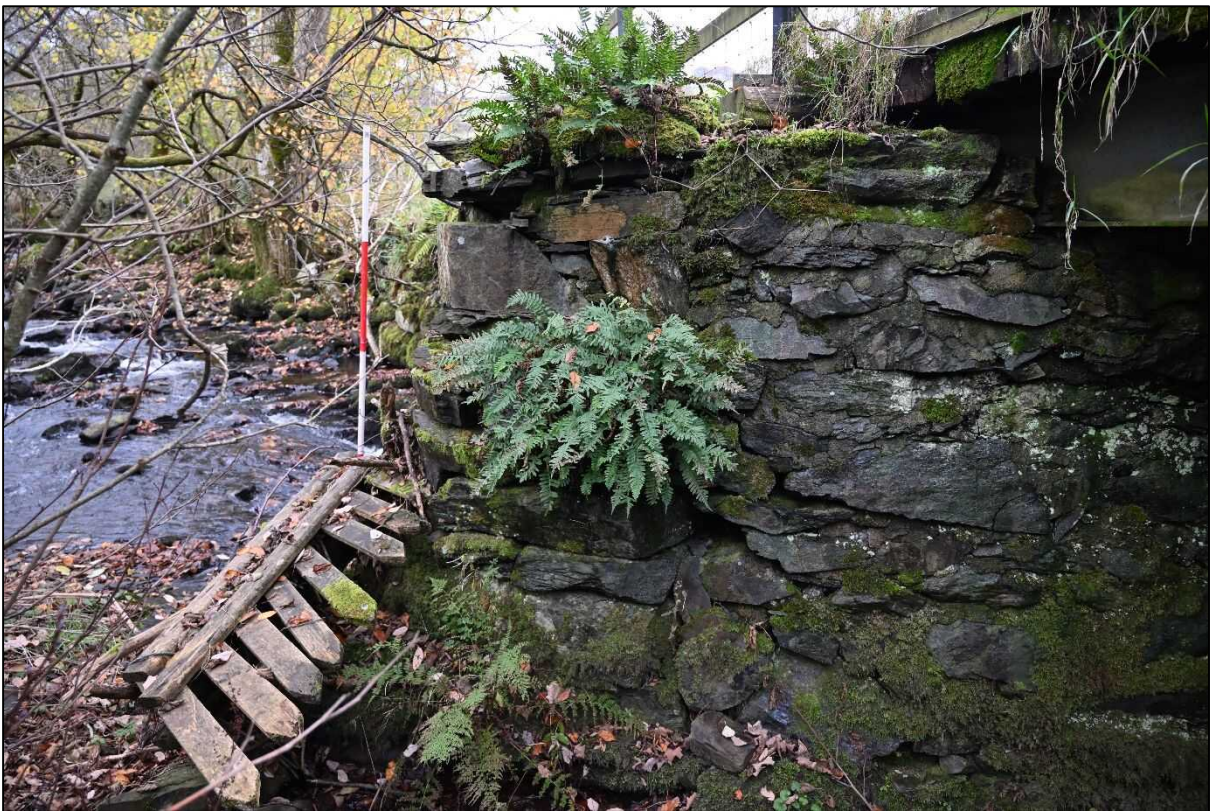
Approximately 45 m downstream from the weir a modern bridge crosses the Afon Iwrch. This appears to be sitting on at least part of a pier which originally held the aqueduct from the weir (Plates 17 and 18). The northern end of the central pier supporting the bridge is marked by much larger stone blocks which are unlike the structure of both the rest of the central pier and the abutments for the bridge. It would, therefore, seem likely that these were originally the central support for the aqueduct shown on the historic mapping.

Plate 17: Probable support for the aqueduct, looking south east

Plate 18: Probable support for the aqueduct, looking east

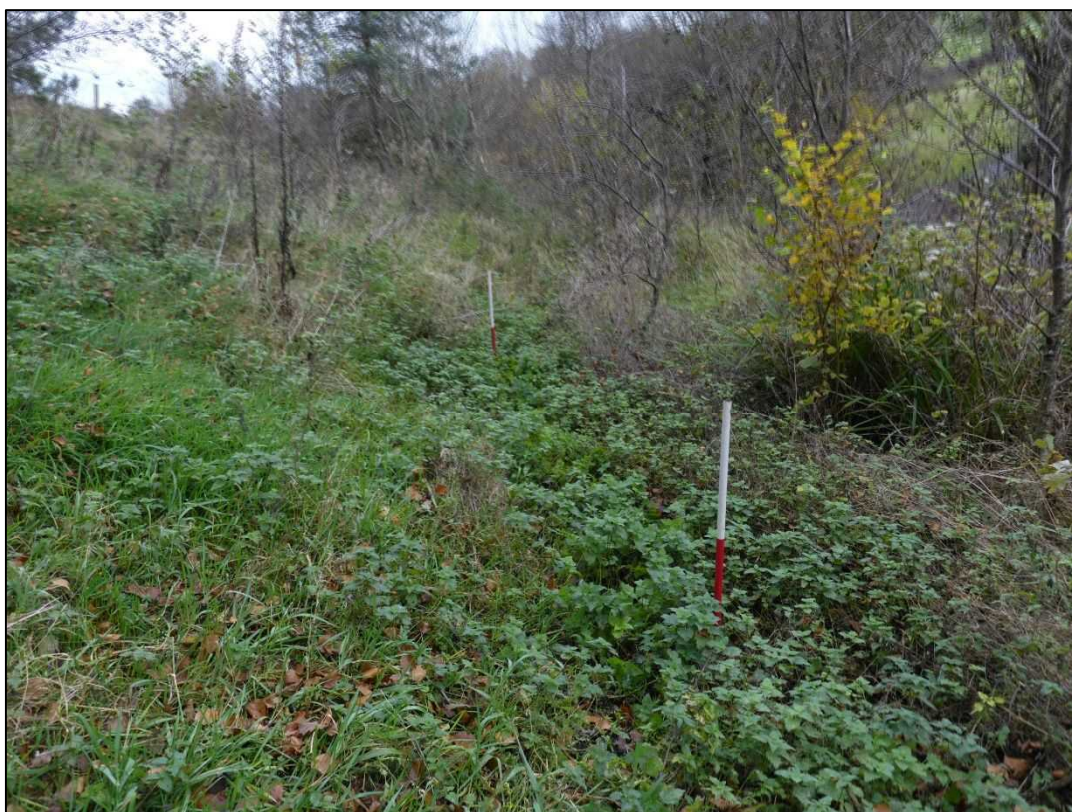
Plate 19: Possible line of the aqueduct to the south west of the bridge, looking north east

The weir was constructed to raise the river level such that the water could be diverted into an aqueduct. This ran to the south west, crossing the river and lead towards a small copse shown on the historic Ordnance Survey mapping. Fieldwork shows there is a linear hollow, south west of the bridge across the river which might mark the line of the aqueduct (Plate 19) and there is a quarry (NT HBSMR 47395) near to the mapped, south western, end of the aqueduct (Plate 20). It is therefore possible that the aqueduct fed some sort of water powered machinery associated with the quarry. Another possibility is that the aqueduct curved to the south and linked in to the aqueduct feeding the sawmill within the farm complex (NT HBSMR MNA156786 / MNA156786), however, none of the mapping shows this link.

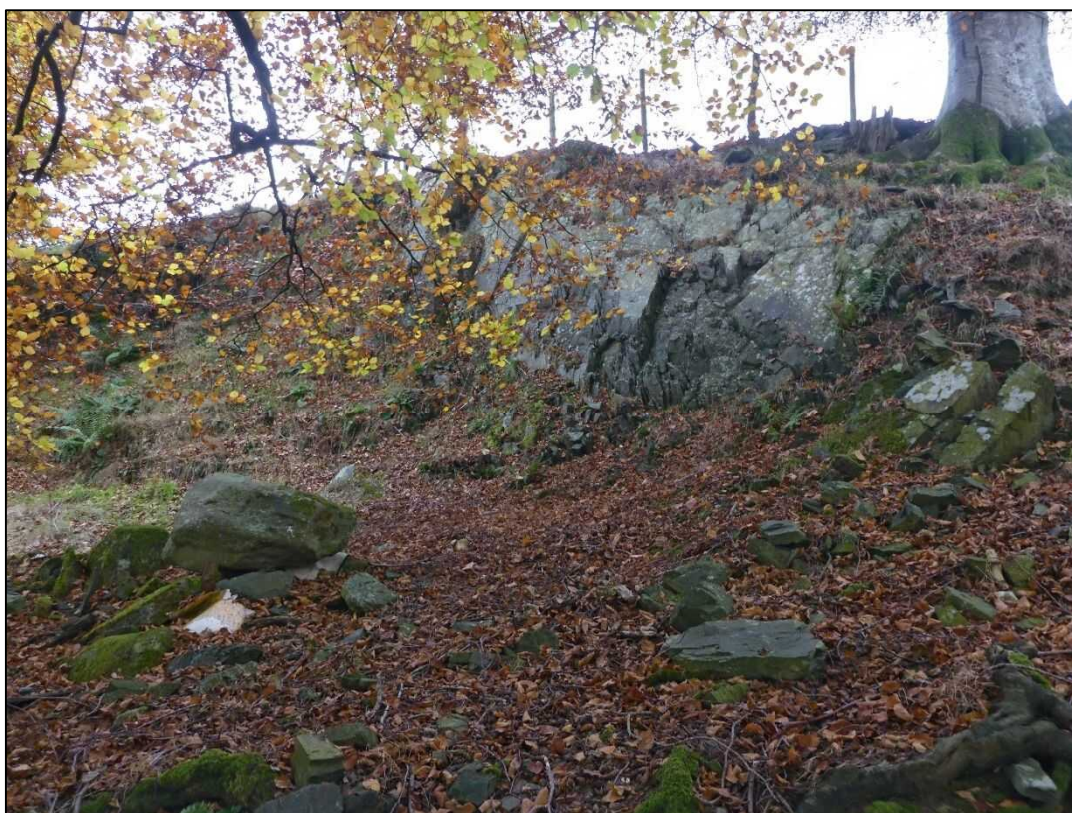
Plate 20: Quarry, looking south west

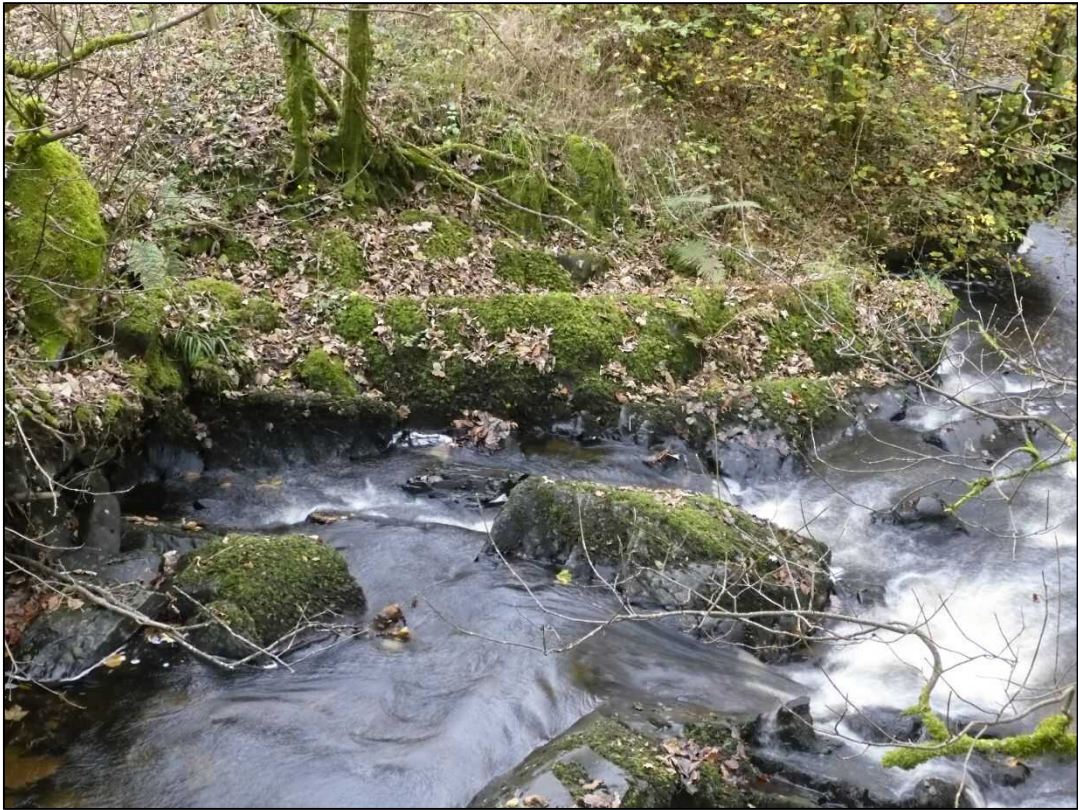
Plate 21: Possible channel on the eastern bank of the Afon Iwrch

It can be argued that the weir is a multi-phased structure with the concrete weir and northern headwall replacing an earlier structure, constructed of stone. Laws and Brooks (2008) assumed that the weir fed the turbine house (NT HSMR 47393) (Plate 22), approximately 85 m downstream, and it is possible that the weir was repurposed to supply the turbine house. If so, a channel observed, to the south of the current bridge (Plate 21) may mark part of the link between the weir and the turbine house.
