# INFILTRATION TESTING REPORT

Report Reference: 511 – R1

PROPOSED CONVERSION OF EXISTING  
AGRICULTURAL BUILDINGS INTO A WEDDING  
VENUE AT TYDDYN Y GWYNT, MOELFRE

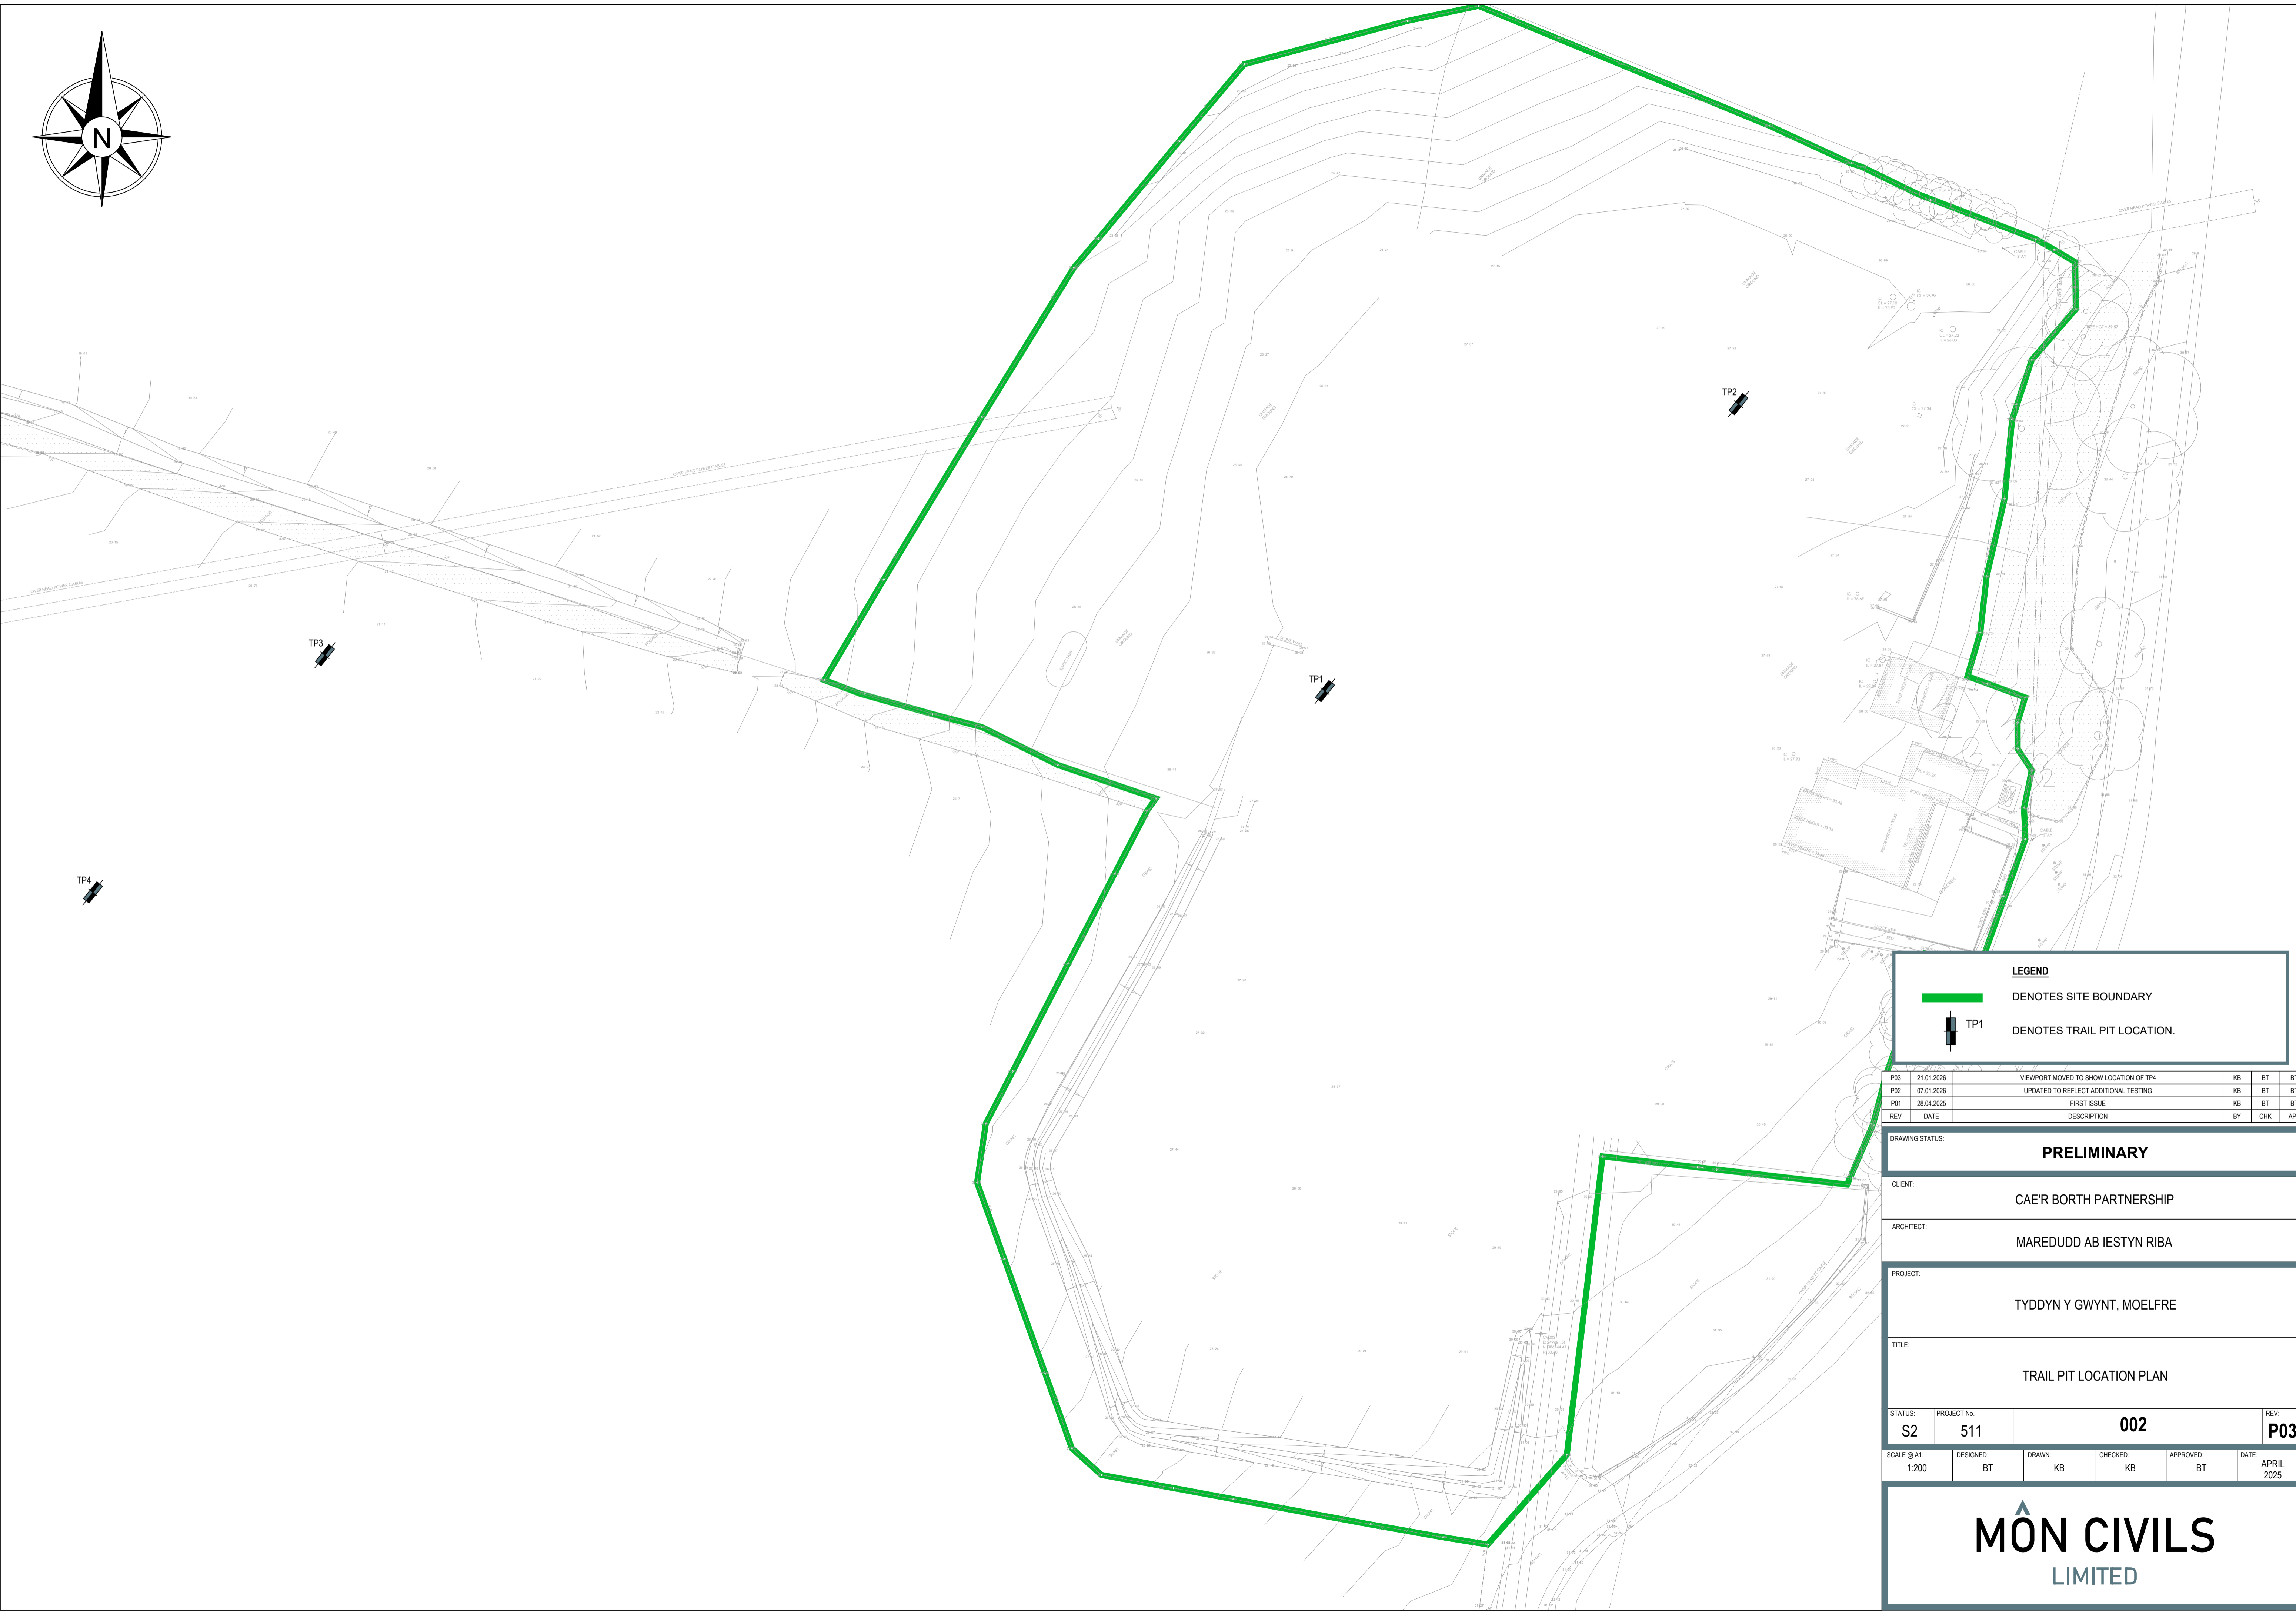
TITLE: TRAIL PIT LOCATION PLAN

Infiltration testing has been undertaken on the 17<sup>th</sup>/03/2025 however, additional testing was undertaken on the 6<sup>th</sup>/01/2026 where the foul infiltration test was conducted within TP3 & TP4. Therefore, four trial holes were excavated within the site, referenced TP1, TP2, TP3 & TP4 excavated to a maximum depth of 1.500m below ground level. Infiltration testing was conducted within both trial holes, no ground water was encountered during the intrusive investigation. The location of the trial pits is indicated on the trial pit location plan contained within **Appendix B**.

TP1 DENOTES TRAIL PIT LOCATION.

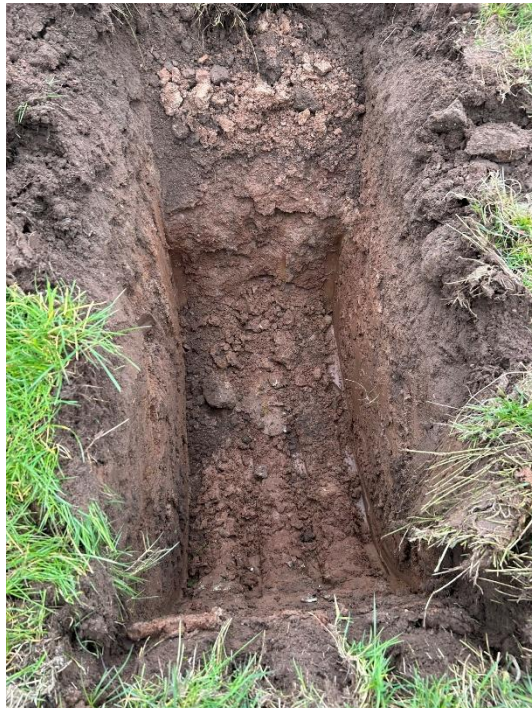
## Trial Pit 1 (TP1)

0.000m – 0.400m	Topsoil: loses sandy, SILTY gravels medium to small sub rounded, dark brown in colour.
0.400m – 1.200m	Reddy brown, damp gravely CLAY. Gravels are medium sized rounded to sub-rounded.

1. Trial pit dimensions: 1.300m (L) x 0.700m (W) x 1.200m (D)
2. No ground water was encountered within the trial pit.
3. Sides of trial pit where stable throughout.

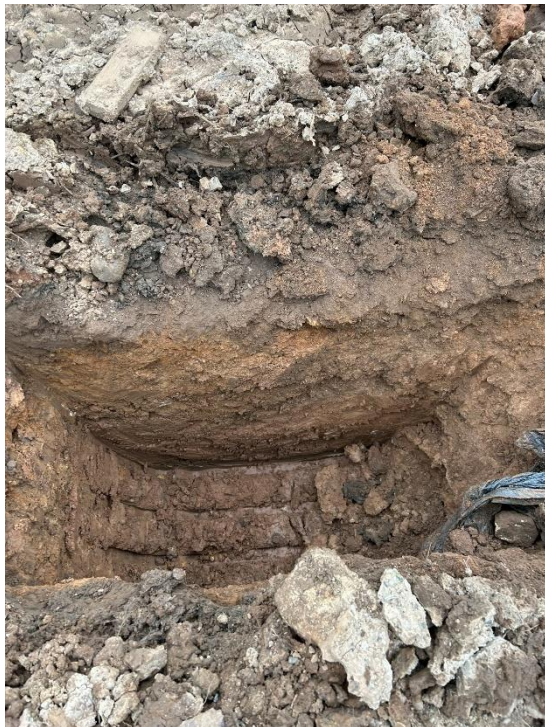
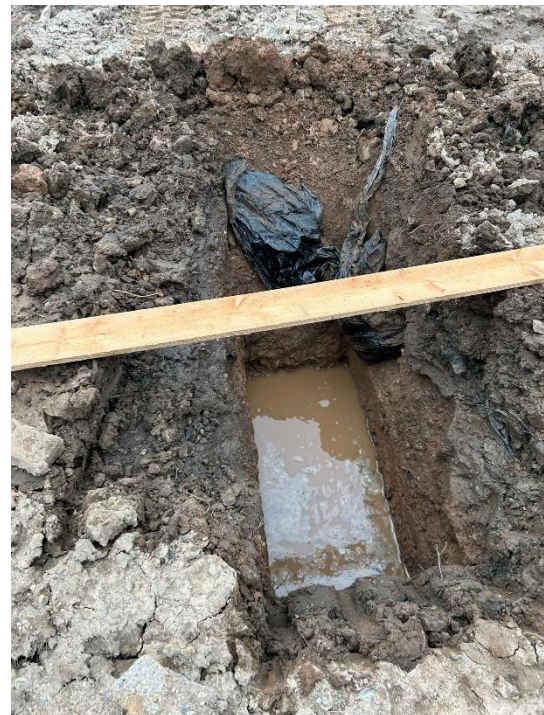
## Trial Pit 2 (TP2)

0.000m – 0.400m Topsoil: loses sandy, SILTY gravels medium to small sub rounded, dark brown in colour.

0.400m – 1.500m Reddy brown, damp gravely CLAY. Gravels are medium sized rounded to sub-rounded.

1. Trial pit dimensions: 1.700m (L) x 0.700m (W) x 1.500m (D)
2. No ground water was encountered within the trial pit.
3. Sides of trial pit where stable throughout.

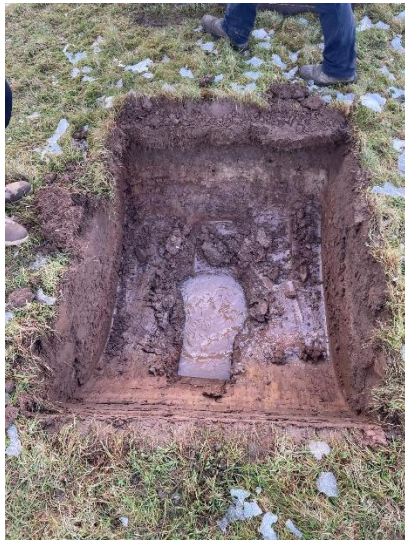
**Image 1**

0.000m – 0.400m	Topsoil: loses sandy, SILTY gravels medium to small sub rounded, dark brown in colour.
0.400m – 1.000m	Reddy brown, damp gravely CLAY. Gravels are medium sized rounded to sub-rounded.

1. Trial pit dimensions: 1.100m (L) x 0.800m (W) x 1.000m (D)
2. 0.300m (L) x 0.300m (W) x 0.300m (D) cube excavated in base of trail hole from 0.70m bgl to 1.0m
3. A separate hole was dug to a depth of 2.2m and no ground water was encountered within the trail pit reference image 3.
4. Sides of trail pit where stable throughout.

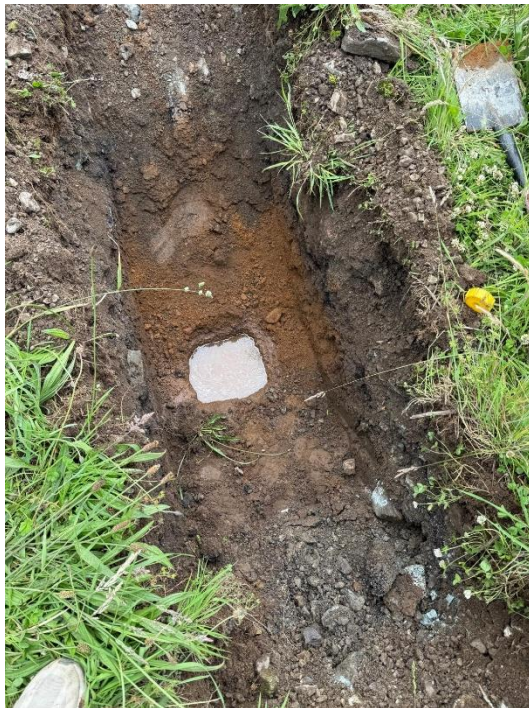
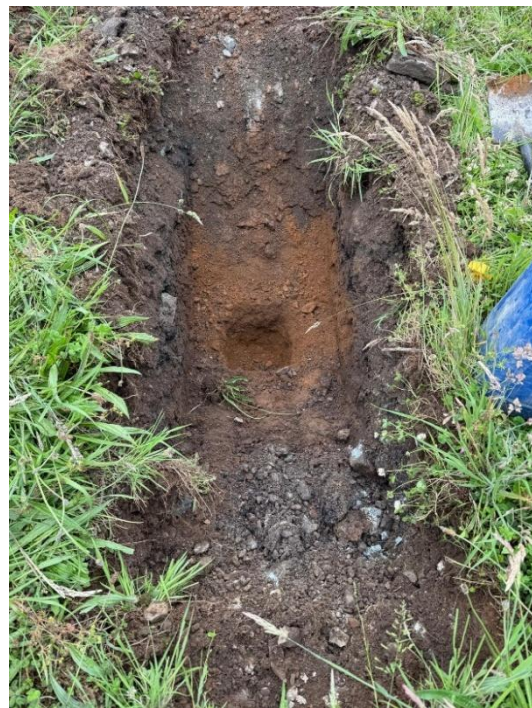
## Trial Pit 4 (TP4)

0.000m – 0.400m                      Topsoil: loses sandy, SILTY gravels medium to small sub rounded, dark brown in colour.

0.400m – 1.000m                      Reddy brown, damp gravely CLAY. Gravels are medium sized rounded to sub-rounded.

1. Trial pit dimensions: 1.100m (L) x 0.800m (W) x 1.000m (D)
2. 0.300m (L) x 0.300m (W) x 0.300m (D) cube excavated in base of trail hole from 0.70m bgl to 1.0m
3. No ground water was encountered within the trial pit.
4. Sides of trail pit where stable throughout.
