Connah's Quay Low Carbon Power

Environmental Statement Volume IV Appendix 15-G: Arboricultural Impact Assessment (AIA)

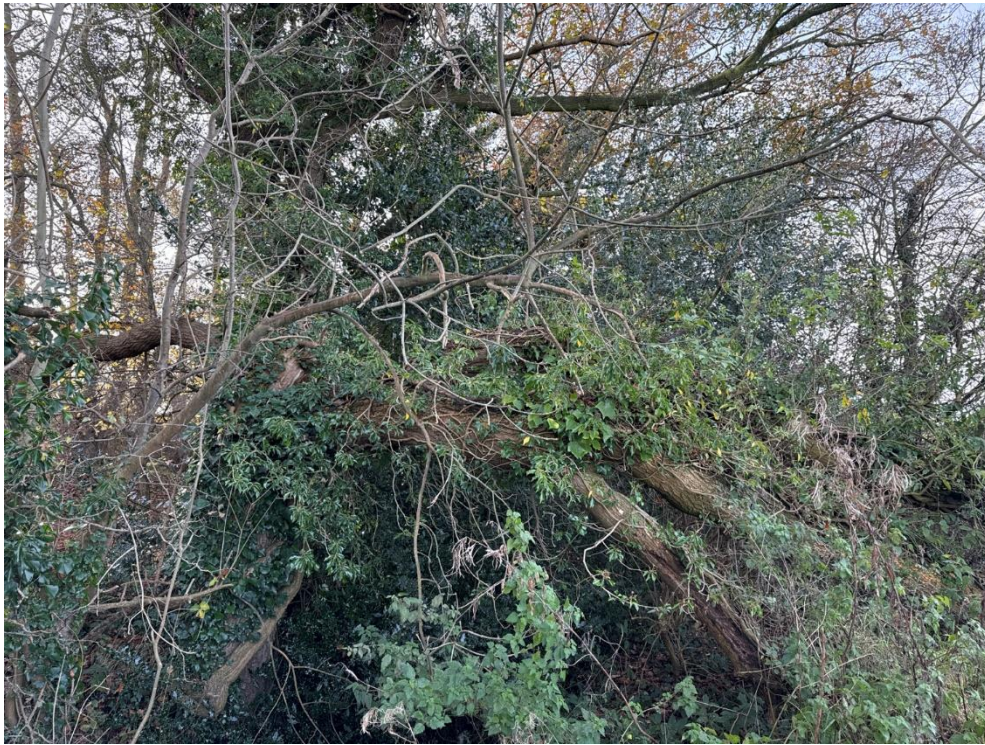
Photograph 3 A veteran common oak (T13) located at the northern end of the ancient woodland. Partially collapsed towards the Construction and Operation Area with significant decay in collapsed sections.

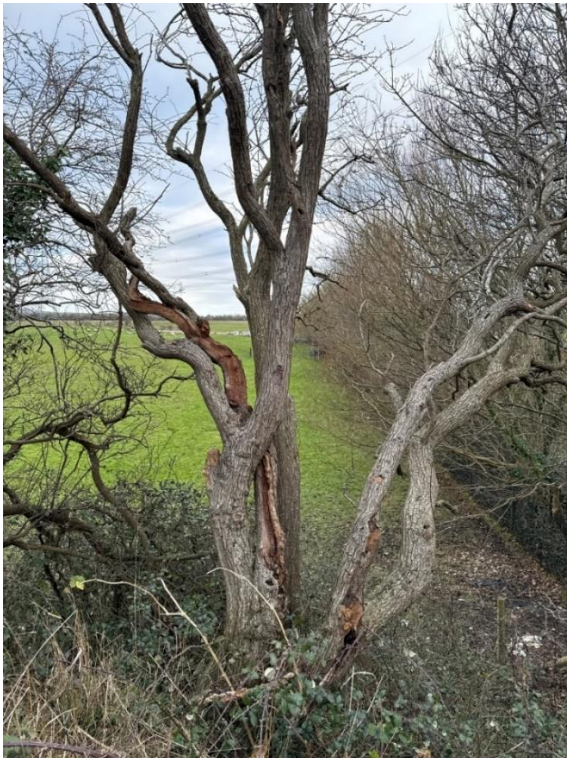
Photograph 6 Mature hawthorn (T77) considered to be veteran due to the significant decay in two of three stems.

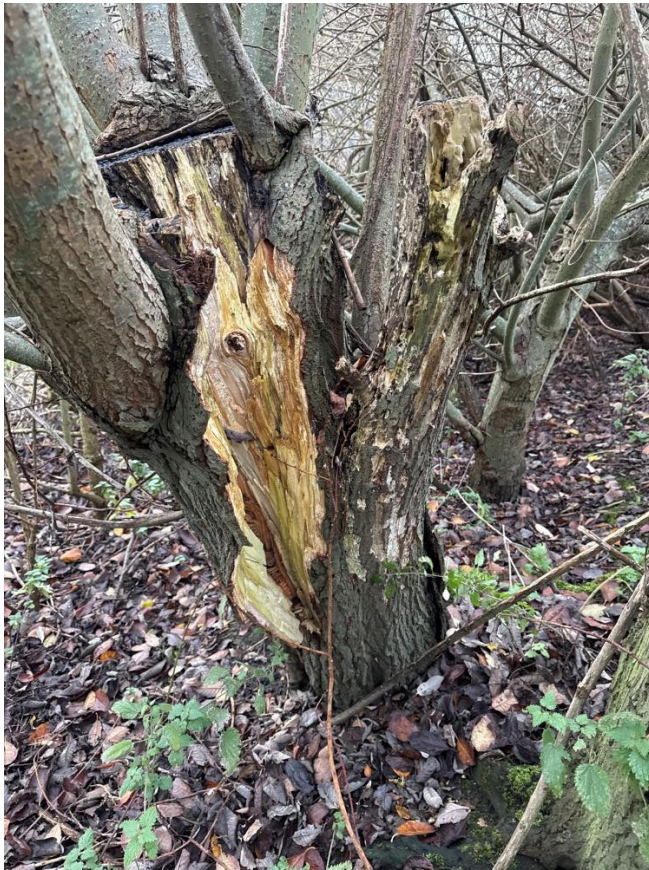
Photograph 11 A mature, veteran goat willow (T272) with significant decay to its main bole.

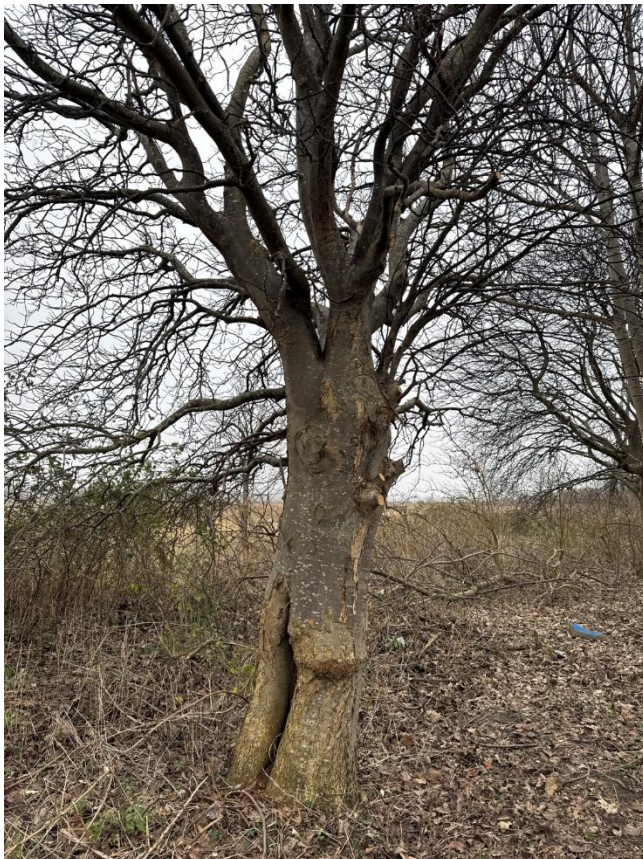
Photograph 12 A mature, veteran Swedish whitebeam (T350) with significant internal decay evident through large cavity opening at base.

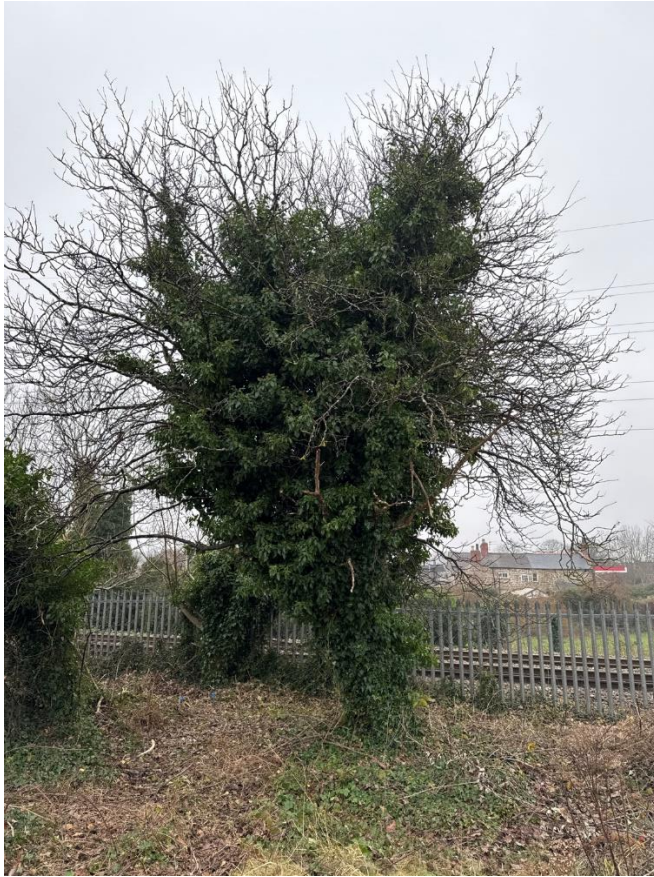
Photograph 13 T356 A mature potential veteran Swedish whitebeam covered in dense ivy.
