# Load out Facility Water Quality Monitoring

Dredging Operation  
Fourth Round

**Status:** Final Report

**Client:** Airbus Operations Ltd.

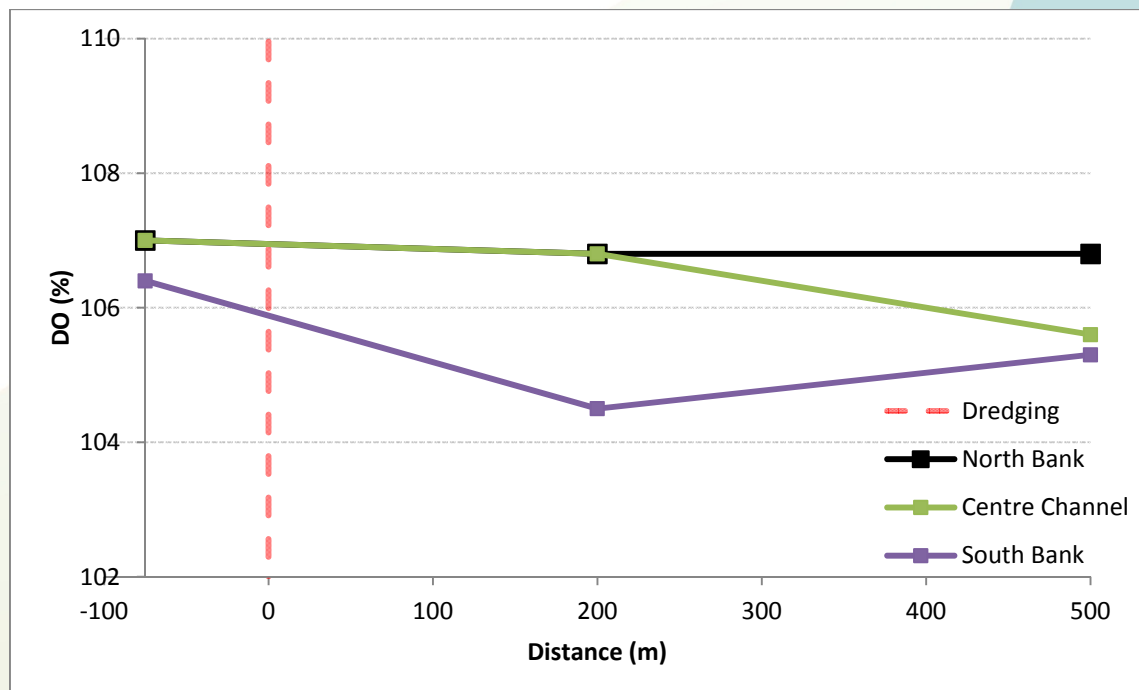
**Figure B-2** Dissolved oxygen (DO) levels in the River Dee collected around the load out facility on 16<sup>th</sup> August 2013

The results of the DO measurements taken on 16<sup>th</sup> August 2013 are presented in **Table B-1** and **Figure B-2**, in **Appendix B**. Dissolved oxygen concentrations showed low variation between sample locations, ranging from approximately 104.5% to 107.0%.

The results show a similar trend to the TSS levels, dropping slightly downflow of the dredging at 200m and then rising again at 500m. The exception to this was in the centre channel where DO levels were lowest at 500m downflow of the dredging.

Changes in DO levels followed a similar trend as TSS levels in the river; however, with a much reduced level of variation, the largest being only 1.9%. Overall, the dredging operations are not considered to be significantly affecting the dissolved oxygen field in the river.
