**PB GELATINS UK LIMITED  
TREFOREST INDUSTRIAL ESTATE,  
PONTYPRIDD**

**ENVIRONMENTAL PERMIT SURRENDER APPLICATION  
SITE CONDITION REPORT**

**January 2026**

**Project Reference: NS\_0118\_32**

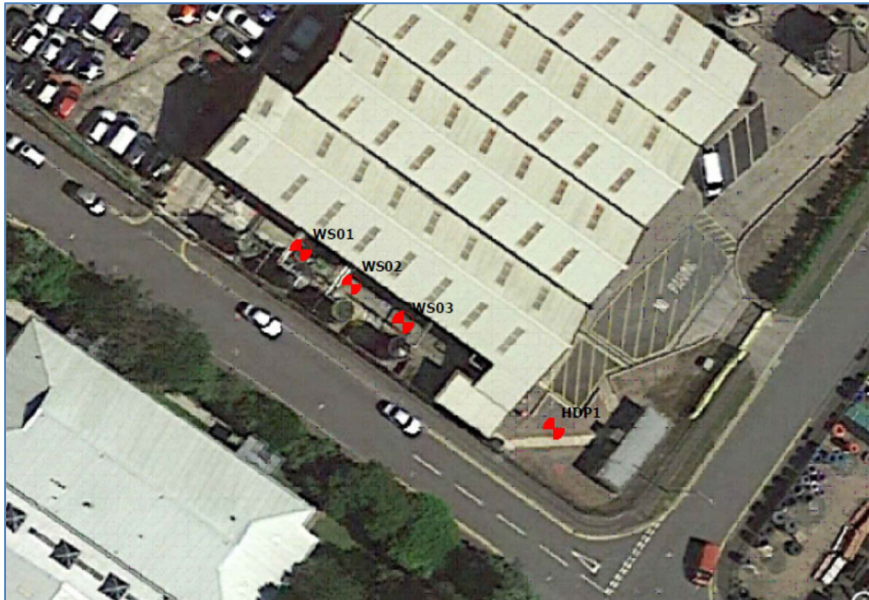
**Figure 6. November 2020 Ground Investigation Locations** (extracted from ECL, December 2020 Geo-Environmental report).

The ground investigation concluded no evidence of sodium hydroxide beneath the concrete spill area. The concrete hardstanding and drainage system were in good condition, with the spill managed via the site's drainage system.

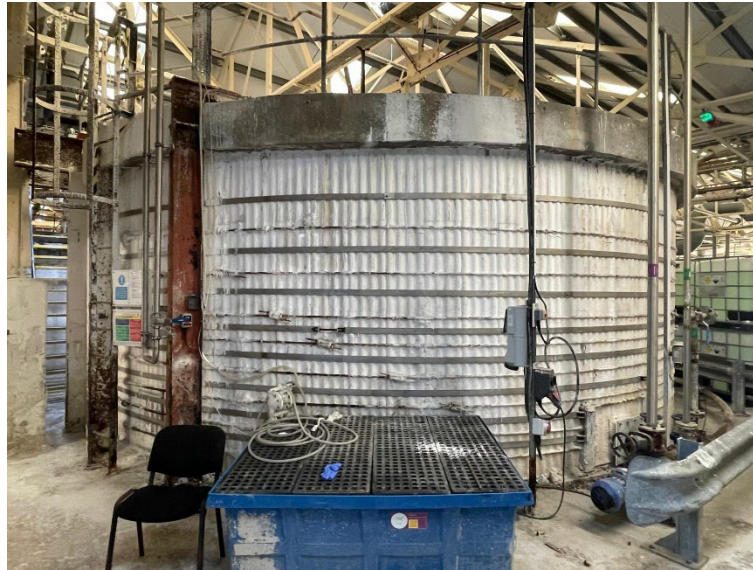
Equipment Description	Lime Silo – contains Hydrated Lime
Size	8m Diameter, 3m High
Quantity	1
Waste	Hydrated Lime
Estimated Quantity	40 Tonne
CSE Required	Yes
Start Date	July 2025

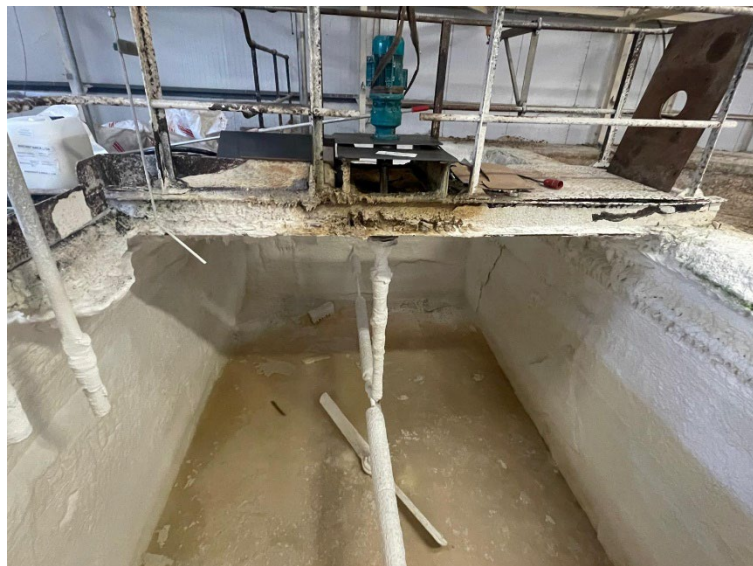
Equipment Description	Lime Mixing Pits
Size	5.8m long, 3.5m Wide, 2.6 high
Quantity	2
Waste	Hydrated Lime
Estimated Quantity	10 Tonne
CSE Required	Yes
Start Date	July 2025

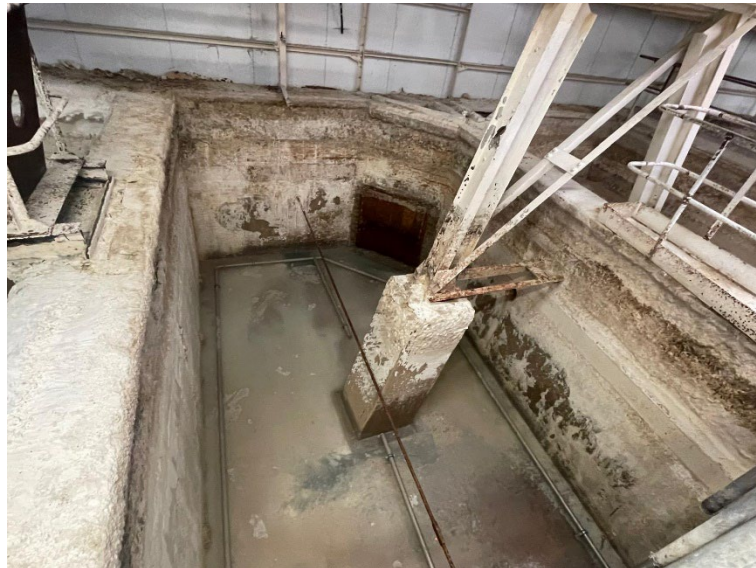
Equipment Description	40 Ton Liming Pits
Size	5.8m long, 3.5m Wide, 2.6 high
Quantity	10
Waste	Ossein, dispose of on site
Estimated Quantity	NA
CSE Required	No
Start Date	WC 23 <sup>rd</sup> June

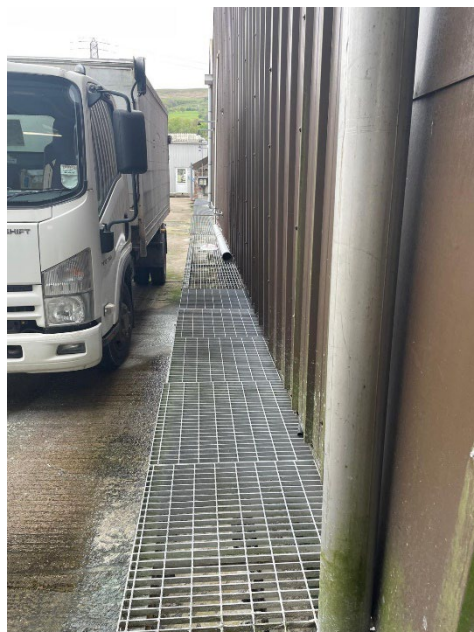
Equipment Description	40 Ton Liming Pits Drainage Channels
Size	44m Long, 0.6m Wide, 1m Deep (176m in total)
Quantity	4
Waste	Hydrated Lime
Estimated Quantity	4 Tonne
CSE Required	No
Start Date	July 2025

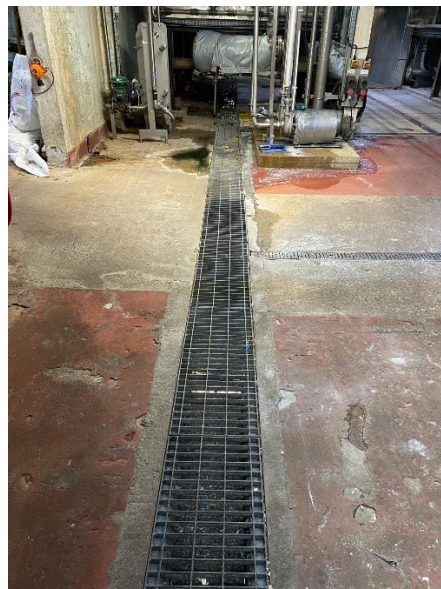
Equipment Description	Internal Drainage Channels
Size	50m Long, 0.5m Wide, 0.5m Deep (200m in total)
Quantity	4
Waste	Ossein
Estimated Quantity	1Tonne
CSE Required	No
Start Date	July 2025

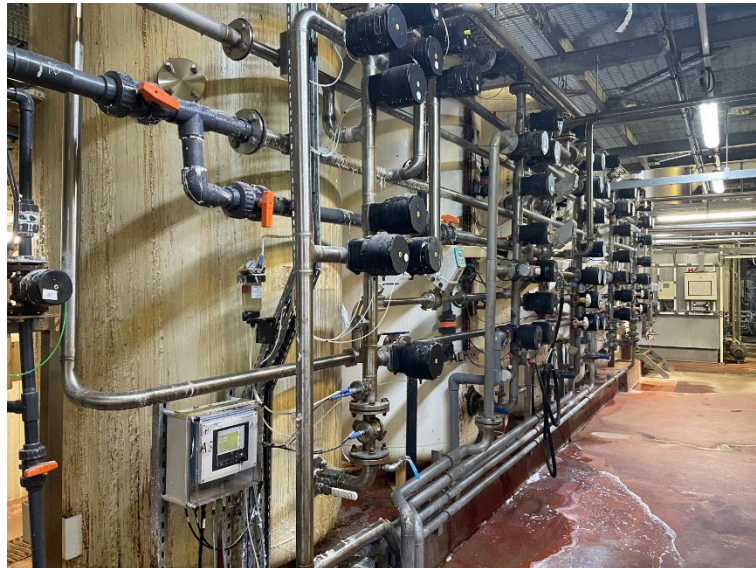
Equipment Description	Ion Exchange Vessels
Size	1.4m Diameter, 3.5m High
Quantity	9
Waste	Anion & Cation Resins
Estimated Quantity	20 Tonne
CSE Required	No
Start Date	July 2025

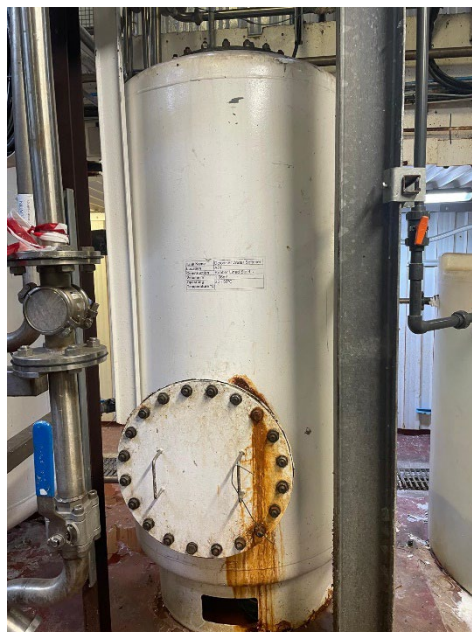
Equipment Description	Ion Exchanger water softener
Size	0.9m Diameter, 1.6m High
Quantity	1
Waste	Cation Resin
Estimated Quantity	0.25 Tonne
CSE Required	No
Start Date	July 2025

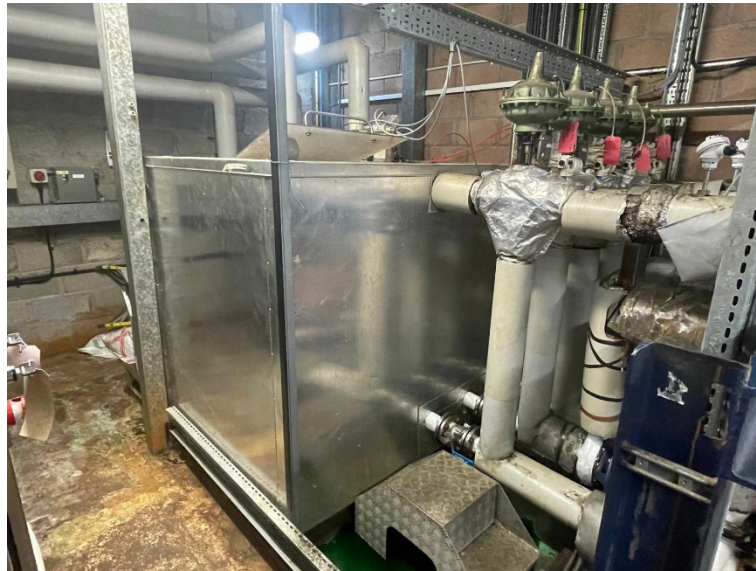
Equipment Description	Glycol Tank
Size	2m Long, 1.2m Wide, 1.4m High
Quantity	1
Waste	Mono Propylene Glycol
Estimated Quantity	4,000 litres
CSE Required	No
Start Date	July 2025

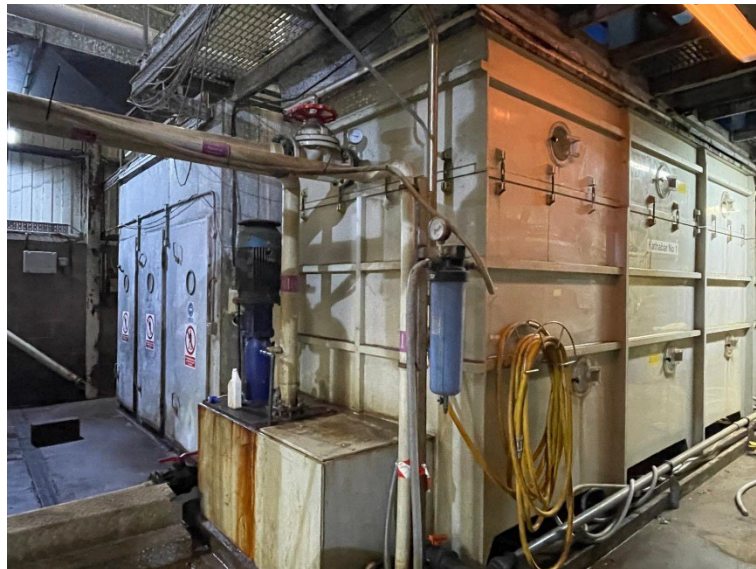
Equipment Description	Kathabar
Size	
Quantity	2
Waste	Lithium Chloride
Estimated Quantity	3,000 litres
CSE Required	No
Start Date	July 2025

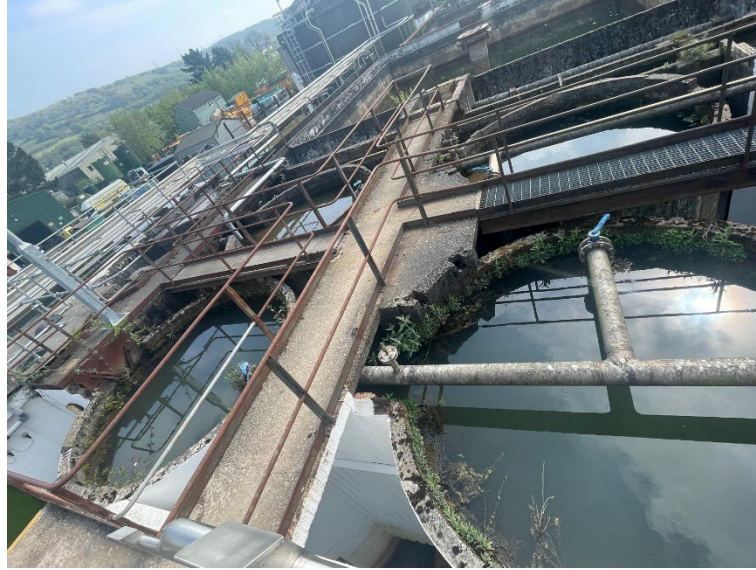
Equipment Description	Floculators
Size	3m Diameter, 4.3m High
Quantity	6
Waste	River Silt
Estimated Quantity	180 Tonne
CSE Required	No
Start Date	Mid-August 2025

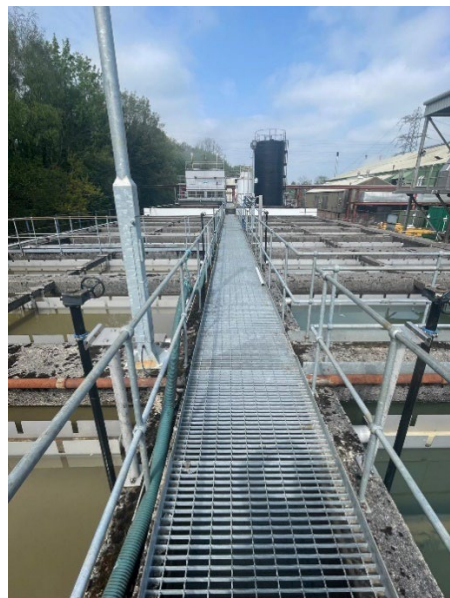
Equipment Description	Settling Pits Trough
Size	45m Long, 1m Wide, 1m Deep
Quantity	1
Waste	River Silt
Estimated Quantity	30 Tonne
CSE Required	No
Start Date	Mid-August 2025

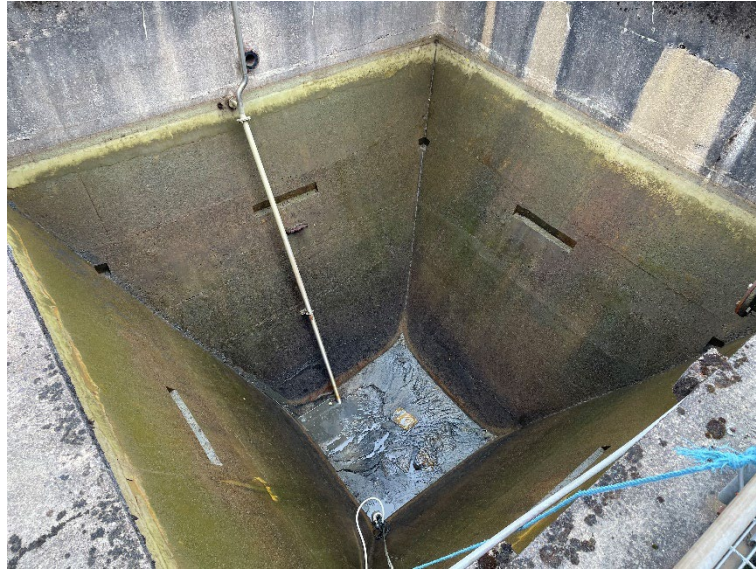
Equipment Description	Settling Pits
Size	6m Long, 6m Wide, 4.5m Deep
Quantity	8
Waste	River Silt
Estimated Quantity	480 Tonne
CSE Required	No
Start Date	Mid-August 2025

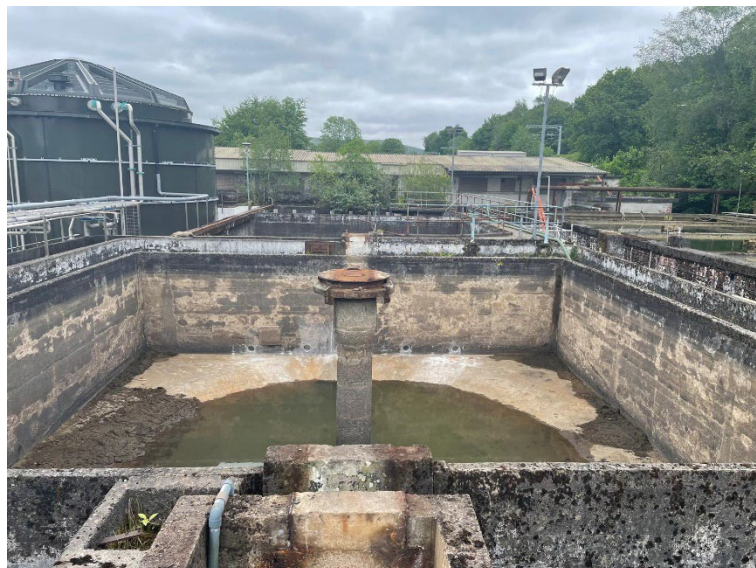
Equipment Description	Grade 1 Reservoir
Size	30m Long, 12m Wide, 4.5m Deep
Quantity	1
Waste	River Silt
Estimated Quantity	240 Tonne
CSE Required	Yes
Start Date	Mid-August 2025

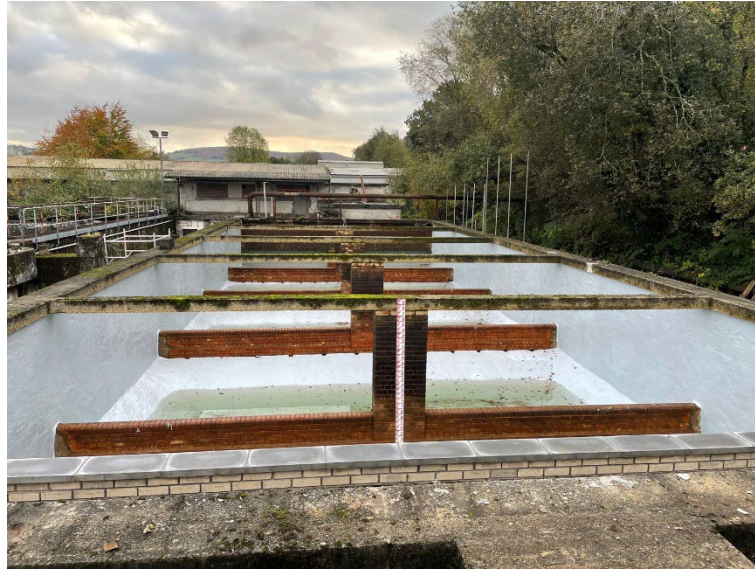
Equipment Description	Grade 3 Reservoir
Size	32m Long, 12m Wide, 4.5m Deep
Quantity	1
Waste	River Silt
Estimated Quantity	180 Tonnes
CSE Required	Yes
Start Date	Mid-August 2025

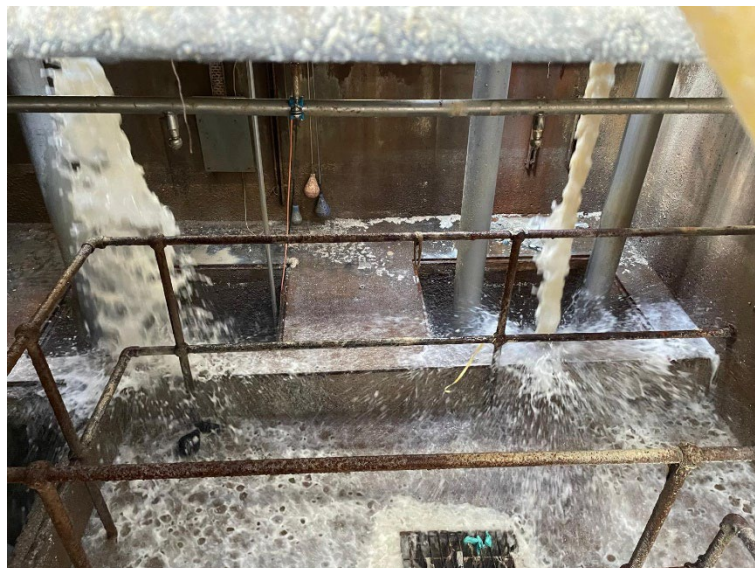
Equipment Description	A18 Pumping Chamber
Size	4m long, 4m Wide, m Deep
Quantity	1
Waste	Ossein
Estimated Quantity	30 Tonnes
CSE Required	Yes
Start Date	Mid-September 2025

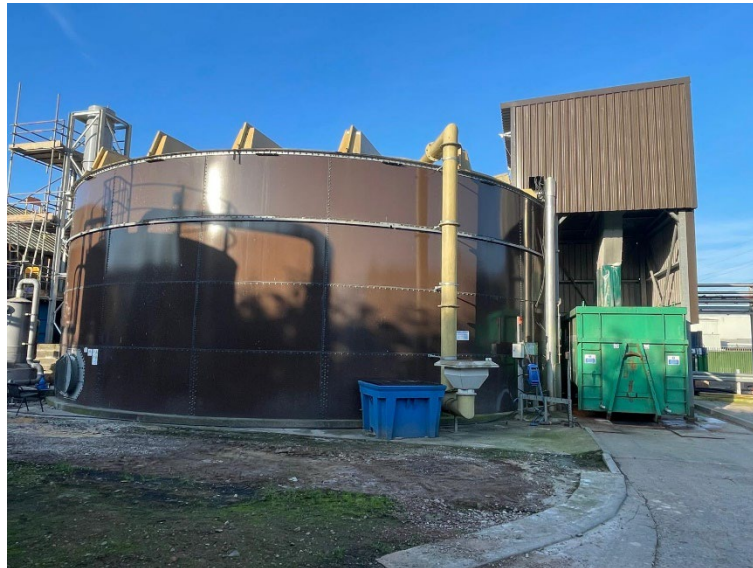
Equipment Description	A18 Balance Tank
Size	13m Diameter, 5.7m High
Quantity	1
Waste	Sludge
Estimated Quantity	40 Tonne
CSE Required	Yes
Start Date	End July 2025

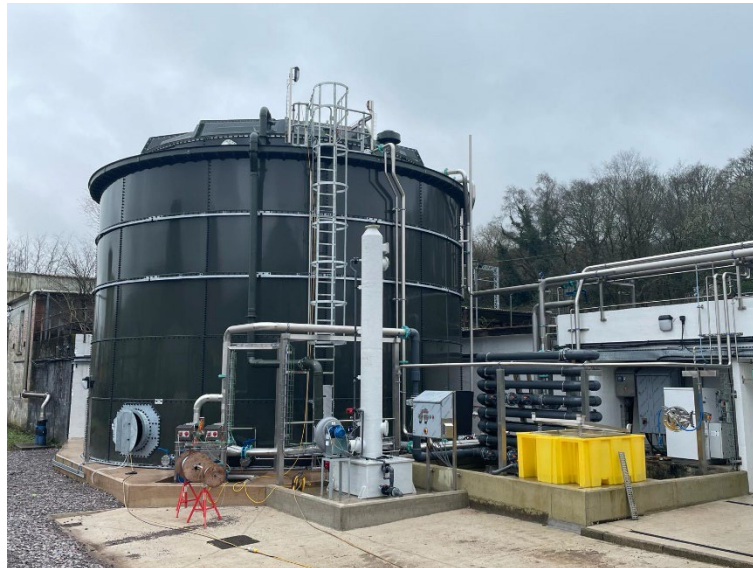
Equipment Description	A21 Balance Tank
Size	8.5m Diameter, 7.7m High
Quantity	1
Waste	Sludge
Estimated Quantity	20 Tonne
CSE Required	Yes
Start Date	End July 2025
