## mWave Marine Energy Device and Onshore Infrastructure

### ENVIRONMENTAL STATEMENT

### CHAPTER 16: Geology, Hydrology and Land Quality

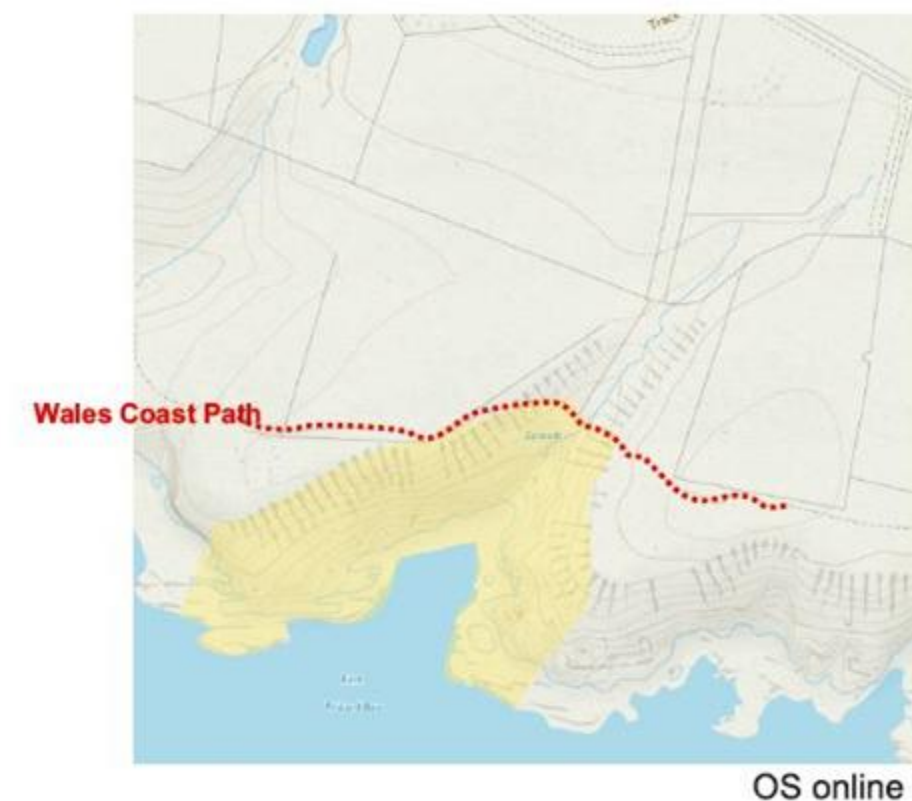
Figure 16.1 Geological study area - topography and extent (online OS)

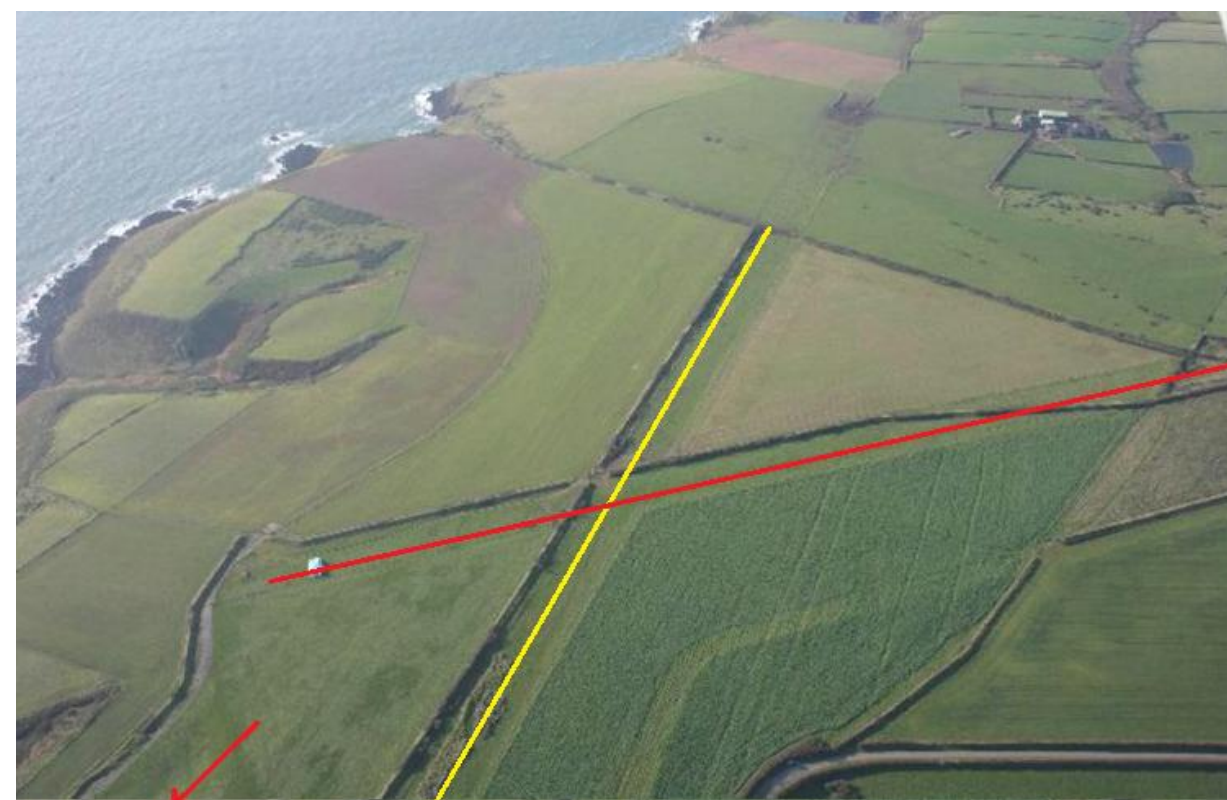
Figure 16.2a Aerial showing lines of old runways with direction of control station

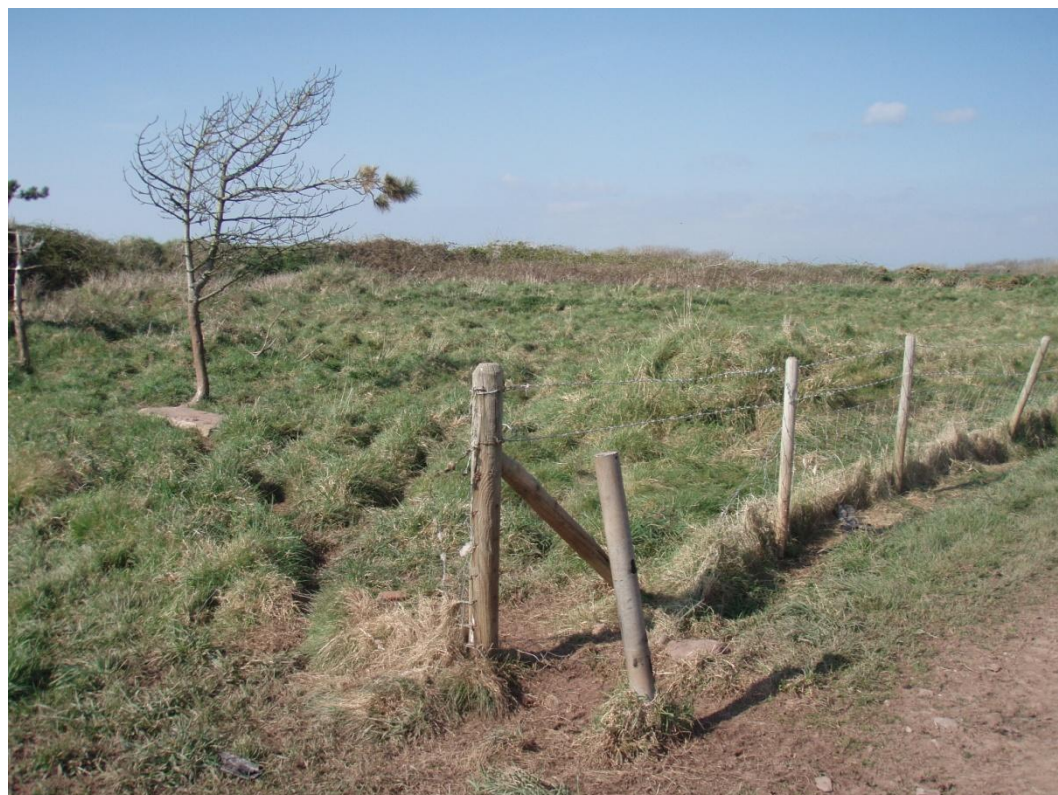
**Figure 16.2c Control Station site.**

- 16.3.1.5 Prior to the installation of the control station there will be minimal works. The ground will be levelled with a digger with surface scrape soil being retained on site. A layer of stone will be placed on the ground before the control station units are delivered to site and lifted into place (Chapter 2 Project Description). The onshore cable will be laid on the surface and will not be buried (other than crossing the coastal path). With the proposed cable installation method, the minimal ground works at the control station site and any material being retained on site, there should be minimal risk in terms of contaminated land.

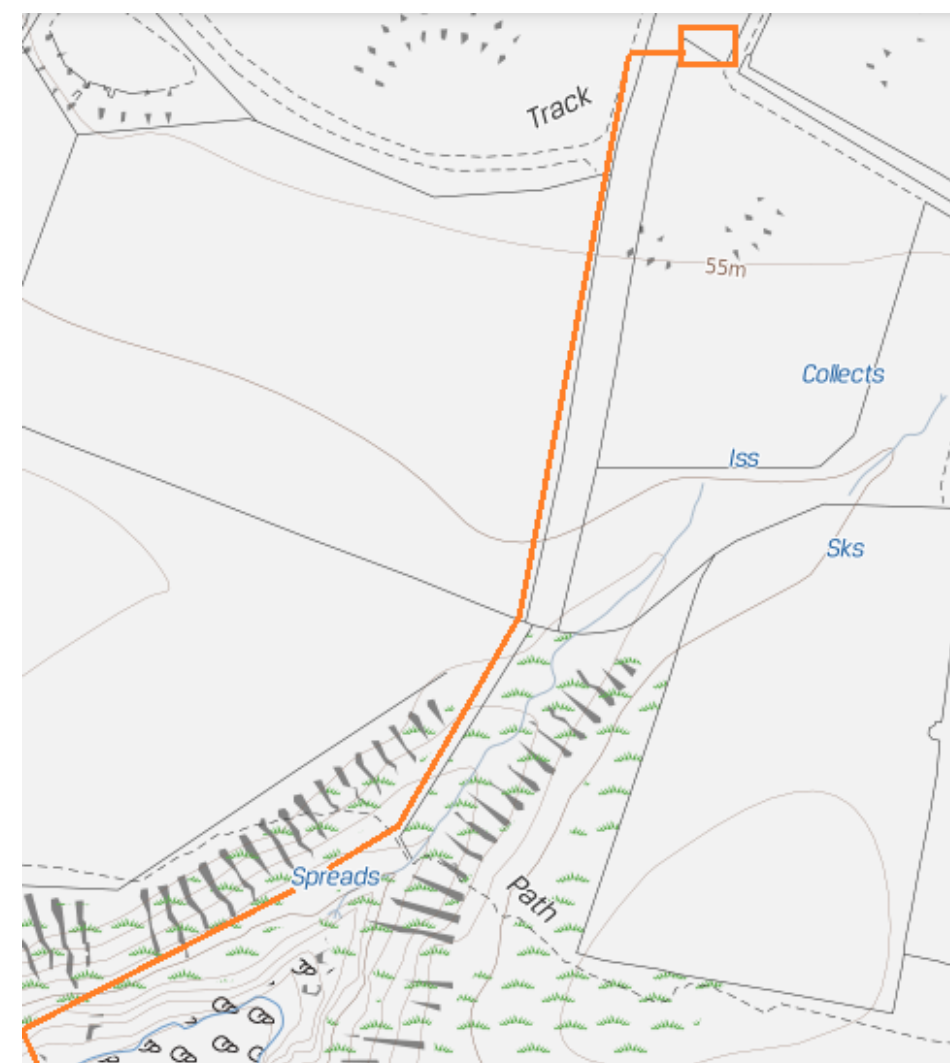
**Figure 16.3 Study area - water features and cable route<sup>3</sup>**

- 16.3.1.6 With respect to water features in the area, there is a small stream which forms from two springs approximately 100m to the south east (>5m downhill) of the control station site. The stream then follows the valley down into the narrow gully of East Pickard Bay and onto the intertidal area (Figure 16.3). Looking at the data available from Cycle 2 River and Water bodies<sup>2</sup>, the groundwater within the Angle Peninsula is identified as good both qualitatively and chemically.

- 16.3.1.7 As identified above the control station site and the cable route is distant from any water course. The control station site will require minimal groundwork/levelling with a layer of stone being placed on site before the units are brought to site and lifted into position. The cable will be brought out of East Pickard Bay gully in the lower tidal section thereby avoiding being laid near the stream. Staff involved in the works in the intertidal area will be kept to a minimum thereby reducing trampling adjacent to the watercourse. The cable will be laid on the surface of the ground, secured by soil nails, where appropriate, crossing the coastal path by a gate remote from the stream. With standard good construction practice on site, this method of installation in itself will mitigate the potential for significant impact on any water feature.

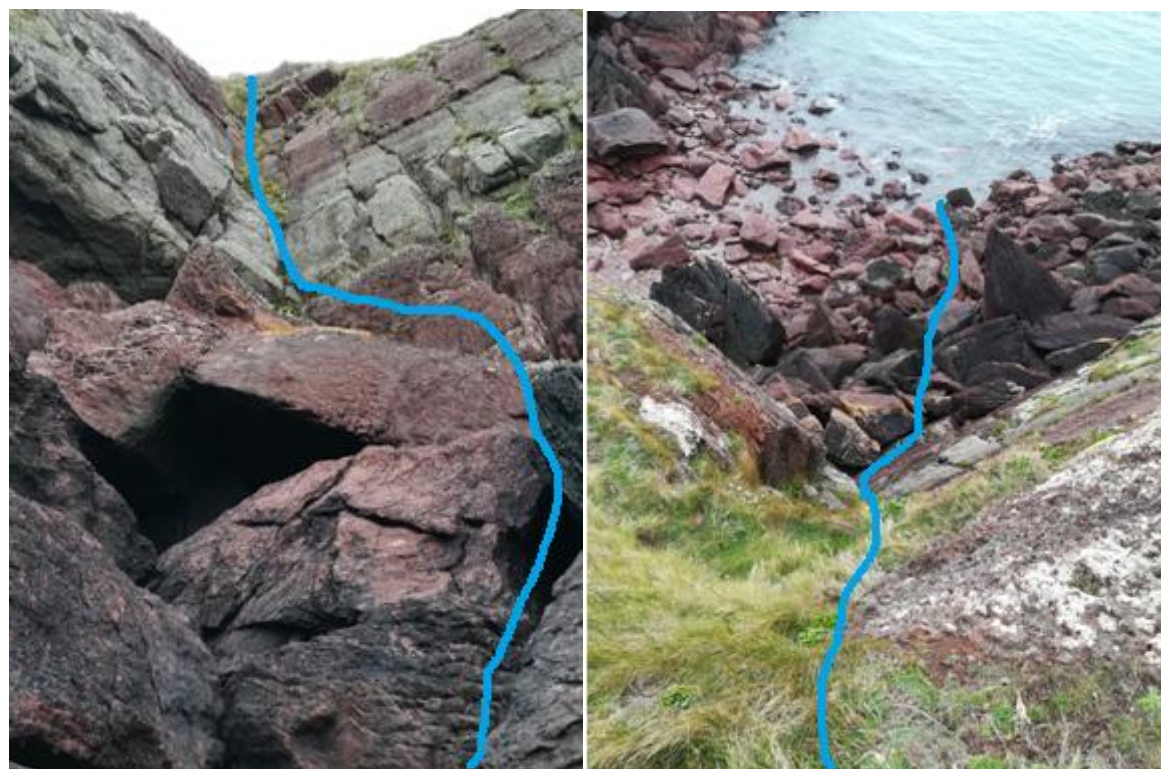
**Figure 16.6 Cable route looking up and down gully**

- 16.7.2.2 The cable will be winched onshore using a manual winch system, with the main pull point being located in agricultural fields to the north and two anchor points near the coast (Chapter 2 Project Description, 2.5.3). Between MLWS to the termination box, which will be above MHWS, the cable will be laid across the surface of a small section of lower intertidal area and then up the vertical western side of the gully to the cliff top (Figure 16.6). Along this section the cable will be within a plastic conduit that is fixed to the rock surface using clamps. The clamps will be attached to the rock face via two bolts and there will be approximately 12-15 plates attached to the rock, i.e. one approximately every 5m. The attachment of the clamps to the rock will be undertaken using handheld tools only.

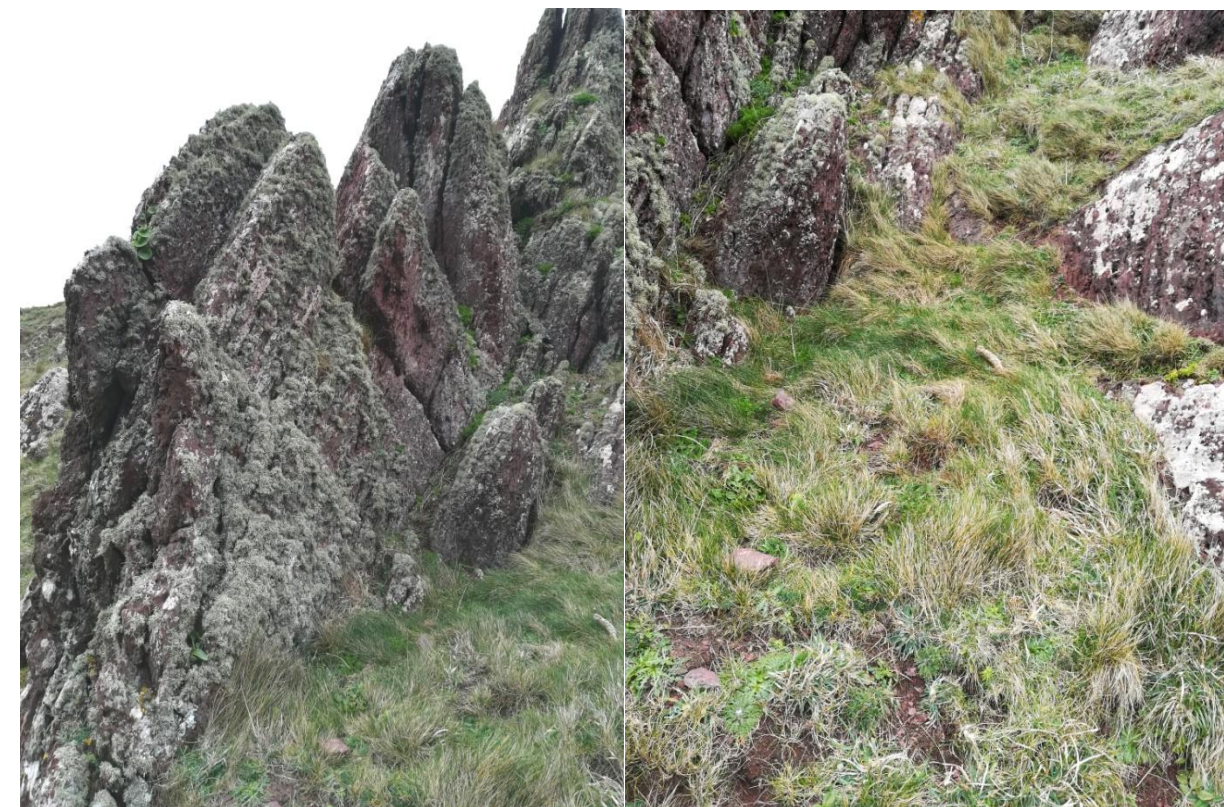
**Figure 16.7a and b showing projecting rocks and potential junction box location**

- 16.7.2.3 A termination box (approximately 100cm x 60cm x 60cm) will be required at the top of the intertidal section. A location between existing rock features will be identified and the termination box will be hidden using rock or turf or buried using hand tools. The cable will also need to be anchored to take the strain of tidal movement. The anchor point, which will be located near the termination box, is likely to comprise two ~32mm thickness steel hollow bars installed and fully grouted into a 76mm diameter hole. The exact number and thickness of hollow bars will be determined during anchor design. The cable will be clamped to the anchor. Rocks or turf will be used for screening, where necessary.

- 16.7.2.4 Figure 16.7a & 16.7b shows the projecting rocks located approximately 70m from the coastal footpath. This could be used as an anchor point for the cable, with an area adjacent suitable for positioning the termination box.

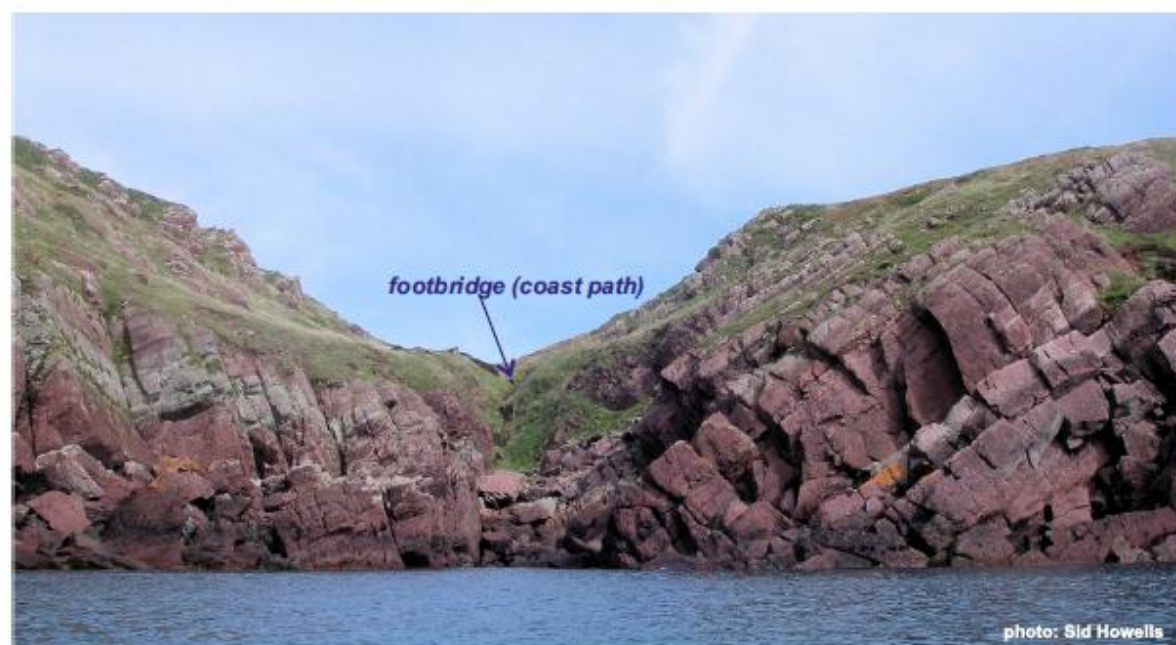
**Figure 16.9** View from kayak showing the gully at the back of East Pickard Bay and the lower part of a valley extending back up to the coastal plateau.

- 16.8.2.3 Below a small footbridge (at c.30mOD) on the Wales Coast Path, a small stream drops to the bay through the fault gulley (Figure 16.9). In the intertidal area of the bay the bedrock is mostly obscured by boulders, but clean and accessible exposure can be found near high water and in the cliff faces.

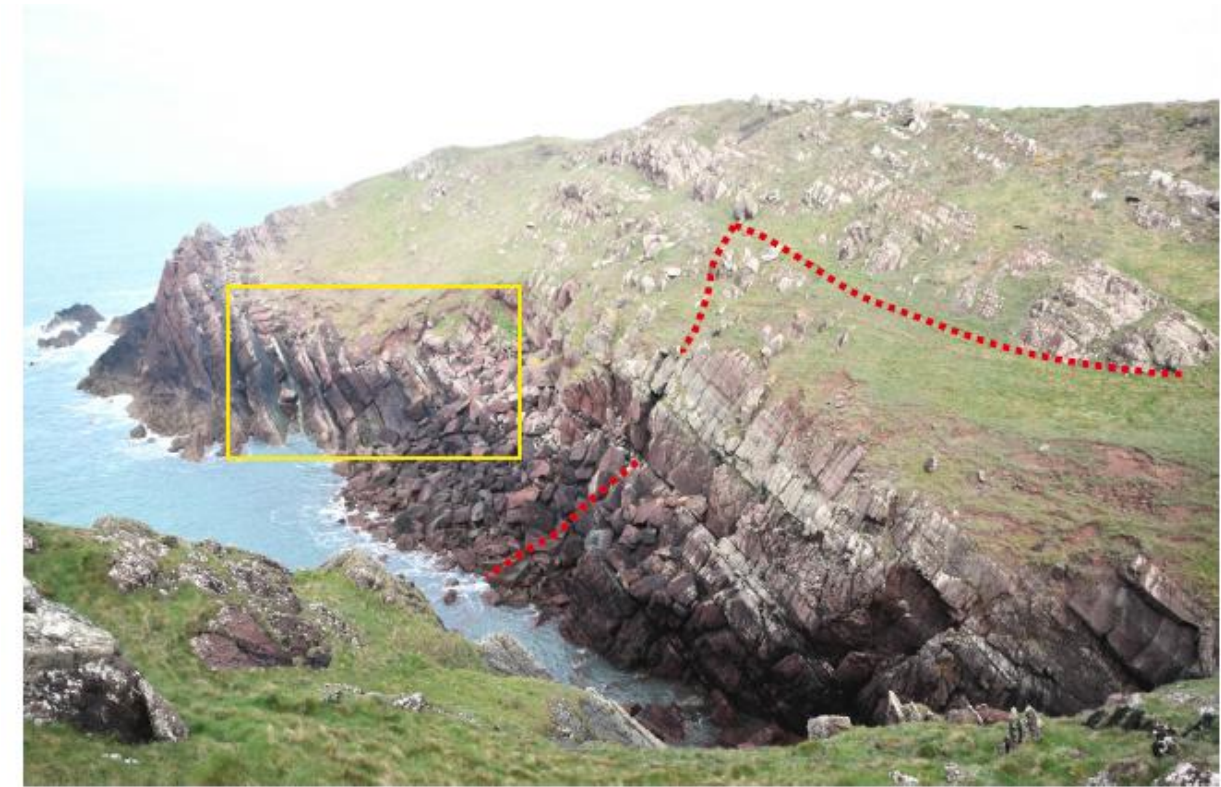
Figure 16.12 Western cliff section at East Pickard Bay, showing the Old Red Sandstone sequence that includes exposures of the Townsend Tuff and Pickard bay Tuff (boxed area as shown in more detail below) and cable route

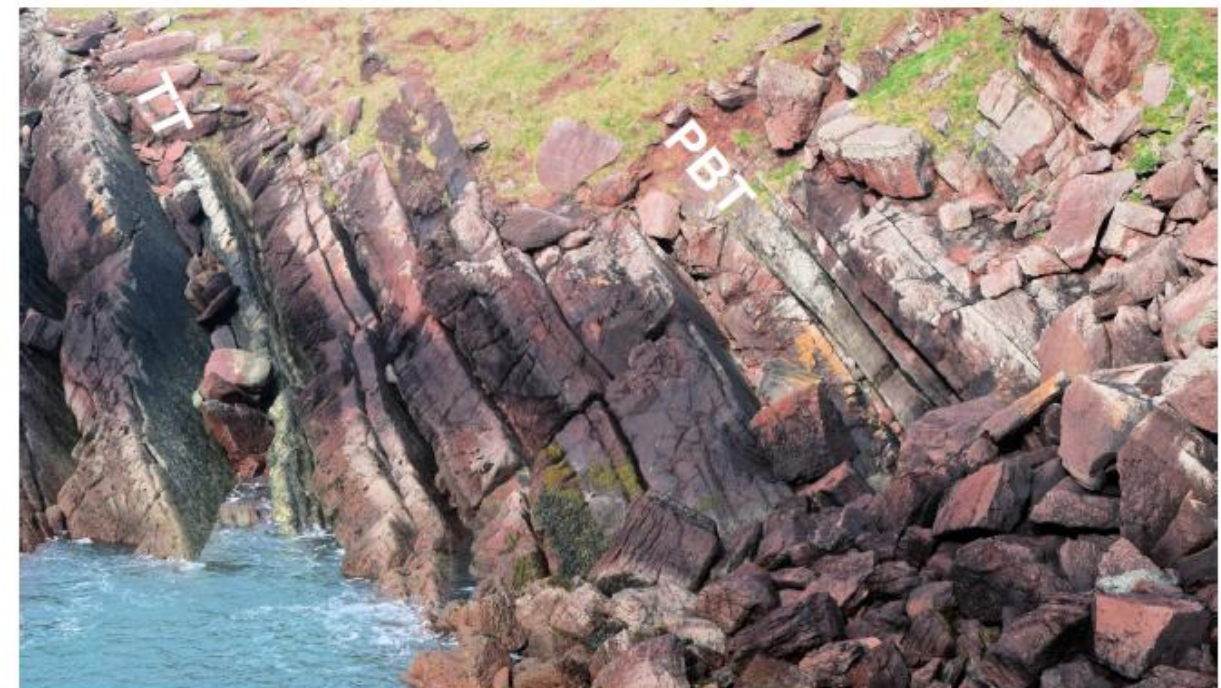
Figure 16.13 Townsend Tuff (TT) and Pickard Bay Tuff (PBT) exposures in western cliff section at East Pickard Bay

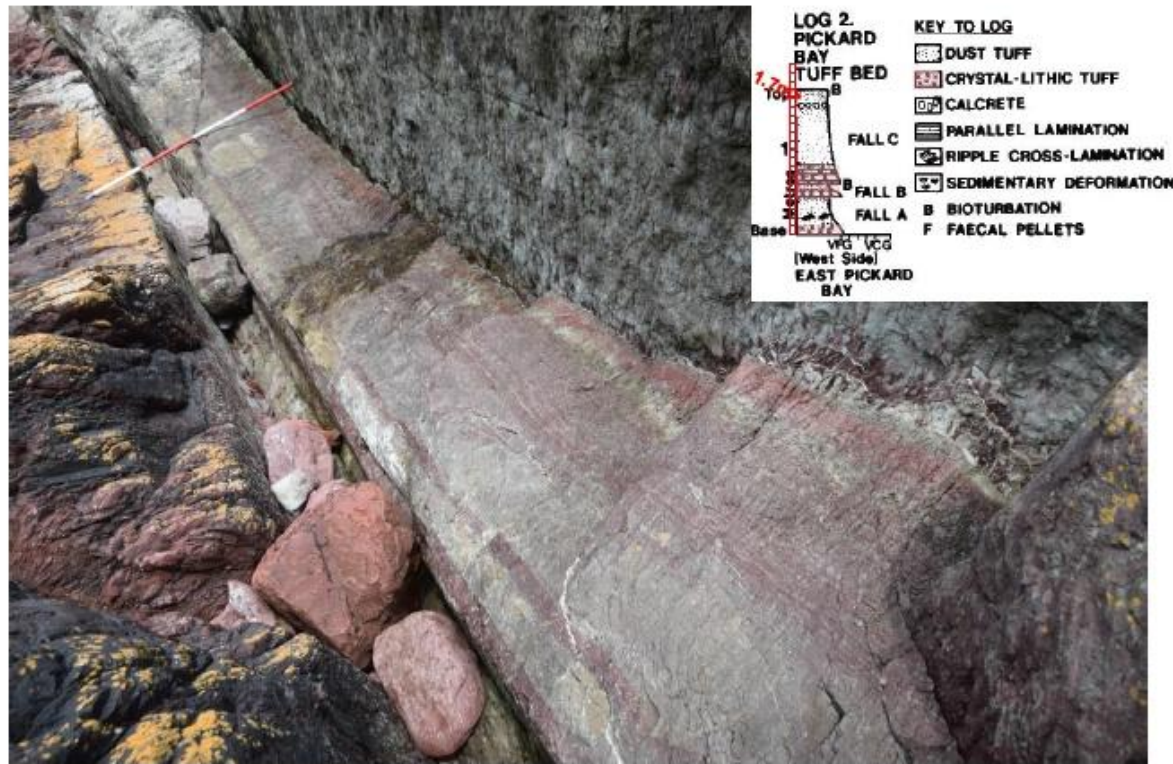
Figure 16.14 Detail of Pickard Bay Tuff exposure in the western cliff section at East Pickard Bay (inset: log from Williams, et al. 1981)

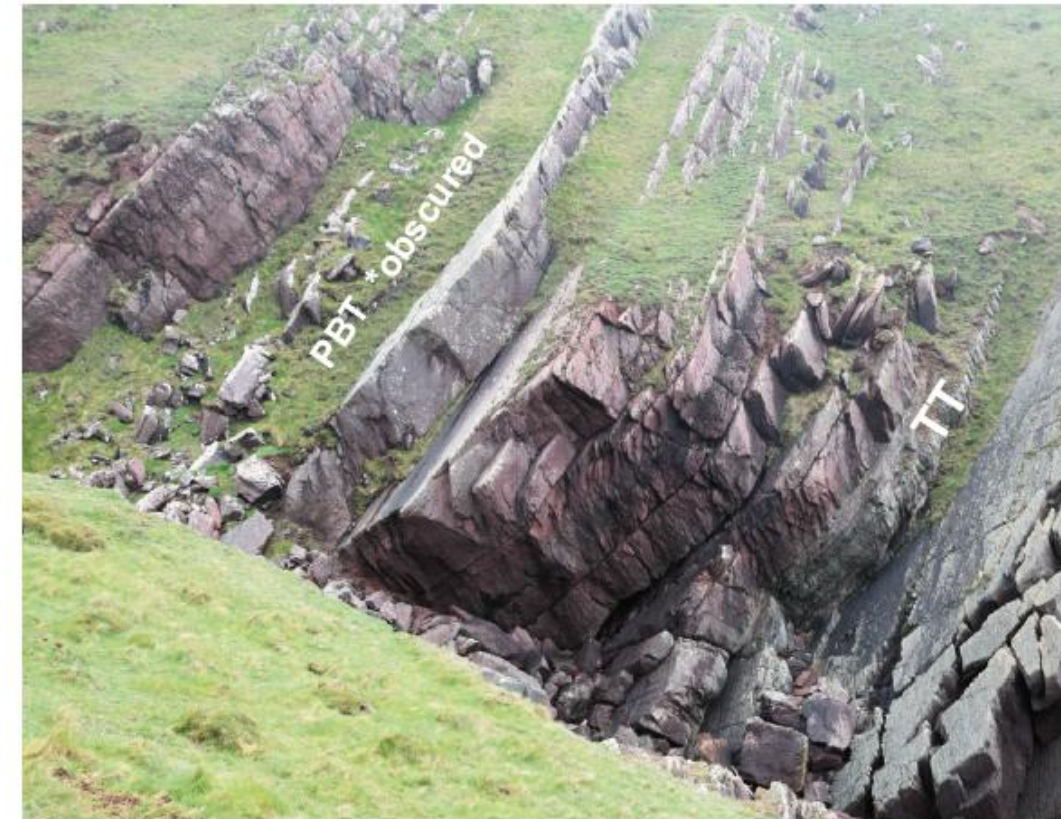
Figure 16.16 Townsend Tuff (TT) exposures in eastern cliff section at East Pickard Bay

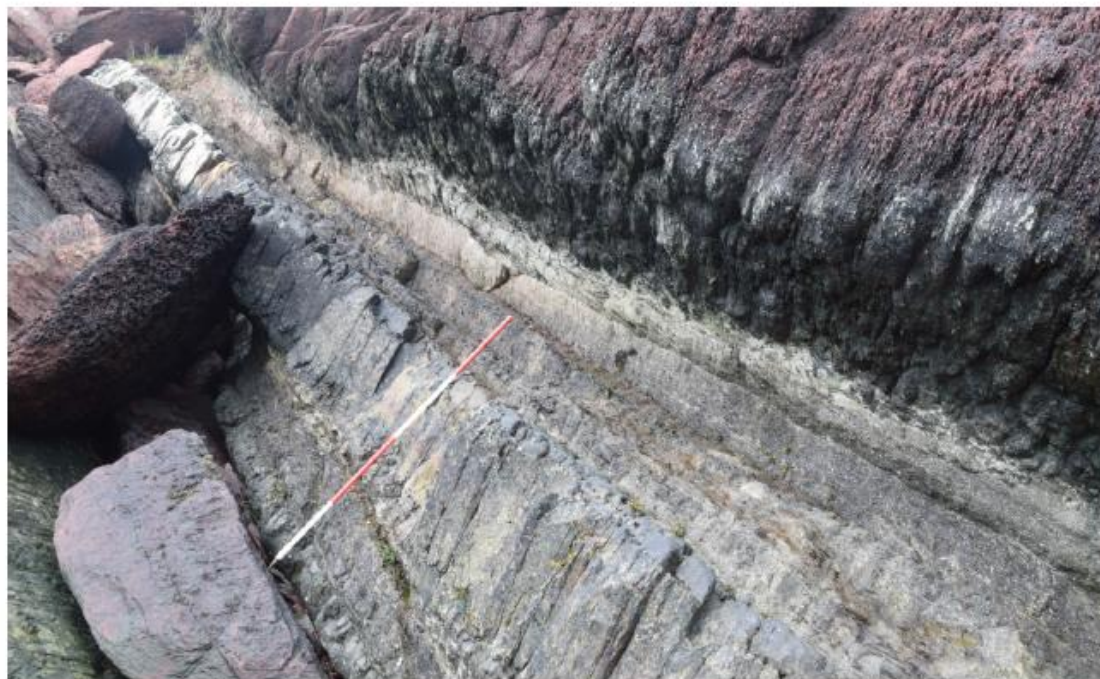
Figure 16.15 Townsend Tuff (TT) exposures in eastern cliff section at East Pickard Bay

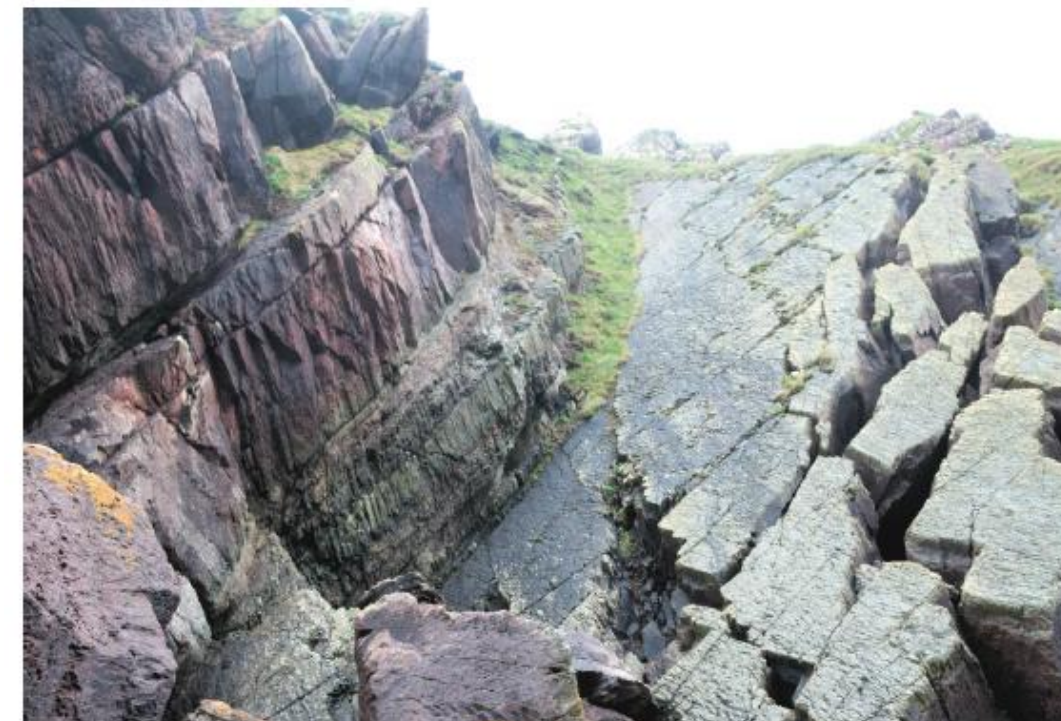
Figure 16.17 Detail of Townsend Tuff exposure in the cliff section east of the fault gully in East Pickard Bay
