Compliance Assessment Report CAR_NRW0050438

Permit being assessed: AN0376701

At: A1 SKIPS, WESTWAY ROAD, ALEXANDRA DOCK, NEWPORT, NP20 2UW.

Type of assessment carried out: Site Inspection,

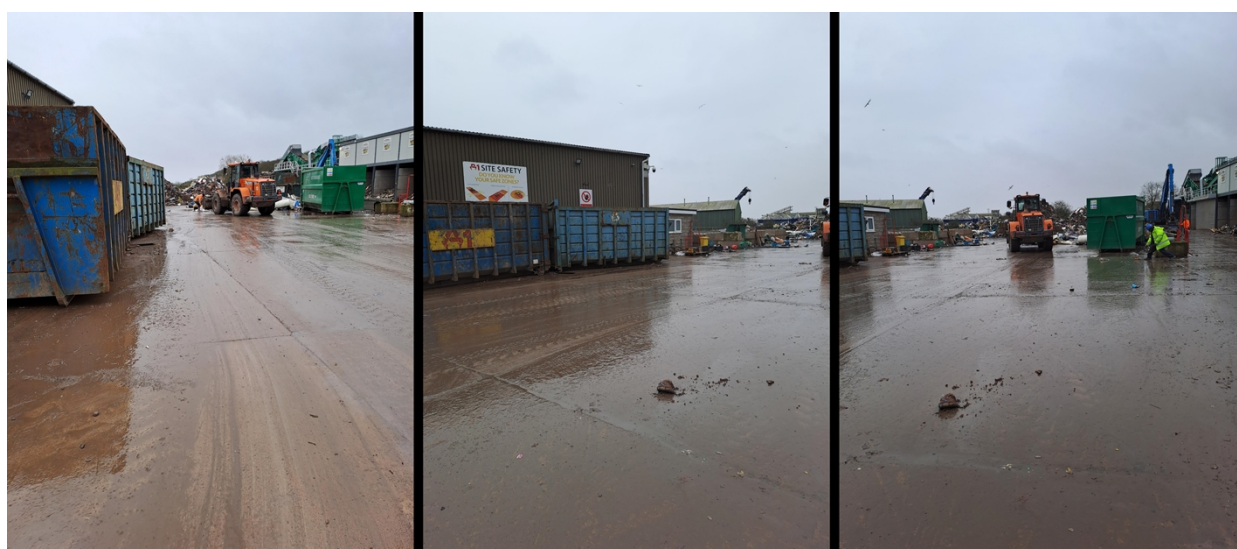
General site conditions were observed to be satisfactory. There was no large volumes of standing water present and no runoff departing site in any location other than via the interceptor. There was some visible oil/fuel present in areas but this was not seen discharging off site. I verbally requested that any spills be dealt with as soon as practicable and that all storage of liquids on site be undertaken using appropriate bunding. Figure 1 is evidence of the general site conditions as observed at the time of the visit.

Figure 1 – Site conditions at the time of the visit.

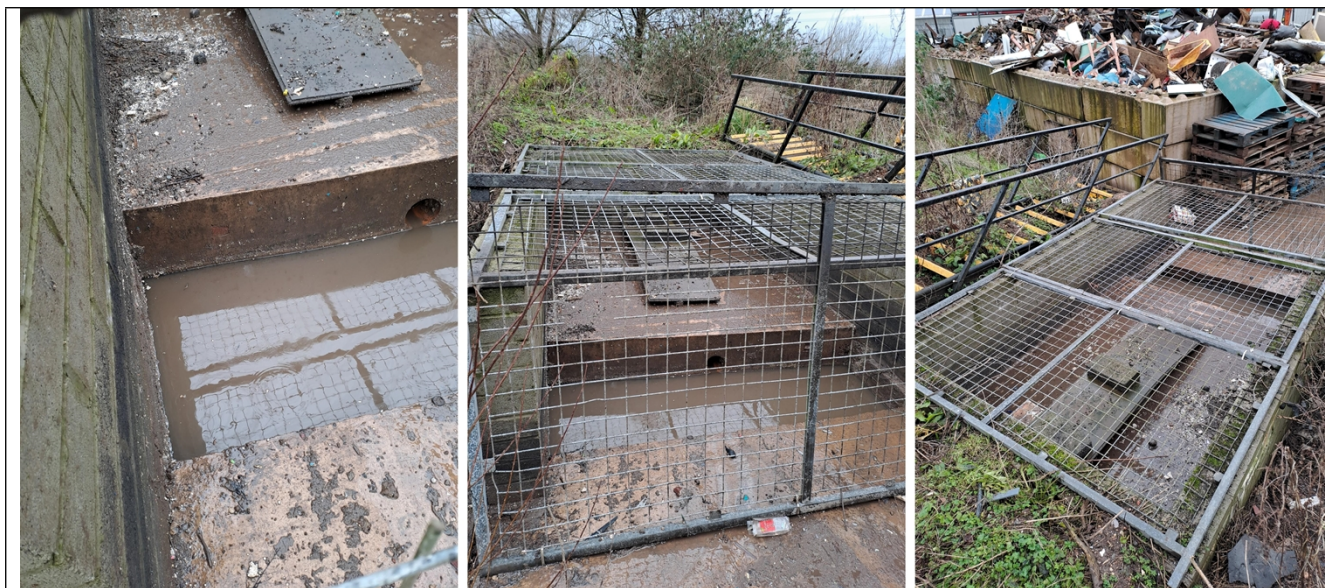
The site's interceptor was noted to be located at ST3099785832. On inspection it was noted to be secure and fit for purpose. There was some water present in the settlement tank but it did not look overly polluted with no oil visibly present. The level of water within the settlement tank appeared to be below the outlet pipe at the time of the visit, and as such it was assumed that there was very minimal discharge (if any). Figure 2 shows the condition of the interceptor as described at the time of the visit.

Figure 2 – The condition of the interceptor as observed during the visit.

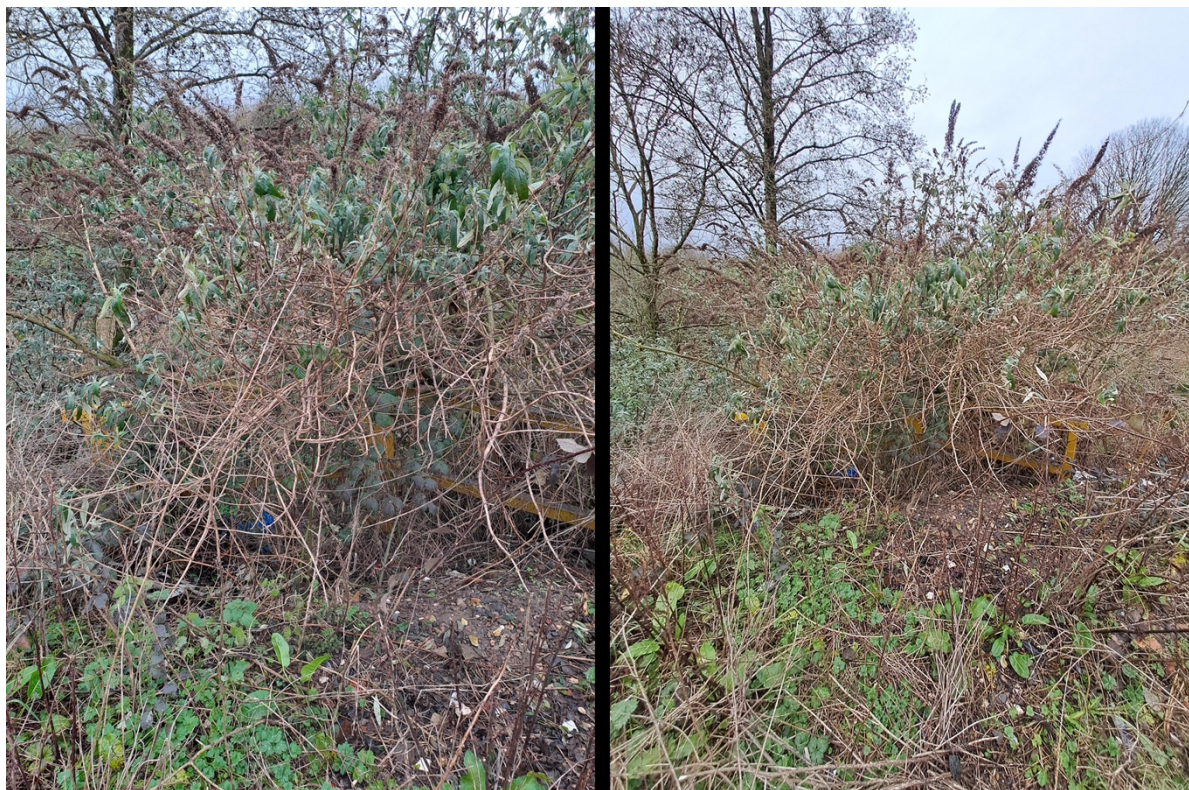
On attempting to reach the sampling point it was clear that the area was overgrown with vegetation and inaccessible. The closest we were able to access was ~ST3098785832. Evidence is shown in Figure 3. This stands as a minor breach of Condition 1.3.1 and is reflected in the breaches section. Please see the required actions by the specified deadline below. RT noted that the sample and discharge points were located just beyond the yellow barrier visible in Figure 3.

Figure 3 – The vegetation restricting access to the sampling point as observed during the visit.

Justification: The sample point could not be accessed at the time of the visit meaning that a representative sample could not have been taken. Please see the actions list below for the requirements to rectify this issue.

1. Undertake a cut of the vegetation to allow access to the listed sample point at ST3094085810 and submit photographic evidence to confirm its completion.
Ongoing maintenance should be undertaken to ensure continued access.

Deadline: 05/03/2026
