# Mumbles Sea Defence, Swansea

## Archaeological desk-based assessment

**May 2019**

A report for City and County of Swansea  
By Daria Dobrochna Dabal MA MA ACIfA

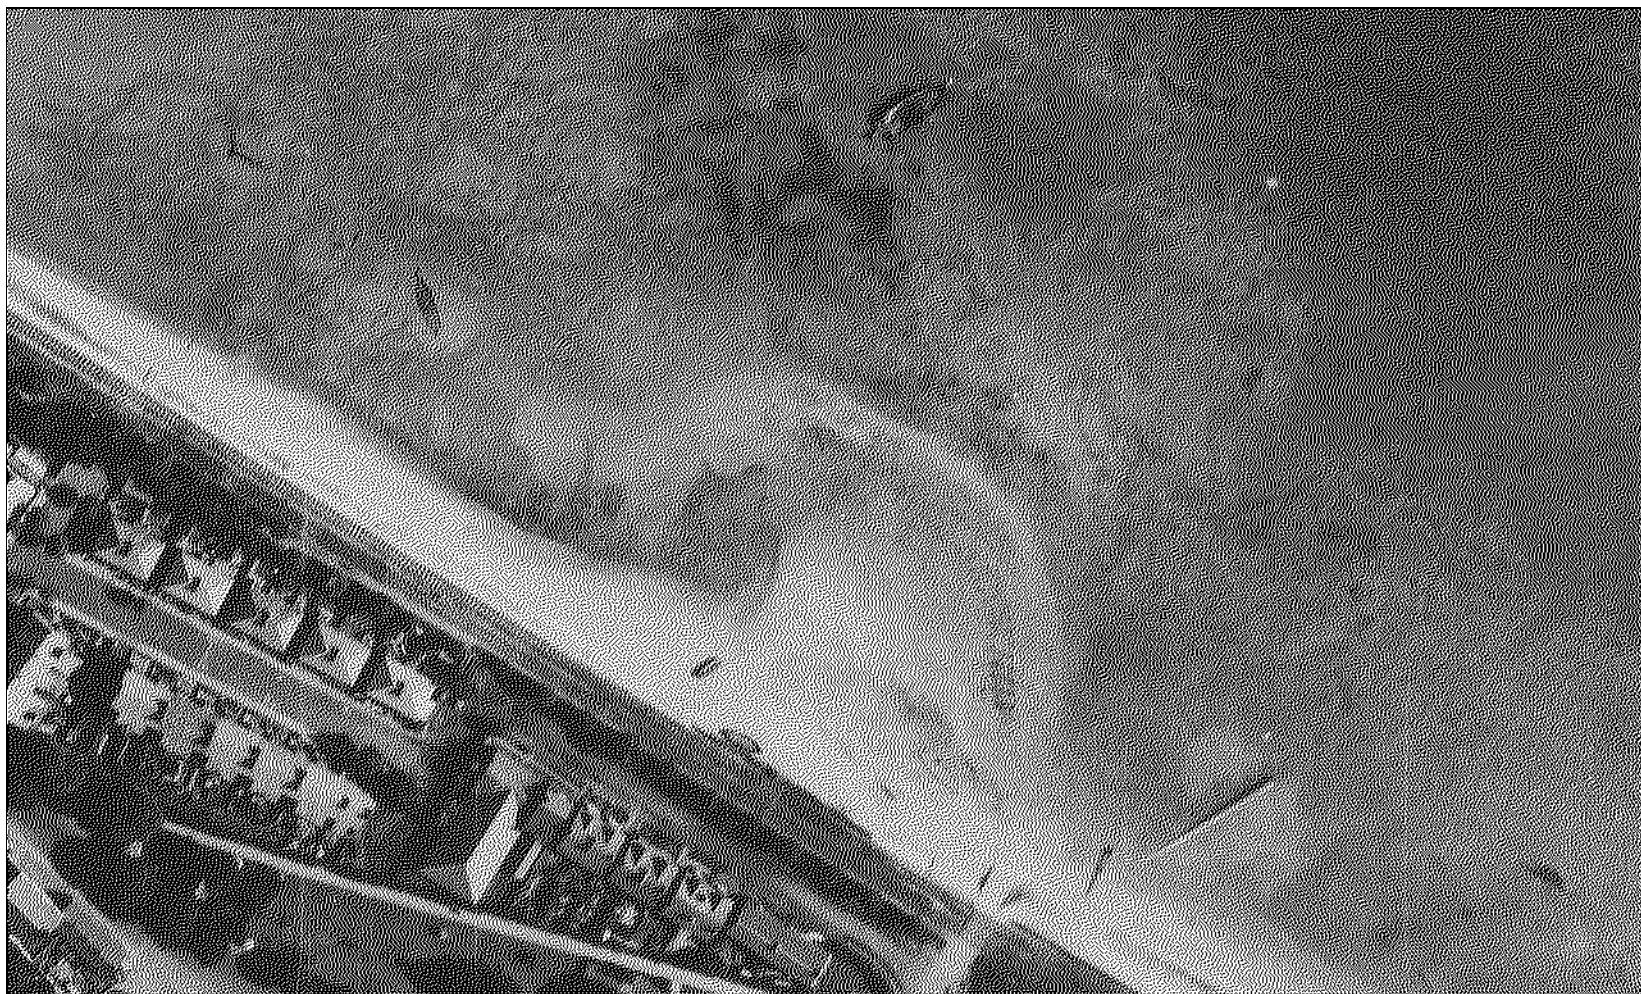
The 1946 photos (4641 106GUK\_1630 5223-5229) show that the train line comprised of two railway tracks stretched between Oystermouth and the western edge of Hennebont Gardens, and a single track between Hennebont Gardens and Mumbles Pier. Along the railway are numerous houses with gardens facing the waterfront, tennis courts, bowling field, and public gardens or grassed areas. Within the intertidal zone, a few shipwrecks (05800w and 05801w) and remains of the wooden groyne (05799w) are shown on the photo. On one of the aerial photo of 1946 shipwreck was noted to the southwest of the

groyne (4641 106GUK\_1630 5223 1946, see Plate 9). This wreck was not noted on later photos.

Plate 9. Part of 1946 aerial photograph (4641 106GUK\_1630 5223 1946), showing shipwrecks (05801w and 05800w), remains of wooden groyne (05799w) and slipway (05798w) within Swansea Bay.

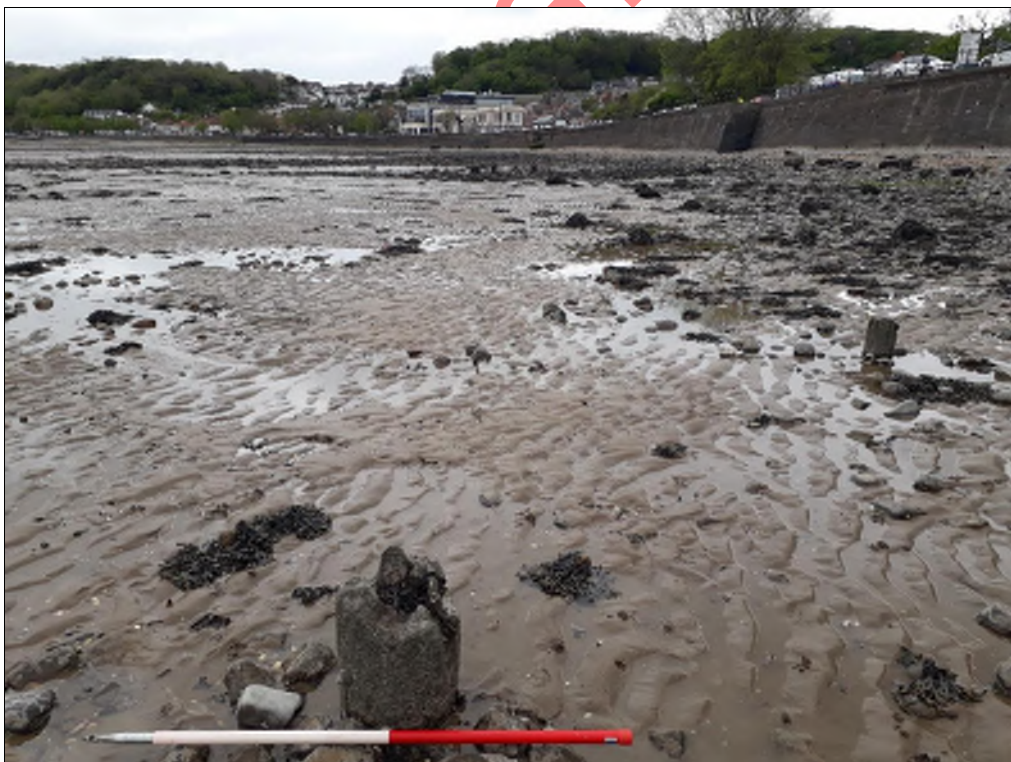
MSD01 – A group of two round wooden posts (Figure 2, Plate 11) were noted within the intertidal zone to the front of Clasemont Cottages (approximate location NGR SS6161088404). Posts were of 40cm and 38cm height.

Plate 11. Group of two wooden posts MSD01 (one to the front other back to the right) in Swansea Bay near Oystermouth Car Park.

View to the north, scale in 0.5m divisions.

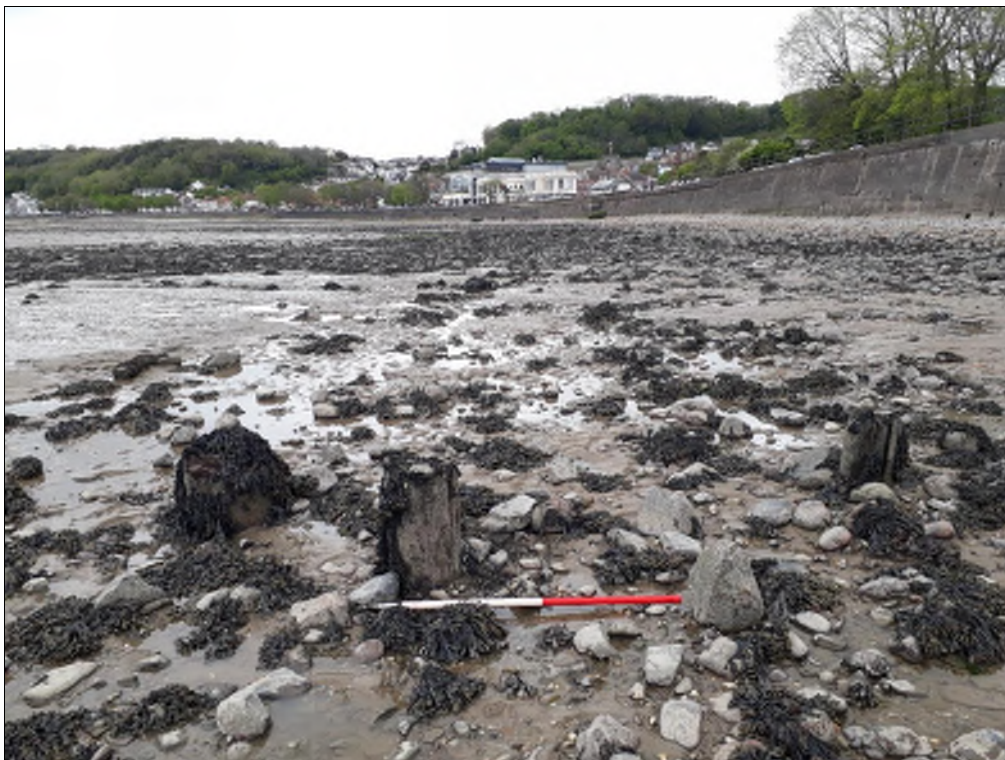
MSD02 – A group of three round wooden posts (Figure 2, Plate 12) were noted within the intertidal zone to the front of Clasemont Cottages (approximate location NGR SS6162688359). Posts were of 42cm, 45cm and 46cm height.

**Plate 12. Group of three wooden posts MSD02 near Oystermouth Car Park.  
View to the north, scale in 0.5m divisions.**

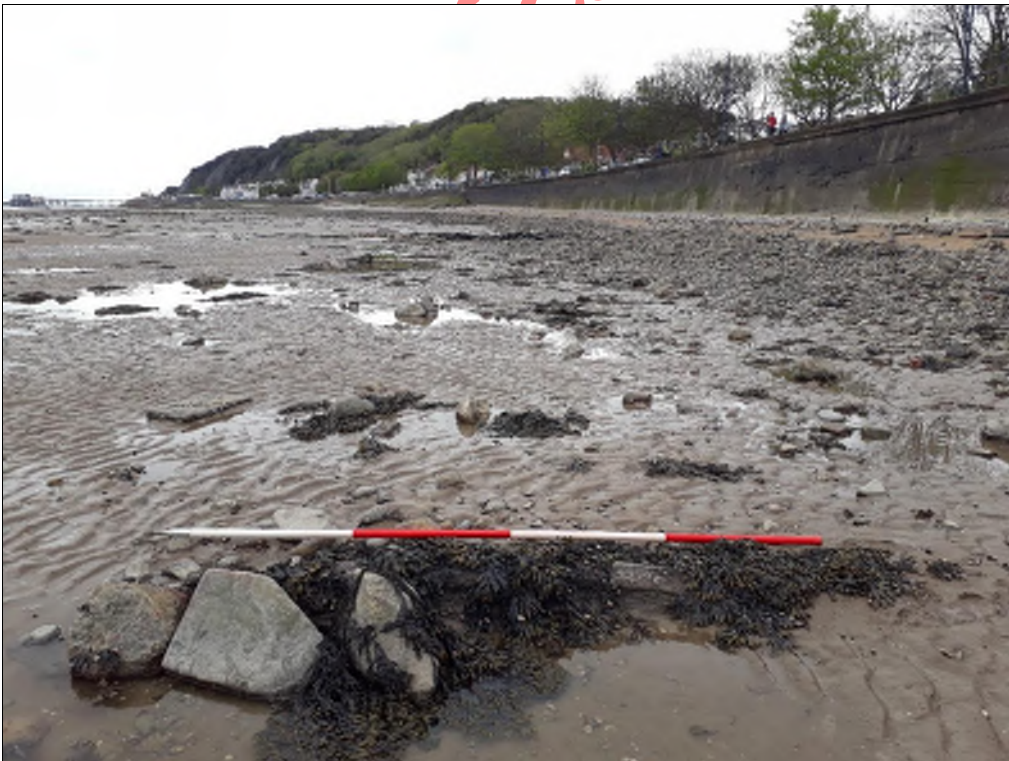
MSD03 – A shipwreck (Figure 2, Plate 17) was noted within the intertidal zone to the front of Oyster Wharf. Overall dimensions of the wreck remains were 150m long. Some rusted iron nails were noted within the wood.

**Plate 17. Fragment of shipwreck MSD03 near Oyster Wharf.**  
**View to the south, scale in 0.5m divisions.**

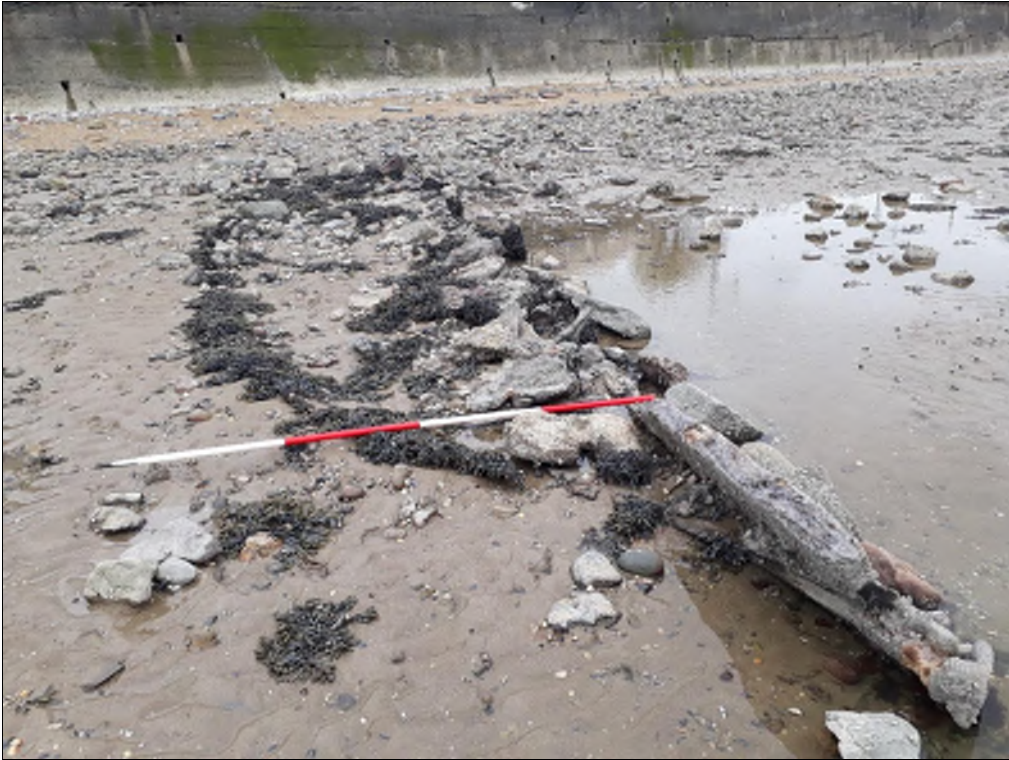
MSD04 – A shipwreck (Figure 2, Plate 18 and Plate 20) was noted within the intertidal zone to the front of Tennis Courts. Overall dimensions of the wreck fragment were 6.0m long by 2.0m wide. Some rusted iron nails and metal elements were noted among the

**Plate 18. Shipwreck MSD04 near Oyster Wharf.**  
**View to the west, scale in 0.5m divisions.**

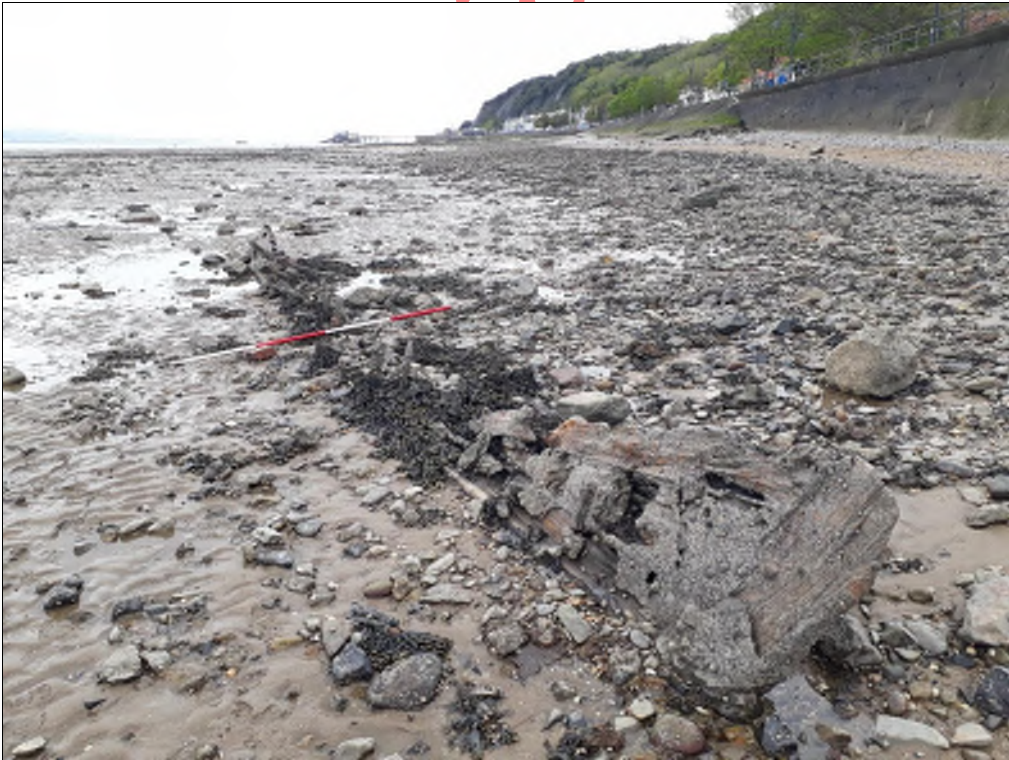
MSD05 – A shipwreck (Figure 2, Plate 19 and Plate 20) was noted within the intertidal zone to the front of Tennis Courts. Overall dimensions of the wreck fragment were 800cm long by 70cm wide. Some rusted iron nails and metal elements were noted among the wooden fragments of the hull.

**Plate 19. Fragment of shipwreck MSD05 near Tennis Courts.**  
**View to the south, scale in 0.5m divisions.**

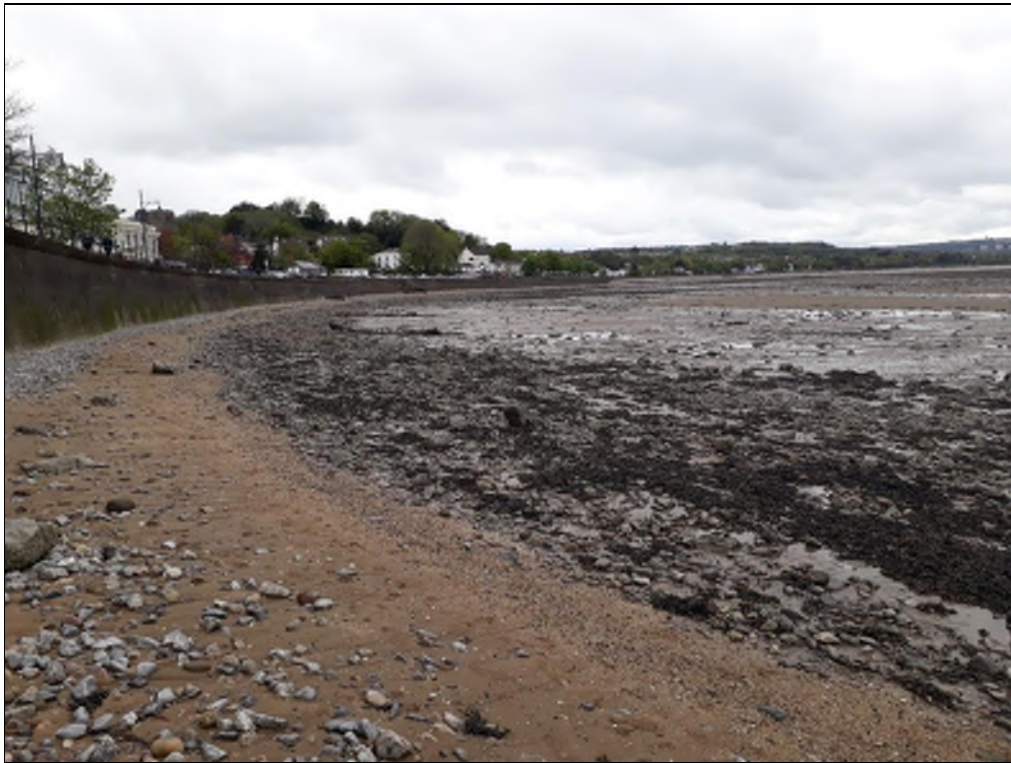
**Plate 20. Location of shipwrecks MSD04 and MSD05.  
View to the northwest.**

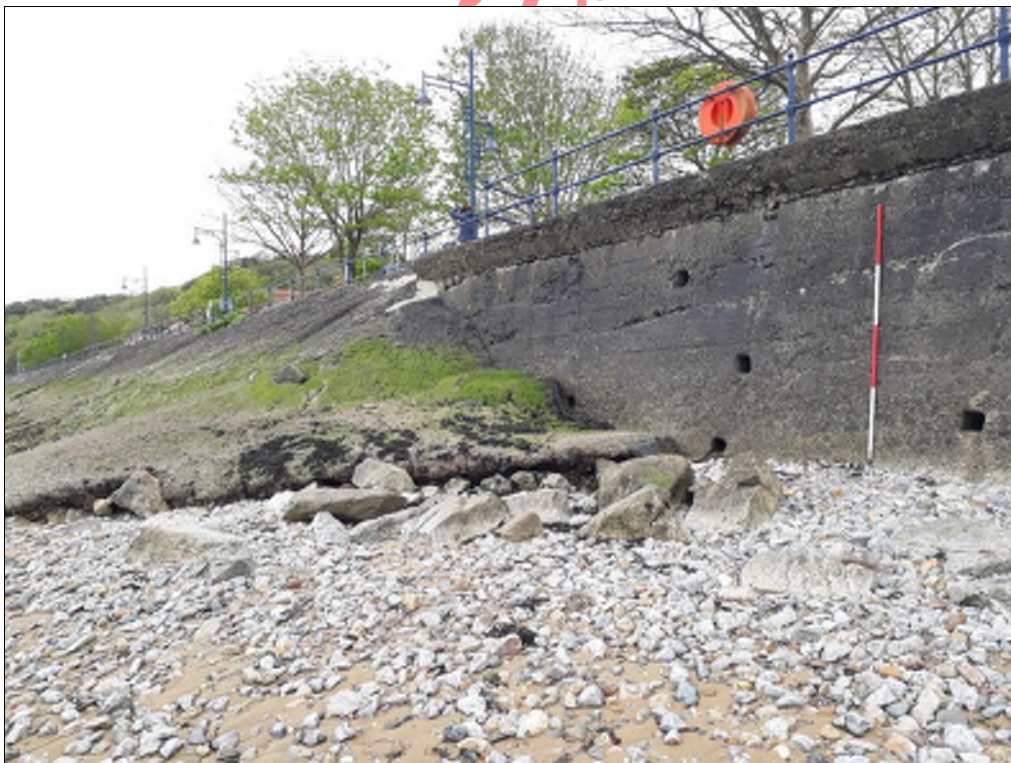
**Plate 21. Sea defence wall (modern concrete wall and earlier stone wall coated by concrete).  
View to the south, scale in 0.5m divisions.**

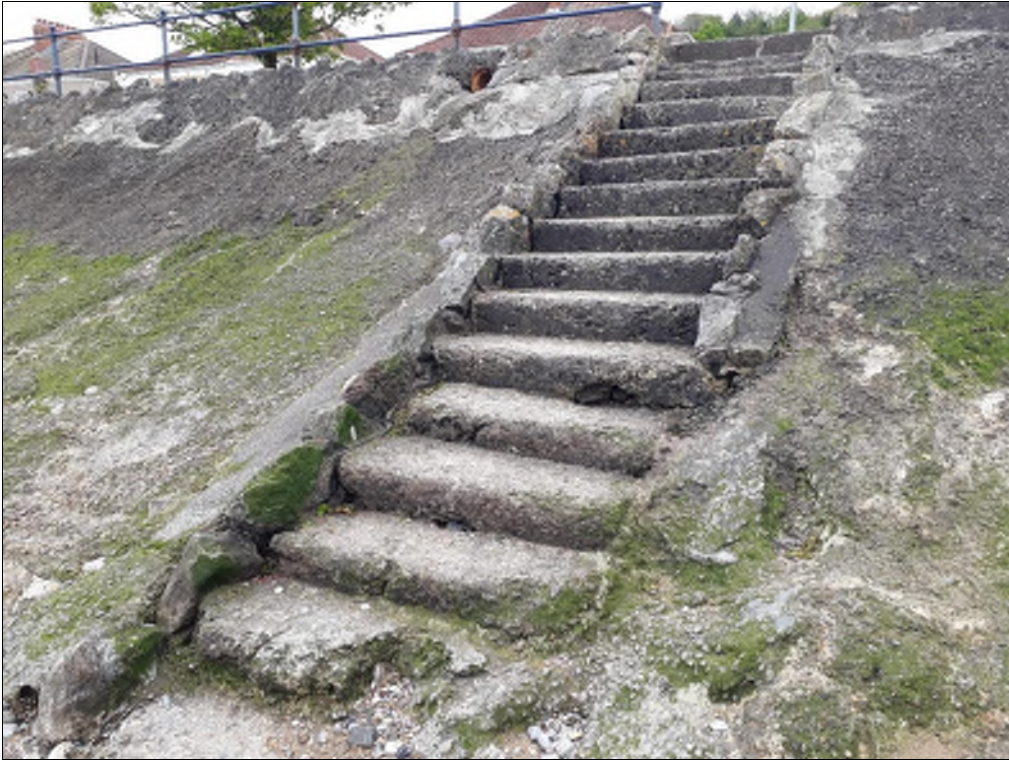
**Plate 24. Detail of stairs to the front of Devon Place.  
Note stones used as edging. View to the west south.**

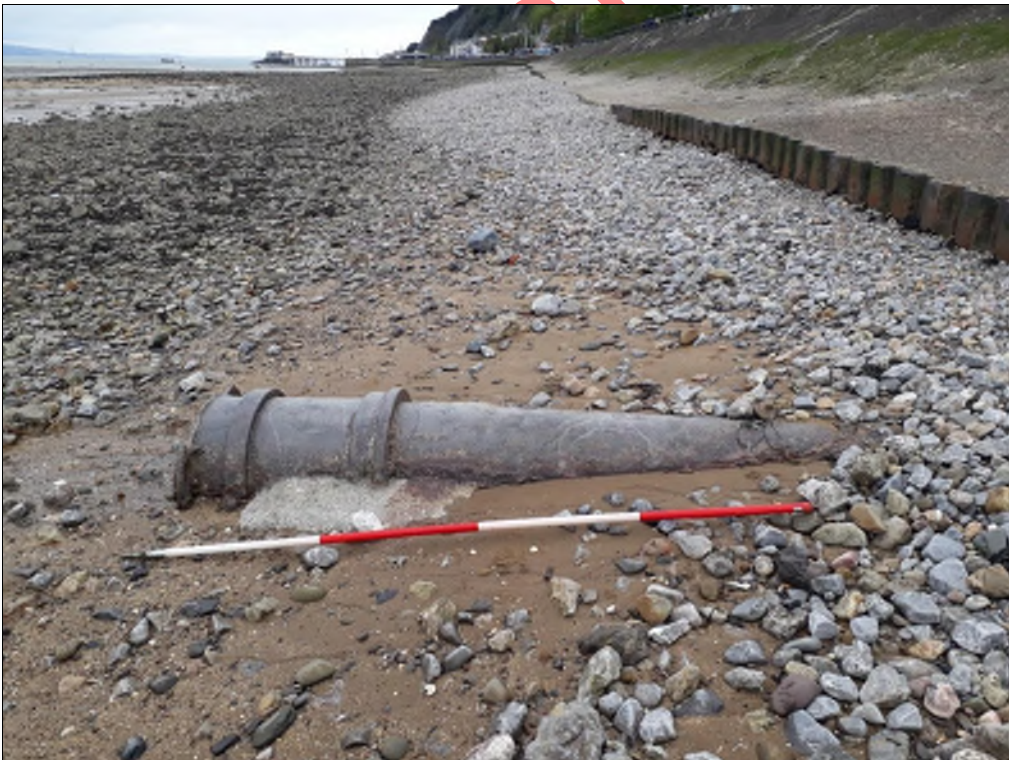
**Plate 25. Cast iron sewage pipe in the bay near sea defence wall.  
View to the southeast, scale in 0.5m divisions.**

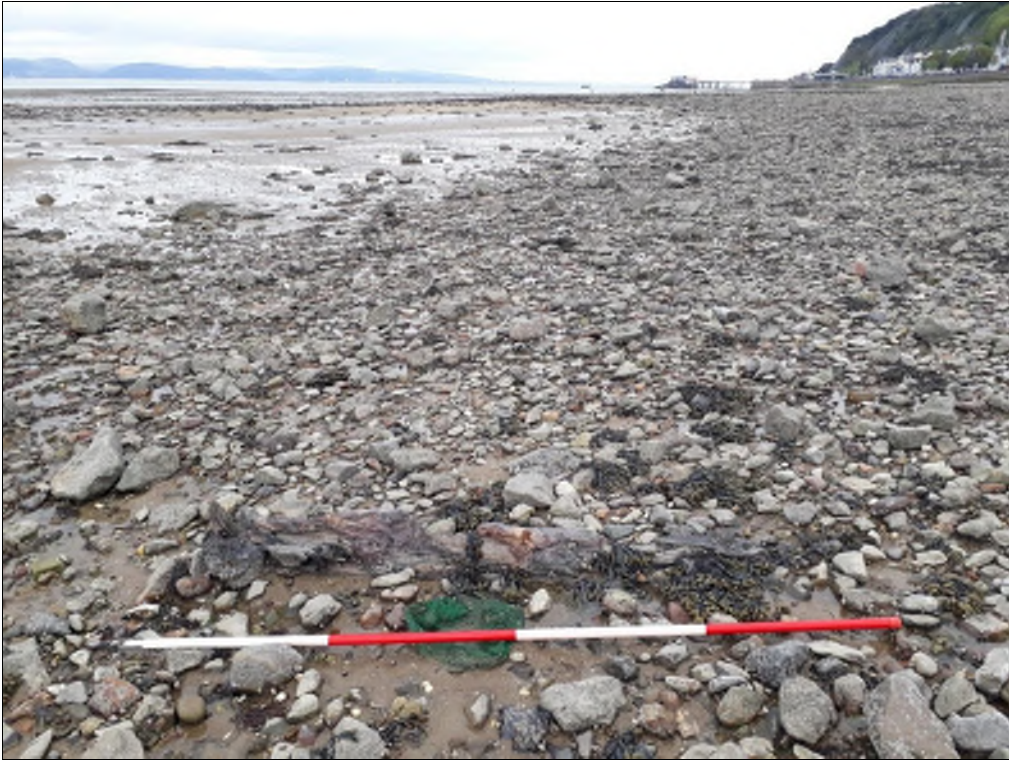
MSD06 – A fragment of shipwreck (Figure 2, Plate 26) was noted within the intertidal zone to the front of Devon Place in Mumbles. Overall dimensions of the find were 150cm by 20cm long. Some rusted iron nails were noted within the wood.

**Plate 26. Fragment of shipwreck MSD06.**  
**View to the southeast, scale in 0.5m divisions.**

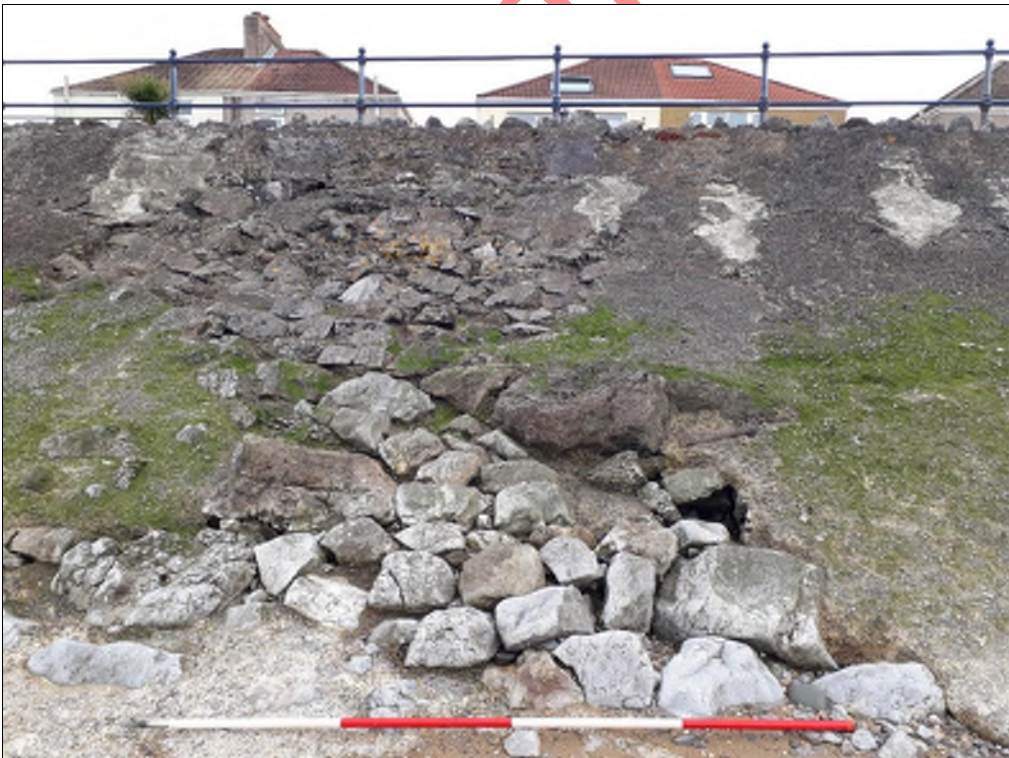
**Plate 27. Detail of sea defence wall along Devon place.**  
**Note old stone wall coated with modern concrete. View to the southwest, scale in 0.5m divisions.**

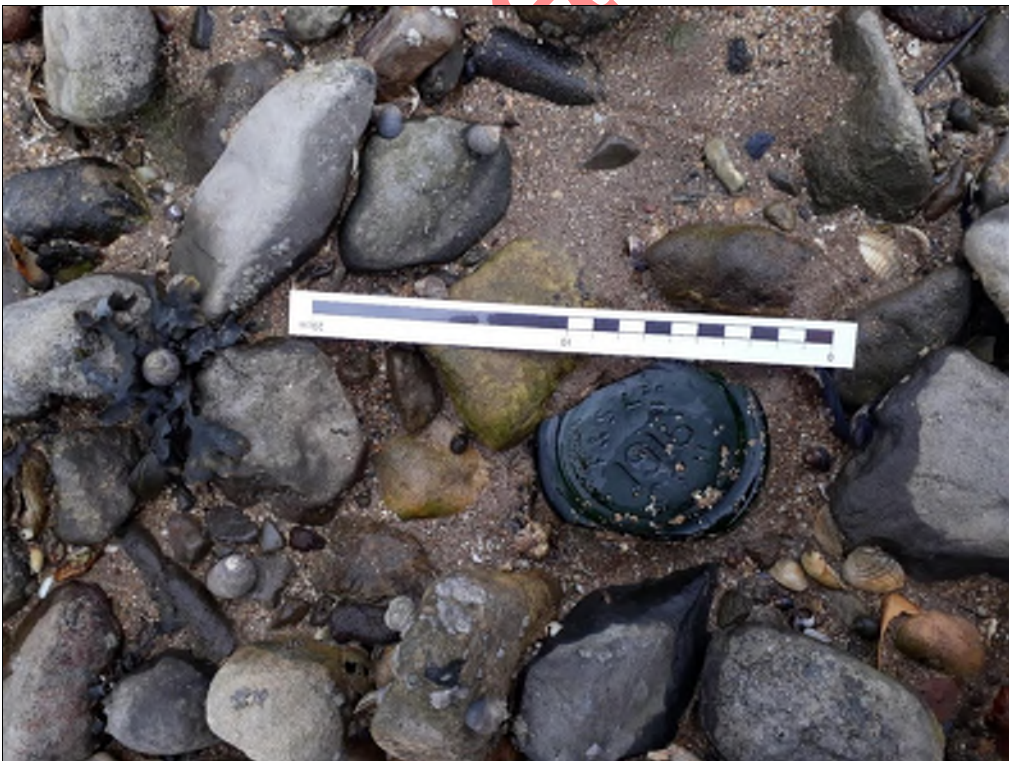
One pottery sherd of medieval date (approx. location SS6161788291) and a fragment of glass bottle with date 1916 (approx. location SS6193687974) were found during the site visit within intertidal zone of Swansea Bay (Plate 29).

Plate 29. Modern glass bottle found in the bay.  
Scale in 1cm divisions.

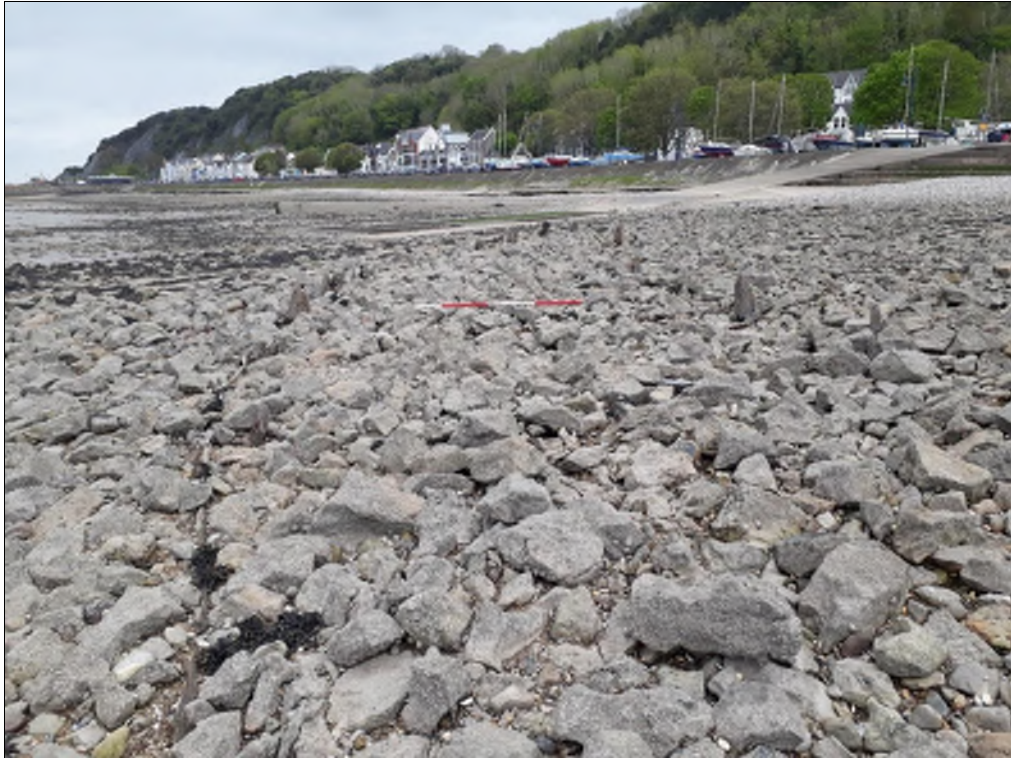
**Plate 30. Remains of wooden groyne/jetty 05799w and slipway 057998w.**  
**Note sewage pipe ion the background. View to the south-southeast, scale in 0.5m divisions.**

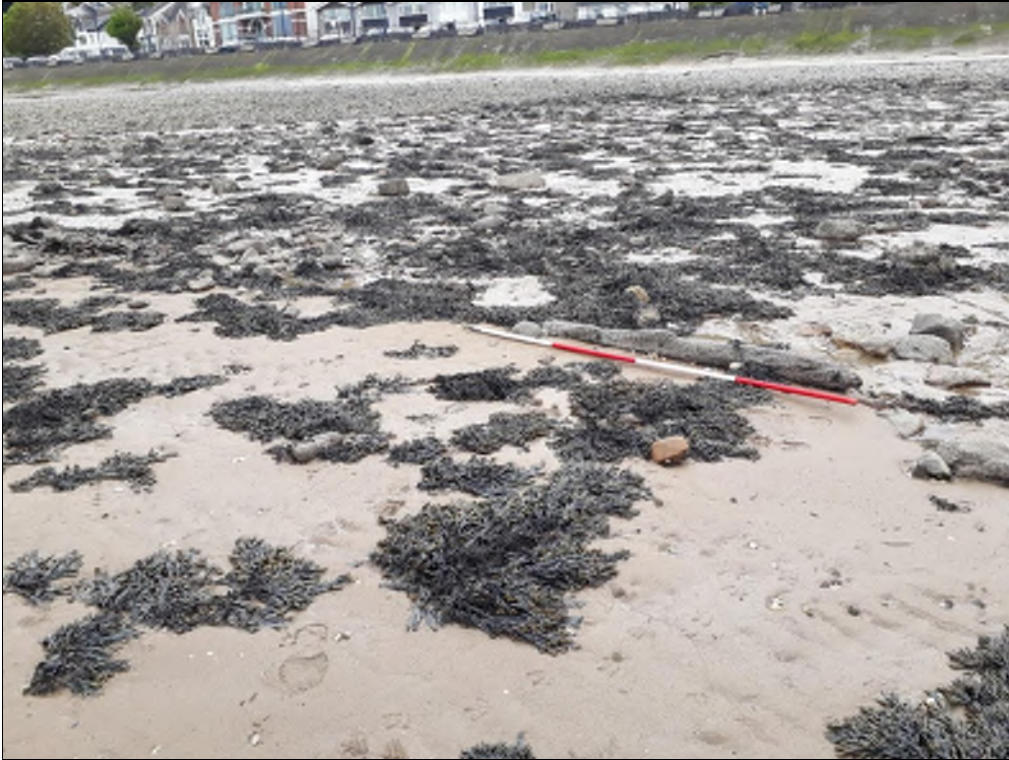
MSD07 – A shipwreck (Figure 3, Plate 32) was noted within the intertidal zone to the front of Southend Car Park. Overall dimensions of the wreck fragment were 200cm long by 20cm wide. Some rusted iron nails and metal elements were noted among the wooden fragments of the hull.

**Plate 32. Fragment of a shipwreck MSD07.**  
**View to the south, scale in 0.5m divisions.**

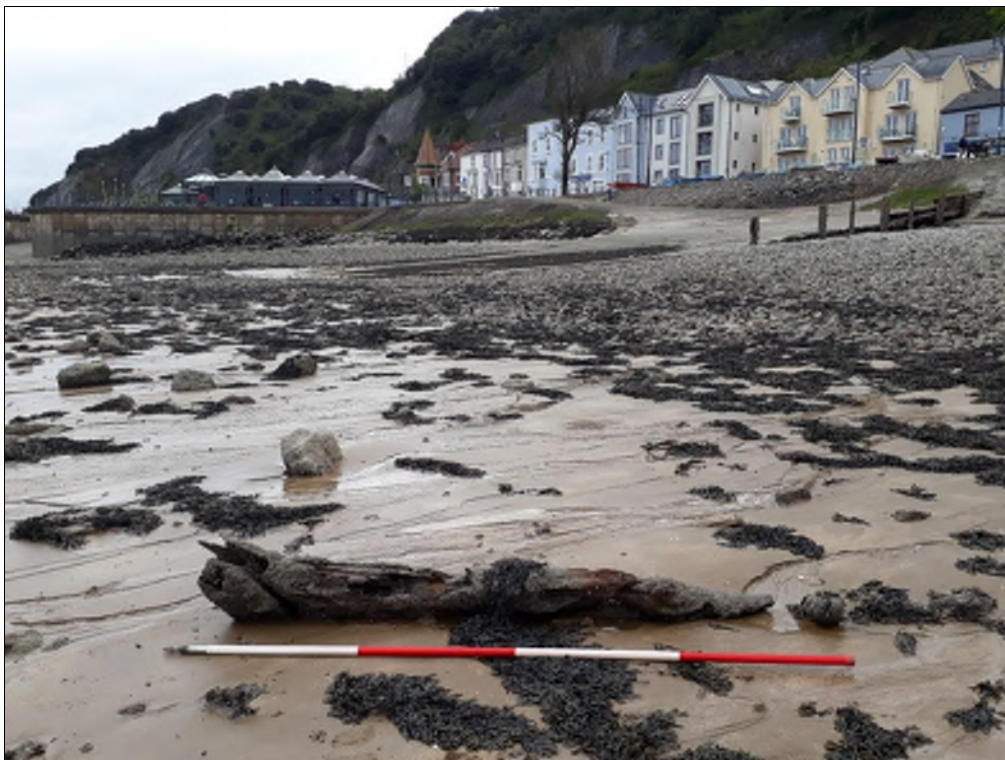
MSD08 – A shipwreck (Figure 3, Plate 34) was noted within the intertidal zone to the front of Southend Car Park. Overall dimensions of the wreck fragment were 160cm long by 25cm wide. Some rusted iron nails and metal elements were noted among the wooden fragments of the hull.

**Plate 34. Fragment of shipwreck MSD08, sea defence wall and slipway 05795w.  
View to the southeast, scale in 0.5m divisions.**
