# MCERTS - EDM Inspection Report

## Llechrhyd SPS 1

10 September 2025

Report No. CFS/ 19150

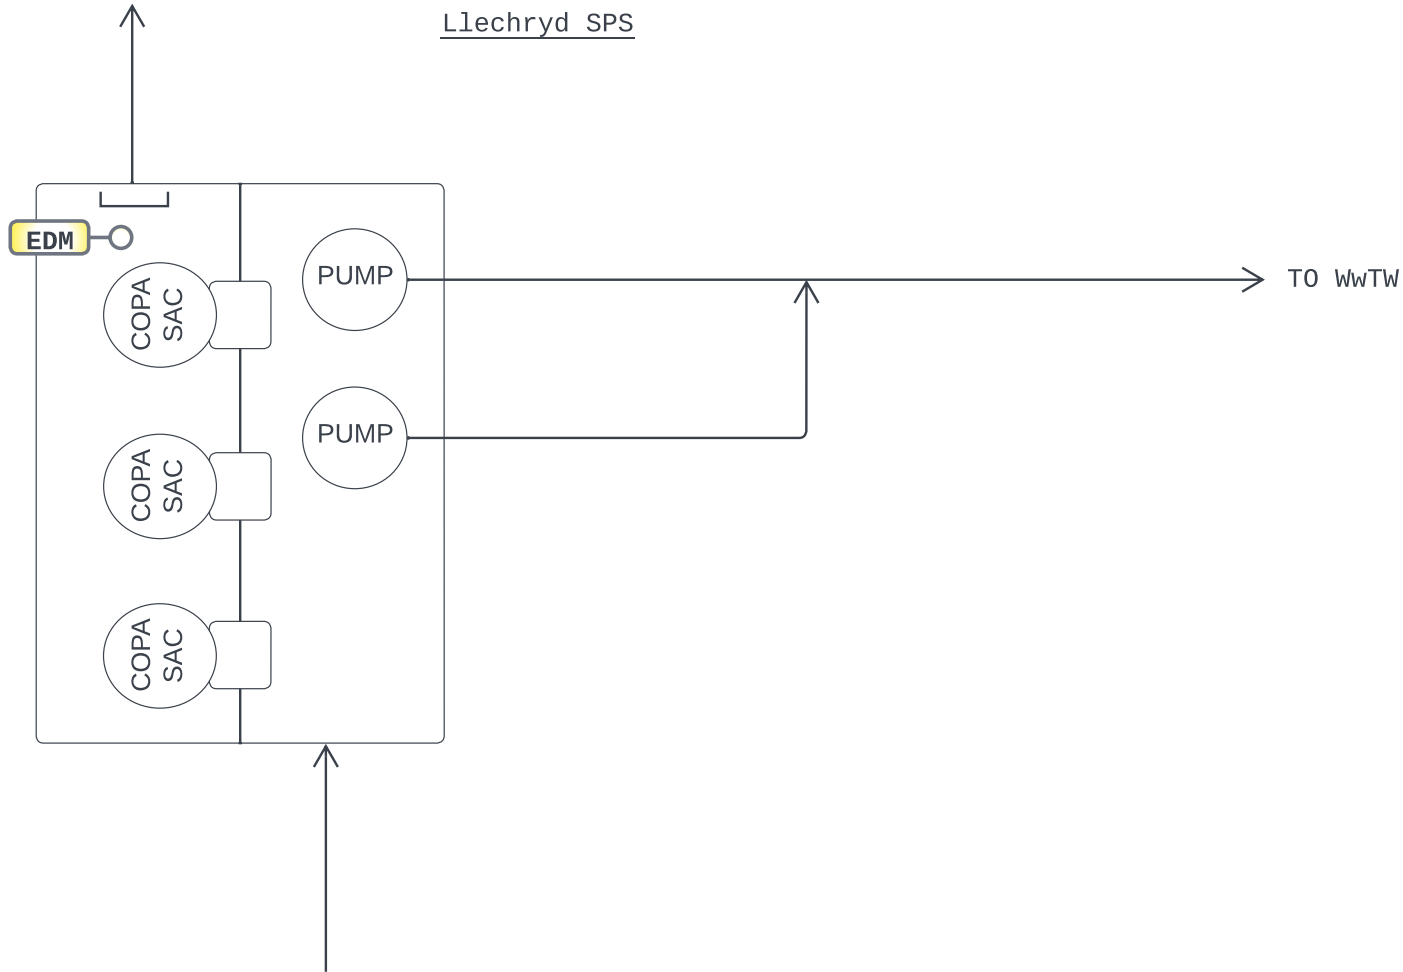
<p>Treated Flow →</p> <p>Storm Flow →</p> <p>Storm Overflow →</p> <p>Humus Returns →</p> <p>Top Liquors →</p> <p>De-Sludge →</p> <p>Washwater →</p>	<p><i>Process interpreted from site visit and has not been confirmed</i></p> <p>Comments -</p>		<p>Process Diagram - Llechryd SPS1</p>	<p>Site Owner - DCWW</p>	<p>Date - 10/09/25</p>
