Compliance Assessment Report CAR_NRW0050498

Permit being assessed: AC0096401

For: BIRDPORT LIMITED CORPORATION ROAD, **held by:** Bird Port Ltd

Type of assessment carried out: Site Inspection,

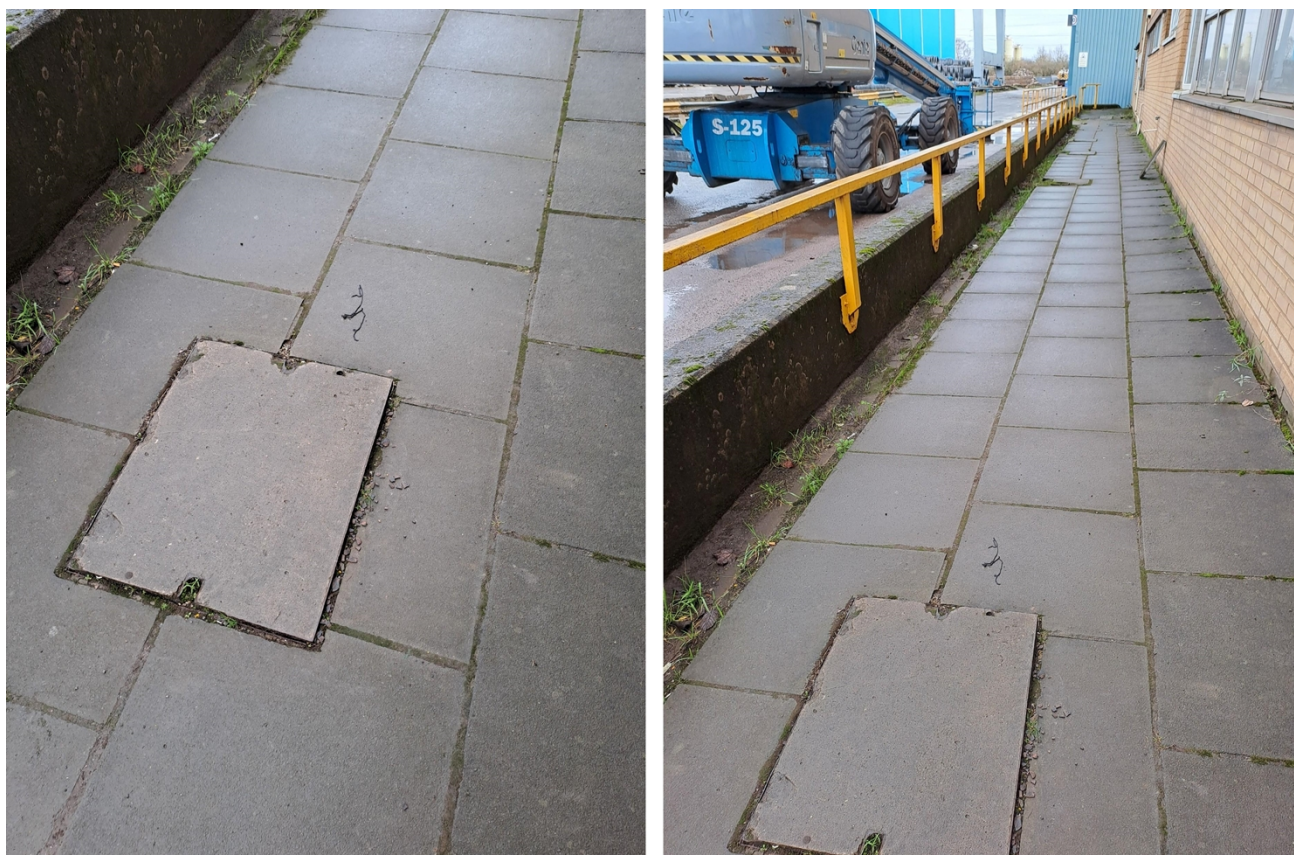
DW first drew my attention to several chambers located near the office building which were identified as the site’s surface water drainage channel. This is where GD Environmental have previously removed effluent from the site. While the chambers were accessible, we were unable to lift them to inspect the internal conditions at the time of the visit. I have added an action to provide evidence of the internal conditions of this system via photographic evidence. These chambers can be seen in Figure 1.

Figure 1 – Site drainage system chambers as observed during the visit.

1. Provide photographic evidence showing the internal conditions and integrity of the site's surface water drainage system.

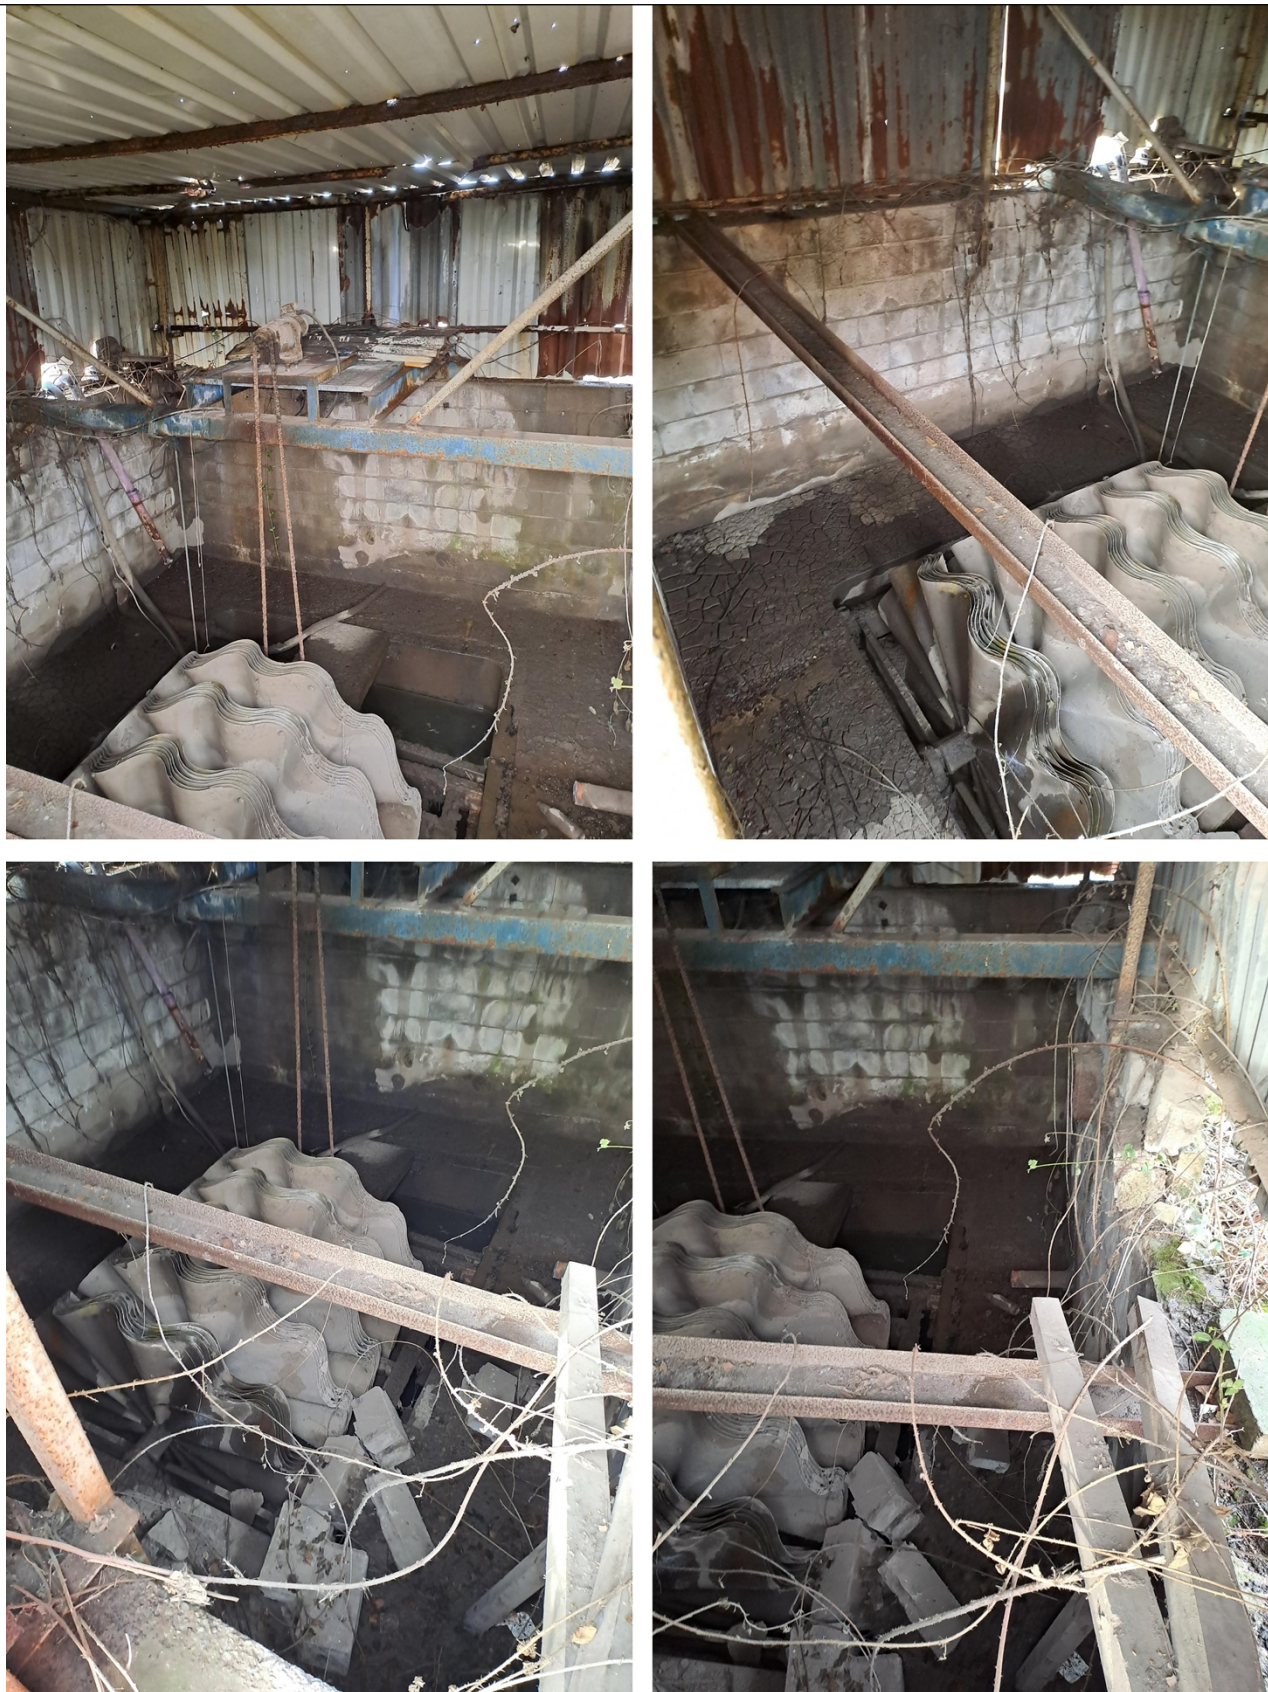
We then proceeded to inspect the sewage treatment system which was located within an enclosed building at ST3301385153 and was accessible at the time of the visit. On opening the system it was clear that it was non-operational as the motor was not running,

the filter drum was not turning and the majority of the components were severely corroded. Additionally, the walls of the chamber was severely deteriorated with several pieces of blockwork having become dislodged and have fallen into the chamber, restricting the internal infrastructure (particularly the drum) from operating. There was no flow observed coming into or discharging from the system at the time of the visit. These observations can be seen in Figure 2.

Figure 2 – The condition of the sewage treatment system as observed during the visit.

From my observations and the evidence provided here I am confident in stating that the system is completely non-operational and not fit for purpose. I advised DW that this was a major concern and that the site effectively does not currently have the ability to conduct sewerage treatment. Any discharges of sewage effluent will be untreated and a breach of permit requirements as well as the Environmental Permitting Regulations (England and Wales)(2016). The requirements and actions needed are discussed further below.

The sewage treatment system is non-operational and is not currently treating any sewage. Due to the excessive corrosion and damage observed the sewage treatment system has been assessed as not fit for purpose and requires immediate attention to bring it back online or replace it entirely as a priority. As there is no active treatment of polluting material that is discharged to the environment a category 2 breach (significant environmental effect) is justified.

8. Commission an assessment/survey of the sewage treatment system by an accredited service technician and make arrangements to repair/retrofit the system or replace the system entirely if needed. Continued updates on the progress shall be communicated with NRW.

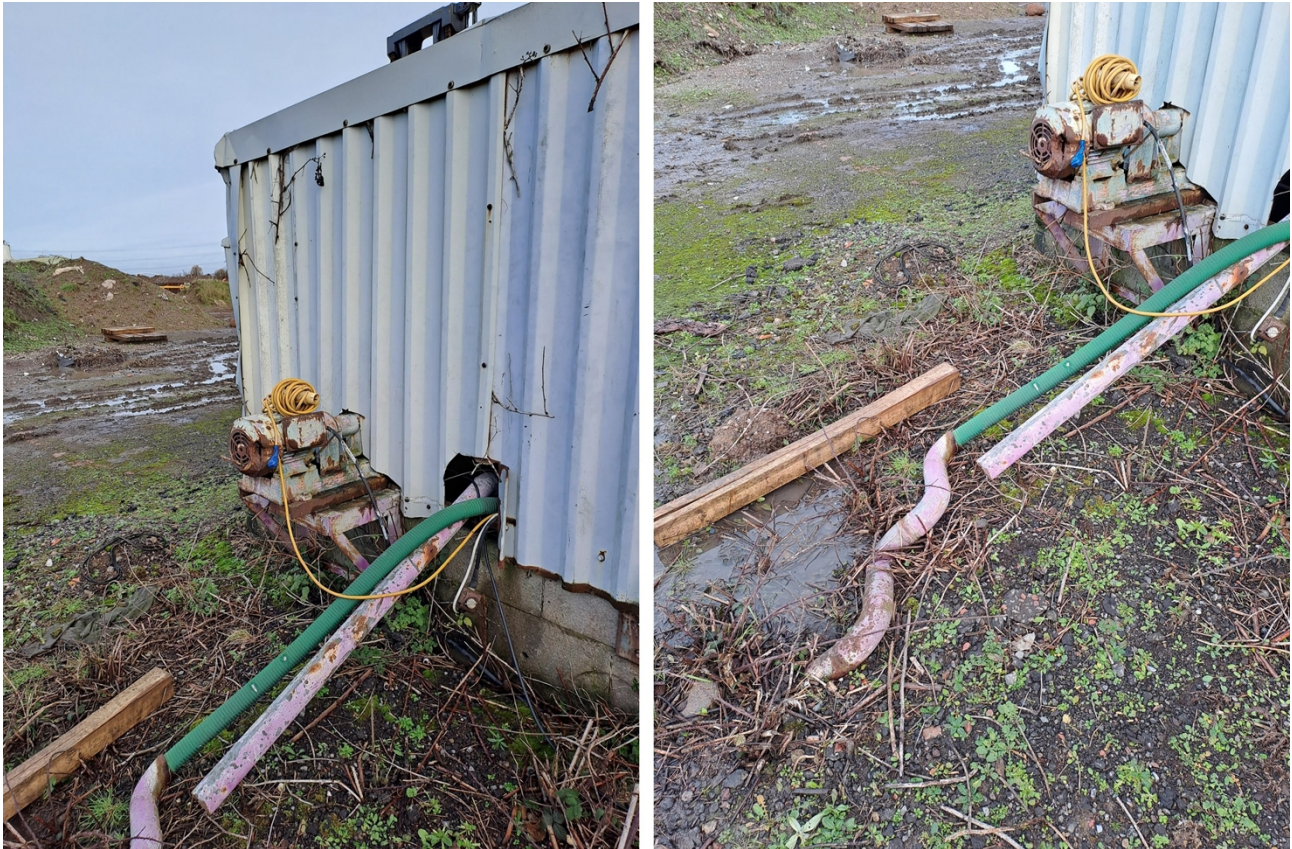
To the rear of the treatment system building there was an additional motor and pipe appearing to leave the building. DW explained that this was the outlet pipe from the system but similarly to the internal infrastructure this was in a poor condition and non-operational. As can be seen in Figure 3, this non-operational condition is supported by the fact that the system is not plugged in.

Figure 3 – The rear of the sewage treatment system as observed during the visit.

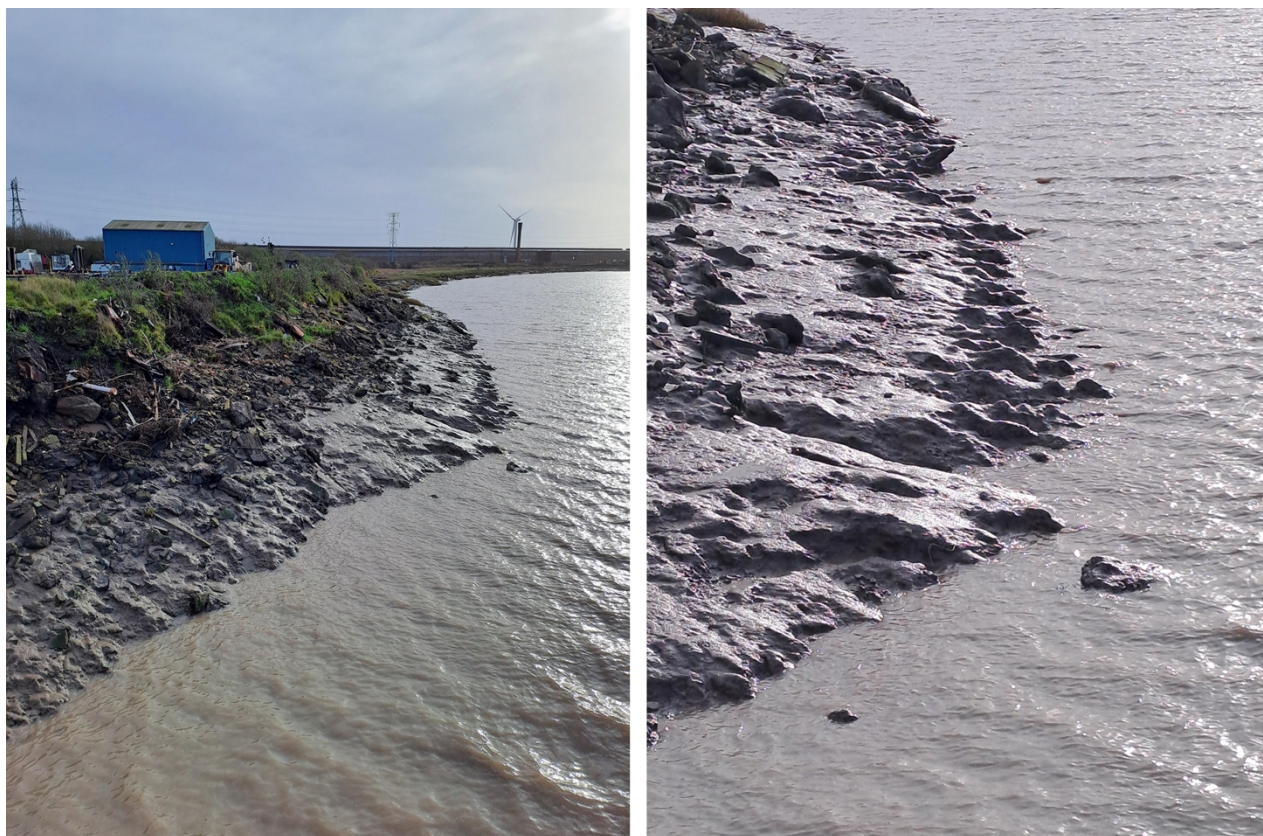
I attempted to locate and observe the discharge/sample point but it was below the water line at the time of the visit as can be seen in Figure 4. A white outlet pipe can be seen in the left hand photo but DW stated the effluent discharge from the treatment system is located in the eroded channel that can be seen in the right hand photo. I actioned DW to supply photographic evidence of the outlet pipe at low tide when it is visible and I will assess any discharge visually.

Figure 4 – The location of the sample/discharge point to the estuary as observed during the visit.

The sample point location (as specified in the location plan) was not accessible due to it being within an estuarine environment. As such a representative sample of the discharge

cannot be easily obtained. This stands as a minor risk to the environment as stands as a category 3 breach.

3. Establish a new, accessible sample point for the treatment system. This can be done as part of the major renovation works needed to re-instate active sewage treatment on site.

4. Provide photographic evidence of the outlet pipe at low tide/when visible so that an assessment of the effluent quality can be undertaken
