## **Site Condition & Baseline Report**

<b>Site Address</b>	Arrow Bio Waste Recycling Facility, Weighbridge Road, Deeside Industrial Park, Deeside, CH5 2LL		
<b>Report Title</b>	Site Condition & Baseline Report		
<b>Job Number</b>	ES2502	<b>Document Ref.</b>	ES2502-12
<b>Date Issued</b>	26 February 2025	<b>Report Version</b>	Final
<b>Prepared by</b>	Melvin Thomas	<b>Signature</b>

- 1.1.1 Caulmert Limited was instructed by Logik WTE Limited to undertake a contaminated land Phase 2 Site Investigation at the former Shotton Power Station ('the site') in Deeside, North Wales, in order to discharge Condition 6 of Planning Permission 058270 for the proposed development of a new waste management facility.

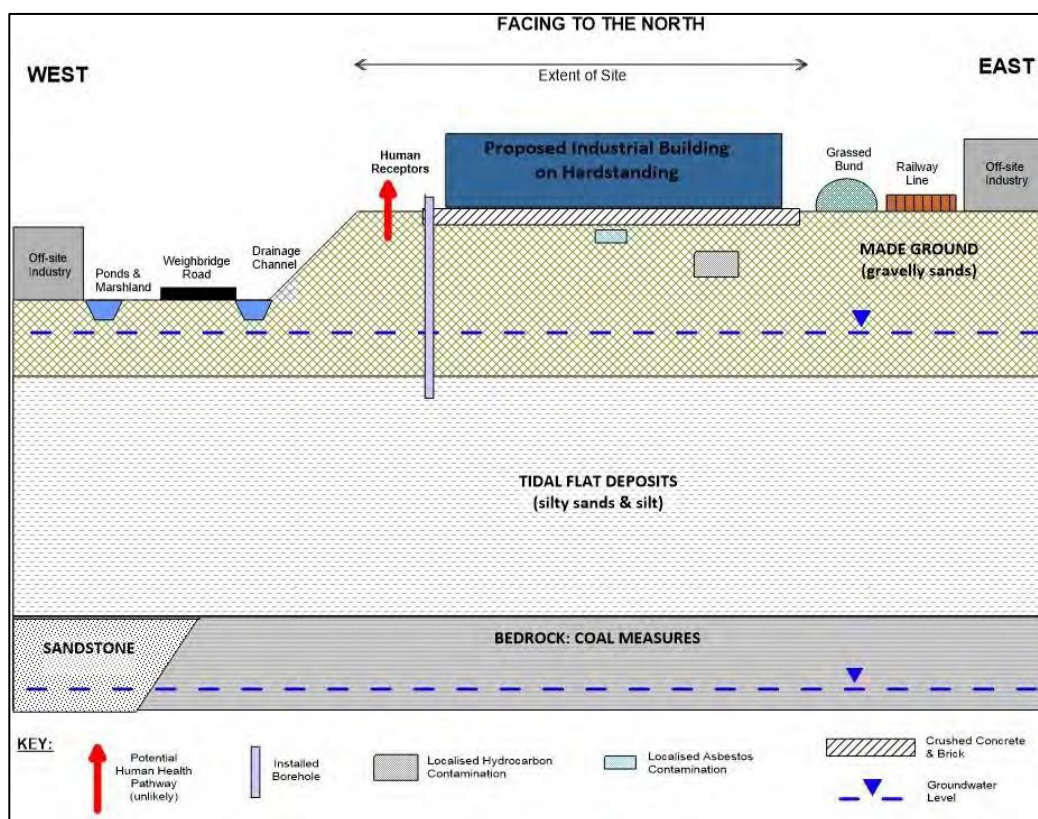
Figure 4 – Updated Conceptual Site Model (cross-section from east to west, looking north)

5.2.1 The site observations made during the ground investigations and subsequent chemical analysis have been included in the updated Conceptual Site Model (CSM) for the site in Figure 4 and a plan view in Figure 5, and the potential pathways and risks to receptors are presented in Tables 12 and 13 below.

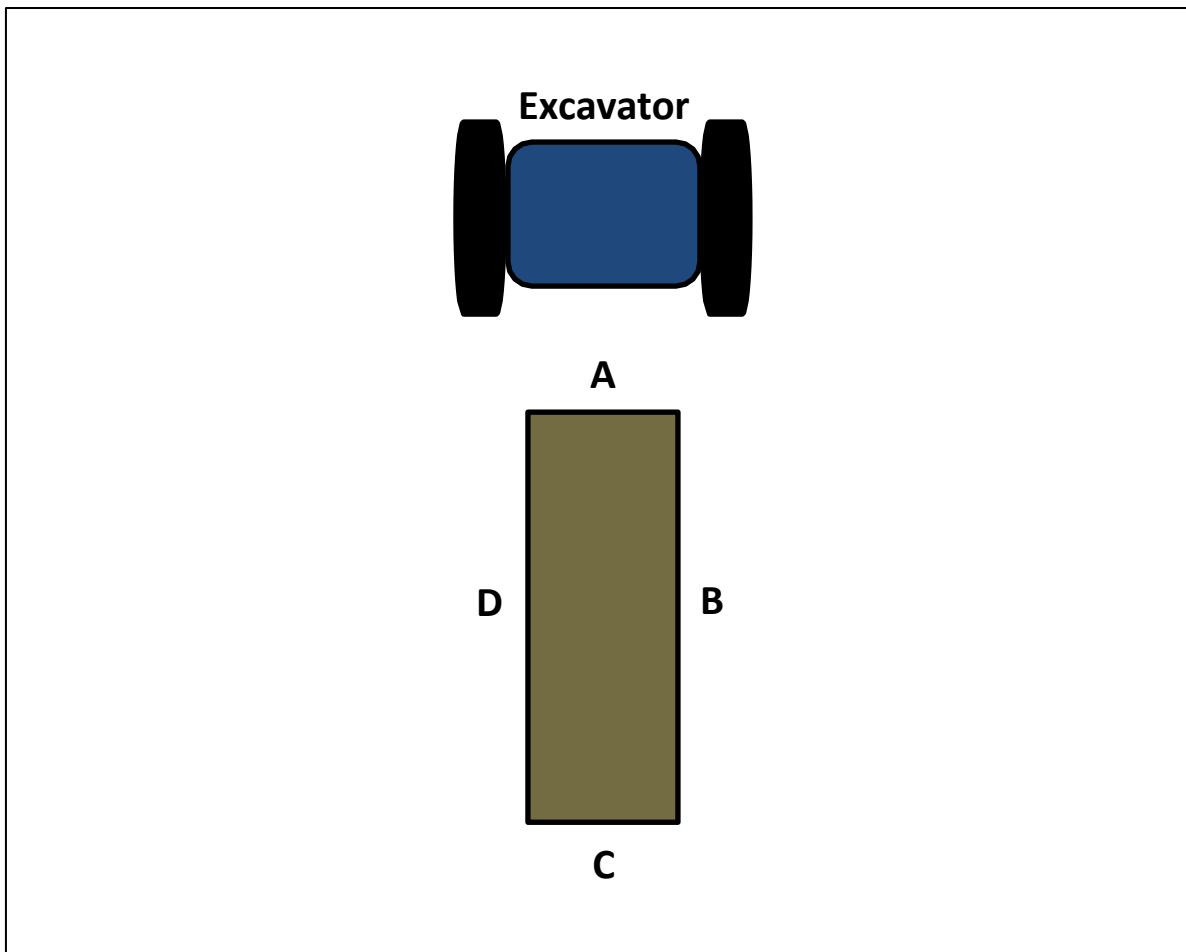
When photographing the trial pits, the sides or faces have been labelled Face A, B, C or D, where Face A is the side closest to the excavator machine, as shown in Figure 1 below:

Figure 1 – Diagram above showing location of trial pit faces in relation to the excavator.

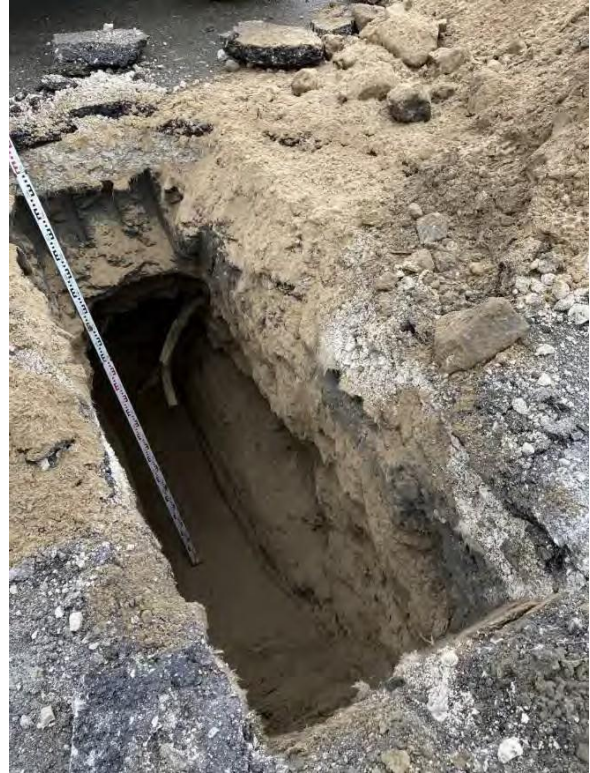
**SA3**

**Wooden Post from Arisings**

6.2.3 The wooden posts found in trial pit location SA3 (see photographs in Appendix 1) in the southwestern area of the site beneath the existing carpark, which emitted a strong odour reminiscent of creosote, were not found to be leaching phenols / other hydrocarbon contaminants into the surrounding Made Ground and therefore do not pose a risk to receptors, humans or controlled waters. However, it is recommended that where

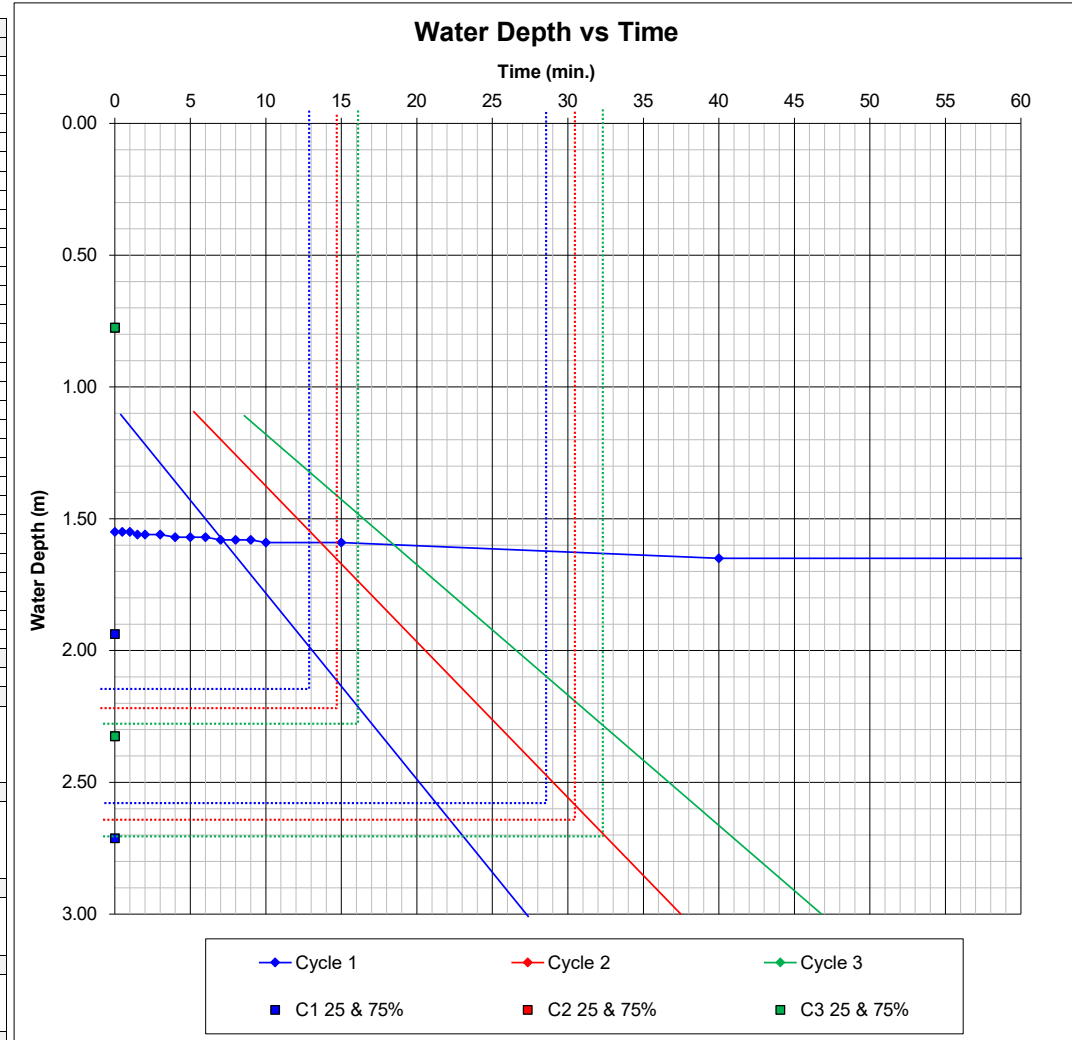
Cycle 1		Cycle 2		Cycle 3	
Time (min)	Depth (m)	Time (min)	Depth (m)	Time (min)	Depth (m)
0	1.55				
0.5	1.55				
1	1.55				
1.5	1.56				
2	1.56				
3	1.56				
4	1.57				
5	1.57				
6	1.57				
7	1.58				
8	1.58				
9	1.58				
10	1.59				
15	1.59				
40	1.65				
140	1.65

Final Excavation Depth (m)	Cycle 1	Cycle 2	Cycle 3
At end of testing cycle	3.10		
<b>Water Depths (m)</b>			
Water depth at start of test	1.55		
Water depth at end of test	1.65		
Effective depth (measured)	0.10		
% Effective storage depth	0.06		
<b>Effective Storage Depths (m)</b>			
Effective storage depth (100%)	1.55		
Effective storage depth (75%)	1.16		
Effective storage depth (50%)	0.78		
Effective storage depth (25%)	0.39		
<b>Outflow Time (min)</b>			
Time for measured outflow	140		
Time for 100% outflow			
Time for 75-25% outflow			
<b>Volume of Outflow (m³)</b>			
Over measured effective depth	0.28		
Over 100% effective depth	4.26		
From 75% - 25% effective depth	2.13		
<b>Surface Area (m²)</b>			
For 100% effective storage	13.91		
For 50% effective storage	8.33		
Over measured depth	3.47		
<b>Soil Infiltration Rate (m/s)</b>			
Over 100% effective depth	#DIV/0!		
Over measured depth	9.4E-06		
Over 75% - 25% effective depth	#DIV/0!

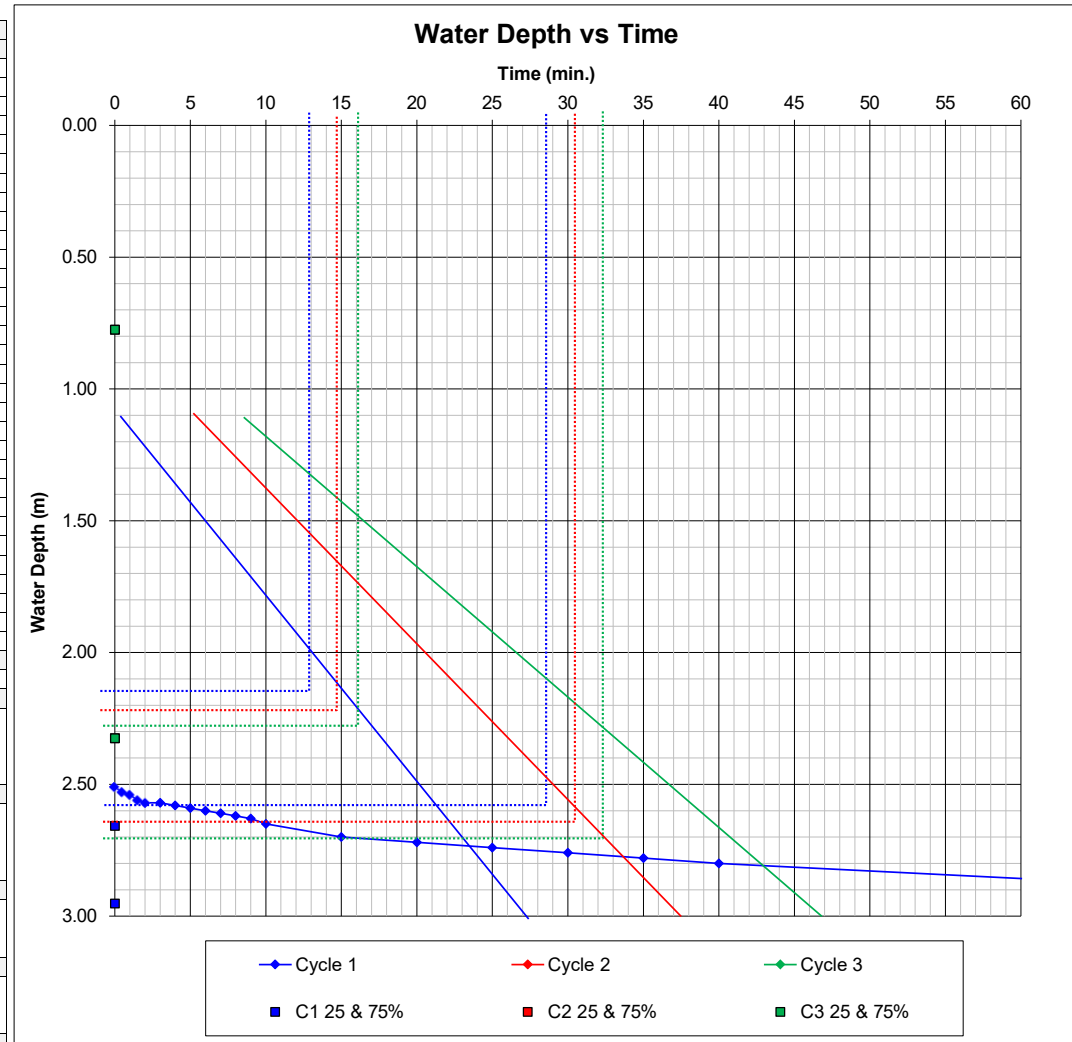
# BRE365 SOIL INFILTRATION RATE TEST - SA3

Cycle 1		Cycle 2		Cycle 3	
Time (min)	Depth (m)	Time (min)	Depth (m)	Time (min)	Depth (m)
0	2.51				
0.5	2.53				
1	2.54				
1.5	2.56				
2	2.57				
3	2.57				
4	2.58				
5	2.59				
6	2.60				
7	2.61				
8	2.62				
9	2.63				
10	2.65				
15	2.70				
20	2.72				
25	2.74				
30	2.76				
35	2.78				
40	2.8				
75	2.9				
120	2.95

Final Excavation Depth (m)	Cycle 1	Cycle 2	Cycle 3
At end of testing cycle	3.10		
<b>Water Depths (m)</b>			
Water depth at start of test	2.51		
Water depth at end of test	2.95		
Effective depth (measured)	0.44		
% Effective storage depth	0.75		
<b>Effective Storage Depths (m)</b>			
Effective storage depth (100%)	0.59		
Effective storage depth (75%)	0.44		
Effective storage depth (50%)	0.30		
Effective storage depth (25%)	0.15		
<b>Outflow Time (min)</b>			
Time for measured outflow	120		
Time for 100% outflow			
Time for 75-25% outflow			
<b>Volume of Outflow (m³)</b>			
Over measured effective depth	0.71		
Over 100% effective depth	0.95		
From 75% - 25% effective depth	0.47		
<b>Surface Area (m²)</b>			
For 100% effective storage	5.15		
For 50% effective storage	3.38		
Over measured depth	4.25		
<b>Soil Infiltration Rate (m/s)</b>			
Over 100% effective depth	#DIV/0!		
Over measured depth	2.3E-05		
Over 75% - 25% effective depth	#DIV/0!

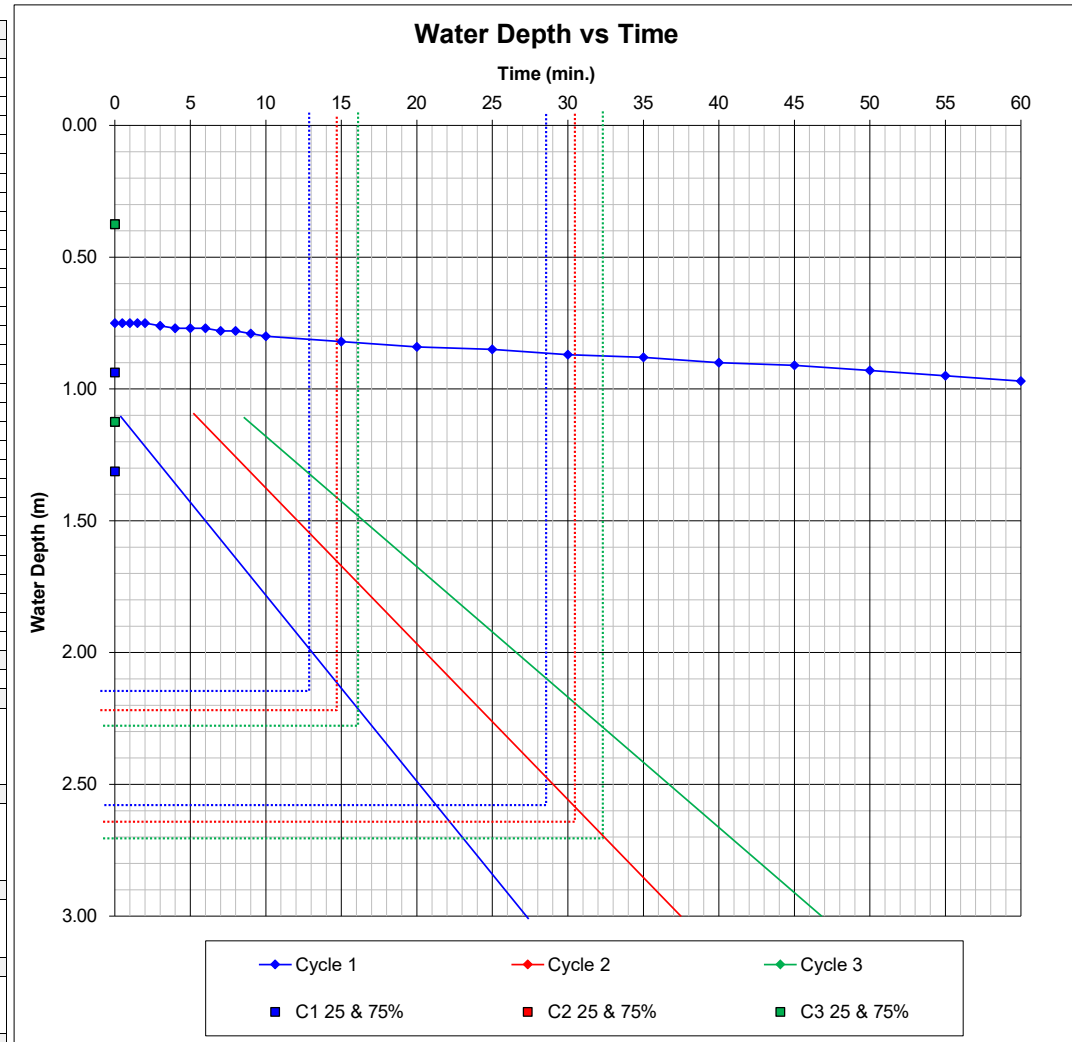
# BRE365 SOIL INFILTRATION RATE TEST - SA5

Cycle 1		Cycle 2		Cycle 3	
Time (min)	Depth (m)	Time (min)	Depth (m)	Time (min)	Depth (m)
0	0.75				
0.5	0.75				
1	0.75				
1.5	0.75				
2	0.75				
3	0.76				
4	0.77				
5	0.77				
6	0.77				
7	0.78				
8	0.78				
9	0.79				
10	0.80				
15	0.82				
20	0.84				
25	0.85				
30	0.87				
35	0.88				
40	0.9				
45	0.91				
50	0.93				
55	0.95				
60	0.97				
75	0.98				
120	1.05				
180	1.13				
240	1.29

Final Excavation Depth (m)	Cycle 1	Cycle 2	Cycle 3
At end of testing cycle	1.50		
<b>Water Depths (m)</b>			
Water depth at start of test	0.75		
Water depth at end of test	1.29		
Effective depth (measured)	0.54		
% Effective storage depth	0.72		
<b>Effective Storage Depths (m)</b>			
Effective storage depth (100%)	0.75		
Effective storage depth (75%)	0.56		
Effective storage depth (50%)	0.38		
Effective storage depth (25%)	0.19		
<b>Outflow Time (min)</b>			
Time for measured outflow	240		
Time for 100% outflow			
Time for 75-25% outflow			
<b>Volume of Outflow (m³)</b>			
Over measured effective depth	0.73		
Over 100% effective depth	1.02		
From 75% - 25% effective depth	0.51		
<b>Surface Area (m²)</b>			
For 100% effective storage	5.11		
For 50% effective storage	3.24		
Over measured depth	4.06		
<b>Soil Infiltration Rate (m/s)</b>			
Over 100% effective depth	#DIV/0!		
Over measured depth	1.3E-05		
Over 75% - 25% effective depth	#DIV/0!

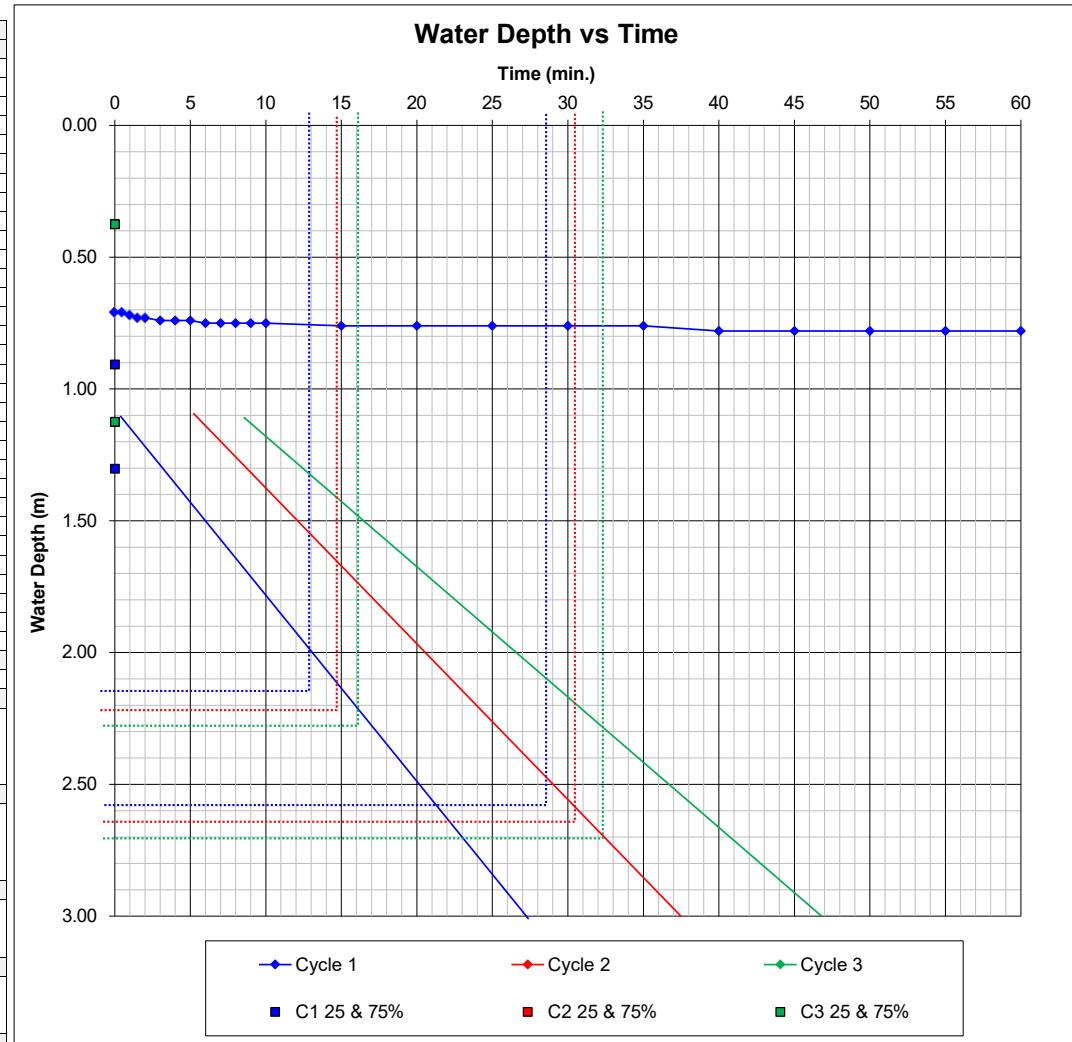
# BRE365 SOIL INFILTRATION RATE TEST - SA6

Cycle 1		Cycle 2		Cycle 3	
Time (min)	Depth (m)	Time (min)	Depth (m)	Time (min)	Depth (m)
0	0.71				
0.5	0.71				
1	0.72				
1.5	0.73				
2	0.73				
3	0.74				
4	0.74				
5	0.74				
6	0.75				
7	0.75				
8	0.75				
9	0.75				
10	0.75				
15	0.76				
20	0.76				
25	0.76				
30	0.76				
35	0.76				
40	0.76				
45	0.78				
50	0.78				
55	0.78				
60	0.78				
75	0.78				
90	0.78				
105	0.78				
120	0.78				
180	0.78				
240	0.78

Final Excavation Depth (m)	Cycle 1	Cycle 2	Cycle 3
At end of testing cycle	1.50		
<b>Water Depths (m)</b>			
Water depth at start of test	0.71		
Water depth at end of test	0.78		
Effective depth (measured)	0.07		
% Effective storage depth	0.09		
<b>Effective Storage Depths (m)</b>			
Effective storage depth (100%)	0.79		
Effective storage depth (75%)	0.59		
Effective storage depth (50%)	0.40		
Effective storage depth (25%)	0.20		
<b>Outflow Time (min)</b>			
Time for measured outflow	240		
Time for 100% outflow			
Time for 75-25% outflow			
<b>Volume of Outflow (m³)</b>			
Over measured effective depth	0.06		
Over 100% effective depth	0.72		
From 75% - 25% effective depth	0.36		
<b>Surface Area (m²)</b>			
For 100% effective storage	4.07		
For 50% effective storage	2.49		
Over measured depth	1.19		
<b>Soil Infiltration Rate (m/s)</b>			
Over 100% effective depth	#DIV/0!		
Over measured depth	3.7E-06		
Over 75% - 25% effective depth	#DIV/0!
