Compliance Assessment Report CAR_NRW0051693

Permit being assessed: NP3599FC.

For: J Pesci & Sons Ltd, **held by:** Pesci J & Sons Ltd

At: Wernddu, Caerphilly, Glamorgan, CF83 3DA.

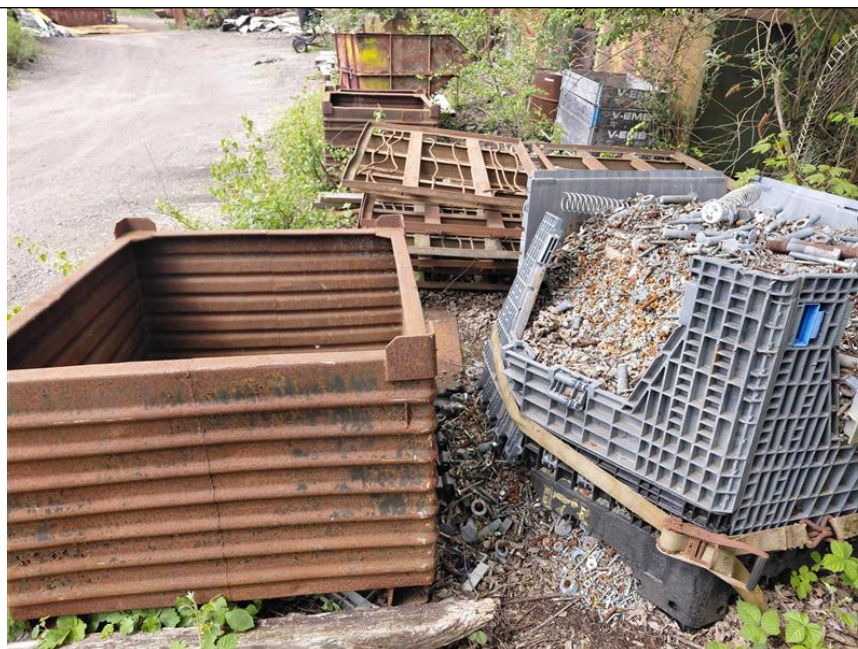
Throughout the site there were containers that were used to store segregated waste following sorting activities, including batteries, which were appropriately contained. However, some containers holding sorted metal waste were damaged at the bottom and the contents were spilling onto the ground (see image 1). Mr PESCI indicated that he was in the process of transferring the contents of these containers to suitable replacements. Please transfer the contents of these containers into suitable replacements and ensure that all spilled material and debris are removed from the ground.

Image 1: Broken storage container containing metal fixtures and fasteners.

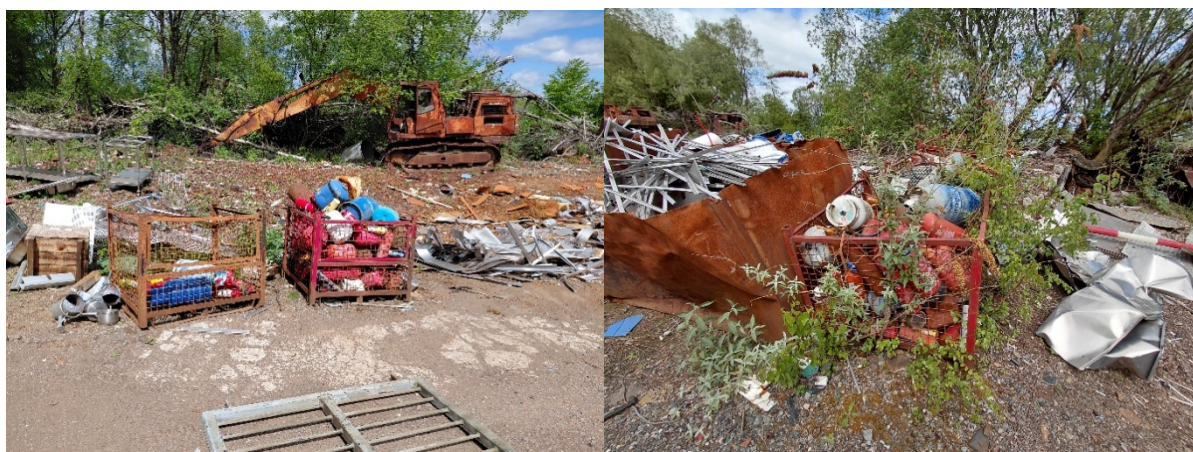
During the inspection, several containers holding gas cylinders fitted with valves were observed across site (see images 2 and 3). Mr Pesci informed officers that the cylinders were empty and awaiting treatment for scrap metal. However, British Compressed Gas Association (BCGA) Guidance ([Leaflet 2](#) and [Code of Practice 44](#)), which is supported by Natural Resources Wales, states that “*even a nominally empty cylinder will still contain residue gases and some pressure, therefore retaining its hazardous properties*” until they have been formally rendered safe. This process requires the complete discharge of any contents and the removal of the valve. Until then they must be stored upright in secure, well-ventilated (preferably outdoor) area and separated according to hazard before treatment. The storage method observed on site does not comply with this recognised good practice, please improve gas cylinder storage practices.

Images 2 and 3: Containers filled with gas cylinders at various locations across site.

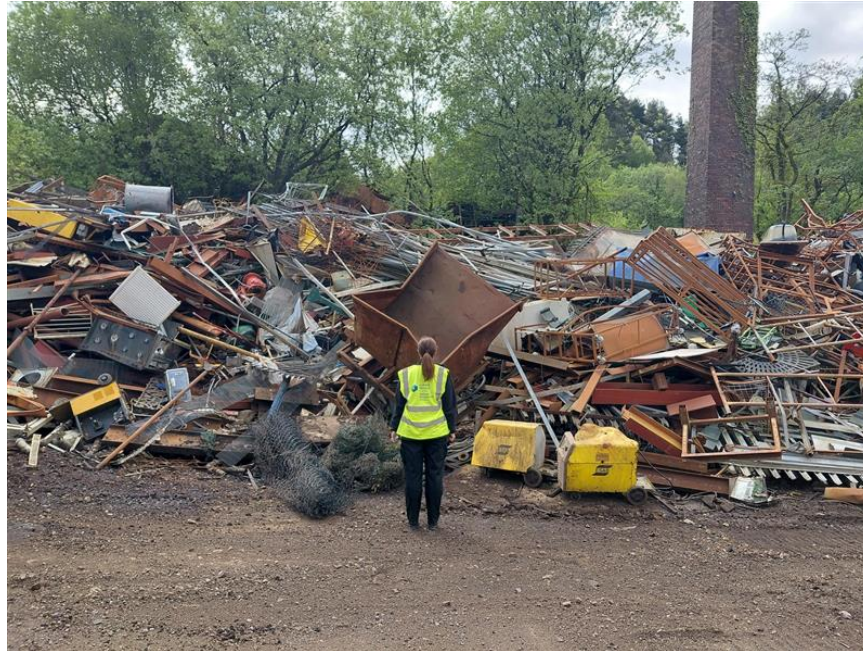
At the bottom of the site, a large scrap metal stockpile was observed awaiting sorting. During a previous site visit, it was noted that the stockpile height exceeded 5 metres, which was not in accordance with the site's working plan. At the time of this visit, the stockpile height had been reduced to below 4 metres (see Image 4). Ensure that stockpile heights continue to be maintained within the limits specified in the site's working plan.

Image 4: Unsorted metal stockpile.

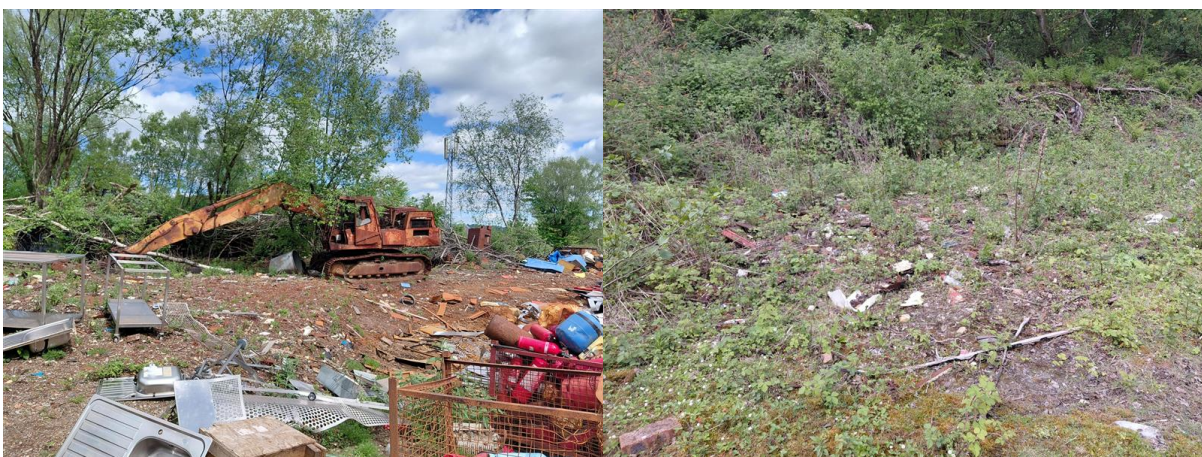
Surrounding the metal stockpile and the area used for the storage of ELVs there was a significant amount of refuse on the grassed areas (see images 5 and 6). Please ensure that good housekeeping is maintained across the site.

Images 5 and 6: Left - Photograph taken next to the metal stockpile, showing a significant amount of refuse. Right - Photograph taken at the ELV storage area, showing a significant amount of refuse.

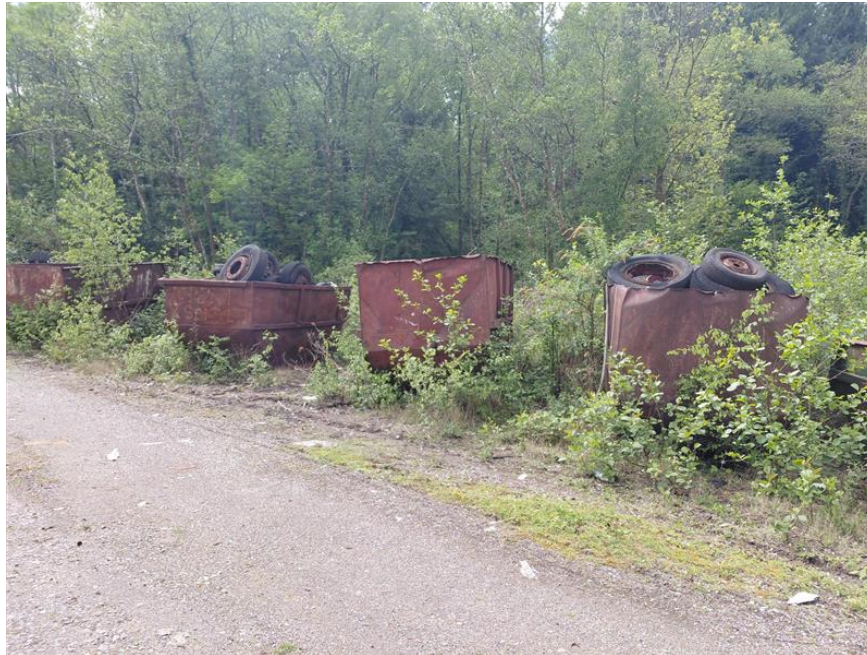
A large number of corroded tyres have been observed across the site. This issue was previously identified in compliance assessment reports NRW0043809 and NRW0040593, dated 6 March 2024 and 4 October 2022, respectively.

As mentioned in the permit breaches section, several skips containing end-of-life tyres were observed at the rear of the site (see image 7). The tyre rims appeared to be significantly corroded. Mr PESCI advised officers that he has experienced difficulty in sourcing a suitable contractor to separate the tyres from the rims due to their size, age, and condition. Please ensure that all waste is managed in accordance with the permitted waste management activities. In particular:

Image 7: Skips containing corroded tyres.

Action: Please ensure that the old tyres identified during the site inspection are removed from the site by the 16 November 2026.

This issue was previously identified in compliance assessment reports NRW0043809 and NRW0040593, dated 6 March 2024 and 4 October 2022, respectively. **Please ensure that the old tyres identified during the site inspection are removed from the site, and that permitted waste storage timeframes are complied with going forward.**
