## Compliance Assessment Report CAR\_NRW0051913

**Permit being assessed:** EP3698FL.

**For:** Nantycaws H C I Transfer & Treatment Facility, **held by:** CWM Environmental Ltd

**Type of assessment:** Site Inspection,

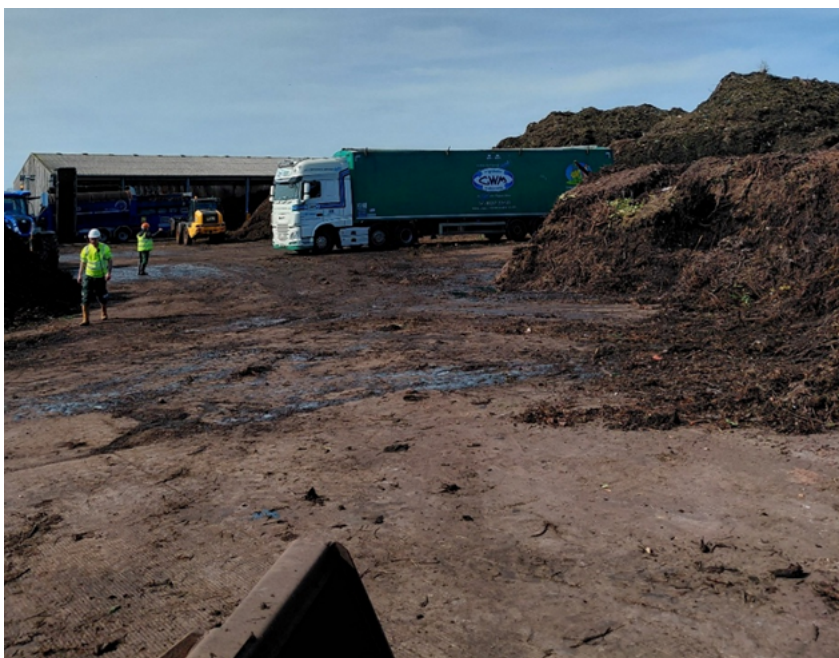
One articulated lorry delivering fresh green waste was observed unloading during the inspection. The operator informed NRW that this was from Swansea Council and confirmed site receives approximately two articulated loads per week.

NRW inspected the load at time of unloading which contained a minor amount of contaminants including wood, a glove and bags.

*Figure 1 Photo showing fresh green waste delivery from Swansea Council.*

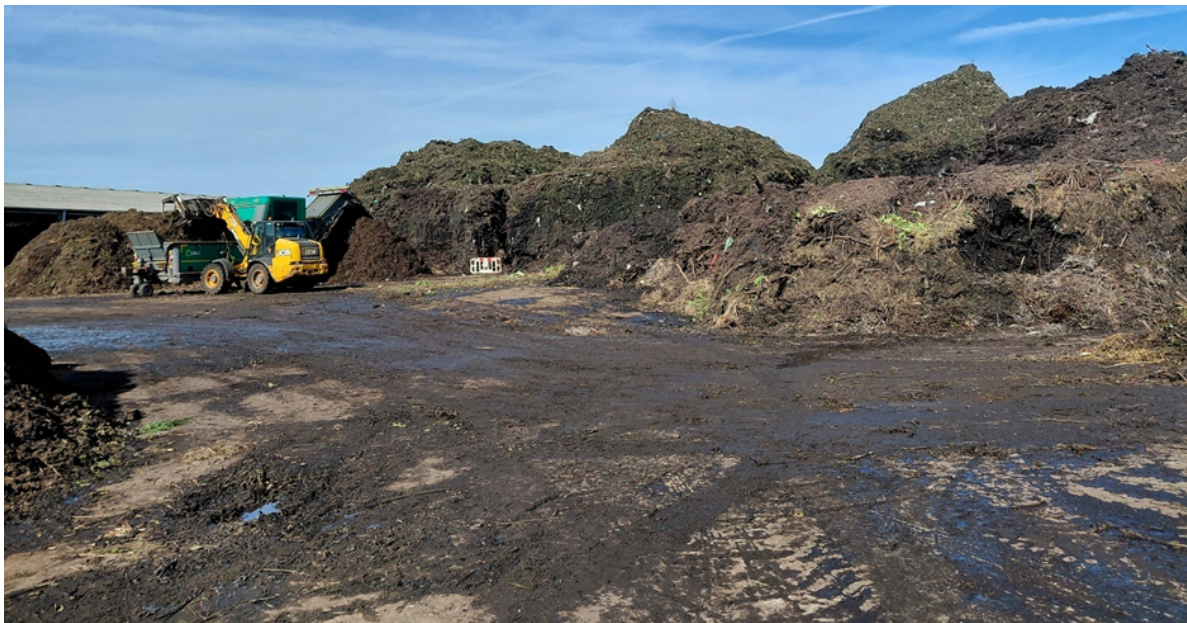
The inspection identified that excessive volumes of legacy green waste feedstock remain onsite. Previously issued Compliance Assessment Reports and a Regulation 36 Notice required the legacy green waste feedstock pile to be reduced in size and volume in order to return to regulatory compliance.

The operator has installed fire breaks which have broken the legacy green waste feedstock pile into blocks, however the block dimensions and size of the separation gaps do not comply with the

approved FPP or FPMP guidance, as referenced by the FPP. Estimated distances between the blocks range from approx. 1m-2m (compared to the minimum of 6m), and in some cases waste has collapsed into the spaces between.

This breach has been assigned a non-compliance category of C3 under compliance criteria IR3IC Fire.

Figure 2 Photo showing large volume of old green waste stockpile.

**Action:** The operator is required to return the legacy green waste feedstock pile to compliance with the FPP.

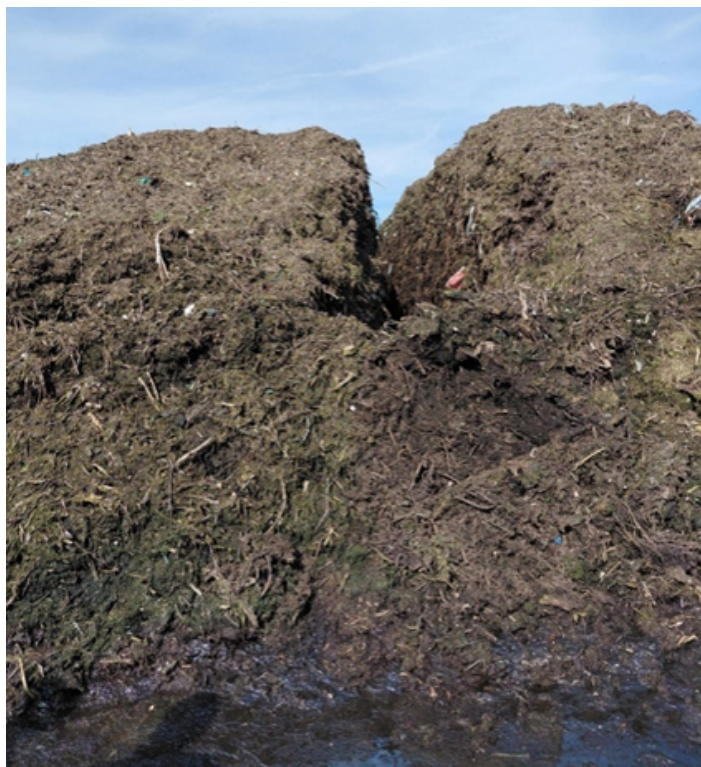
Windrows were not observed to be consistent with the dimensions and shape as set out in the approved SOP. The square, opposed to trapezoid shape of some windrows had led in several cases to collapsed windrow sides which reduced access and fire breaks and caused cross-contamination between batches, with Batch 370 and Batch 371 visibly mixed in some areas.

Some windrows appeared green in colour, including Batch 368, which suggested insufficient turning. During further discussion in the site office, the operator provided documentation showing that turning had occurred three times in total. NRW notes that the approved SOP states turning should occur three times during stabilisation and two times during sanitation.

*Figure 3 Photo showing mixed batches and green algae growth on windrows suggesting insufficient turning.*

**Action:** The operator is to provide monitoring data to NRW, as required by permit condition 3.5 and Table S3.5 to demonstrate that the windrows are being managed to maintain aerobic conditions for

the duration March, April and May 2026.

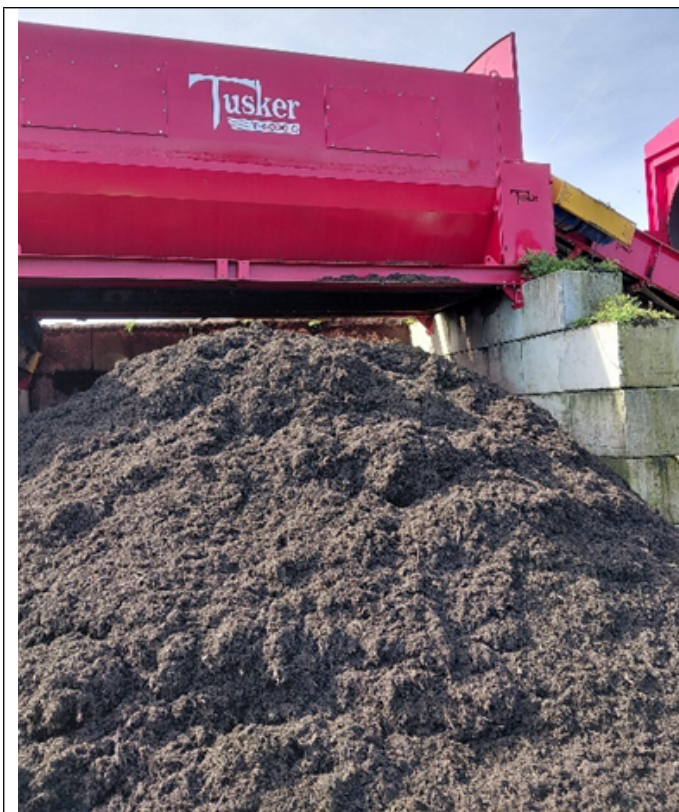
During the inspection, Batch 368 was observed being screened through two red fixed screeners. A large stockpile of oversize material was present adjacent to the fixed screeners. The operator stated this oversize material stockpile is stored on clay lined ground.

Figure 5 Photo showing large red screener

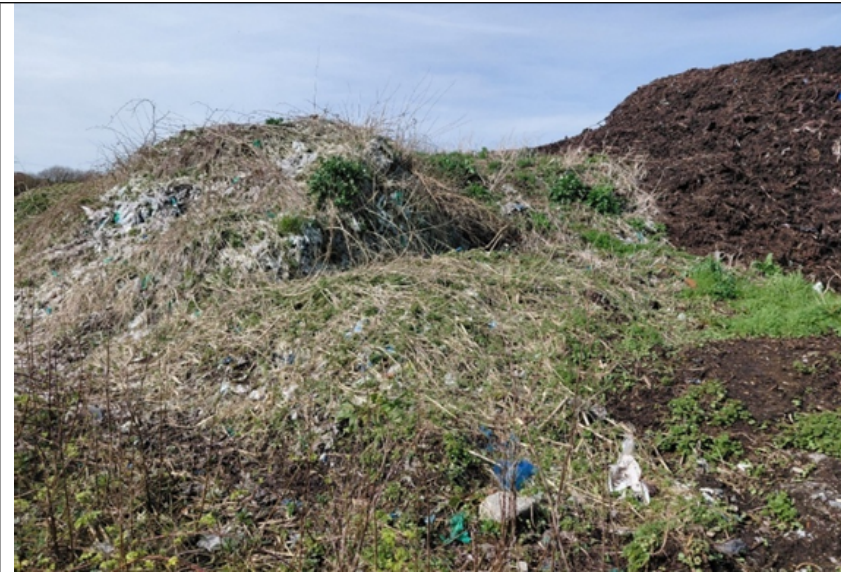
The oversize stockpile contained very high levels of plastic contamination and appeared to have been stored for a substantial period of time, as evidenced by degraded plastic and vegetation growing out of the stockpile. No traceability records were available to identify which compost batches this oversize material originated from, which the operator confirmed during discussions in the site office. As outlined during discussions with the CB representative on site, as part of requirements to meet end of waste certification there must be traceability for the oversize material as well as the other inputs.

Natural Resources Wales considers this storage arrangement to be contrary to the approved SOP, which states under section 8.1 that “*oversize material coming off the screen shall only be re-composted if visual assessment confirms that physical contaminants will not adversely affect the composting process or prevent effective control of compost quality (as stated in the quality policy). Addition of oversize material to a batch of composting material shall only be carried out when it is being formed (see SOPs section 3.4), and this shall be recorded on the 'Batch Record Sheet' for the new batch.*

*Figure 6 Photo showing large volume of plastic in oversize stockpile.*

**Action:** The operator is to confirm the suitability of this material for further re-composting and if not suitable, the material must be treated as a waste product and remove from site. In the event of disposal, the operator is to submit to NRW the relevant Waste Transfer Notes.

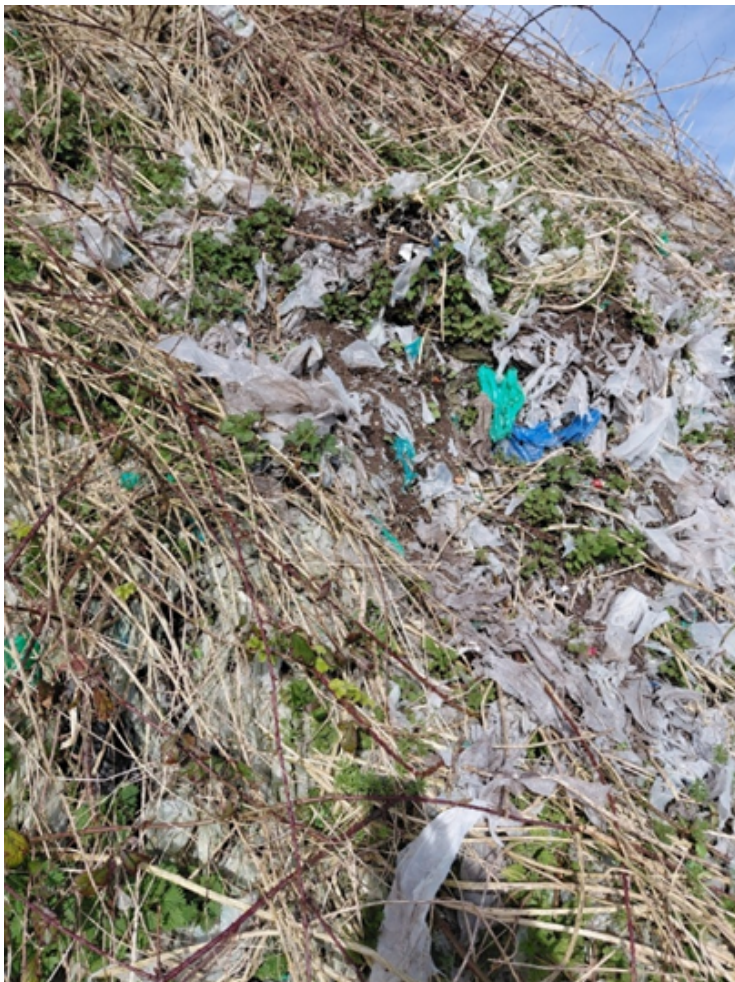
*Figure 7 Photo showing degraded quality of plastic and growth coming out of plastics, suggesting has been stockpiled for a substantial period of time.*

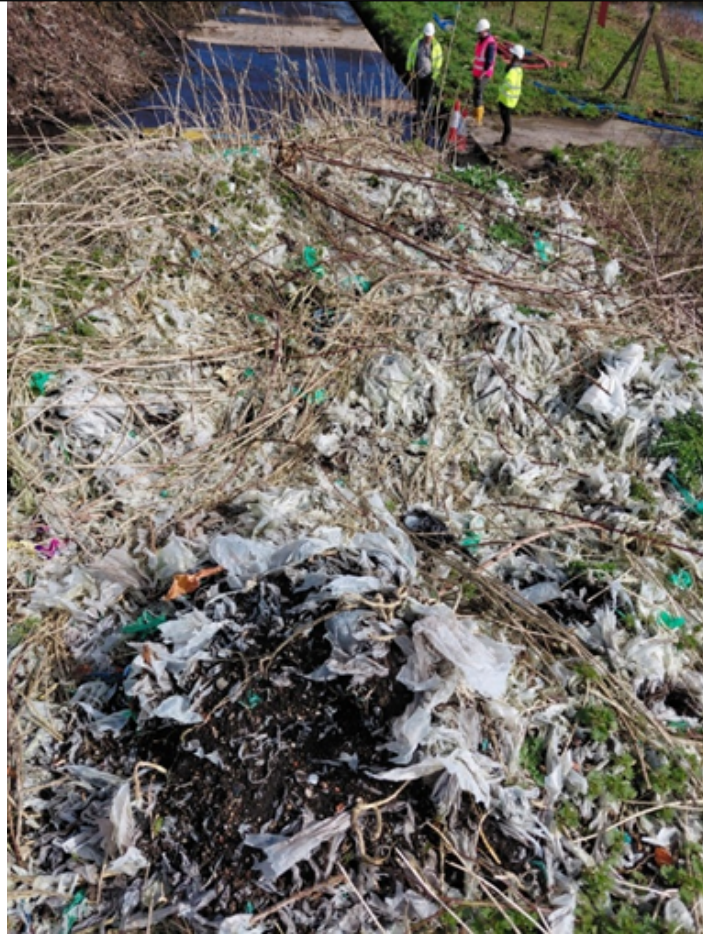
*Figure 8 Further photo showing plastic and oversize stockpile.*

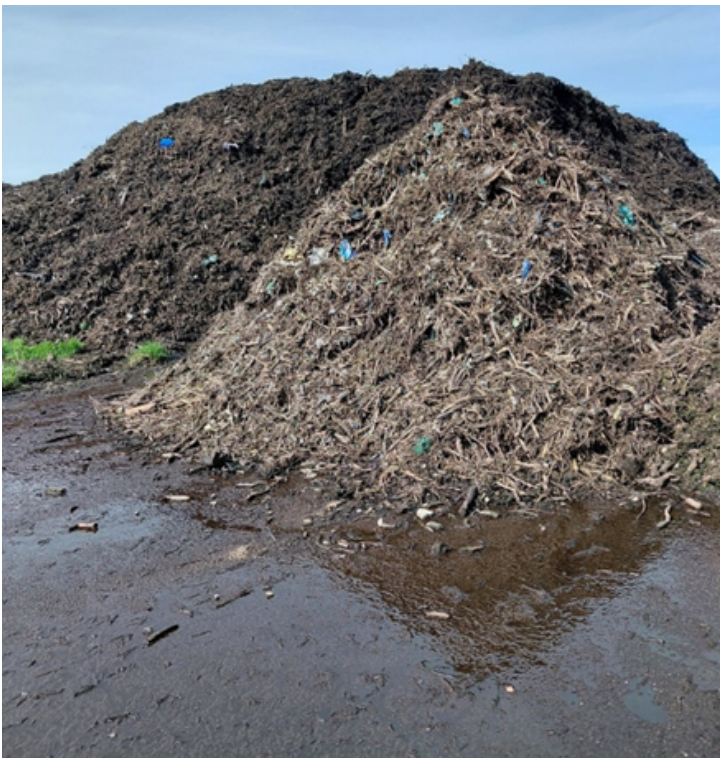
*Figure 9 Further photo of oversize stockpile.*

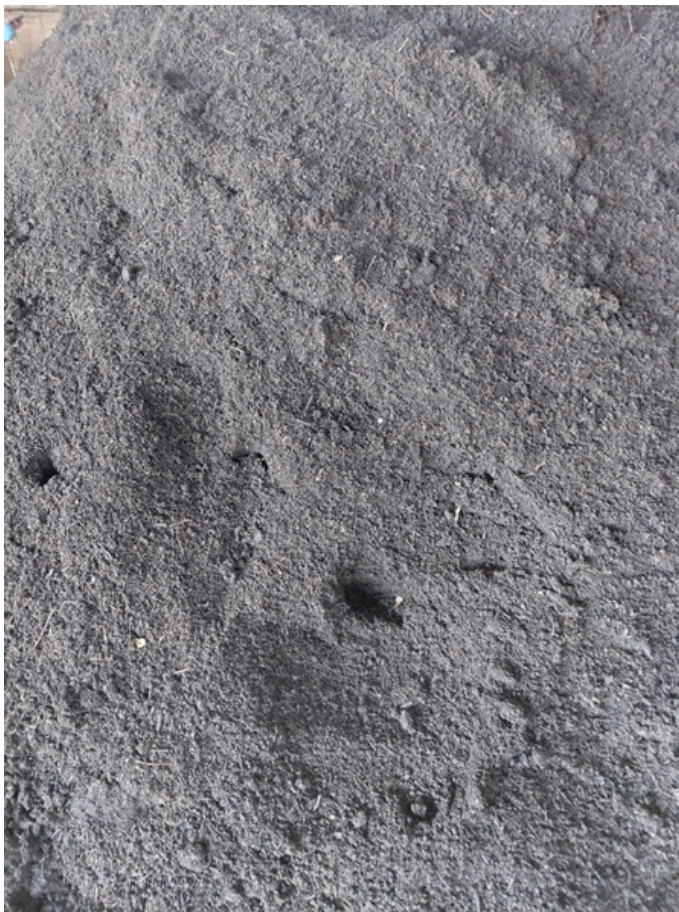
**Batch 358-10** – observed in the storage shed, appeared acceptable on visual inspection.

*Figure 10 photo showing Batch 358-10, 10mm product in storage shed.*

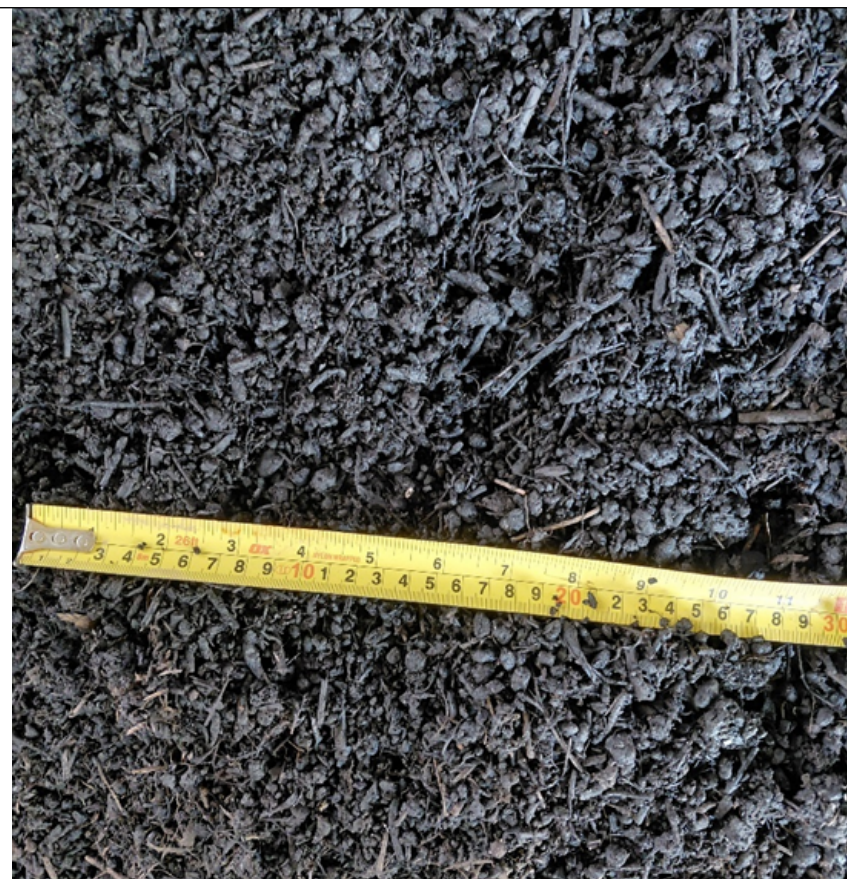
*Figure 11 Photo showing shredding size of Batch 358-10, 10mm product in storage shed*

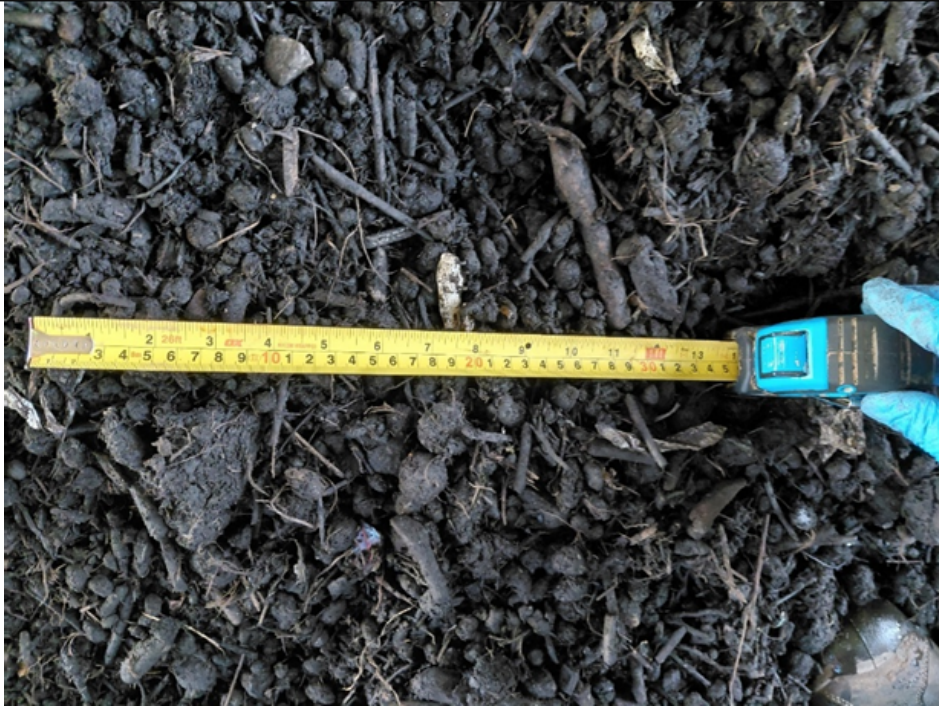
**Batch 368-10** – also observed in storage shed, did not appear to meet specification, due to the presence of large pieces of soil, branches, roots and contaminants. Material appeared visually inconsistent, suggesting it was blended from multiple batches with one side of the pile differing from the other, in size, appearance and texture.

Figure 12 Photo showing shredding side of Batch 368-10, 10mm product in storage shed.

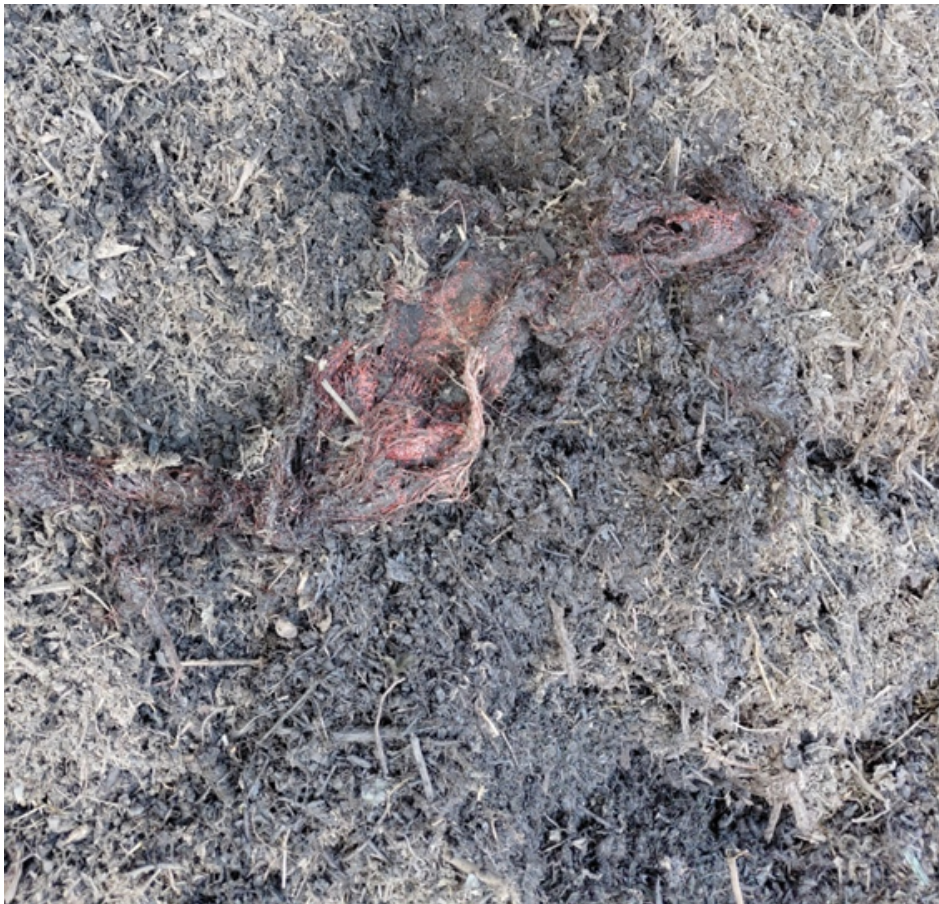
Figure 13 Photo showing contaminants in Batch 358-10 in storage shed.

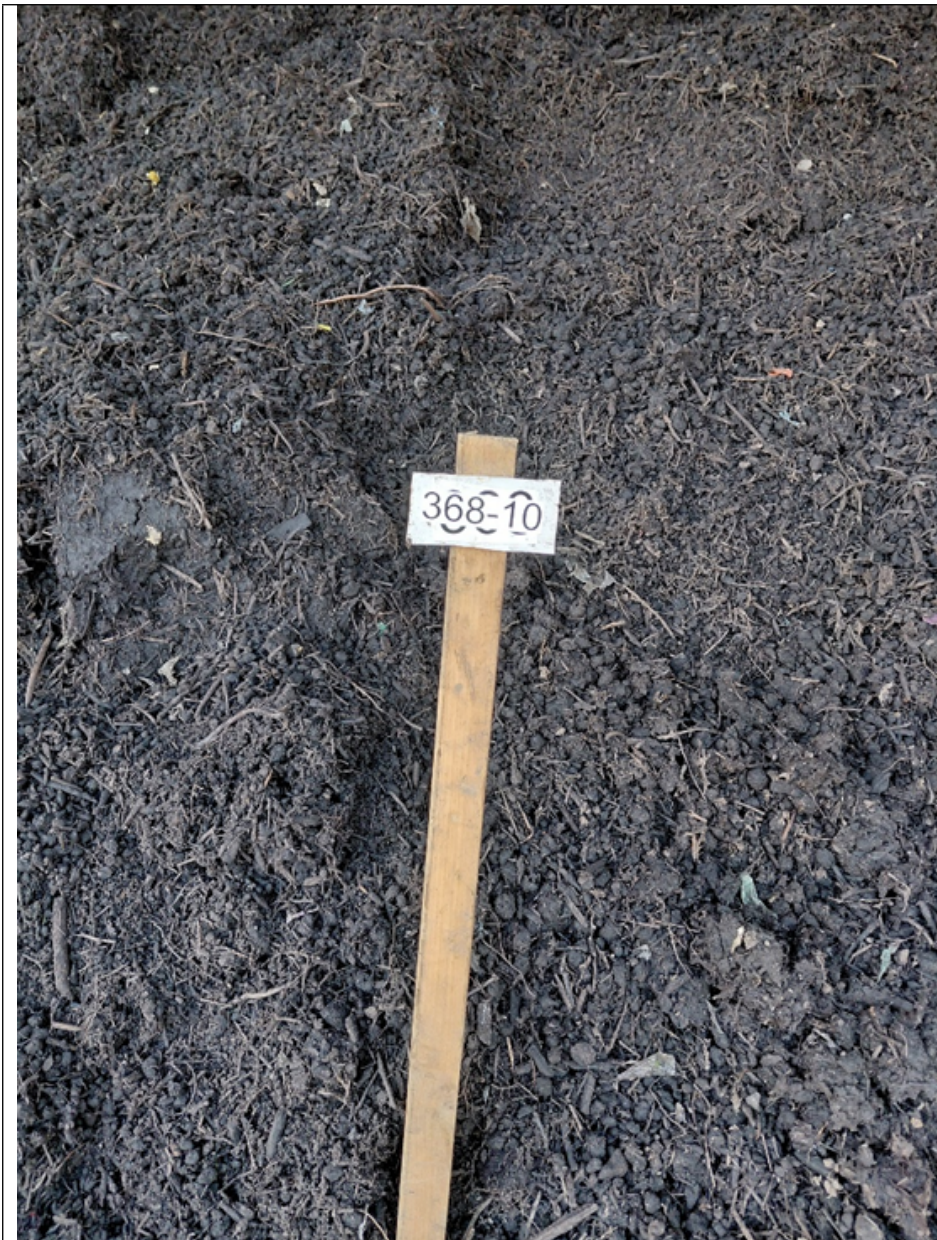
*Figure 14 Further photo showing batch 358-10.*

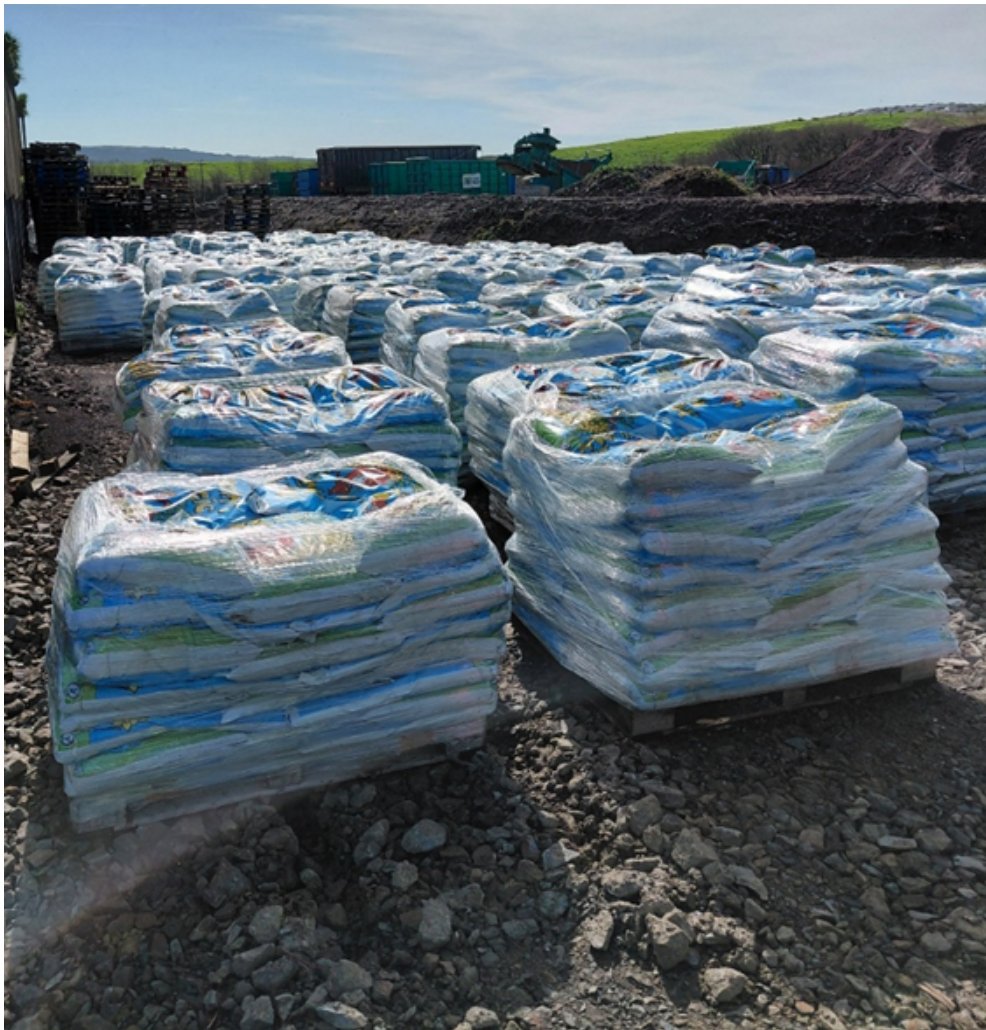
To the side and rear of the shed were large numbers of palletised and shrink-wrapped bagged compost which appeared ready for shipment off site. These pallets had no batch numbers and no guidance stickers.

The operator explained these were produced by a contractor and that all bags would need to be opened, re-tested, assigned new batch numbers and re-bagged with correct labels to comply with the Compost Certification Scheme.

Figure 15 Photo showing shrink wrapped, palletted bagged compost being stored to rear and side of shed. No batch numbers and guidance stickers.

**Action:** The operator is to submit to NRW confirmation that these products have been re-tested and bagged with the required information prior to onward use.

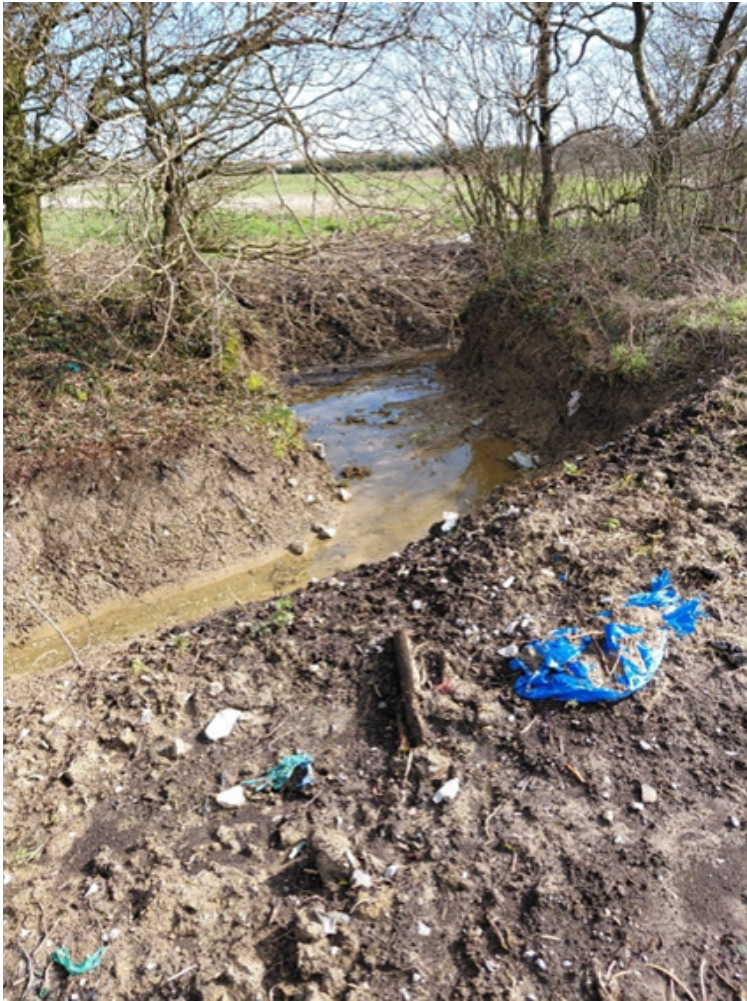
To the north of the compost pad, the operator has begun digging a perimeter drainage ditch, flowing to the east of the site.

*Figure 16 Photo showing newly dug drainage ditch to north of compost pad.*

**Action :** Operator to submit to NRW the design and specification of the drainage ditch and bunding for approval.

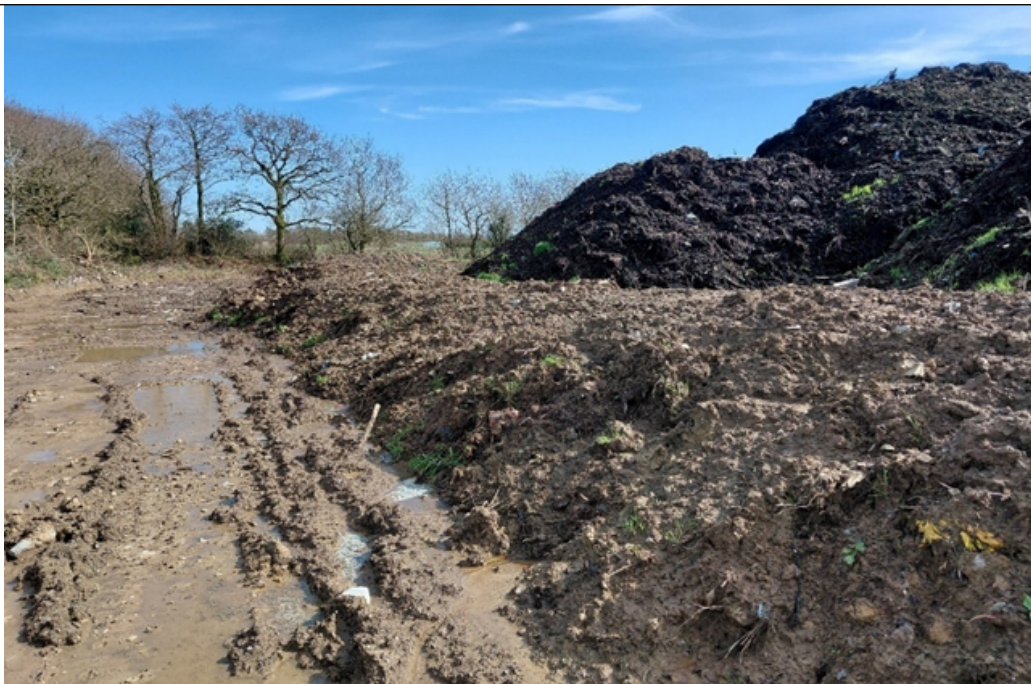
Operator has also installed additional bunding at the base of the rear old feedstock pile to divert runoff.

*Figure 17 Photo showing additional clay bunding installed to base of old green waste stockpile.*

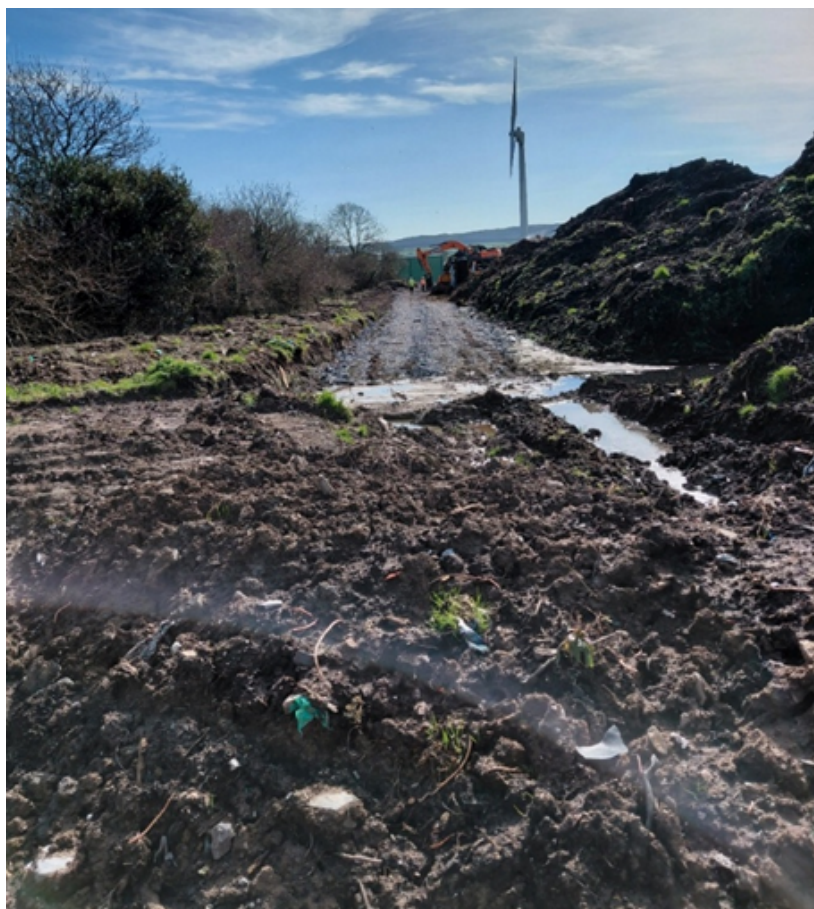
A contractor was on site at the time of inspection installing a stone hardstanding access path to the east side of the compost pad, new drainage runs, Aco drains and kerbing.

*Figure 18 Photo showing newly installed hard standing access path to east of compost pad.*

**Action :** Operator to submit to NRW updated complete site layout plans including drainage runs, falls, bunding, hard standings and infrastructure.

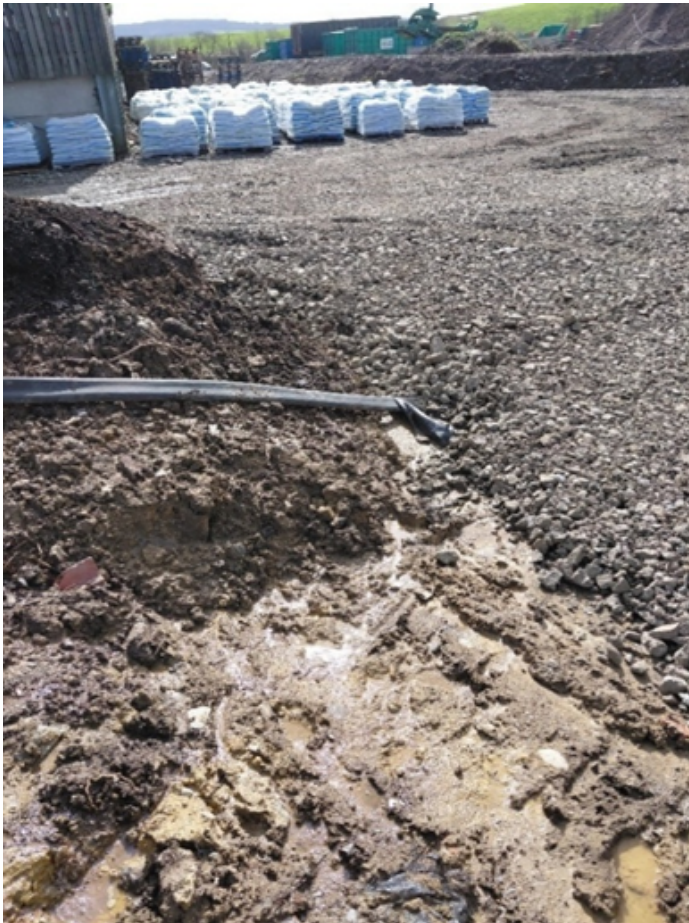
A soft firewater pipe was seen emerging from the newly compacted hardcore area adjacent to the storage shed. The pipe appeared crushed by the stone weight above it. NRW advised this was not suitable and must be replaced.

*Figure 19 Photo showing crushed fire water pipe emerging from newly installed hardstanding.*

Operator stated they have a new double-skin rigid pipe ready to be installed as a replacement.

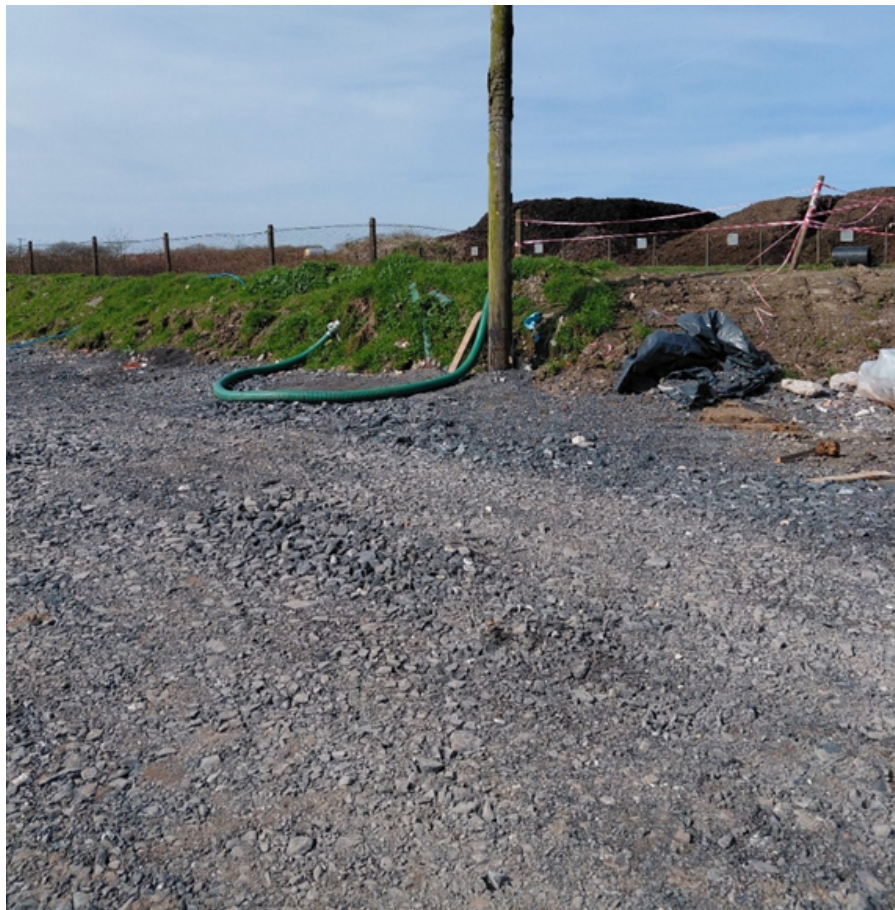
Tankering operations were taking place on the south side of the lagoon, which is not the designated, purpose-built leachate removal area.

The operator explained this was due to a levels issue within the lagoon and this location may be used in the future.

*Figure 20 Photo showing southern location leachate removal being taking from.*

**Action :** The operator is to confirm the suitability of this alternative leachate removal area when

compared to the purpose built leachate removal point, including measures in place to contain and manage any potential leachate spillages during transfer to the tanker. Containment system must be designed to prevent pollution during operations where hazardous liquids are handled as per CIRIA C736 guidance.

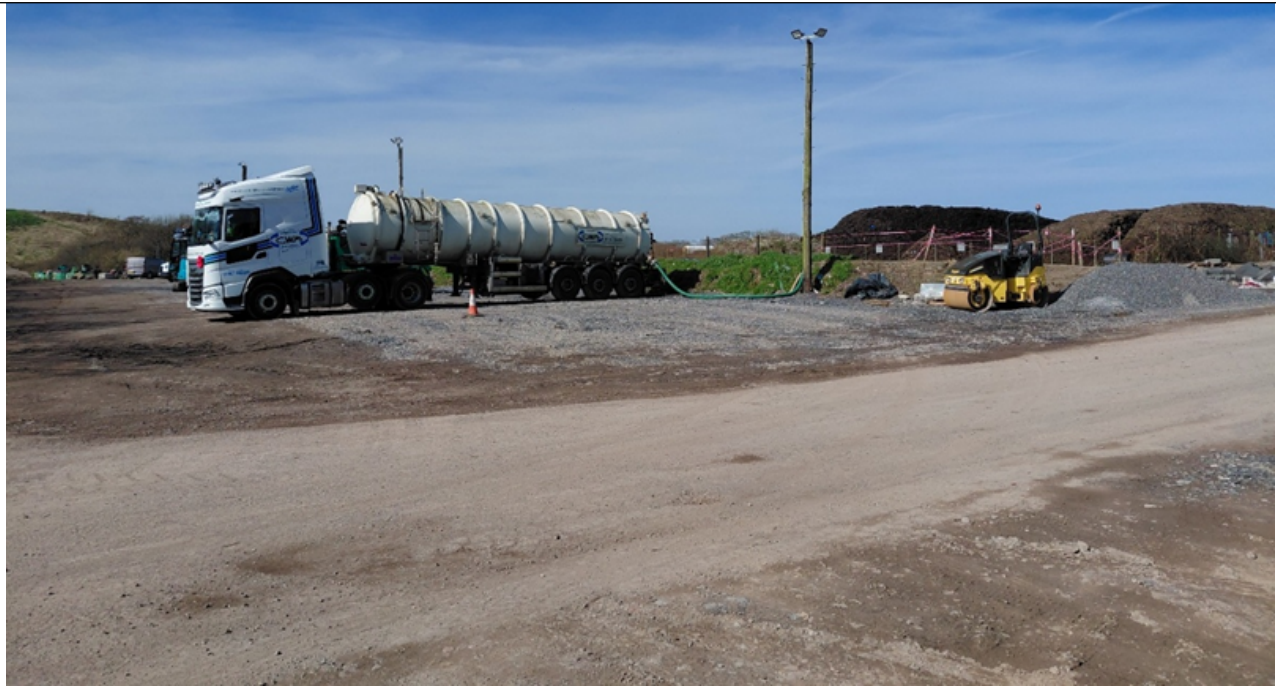
At the time of inspection, the leachate lagoon was being emptied via tanker.

Figure 21 Photo showing leachate removal to tanker at southern side of leachate lagoon.
