## Waste Audit Report

| Permit Number | WP3498FW | Ref | HWARCC0009 |
| Operator / Permit holder | JAB 93 Car Dismantlers | | |

### Section 1 Assessment Summary – Hazardous Waste

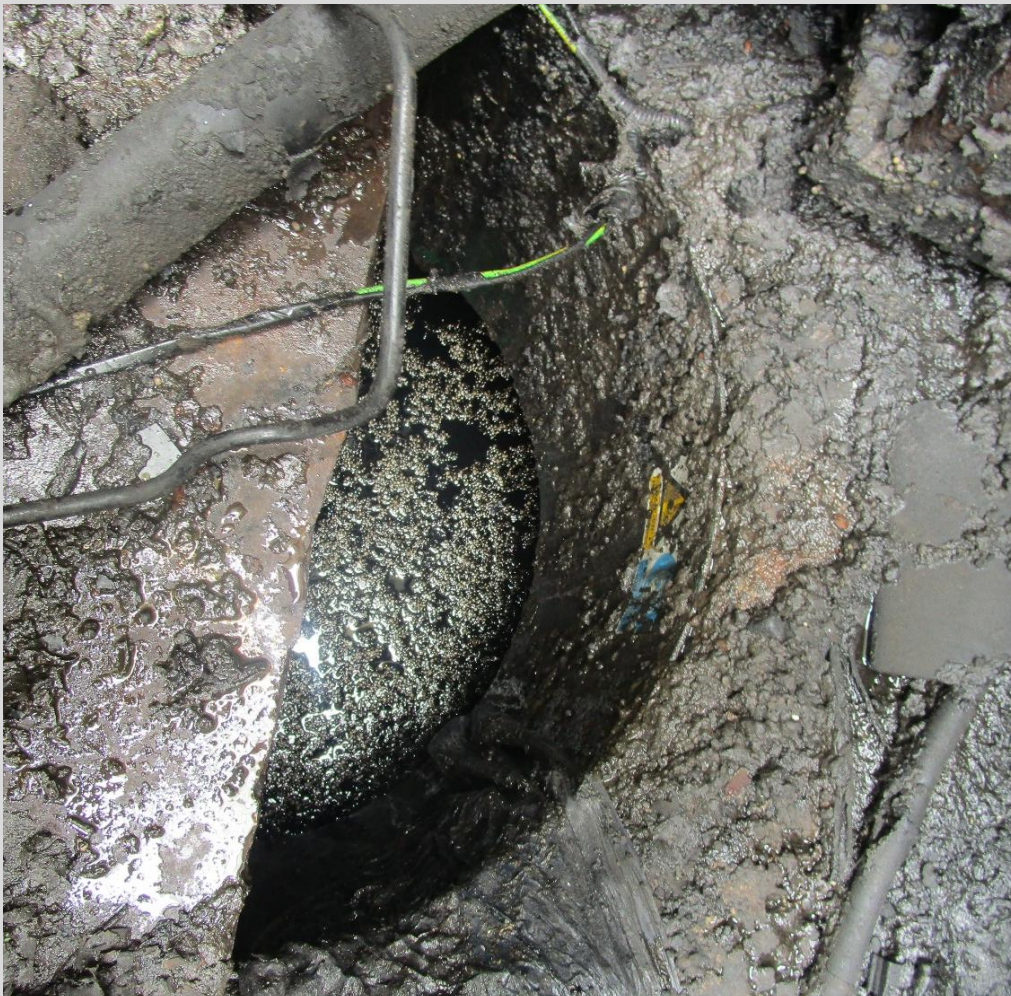
The site surface was observed to be impermeable and in generally good condition at the time of the visit. The site drainage is arranged to follow the fall of the yard from south to north, with run-off directed towards a slot drain at the site entrance. Additional drainage points within the site also feed into the interceptor system. The depollution bay includes a drain beneath the working area, and vehicles are depolluted over this drain. Drainage from the depollution bay discharges directly to the interceptor system.

Access to the chamber associated with the entrance slot drain was obstructed by a vehicle at the time of the visit. The chamber could not be inspected because the site crane operator was not available to move the vehicle. This limited NRW's ability to fully inspect this part of the drainage system during the visit, and the chamber should be made accessible and checked during a future site inspection to confirm its condition.

The interceptor system receives drainage from operational areas where ELVs are depolluted and where hazardous wastes and vehicle fluids may be present. The drainage plan provided indicates a foul line and connection to the mains sewer. Following treatment through the interceptor system, site drainage is understood to discharge to the foul sewer network. Subsequent enquiries made by NRW with Dŵr Cymru Welsh Water have confirmed that the site holds a valid consent for discharge to the foul sewer.

| <b>Non-compliance identified</b> | <b>Action Required / Advised</b> | <b>Due Date</b> |
|---|---|---|
| Access to the chamber associated with the entrance slot drain was obstructed by a vehicle and could not be inspected during the visit. | Make the entrance slot drain chamber accessible for inspection and confirm its condition. Ensure access to drainage infrastructure is maintained to allow inspection and maintenance. | Within 28 days of this report |

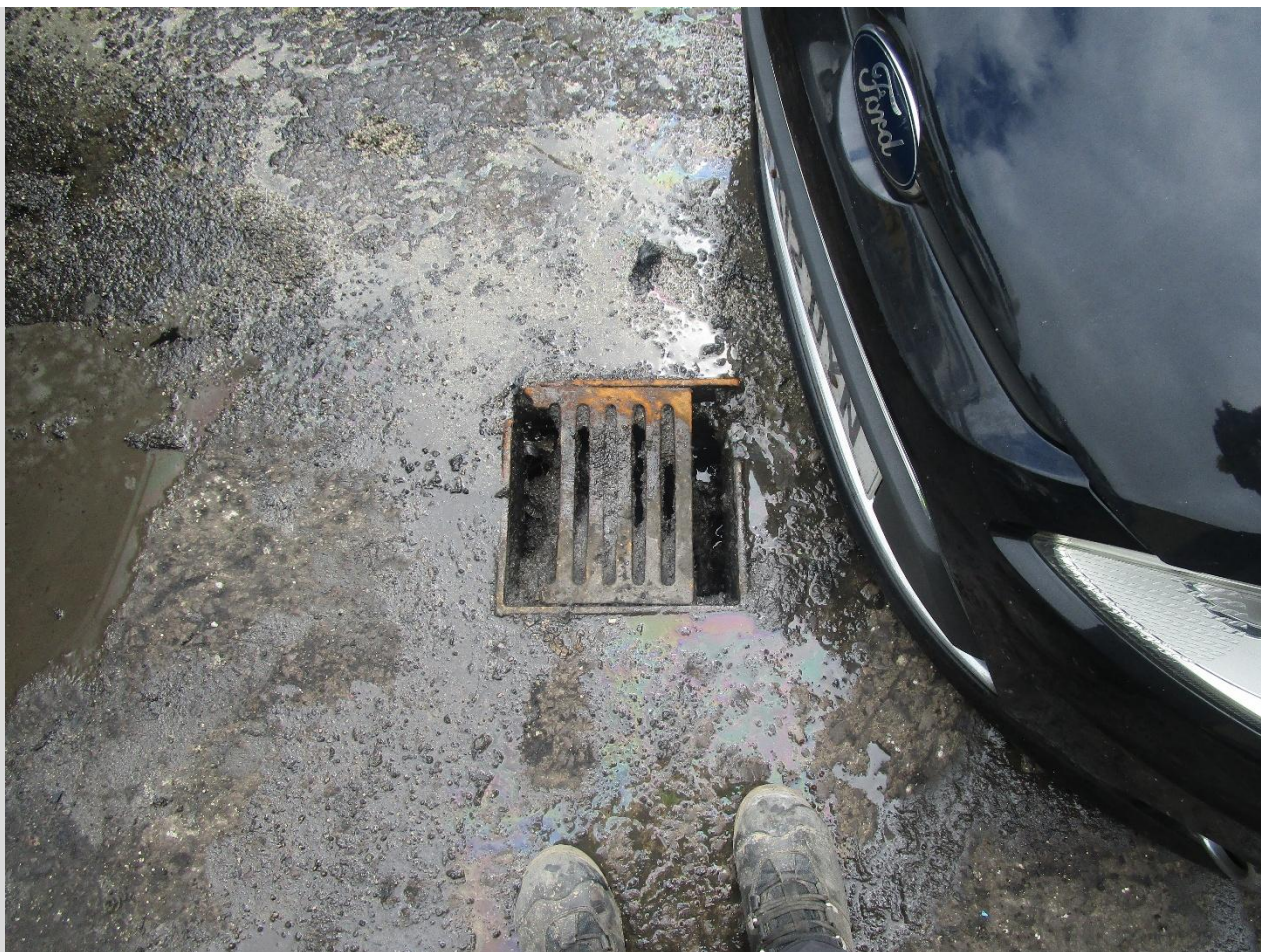
A drain above the depollution bay was observed to be blocked during the visit. The blockage appeared to consist of dirt, silt and grit bound together with oily residues. Given that this drain receives run-off from an operational area where ELV depollution takes place, material removed from the drain should be appropriately assessed, classified and consigned where required.

| <b>Non-compliance identified</b> | <b>Action Required / Advised</b> | <b>Due Date</b> |
|---|---|---|
| Drain above the depollution bay was blocked with material appearing to consist of dirt, silt, grit and oily residues. | Clear the blocked drain above the depollution bay. Any material removed from the drain must be appropriately assessed, classified and consigned where required. | Immediate |

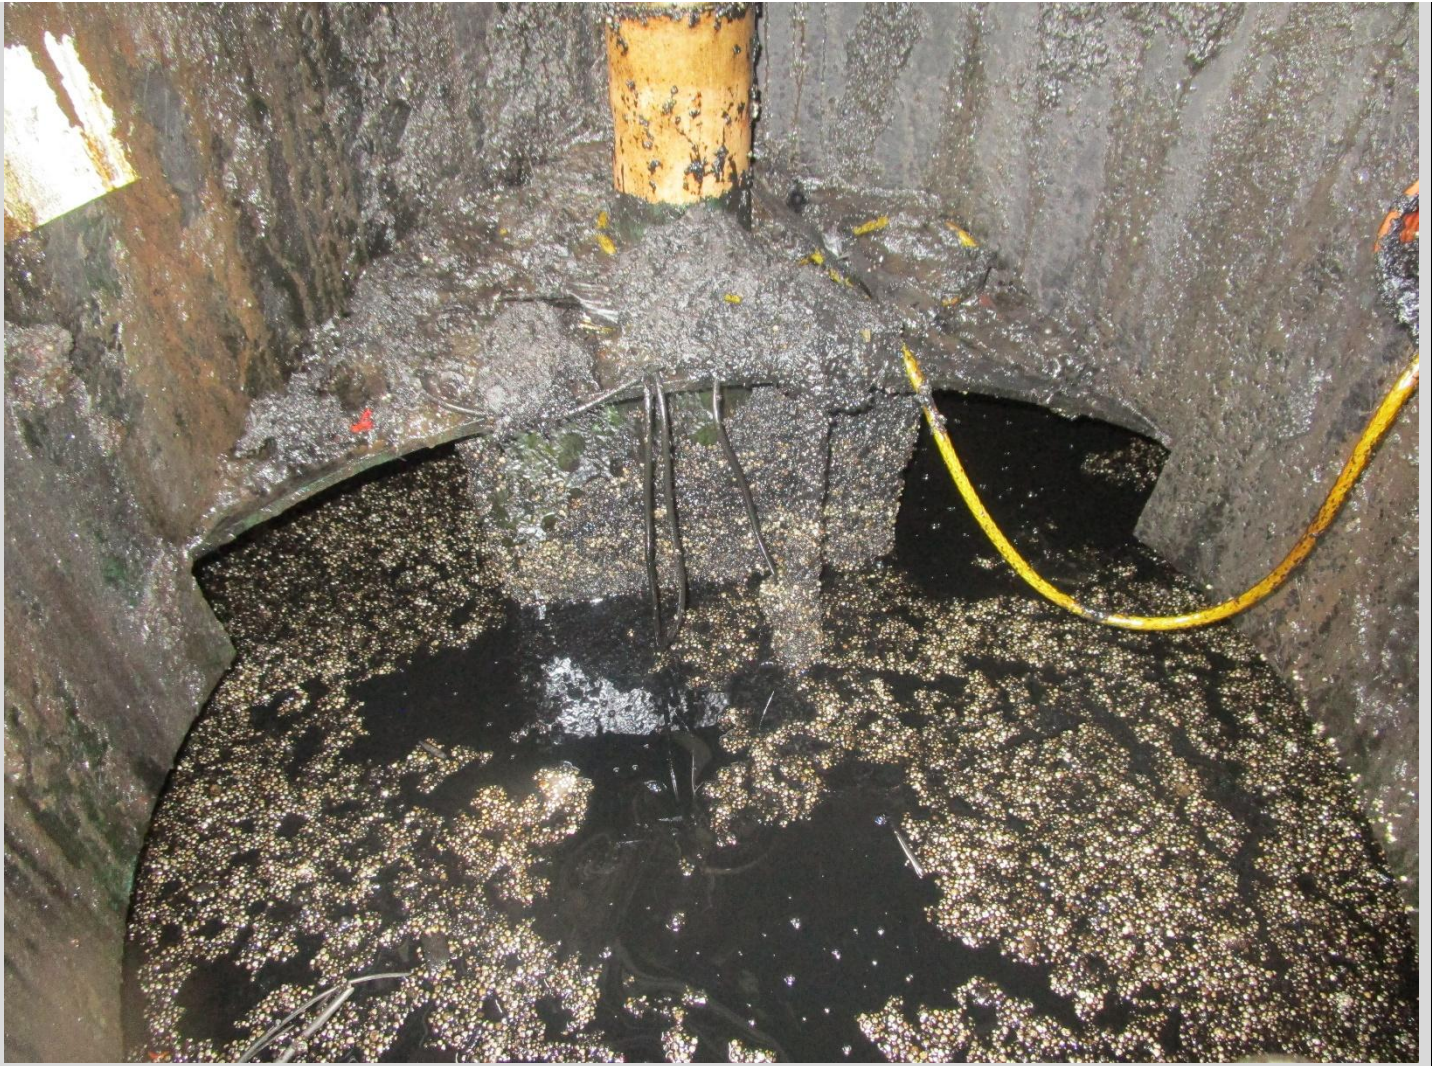
Site records were made available during the visit and were generally well kept and organised. Documents requested by NRW officers were readily accessible. Waste returns were available on request and appeared to be in good order. Training records were not checked as part of this assessment. The site maintained a stock of replacement filters for the interceptor system. The technical information provided identifies the interceptor as a SPEL Purceptor Class 1 full-retention separator, incorporating a coalescer unit and automatic closure device. The manufacturer's information states that periodic emptying of retained light liquids and sludge is essential to maintain optimum performance, with maintenance frequency dependent on site conditions.
