## Compliance Assessment Report CAR\_NRW0052058

**Permit being assessed:** AB3196HG

**For:** Trehir Former Landfill Site, **held by:** Caerphilly County Borough Council

**Parts of permit assessed:** Site infrastructure

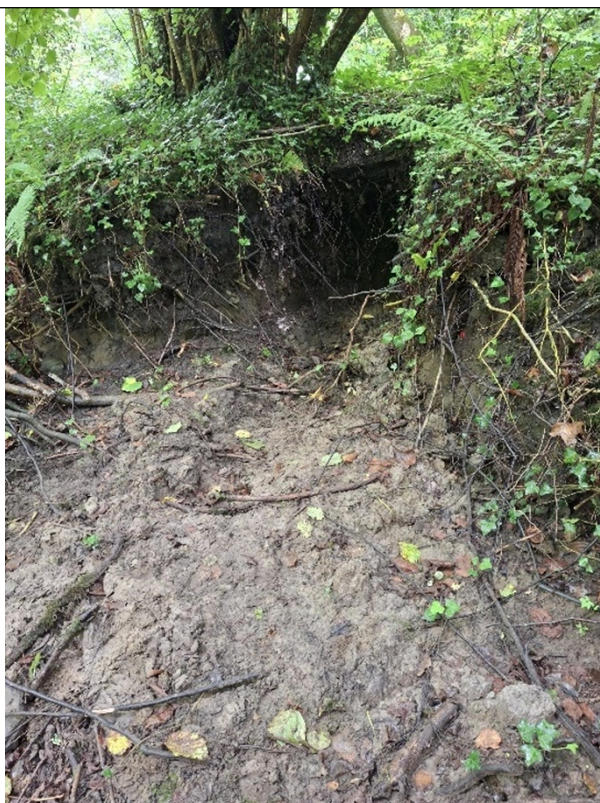
Beginning by checking the access to the sample point it was found to be accessible and at the correct listed point. CCBC have previously undertaken works to improve and maintain access to the sample point due to previous access issues. While access was good, there was no discharge from this point at the time of the visit and no outlet pipe could be identified despite probing the eroded void with a branch. As such it was concluded that there has not been any discharges from this point for a significant period of time. These observations can be seen in Figure 1. Please note, the photo in Figure 1 is from a previous compliance visit but is an accurate depiction of the conditions observed during this visit.

Figure 1 – The conditions of the sample/discharge point similar to that observed during the visit.

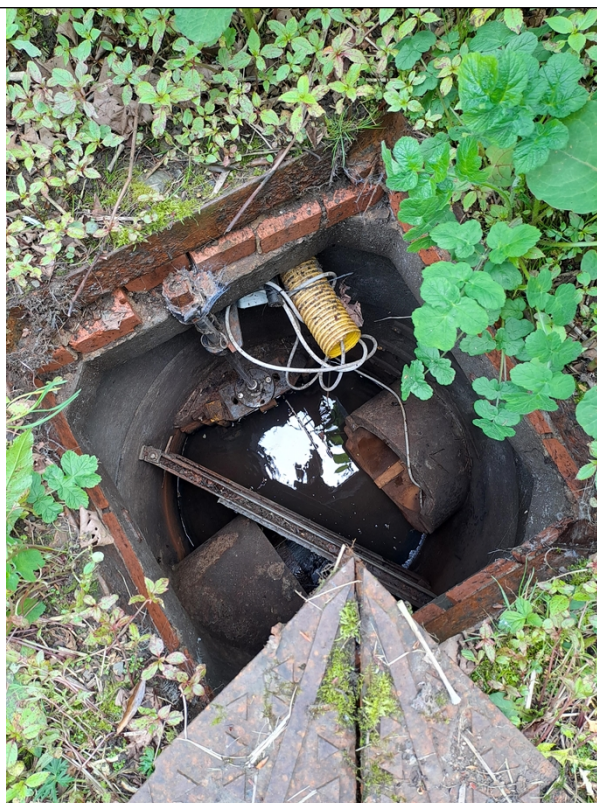
On arrival at the flow monitoring point near ST1517589747 several chambers were identified around the telemetry box. The first chamber was lifted and found to contain input from an upstream line (which is assumed to be the site drainage), an outlet pipe (where no discharge was leaving the chamber), a sensor to monitor flow as well as a penstock which NC described as an emergency overflow which opens during heavy flows to allow the discharge to enter the foul drainage network to alleviate pressure on the consented discharge line. As noted, there was no flow entering the outlet pipe despite there being a constant input, indicating that the discharge was escaping this chamber somewhere rather than using the consented discharge point. These observations can be seen in Figure 2.

Figure 2 – Chamber lifted where site drainage was observed entering but not leaving during the visit.

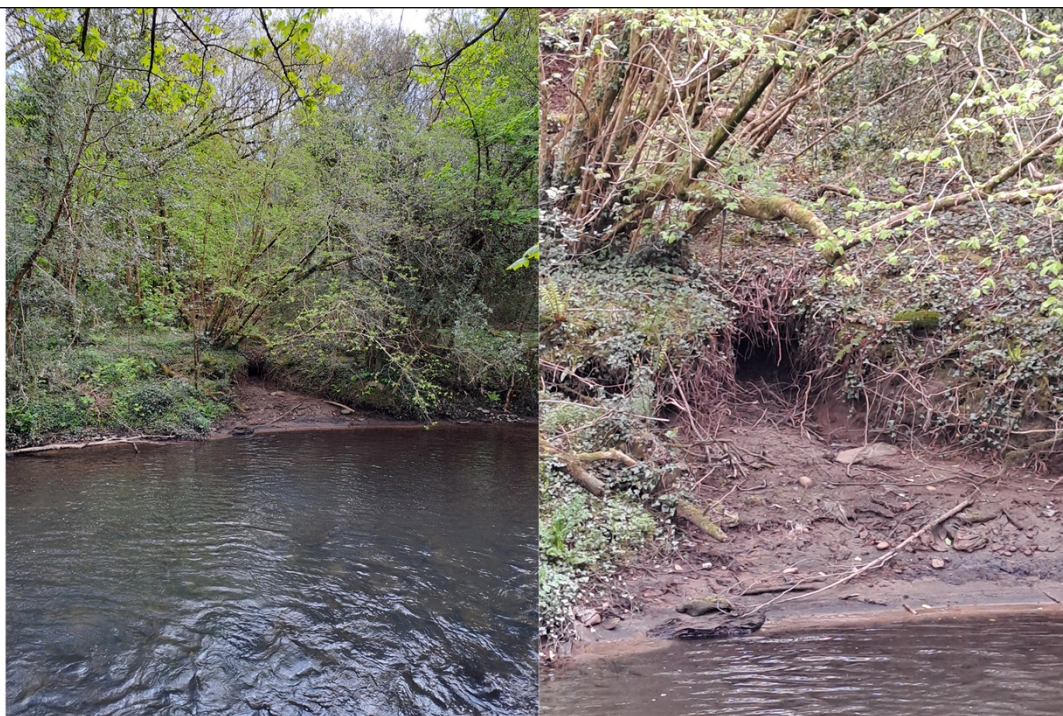
I decided to dye trace this chamber to see where the water was discharging. This was undertaken at 12:19 using green dye. On returning to an observation point where the permitted discharge point could clearly be seen it was confirmed that no dye was seen at any location along the section of river upstream or downstream of this point. This can be seen in Figure 3.

Figure 3 – Conditions on the river after undertaking the initial dye tracing during the visit.

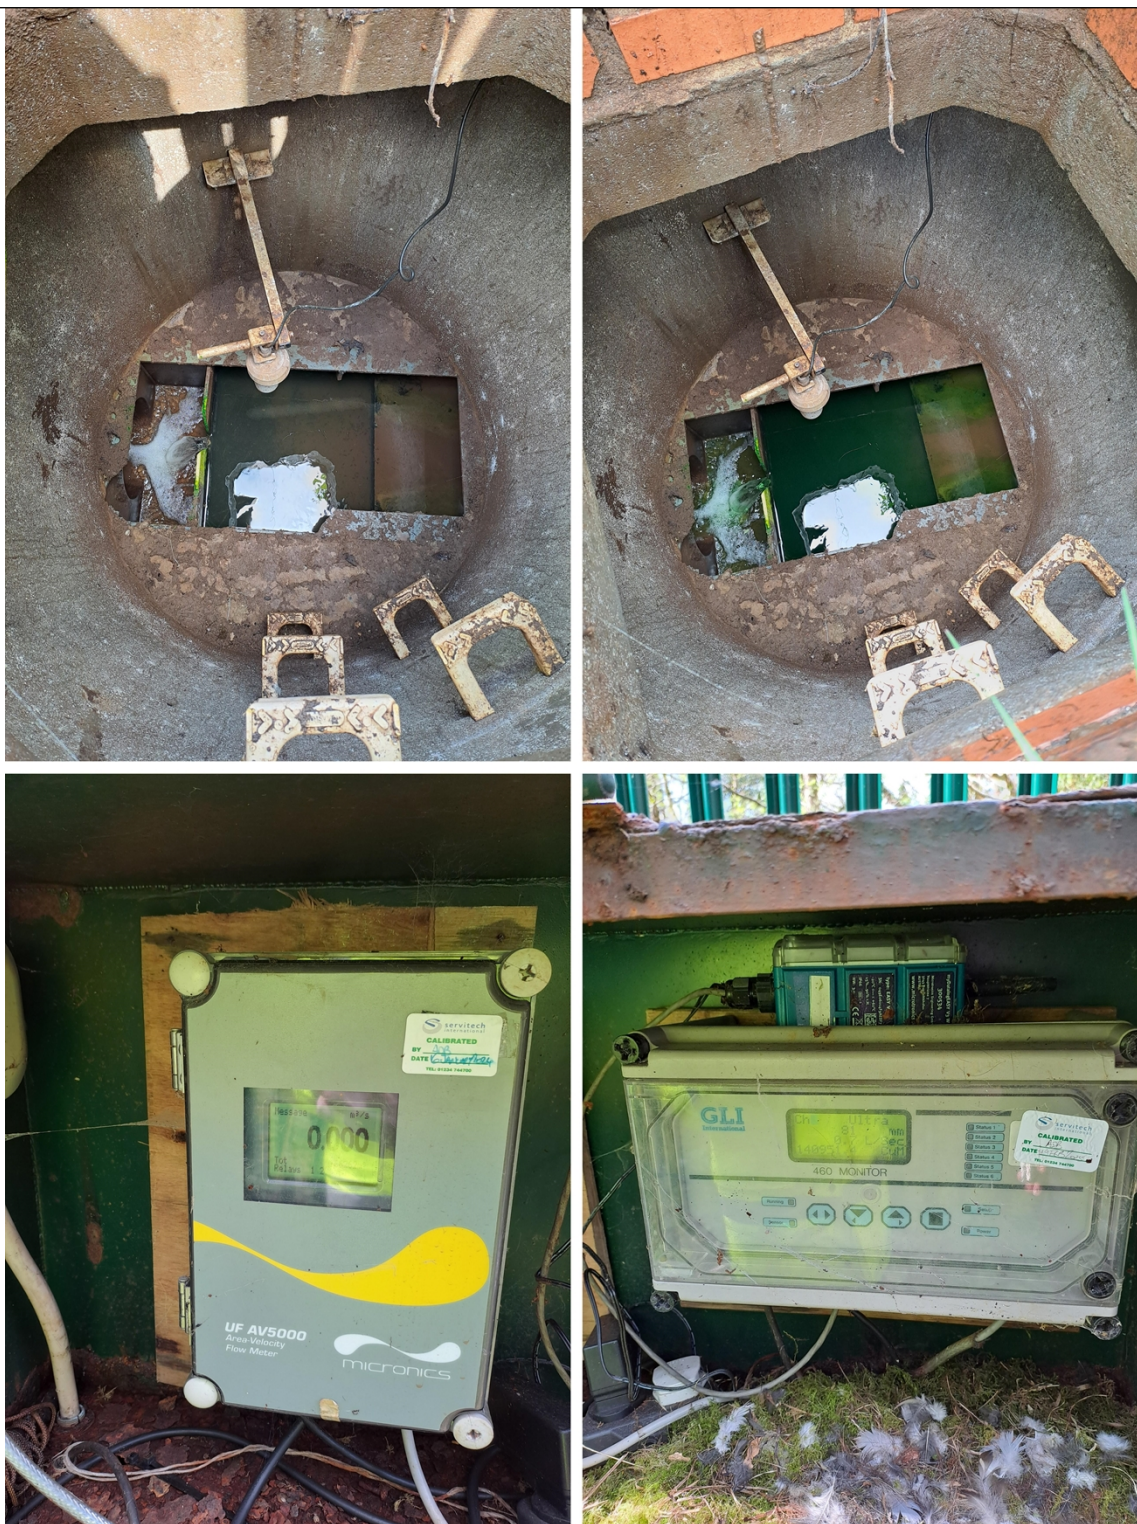
On lifting the chamber known to be the overflow channel to the DCWW foul network, a significant volume of water was observed to be discharging to the foul network via a V-notch. Additionally, a small amount of green dye was seen on the V-notch, indicating the previously dyed water in the prior chamber was making its way into the foul line. On re-dyeing the first chamber green dye was clearly seen entering the foul line, providing the necessary evidence that the site drainage was discharging completely to the foul line at the time of the visit. This was confirmed when checking the telemetry for each sensor with the site drainage showing a discharge of  $0\text{m}^3/\text{s}$  and the DCWW overflow showing a discharge of  $0.7\text{l/s}$ . At the time of the visit it was assumed that the penstock which controls flows to the overflow has somehow become stuck open, allowing all site drainage to discharge via the foul line. These observations are evidenced in Figure 4.

Figure 4 – Evidence to support that site drainage is discharging to the DCWW foul network and not via the permitted point.

From top to bottom, left to right: Initial observations of the overflow channel, the overflow channel after re-dyeing the discharge chamber, telemetry readout for the site drainage line, telemetry readout for the overflow to the foul line.

The site drainage was clearly seen discharging via the overflow channel (which in turn discharges to the foul network), bypassing the permitted site drainage and the permitted discharge point (located at ST1507089747).

On discussing this with NC and JT they agreed with my observations and conclusions. As such, my recommendation is that the drainage infrastructure around the flow monitoring point, specifically the operation of the overflow penstock, be reviewed by CCBC and maintenance undertaken to restore it to the correct operating conditions. DCWW should also be contacted to assess their infrastructure and carry out necessary works to rectify any issues found. This is reflected in the actions list below.

1. Investigate all CCBC infrastructure related to the management of site drainage and identify the issues which are preventing the drainage system from operating as designed.

3. Undertake repairs on all identified issues (both CCBC and DCWW assets) and bring the system back into operating order as designed. Evidence should be provided of all work once completed.

4. Return the site drainage to its permitted discharge point on the Afon Rhymni.
