## Event Duration Monitoring

## Trigger Exceedance Notification

Report type: Stage 2: Full Investigation Proposal

Location: Gowerton WwTW

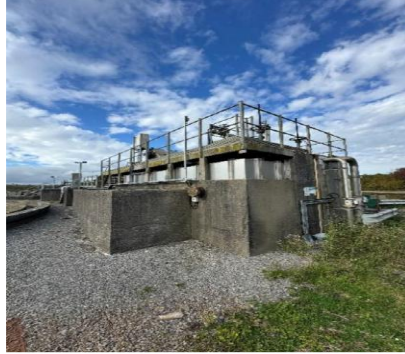
*Figure 4: Gowerton Headworks Splitter chamber.*

Flows in excess of the 912l/s flow to treatment figure, and up to >2,285l/s, arriving through the inlet by gravity is further split where the excess storm flow volume passes over a secondary weir which is where EDMS is monitored by an ultrasonic instrument and a secondary probe instrument.

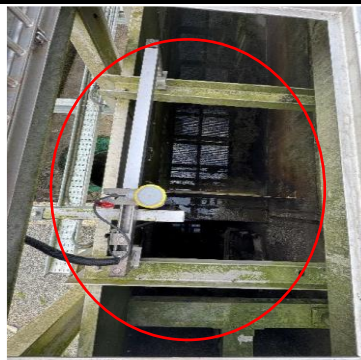
*Figure 5: EDMS Monitoring to Storm Storage Tank Split.*

Storm flow to the storm storage tanks is triggered at this point through telemetry and via the sites outstation (Telemetry ID. 2E123785, Spill to Storm Tanks (EDMS) @ 100%).

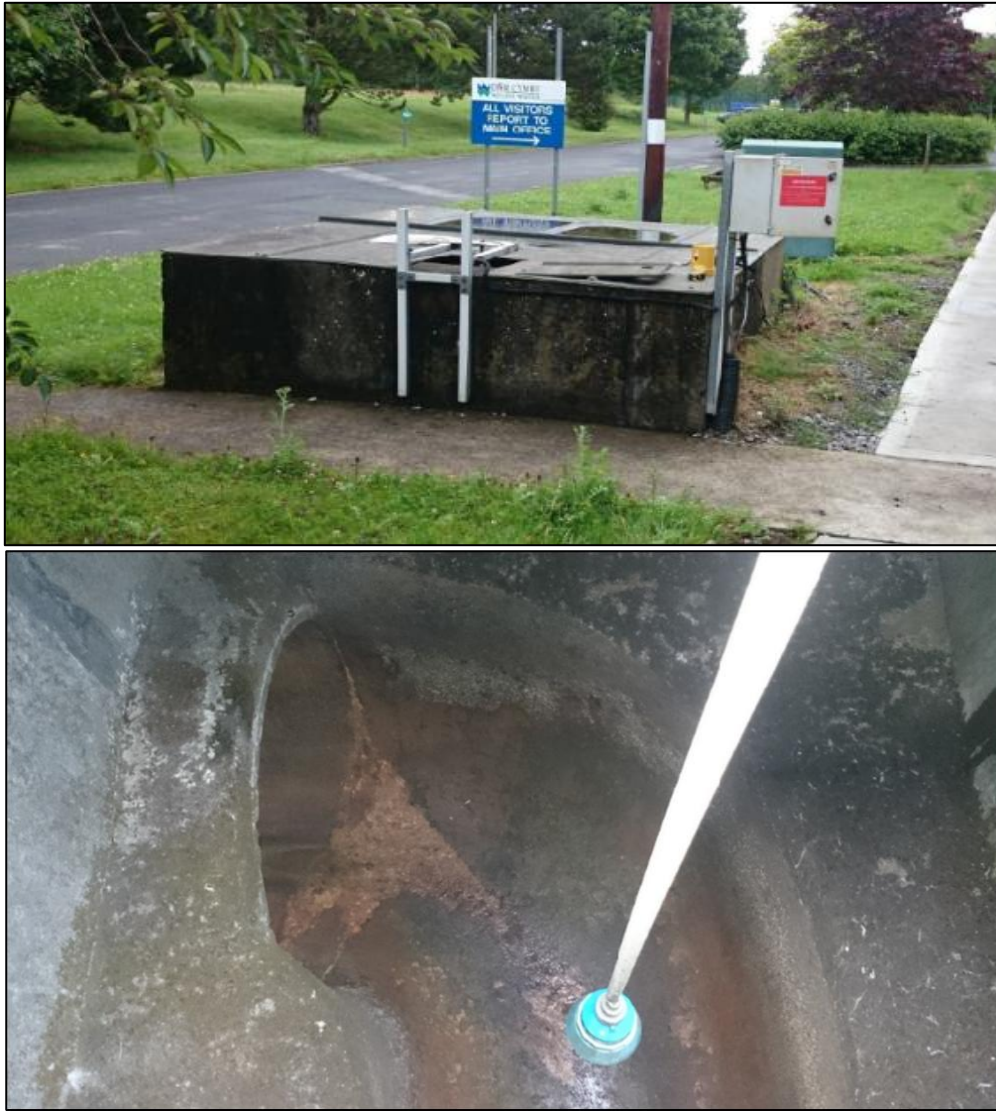
*Figure 6: EDME Monitoring Chamber for Settled and Screened Discharge.*

EDME discharges are monitored using a level control instrument in the storm outlet single pipe discharge chamber, storm flow triggered through telemetry and via the sites outstation (Telemetry ID. 2E23779, 0703 Multi Scenario Derived Spill @ 100%).
