## Compliance Assessment Report CAR\_NRW0052132

**Permit being assessed:** NP3894FK.

**For:** Point Of Ayr Treatment Facility, **held by:** Delyn Metals Ltd

**Type of assessment:** Site Inspection,

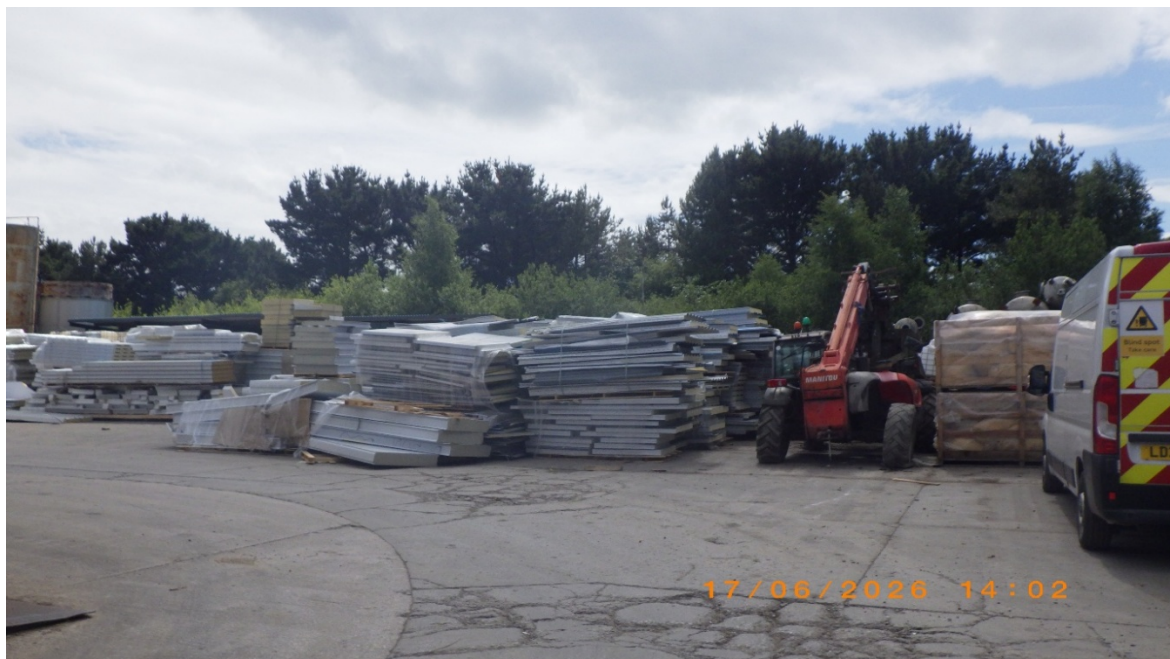
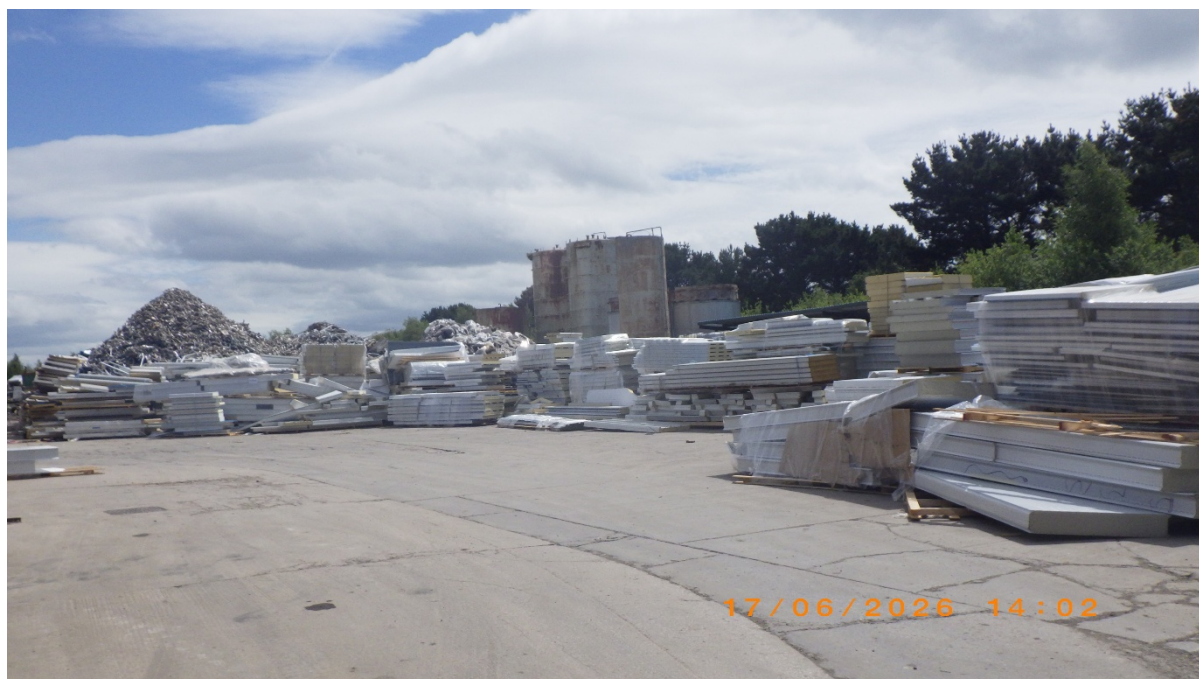
The area at the back of the site office is shown as an ELV process area, on the original site plan, and as a quarantine area, in the updated site plan submitted to NRW.

During this site inspection this entire area was still being used for storage of the panels. Please see the photos below.

### Waste panels in the quarantine area

Waste panels in the quarantine area completely blocking access to the storage areas at the back, including batteries and WEEE storage.

This is a breach of the afore-mentioned permit condition and has been scored as a **C3** non-compliance that has been consolidated with others in the criteria. This has been logged as 'action only' in the results table above as it has been consolidated with the higher CCS score, and there are separate dates for compliance with this breach and others in this criteria

Action: Please ensure that the area is compliant with the site EMS. **For compliance by 31st August 2026**

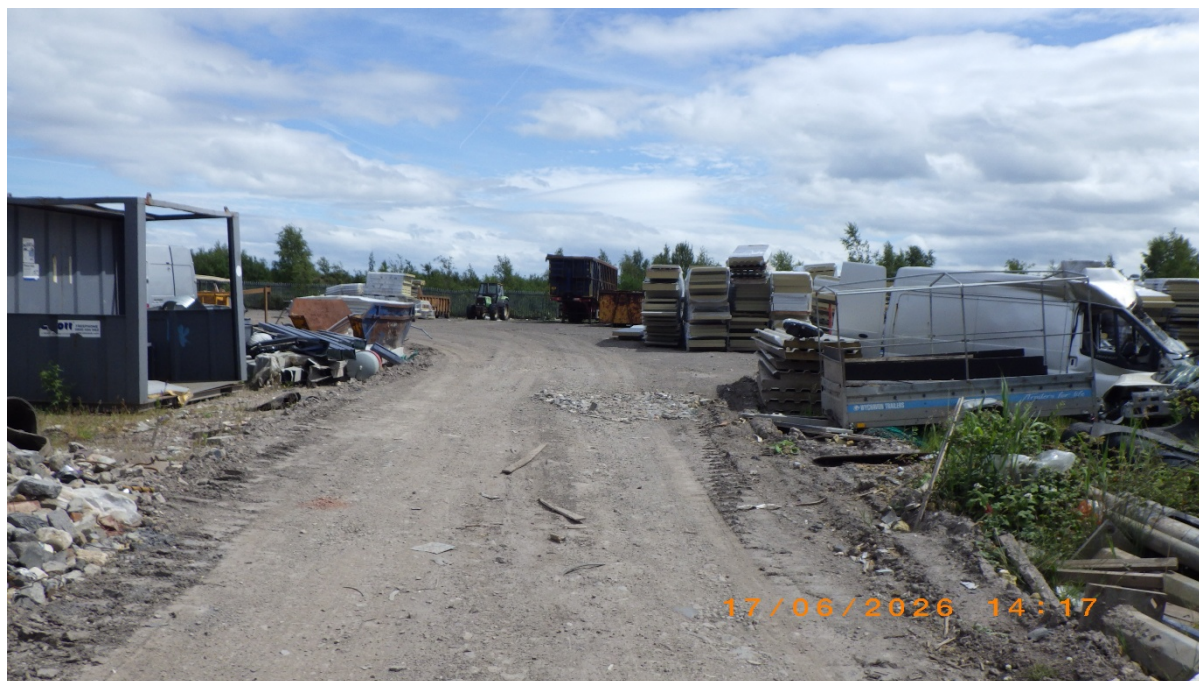
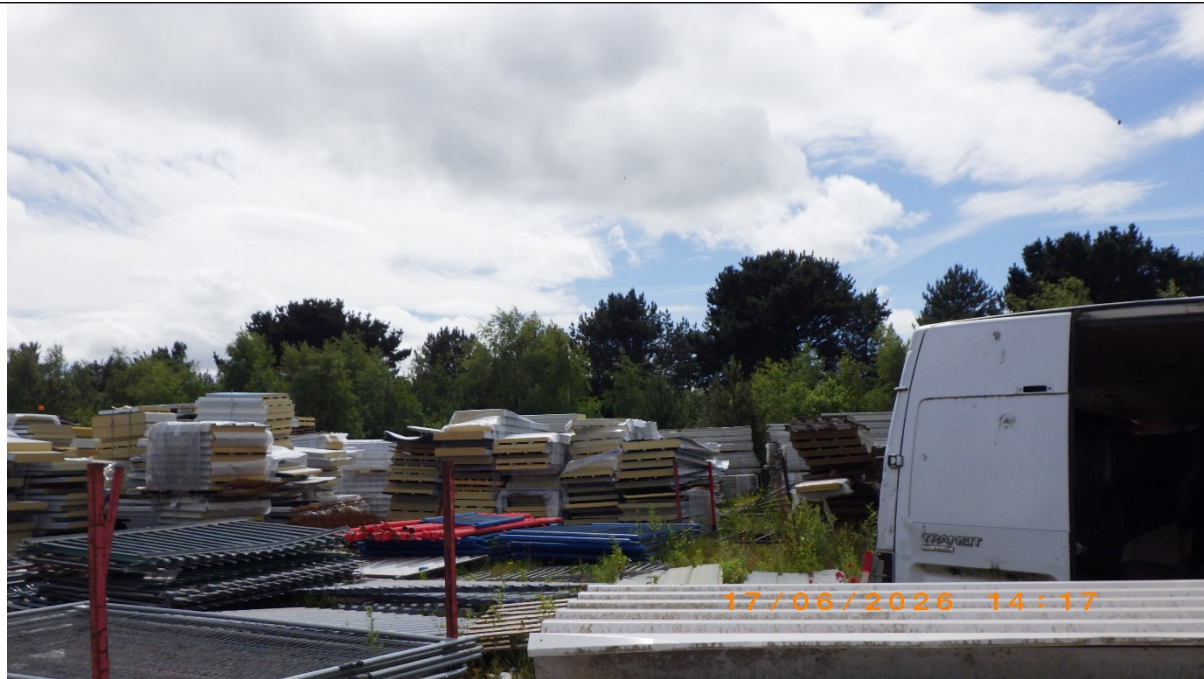
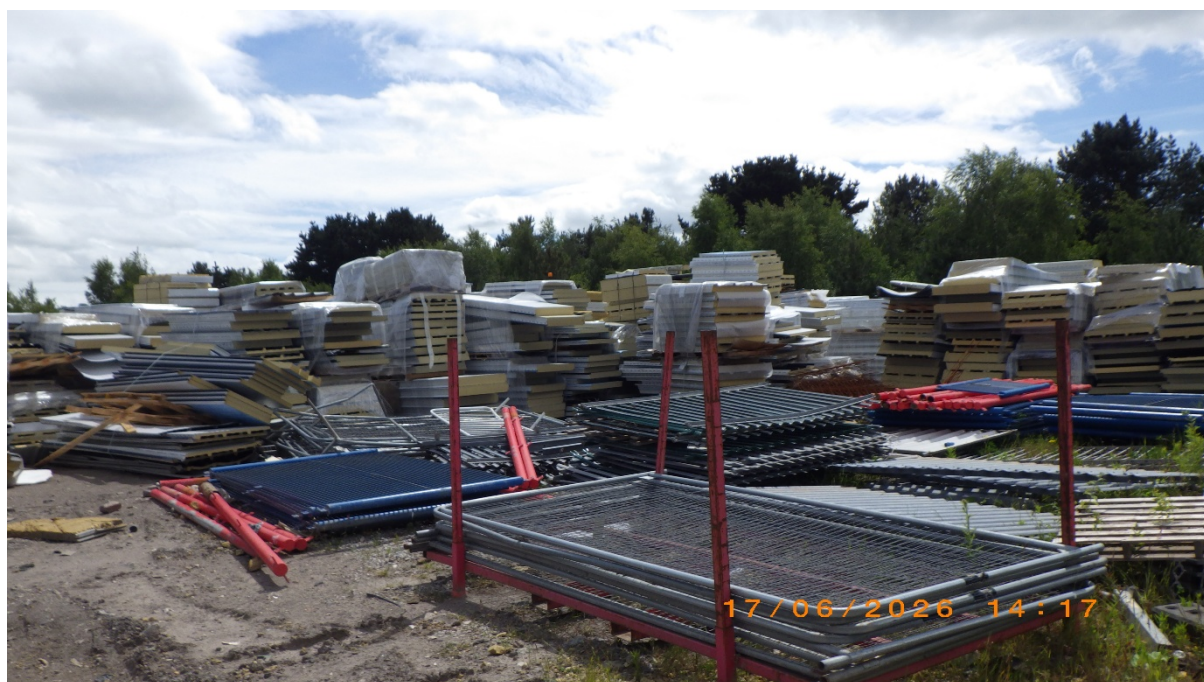
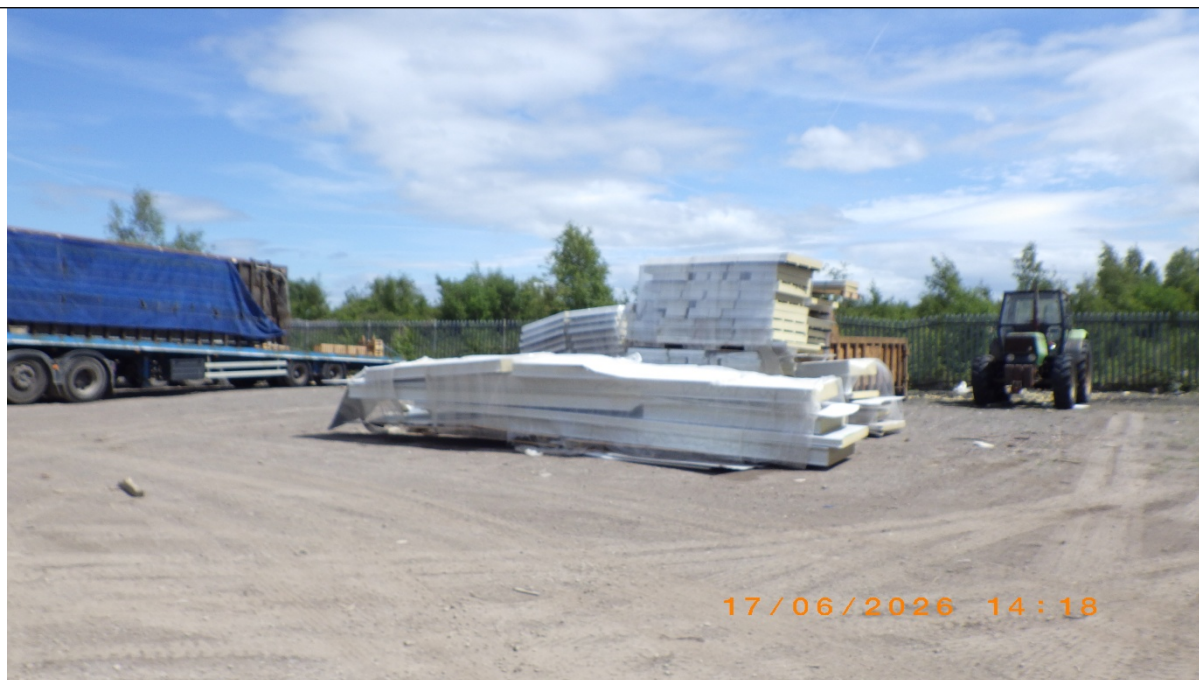
Panels stored at the back of the site

This area is not marked as a storage for panels on both, the original and the updated site plan.

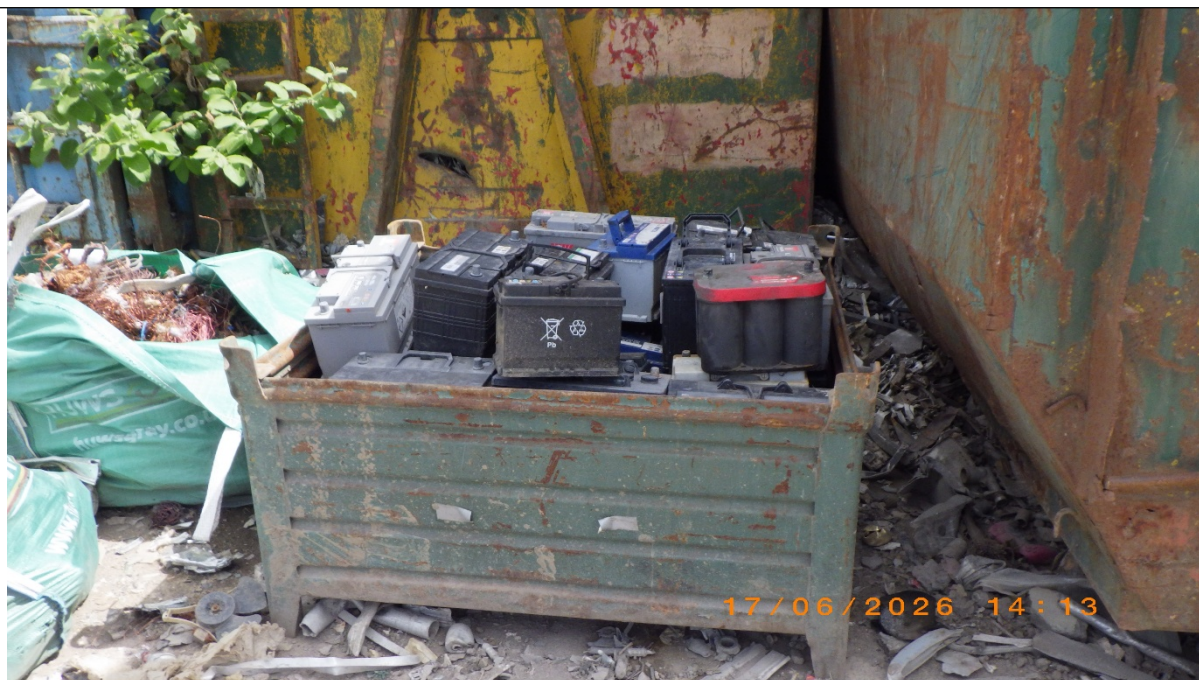
The designated storage area could not be checked by officers due to blocked access. However, officers saw a box containing batteries next to storage skips .

The container was kept outside with no weatherproof cover

Batteries stored in unsuitable metals containers with no cover

**Table 4.4 b) v)** states: "Lead acid batteries shall be stored in containers with impermeable, acid resistant base and a lid to prevent ingress of surface water".

This is a breach of the afore-mentioned permit condition and has been scored as a **C3** non-compliance that has been consolidated with others in the criteria. This has been logged as 'action only' in the results table above as it has been consolidated with the higher CCS score, and there are separate dates for compliance with this breach and others in this criteria

Action: Please ensure the storage of batteries is compliant with the site permit. **For compliance by 31st August 2026**

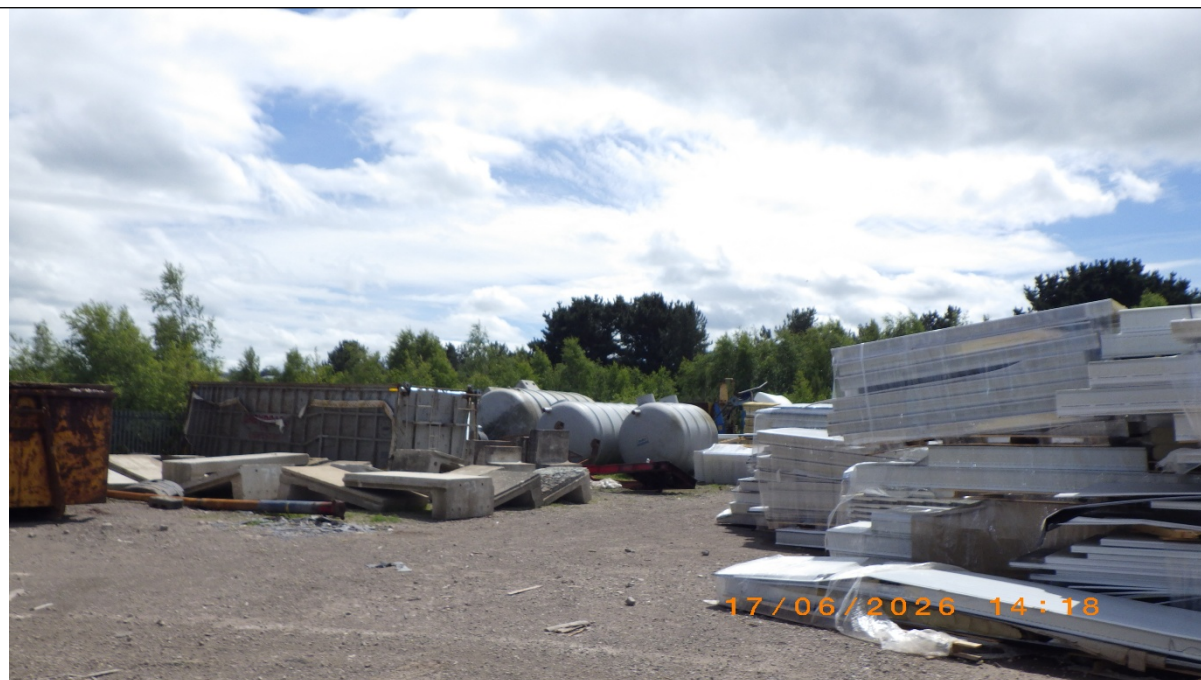
Oversized metal waste seen stored at the back of the site, which is not marked as storage areas on the original and updated site plan.

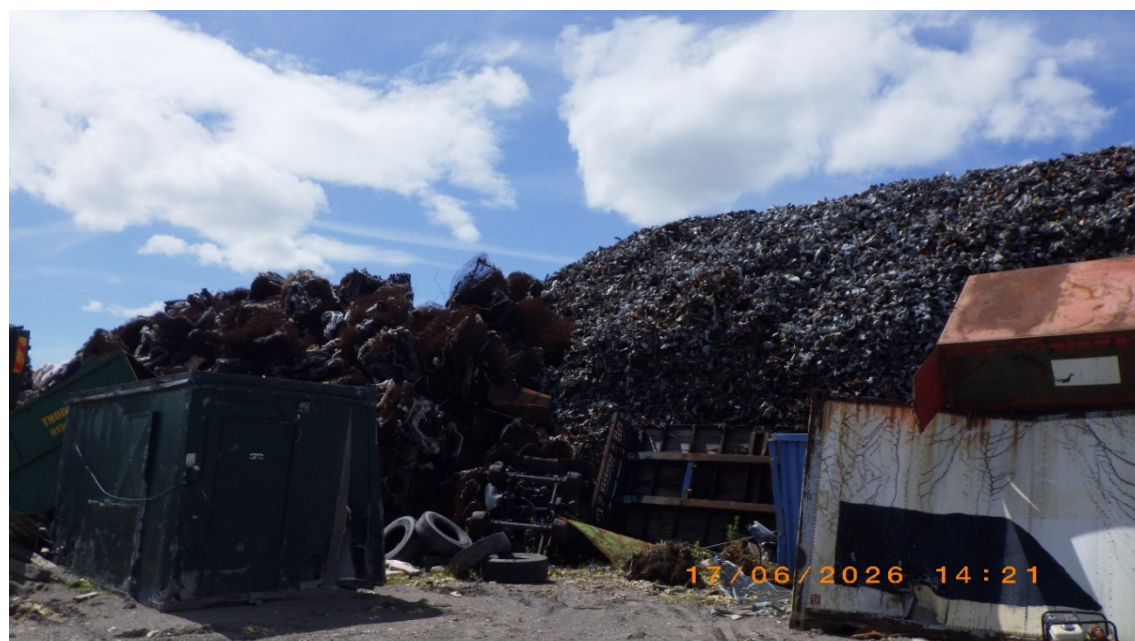
The storage of tyres on site remains non-compliant. This issue was raised during previous inspections.

Tyres stored on permeable ground

Once removed from vehicles, these waste types shall be stored **in separately designated areas** provided with an **impermeable pavement and sealed drainage** in accordance with condition 2.1

This is a breach of the afore-mentioned permit condition and has been scored as a **C3** non-compliance that has been consolidated with others in the criteria. This has been logged as 'action only' in the results table above as it has been consolidated with the higher CCS score, and there are separate dates for compliance with this breach and others in this criteria

Action: Please ensure the storage of waste tyres is compliant with the site permit. **For compliance by 31st August 2026**

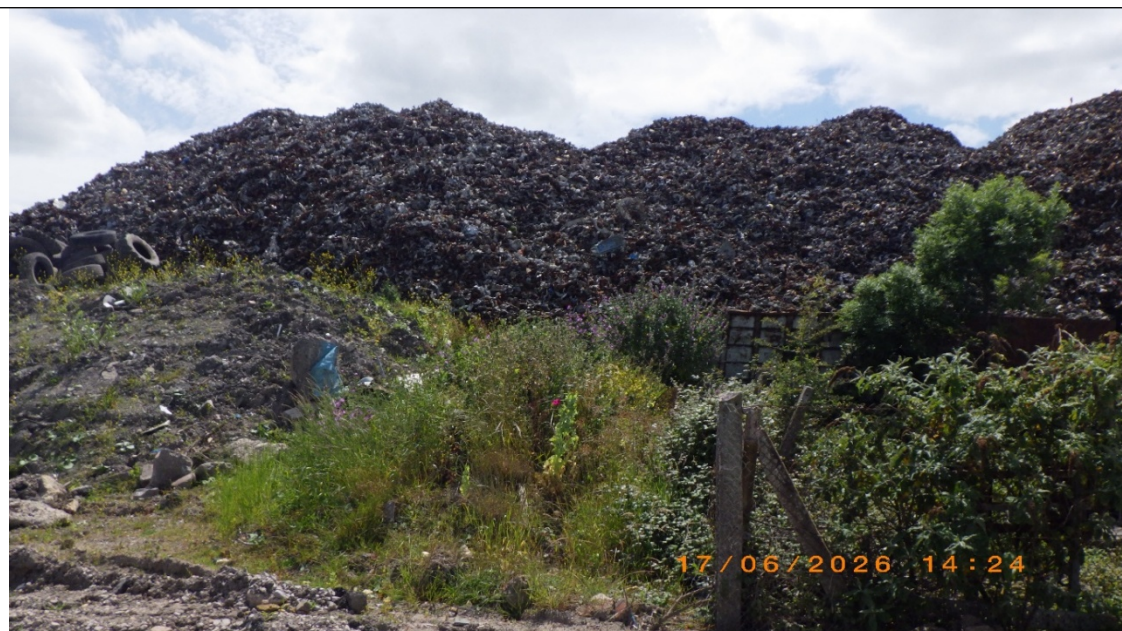
Tyres stored next to shredded metal on permeable ground

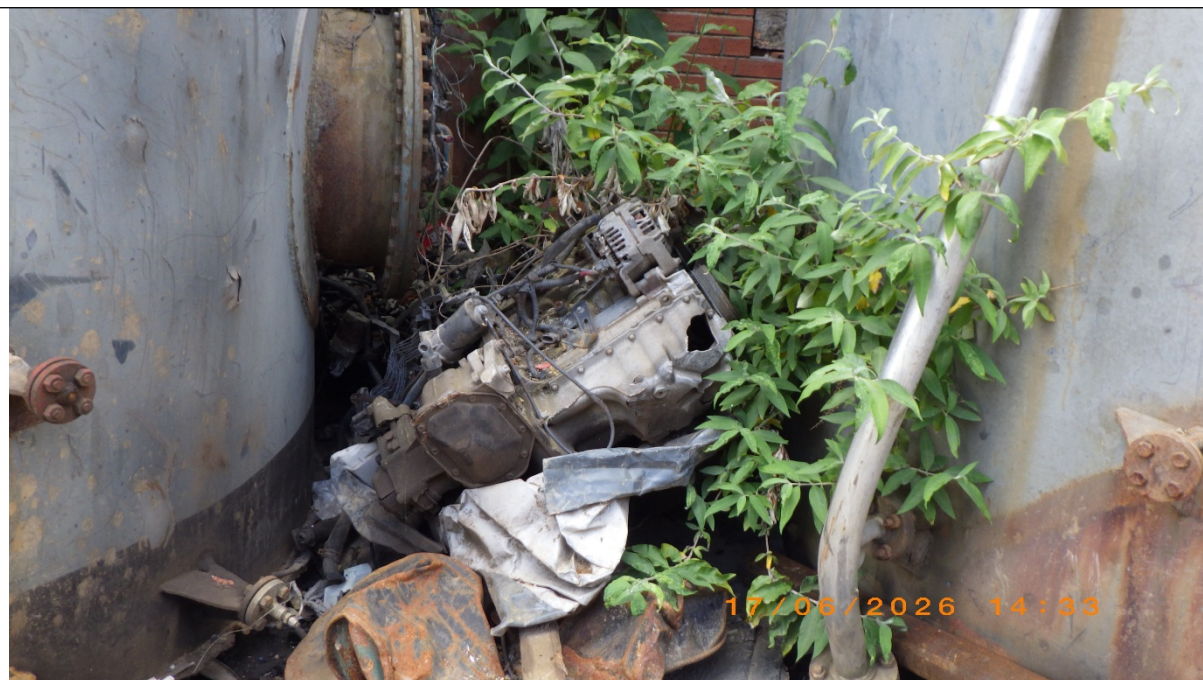
Oily parts next to the designated container

**Table 4.4 (b)** states that oil contaminated parts are to be stored within dedicated appropriate containers which are fit for purpose. The containers are to be clearly and unambiguously labelled regarding their content.

This is a breach of the afore-mentioned permit condition and has been scored as a **C3** non-compliance that has been consolidated with others in the criteria. This has been logged as 'action only' in the results table above as it has been consolidated with the higher CCS score, and there are separate dates for compliance with this breach and others in this criteria

Action: Please ensure a weatherproof cover is available to ensure the storage of oily parts is compliant with the permit conditions. Please comply by the **31<sup>st</sup> of August 2026**.

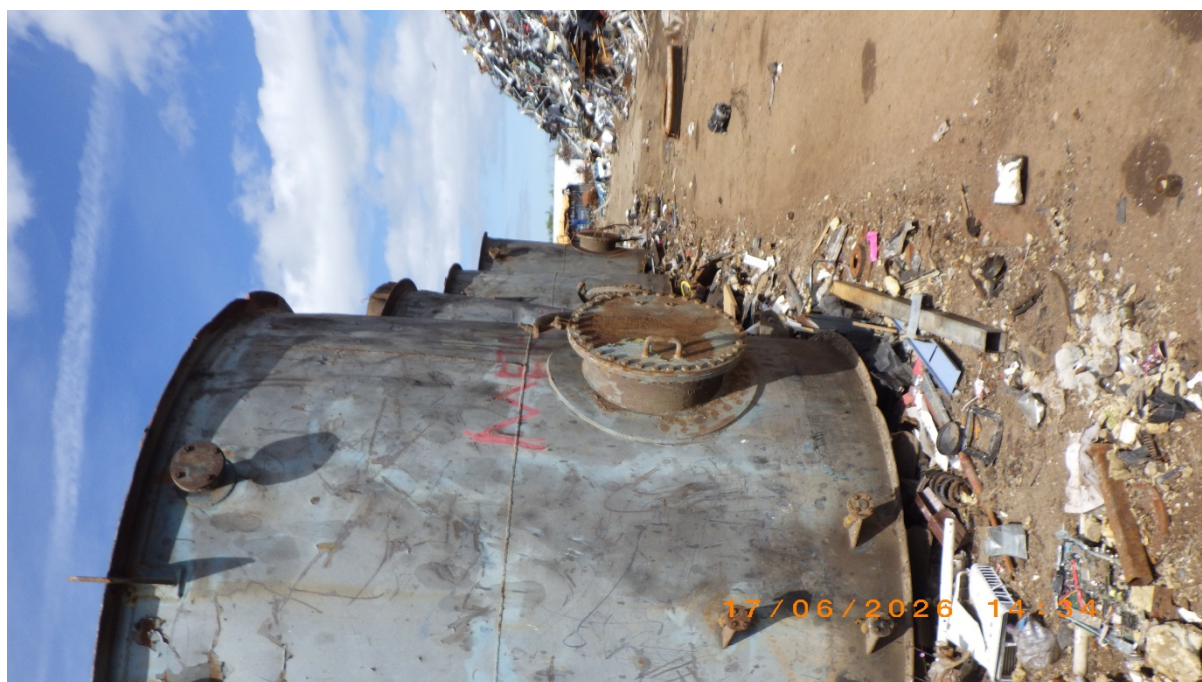
Designated containers for oil parts with no weatherproof cover

The majority of oily part seen during the inspection were seen in upright metal containers. The containers were not weatherproof and did not have a cover. This has been raised with the manager during this and previous inspections.

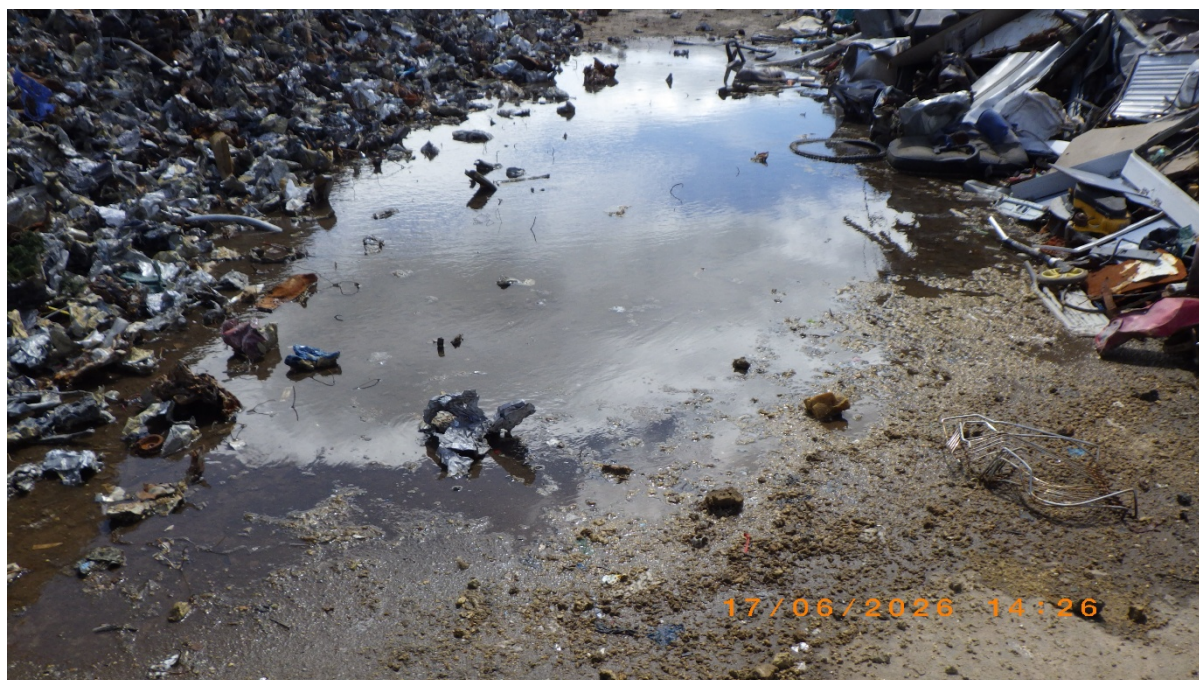
During this site inspection it transpired that the surfaces remain uneven, cracked and filled with standing water after rainfall. This is potential pathway for pollution from the waste stored on site. There was visible oily film on top of the standing water.

Water pooling next to waste piles

This is a breach of the afore-mentioned permit condition and has been scored as a **C3** non-compliance that has been consolidated with others in the criteria. This has been logged as 'action only' in the results table above as it has been consolidated with the higher CCS score, and there are separate dates for compliance with this breach and others in this criteria

Action: Please ensure all surfaces are maintained, kept in good condition and in compliance with the site permit. Please comply by the **30<sup>th</sup> October 2026**. This has a longer date for compliance due to there being a potential for larger amount of work to be carried out to gain compliance.

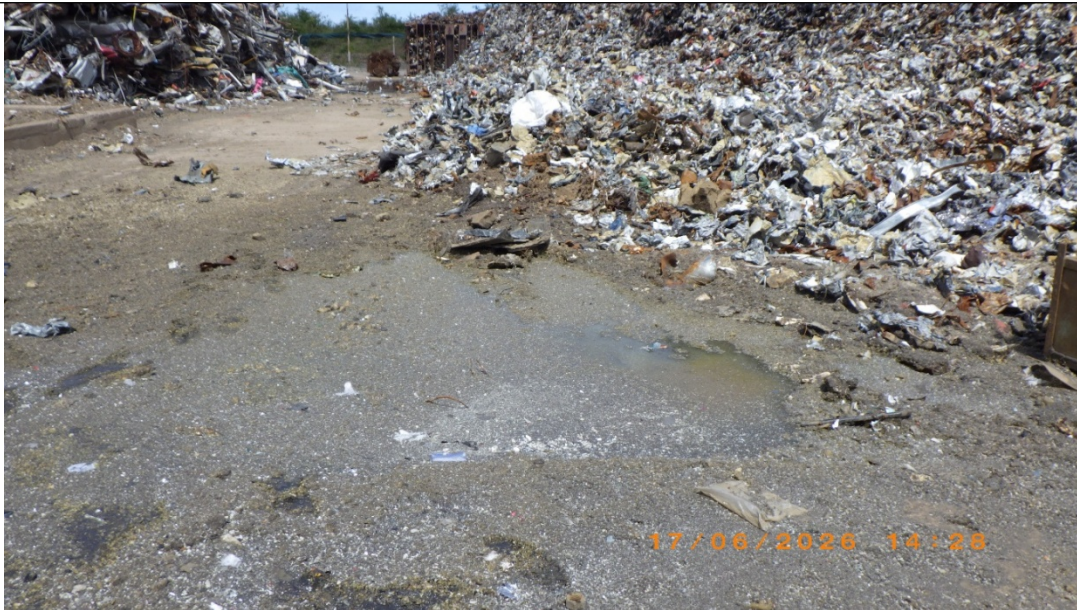
Water pooling with thick surface layer of dirt and shredded waste

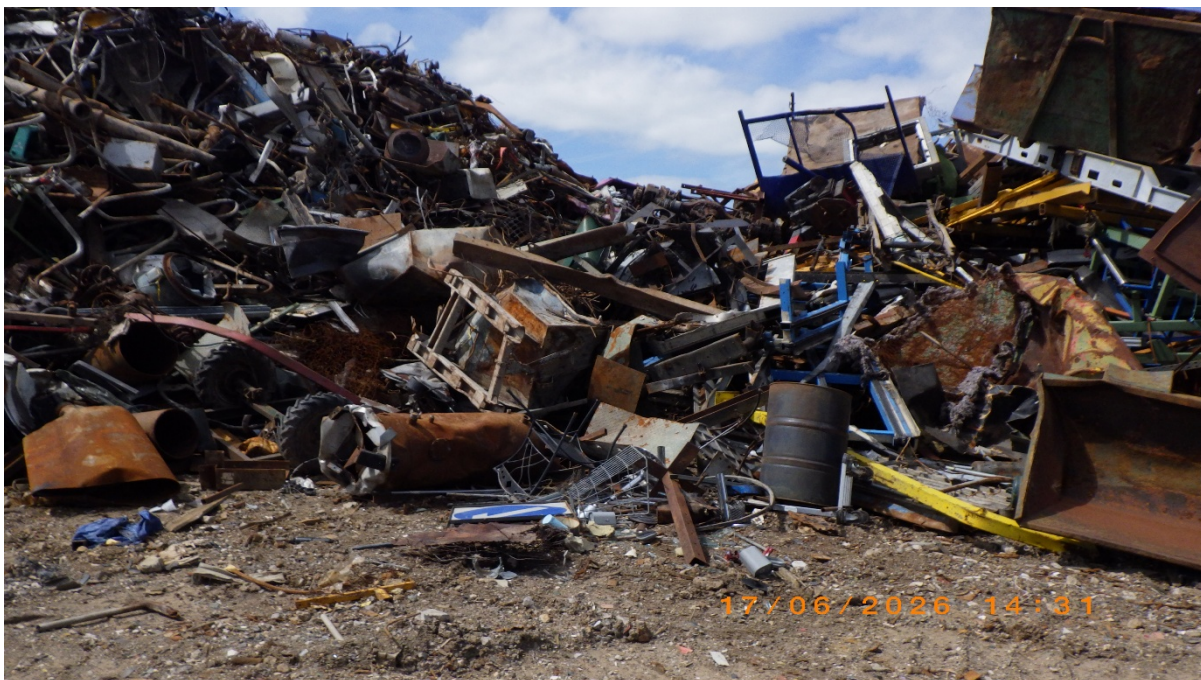
Waste stored on permeable ground

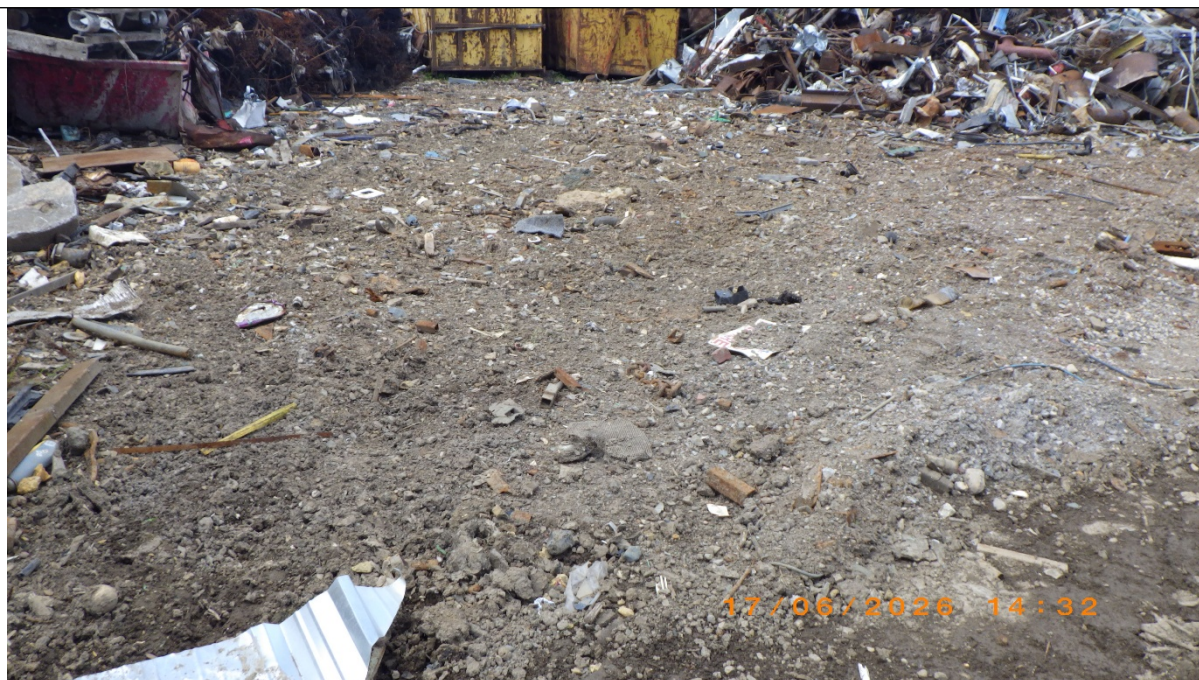
Permeable surface the waste is being stored on

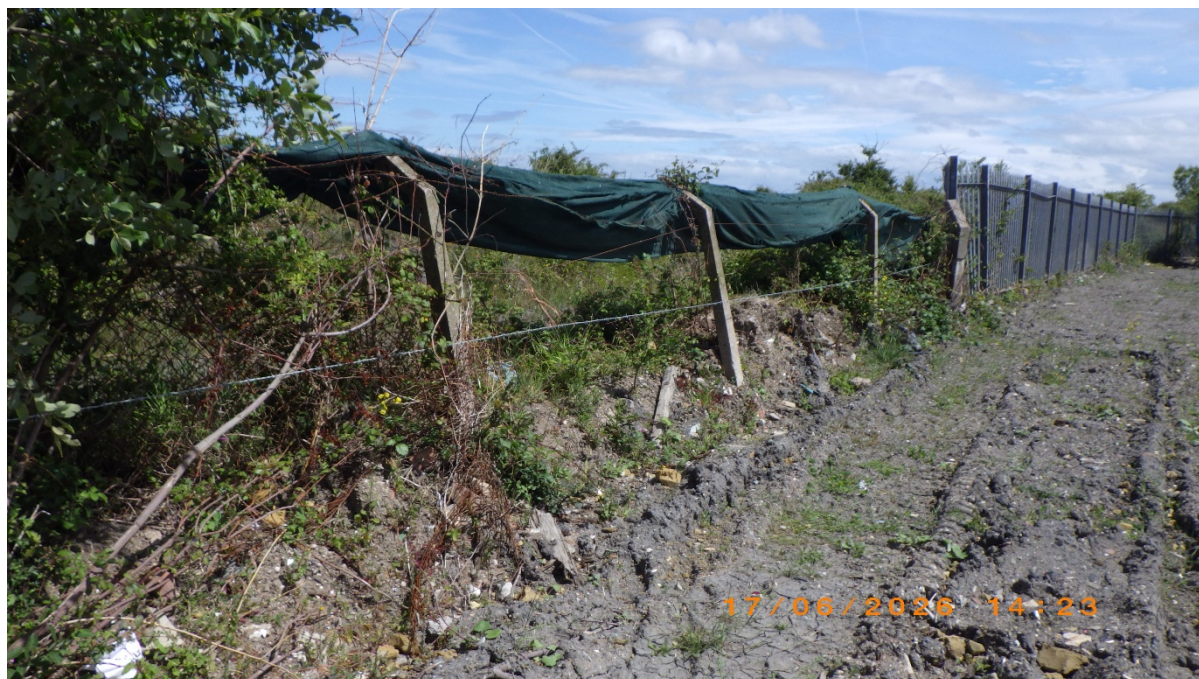
Parts of the site fence does not provide appropriate level of security.

In December 2025 a bund was removed from site but the fence has not been made secure. Please see the photo below.

Maintenance standards: “ The site security shall be fully inspected at the commencement of each working day. Any defects or damage shall be made secure by temporary repair by the end of a working day, and shall be repaired within 7 working days of the damage being detected (...)”

This is a breach of the afore-mentioned permit condition and has been scored as a **C3** non-compliance that has been consolidated with others in the criteria. This has been logged as 'action only' in the results table above as it has been consolidated with the higher CCS score, and there are separate dates for compliance with this breach and others in this criteria

Action: Please ensure the site is fully secure by the **10<sup>th</sup> of August 2026**

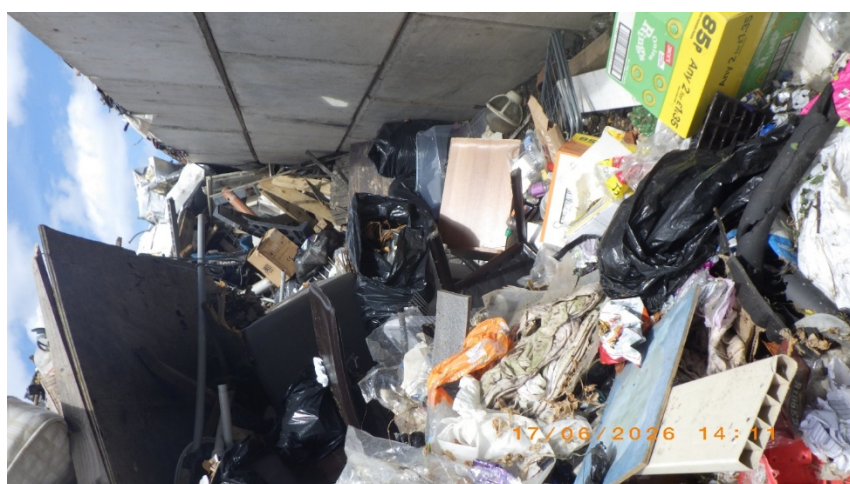
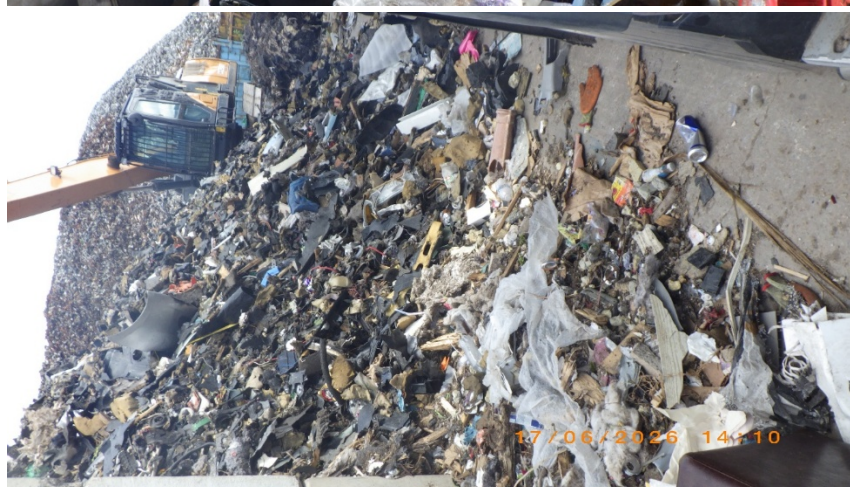
A concrete blocks storage bay was seen to be filled with mixed waste which was

overspilling to the side of the bay as seen on the above photos.

The manager stated that, at times, mixed waste is found in the skips containing metal waste accepted on site. This waste is then shredded and sent off site.

NRW is concerned about this practise and requires further clarification as stated below:

- 1. What code is assigned to this waste stream when accepted on site?
- 2. What is the procedure for checking the skips at the time of accepting the skips on site?
- 3. What is being done with the above pictured waste?
- 4. Under what code the processed waste is being sent off site?
- 5. How much of this waste has been processed and sent off site from 1<sup>st</sup> January 2026 to 17<sup>th</sup> July 2026?

Please provide your response by the **14<sup>th</sup> of August 2026**.

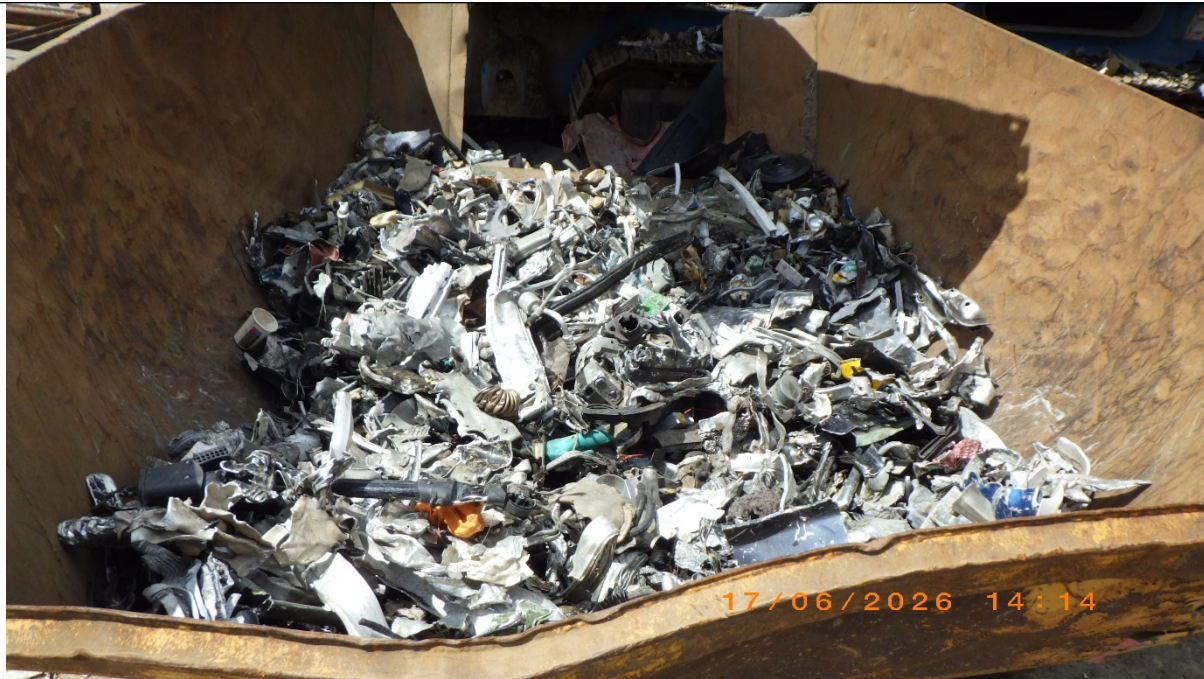
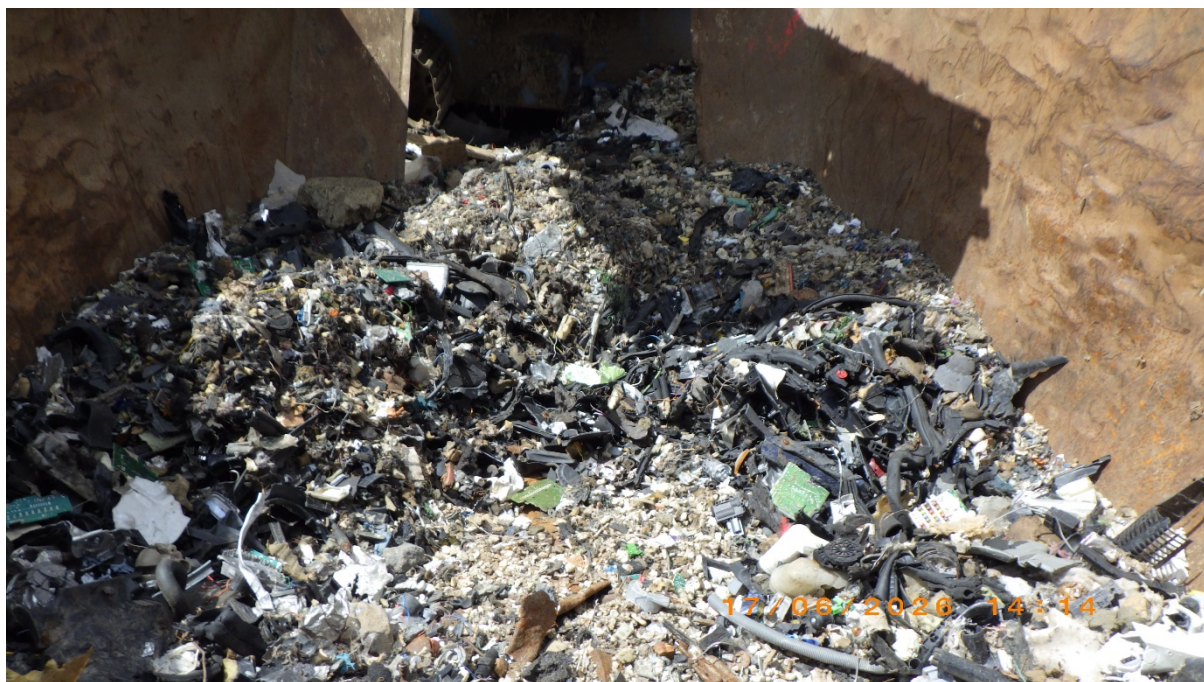
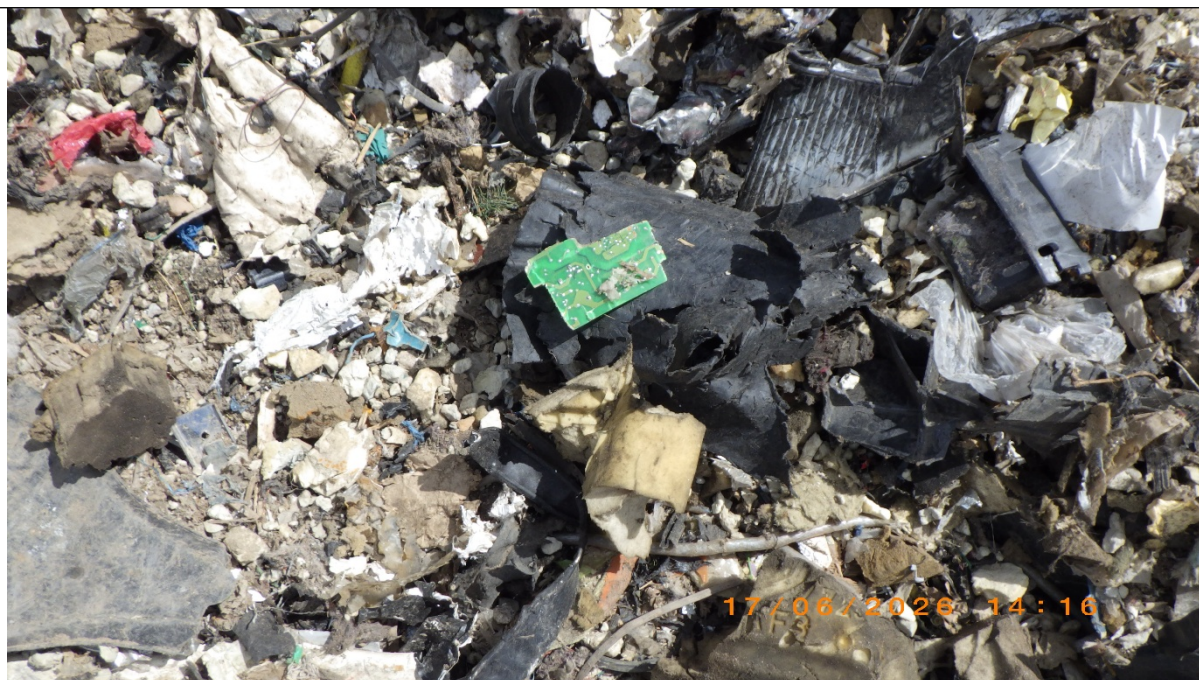
During this inspection PCB were seen on site again

Mixed shredded metals including PCBs

“ Batteries, PCBs/PCTs containing capacitors and other hazardous waste must be stored in dedicated, labelled appropriate containers”.

During the inspection multiple PCBs were observed in piles of waste and not in dedicated containers.

This breach has been assigned a **CCS3 score** under the W2C – Operating Techniques criteria.

**Action:** Please ensure your acceptance procedures are adhered to and all non-conforming waste is separated from other waste streams. **For compliance by 31st August 2026**

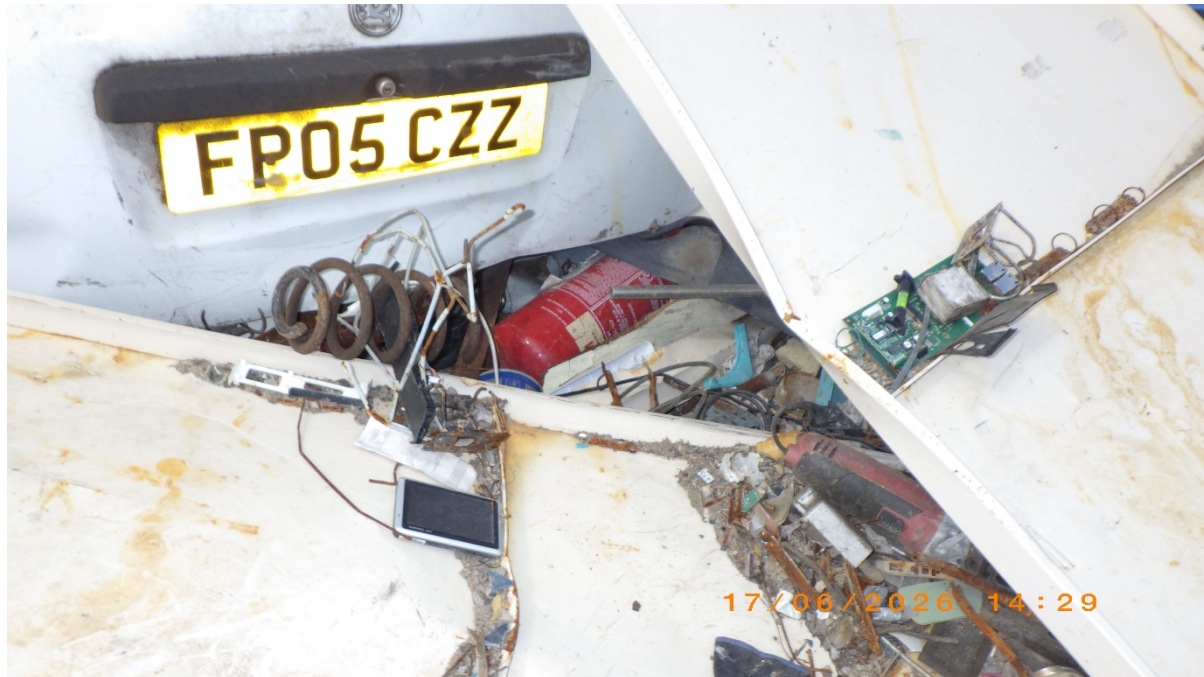
A fire extinguisher was seen amongst other waste on the ground. Please see the photo below.

This waste type (EWC code 16-05-05 Gases in pressurised containers) is not on the list of wastes that can be accepted on site.

This breach has been assigned a **CCS3 score** under this criteria

Pressurised gas container amongst other waste on site

**Action:** Please ensure your acceptance procedures are adhered to and all non-conforming waste is separated from other waste streams. Please ensure all pressurised gas containers are kept in the quarantine area in an upright lockable cage. **For compliance by 31st August 2026.**

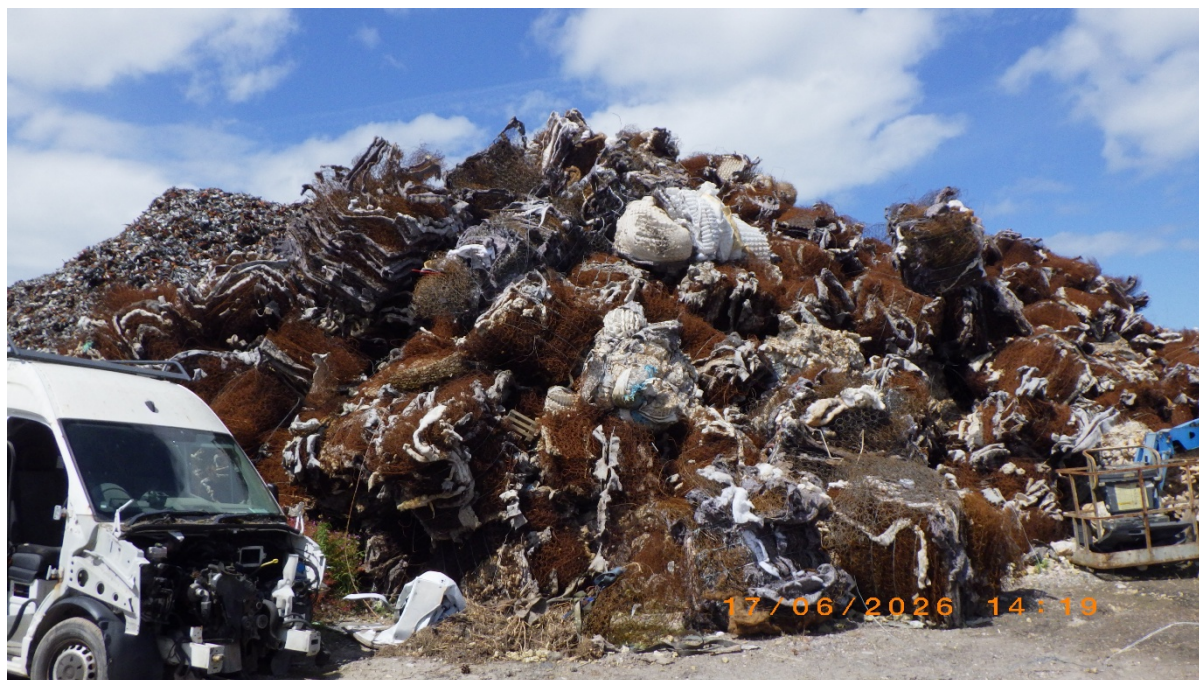
Officers noted a large pile of, what appeared to be, mattresses springs that have been on site for a considerable amount of time.

Whilst it is apparent that some waste has been processed and removed from site, a considerable amount remains in place despite previous discussions with the management to remove it.

Waste that remains on site beyond permitted timeframes is more likely to degrade, generate leachate, increase fire risk and potentially cause pollution.

**Action:** Please clarify the below in relation to this waste, seen on the below photo by the

**14<sup>th</sup> of August 2026.**

1. What is the purpose of keeping the waste on site?
2. How long has this waste been kept on site?
