MWC0116, COLWYN BAY STEPS.

OS REF: SH 87591 – 78711.

ECOLOGY SURVEY.

Ref No: 190125.

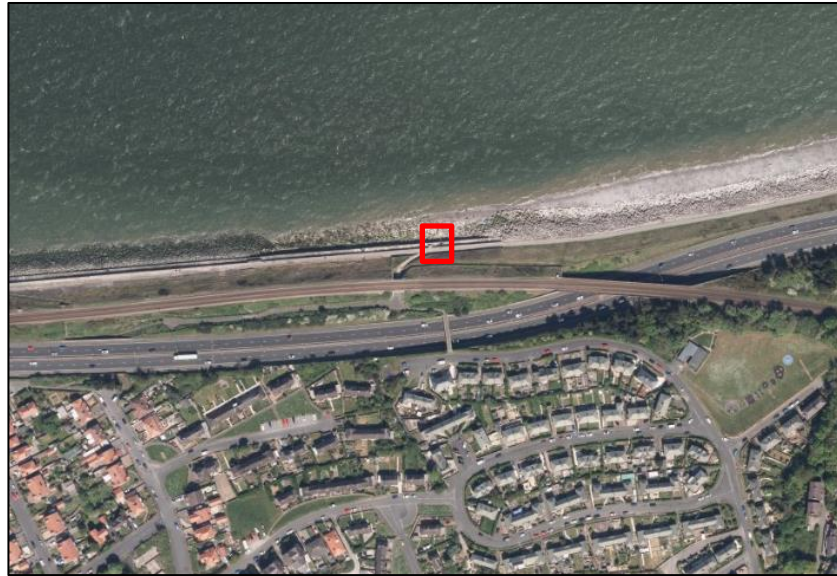
3.2.1. The surveyed area was a set of stone and concrete steps that link the promenade to the beach at Colwyn Bay. The aerial photograph below shows the surveyed area highlighted in red and the surrounding area.

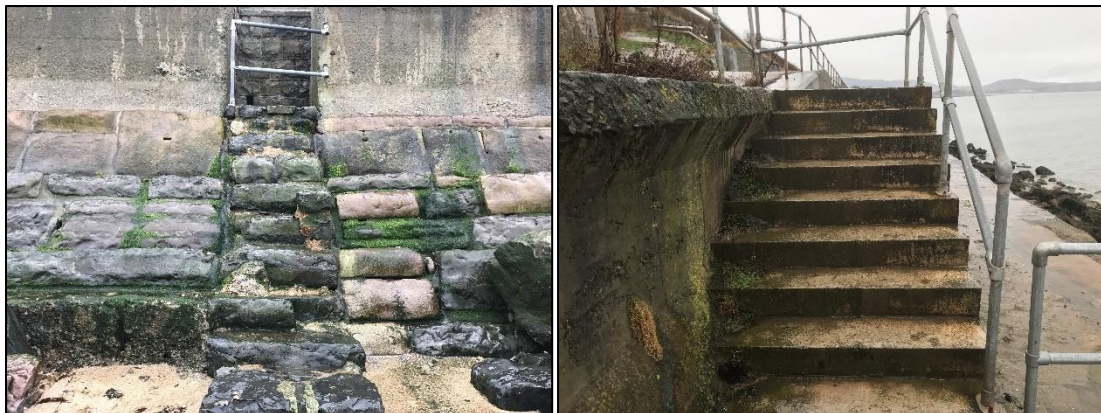
3.2.3. The surveyed steps are constructed from stone and concrete and have metal rails. At the bottom of the surveyed steps is a further set of steps that lead to the sea, (these steps are not part of the proposed works).

3.2.3.1. The photographs below show the surveyed steps.

3.3.3. The surveyed steps have been corroded by salt water. However, the stone and concrete wall sections of the steps are generally in a good state of repair with no deep cracks, gaps or missing stones that could provide any suitable roosting opportunities for bats.

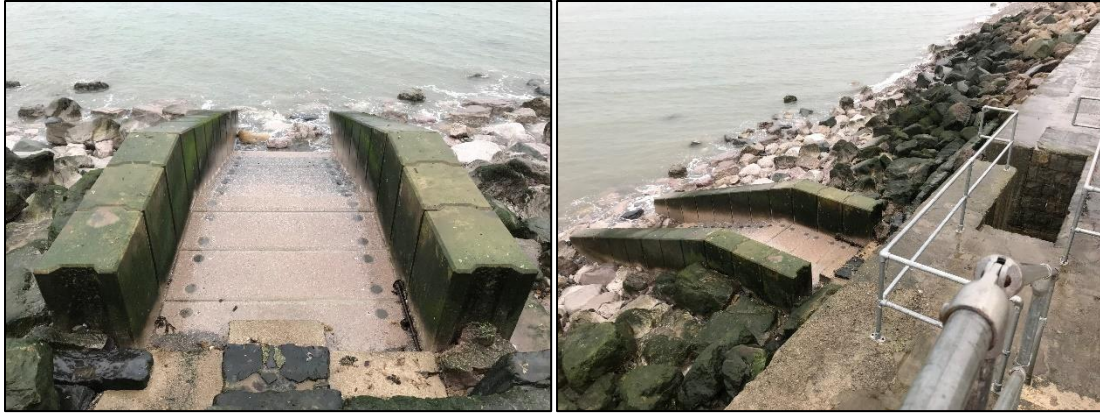
3.2.3.2. The photographs below show the steps that lead from the bottom of the surveyed steps to the sea.
