**DD/REP/XXX/26**

## **Site Restoration Programme**

### **Trawsfynydd Deposit for Recovery Permit Application**

### **The Waste Sampling Plan**

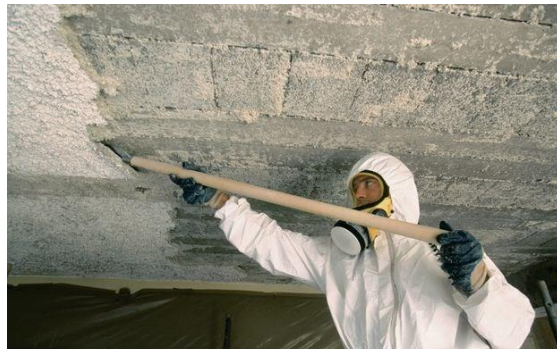
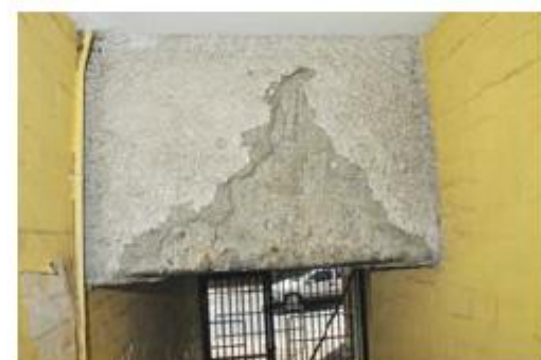
| Product | Image | Extract from HSG264 – Asbestos Survey Guide | | | | | | | | | | | |
|---|---|---|---|--|--|---|--|--|--|---|---|---|---|
| <b>Sprayed coating</b><br><br>Note:<br>products are clearly discernible with substrate / finish relationship e.g. Limpet. | <br> | <table><tr><th colspan="4">Sprayed coatings</th></tr><tr><td>Dry applied, wet applied and trowelled finish.</td><td>Thermal and anti-condensation insulation on underside of roofs and sometimes sides of industrial buildings and warehouses. Acoustic insulation in theatres, halls etc. Fire protection on steel and reinforced concrete beams/columns and on underside of floors. Overspray of target areas is common.</td><td>Sprayed coatings usually contain 55%–85% asbestos with a Portland cement binder. Crocidolite was the major type until 1962. Mixture of types including crocidolite until mid-1971. Asbestos spray applications were used up to 1974.</td><td>The surface hardness, texture and ease of fibre release will vary significantly depending on a number of factors. Sprays have a high potential for fibre release if unsealed, particularly if knocked or the surface is abraded or delaminates from the underlying surface. Dust released may then accumulate on false ceilings, wiring and ventilation systems.<br/><br/>'Limpet' (also used for non-asbestos sprays).</td></tr></table> | | | | Sprayed coatings | | | | Dry applied, wet applied and trowelled finish. | Thermal and anti-condensation insulation on underside of roofs and sometimes sides of industrial buildings and warehouses. Acoustic insulation in theatres, halls etc. Fire protection on steel and reinforced concrete beams/columns and on underside of floors. Overspray of target areas is common. | Sprayed coatings usually contain 55%–85% asbestos with a Portland cement binder. Crocidolite was the major type until 1962. Mixture of types including crocidolite until mid-1971. Asbestos spray applications were used up to 1974. | The surface hardness, texture and ease of fibre release will vary significantly depending on a number of factors. Sprays have a high potential for fibre release if unsealed, particularly if knocked or the surface is abraded or delaminates from the underlying surface. Dust released may then accumulate on false ceilings, wiring and ventilation systems.<br><br>'Limpet' (also used for non-asbestos sprays). |

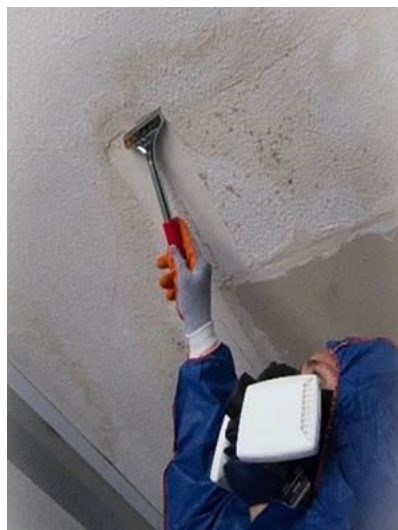
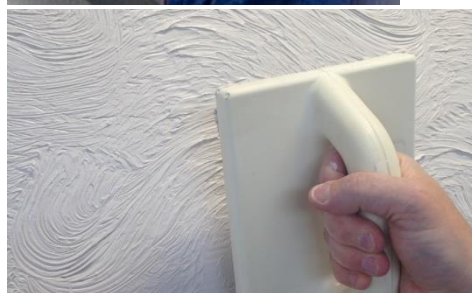
| Product | Image | Extract from HSG264 – Asbestos Survey Guide | | | | | | | | | | | |
|---|---|---|---|--|--|---|--|--|--|---|---|---|---|
| <b>Textured coating</b><br><br>Note:<br>products are clearly discernible with substrate / finish relationship e.g. Artex. | <br> | <table><tr><th colspan="4">Other encapsulated materials</th></tr><tr><td>Textured coatings.</td><td>Decorative/flexible coatings on walls and ceilings.</td><td>3–5% chrysotile asbestos. Chrysotile added up to 1984 but old stock may have been used for several more years.</td><td>Generally fibres are well contained in the matrix but may be released when old coating is sanded down or scraped off. 'Artex', 'Wondertex',</td></tr></table> | | | | Other encapsulated materials | | | | Textured coatings. | Decorative/flexible coatings on walls and ceilings. | 3–5% chrysotile asbestos. Chrysotile added up to 1984 but old stock may have been used for several more years. | Generally fibres are well contained in the matrix but may be released when old coating is sanded down or scraped off. 'Artex', 'Wondertex', |

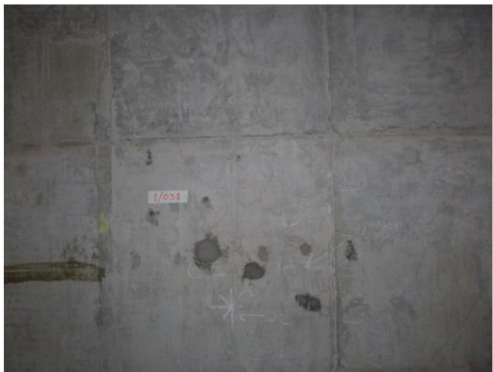
Figure 3: Site surface texture (>2m)

**Trawsfynydd  
Bagwash**

**Note:** Even though patterns are recognisable, the **products are not clearly discernible and substrate / finish relationship not applicable.**

The bagwash product is unique to Trawsfynydd. Referring to it as a coating or textured coating product can be misleading as it infers a substrate and finishing build-up **which is clearly not the case at Trawsfynydd.**

The bagwash has been demonstrated to be a low-hazard, non-friable material, with fibres firmly bound within a cementitious matrix and integral to the concrete substrate. It is stable in situ, not easily discernible from the host material, and not prone to fibre release with administered control measures.
