# **CARDIGAN TIDAL FLOOD RISK MANAGEMENT SCHEME**

## Appendix 6.5 - Otter survey report

## **CARDIGAN FLOOD RISK MANAGEMENT**

### **OTTER SURVEY REPORT June 2nd 2025 (updated 20/6/2025)**

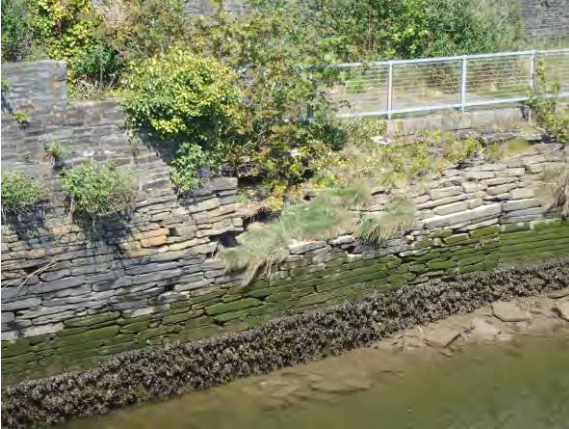
- 1) End of retaining wall by the bridge with a cavity (Plate 1). PRS but could not be checked due to deep mud.
- 2) A stretch of grass bank beneath the sitting area (Plate 2).

Plate 1 Site 1 Cavity in stone wall

**TS 1.** The cavity in the dry stone wall close to the old bridge could not be investigated. It is unlikely to be a PRS because otters need fresh water to wash off salt from their coats. However, otters do use cavities associated with collapsed masonry so it should be considered to be a PRS, and if likely to be affected by the flood defence scheme, should be checked by accessing the site from above using ropes etc.

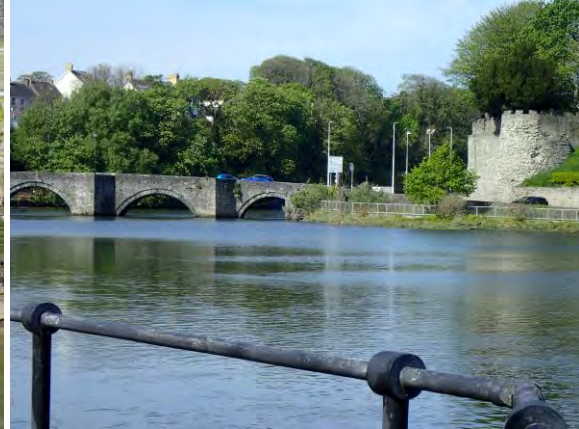
Plate 2 Site 2. Grassy bank below sitting area

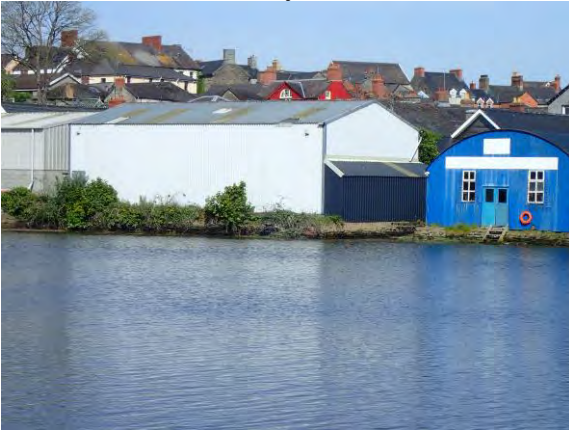
- 3) Stone retaining wall beneath timber building (Kitchen centre).
- 4) 1m wide strip of scrub and young sycamore along the top of the wall adjacent to a corrugated shed (Plate 3). No evidence of otter use. Grass bank along toe of retaining wall (Plate 4) with 1 F, 2 R and an otter path through the grass.

Plate 3 Site 4 Scrub adjacent to shed

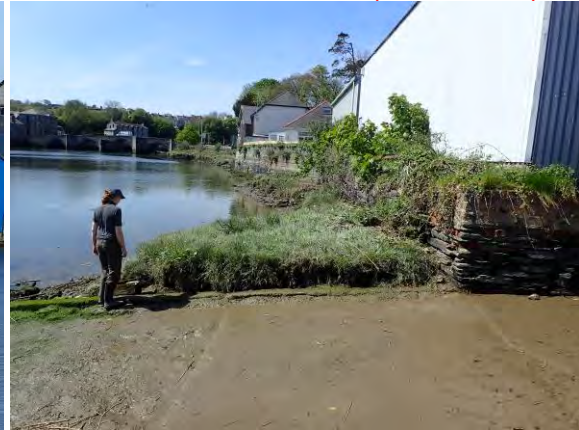
Plate 4 Site 4 Grass bank with *spraints* & otter path

If possible, earth banks along the river edge should be retained, or replaced if they are removed to facilitate construction works.

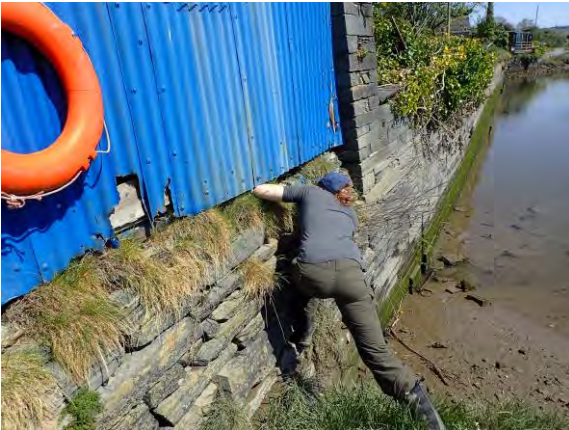
- 5) Boat House (blue) with gaps at the base of the corrugated walls, but no evidence of otter use (Plate 5).
- 6) Downriver from the main slipway is stone retaining wall with no cavities (Plate 6) and a veranda with vegetation below it (Plate 7) but no cavities in the retaining stone wall.

Plate 5 Site 5 Boat Hs with cavities

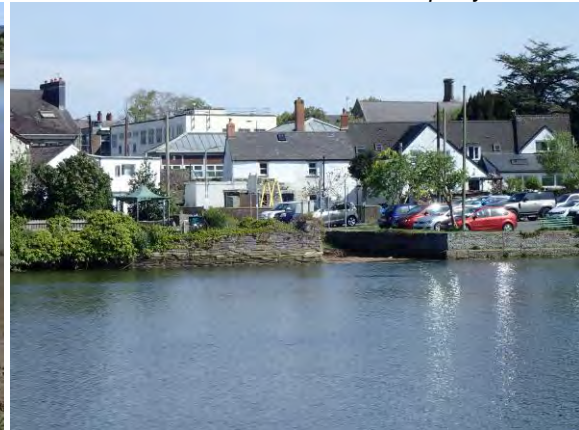
Plate 6 Site 6 Stone wall dr from slipway

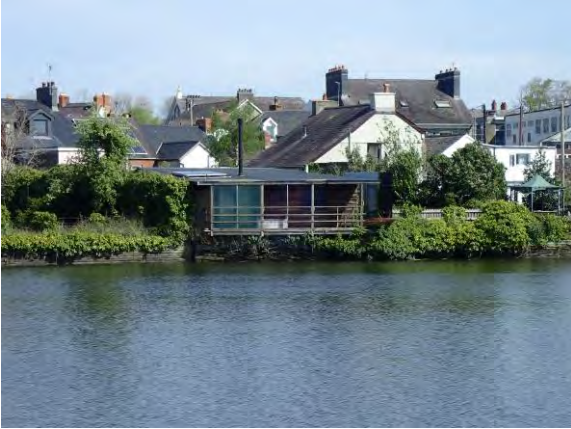
Plate 7 Site 6 Bank beneath veranda

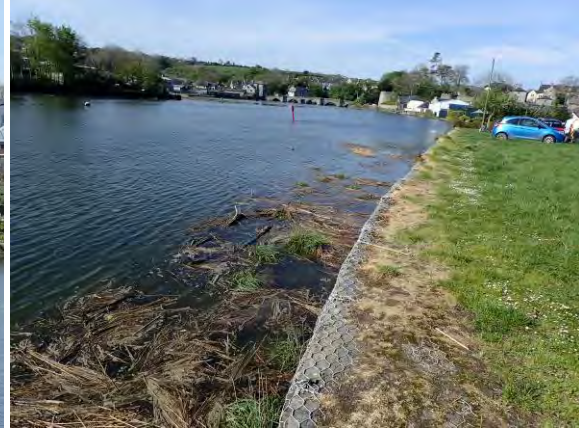
- 7) Upriver from the slipway is a long stretch of gabion basket retaining wall beneath a public carpark (Plate 8). A long stretch of grass bank along the toe of the retaining wall is exposed at low tide, with several sprints and a well-used otter path through the grass.

Plate 8 Site 7 Gabion retaining wall.

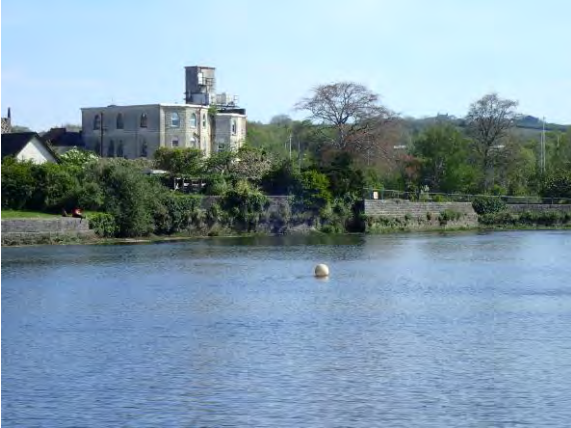
- 8) Scrub forming large area of cover at the end of the gabion wall (Plate 9) but too open to provide security for a RS.
- 9) Stone wall below former hospital site (Plate 9) but no useful cavities for PRS. Otter path continues along grassy bank to the reed bed, with F & R sprints.

Plate 9 Sites 8 & 9 Scrub at end of gabion wall

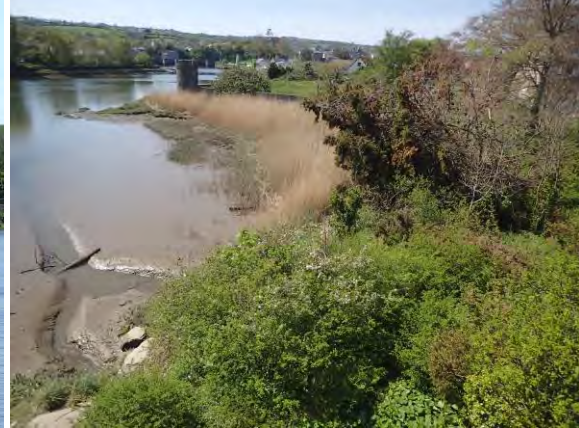
- 10) A large area of trees and scrub with a small stream outlet (Plate 10) close to the bypass bridge. A well-used human path runs through the cover (Plate 11) but there are also areas of dense cover created by a fallen tree (Plate 12) with possible mammal paths leading into it from the water – so a PRS. The large stones beneath the bypass bridge provide a well-used sprinting site, with several F, R & Old sprints (Plate 13)

Plate 10 Site 10 Area of scrub & trees

- c) **TS 10.** The scrub & tree covered inlet with the small stream / ditch is the most likely PRS along this stretch, partly because it has dense cover (at the fallen tree) and fresh water close by in the stream / ditch. Although the cover is suitable for a PRS, the presence of human disturbance may affect its use.

This area of scrub / woodland habitat should be retained if possible. Protection measures could include installing a sheep netting fence along the river-side edge of the human footpath (unless it's possible to prevent human access to the area).

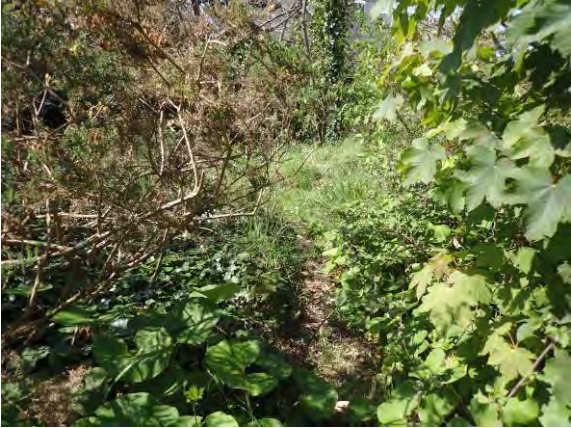
Plate 11 Site 10 Human path

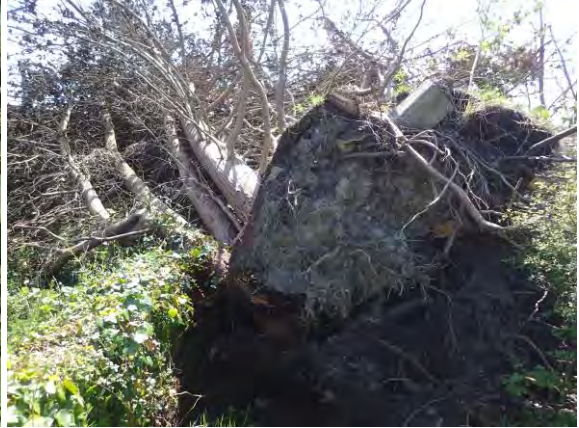
Plate 12 Site 10 Fallen tree **PRS**

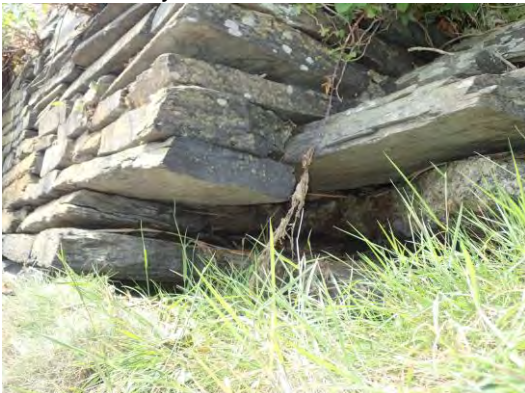
*The cavity (Plates a & b) is relatively shallow and not deep enough to conceal and otter. It is approx. 80cm above the high tide level on top of a sheer wall – there was no evidence of otter use (e.g. flattened areas or spraints) within the cavity (Plate b). The long wall adjacent to the cavity is intact, with no otter access haul outs (e.g. low banks or collapsed wall sections) that would enable otters to climb onto the top of the wall.*

Plate a Cavity at base of wall

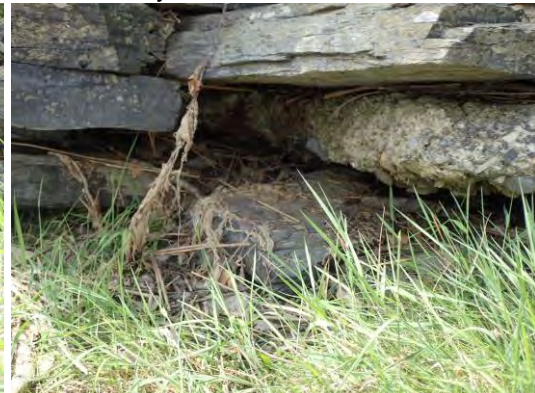
Plate b Cavity internal view
