# **CARDIGAN TIDAL FLOOD RISK MANAGEMENT SCHEME**

## Appendix 6.8 - Preliminary Roost Assessment Report

Afon Teifi / River  
Teifi  
**Proposed Flood  
Defences  
Cardigan**

| <b>Report Title</b> | <b>A Preliminary Roost Assessment</b> |

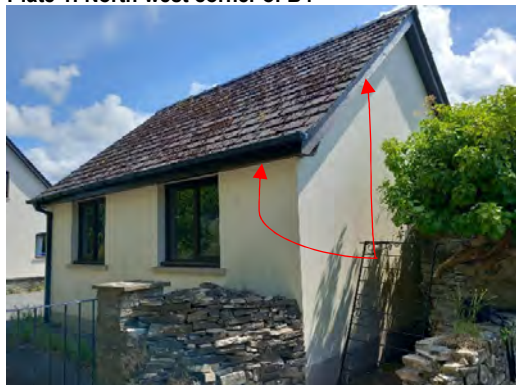
- 5.2 Building 4 (B4) is situated at NGR SN 18052 46000 at 5m AOD.
- 5.3 The outbuilding at Caerhuan is a simple, detached rectangular building, appearing modern in construction with a smooth cement render cladding the exterior. It forms part of the land ownership and dwelling of Caerhuan, positioned within the driveway of the property. It was not possible to gain access inside and therefore it was not possible to know whether it is built in brick or concrete blockwork. It is situated on an east/west position, and is covered with a pitched roof laid with slate-type composite tiles and clay ridge tiles. Associated roof features, such as soffits/fascia boards/barge boards are timber, with all rainwater goods formed from uPVC. Access would normally be possible through doors on each gable to the east and west, with an up-and-over metal garage door present on the eastern gable end. Windows are set into the north elevation, and appear to be double-glazed and set in timber-style uPVC frames.

Plate 1: North-west corner of B4

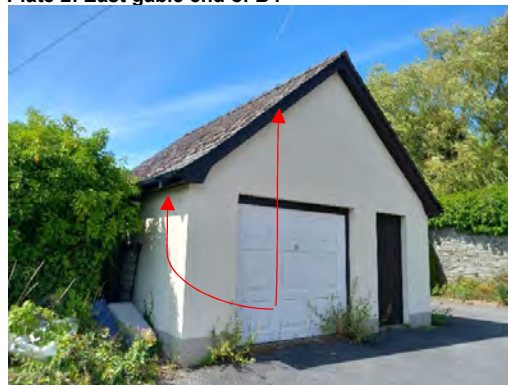
Plate 2: East gable end of B4

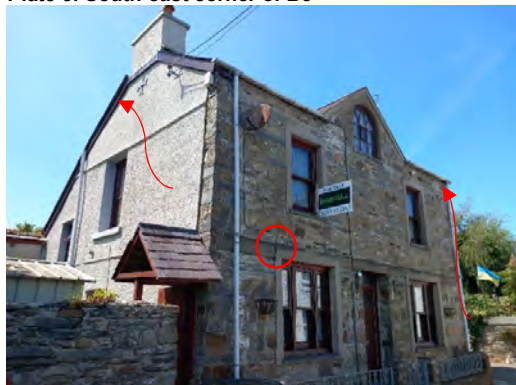
- 5.4 Building 5 (B5) is situated at NGR SN 17987 45985 at 5m AOD.
- 5.5 The dwelling of Teifi House is a detached structure on the corner of Gloster Road and The Strand. It is a dwelling built in stone as is traditional for the area, with a saltbox-style roof laid with slate. The dwelling stands on a north-south position, and is covered with a saltbox-style roof laid with slate. The longer of the two pitches faces west, and to the east a half/wall and pitched dormer projects from the roof. Stone chimneys stand at both the northern and southern gable ends, with the southern gable clad in painted pebbledash rendering. Windows where present appear to be double-glazed and set into uPVC sash frames. A small wraparound garden is present to the east and south. Internal access was not permitted during the survey, however, due to positioning of windows on the east elevation it appears that the loft space has been converted for use.

| Feature | Live bats? | Evidence of bats? | Potential for bats to be present? | Further detail | Level of potential to support roosting bats | Additional survey required? | Number of surveyors recommended |
|---|---|---|---|---|---|---|---|
| B5 | X | X | ✓ | <ul style="list-style-type: none"> <li>lifted render on east elevation, above ground-floor window;</li> <li>cracks between mortar and stonework on east elevation;</li> <li>gap between barge board and pebbledash render on south gable end;</li> <li>lifted roof tiles on western roof pitch;</li> <li>gaps between fascia board and render on west elevation.</li> </ul> | Moderate | Two (2) | Three (3) |

Plate 3: South-east corner of B5

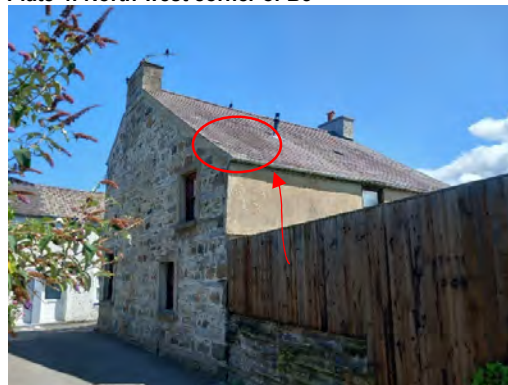
Plate 4: North-west corner of B5

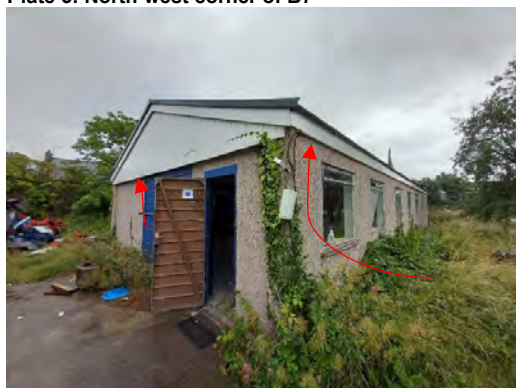
- 5.6 Building 7 (B7) is situated at NGR SN 17962 45969 at 5m AOD.
- 5.7 The Scout hut is a simple, rectangular and detached structure set within a grassed enclosure. It is situated on a north-south position, appears to be constructed from concrete panels clad in Canterbury spar rendering. A pitched roof covers the structure, laid with interlocking concrete tiles and clay ridge tiles. Fascia and barge boards are formed from uPVC, with no soffit present. The gable ends are clad with uPVC boards affixed to an external timber framework, covering only the section between the ceiling and gable apex. Windows are single-glazed and set into metal frames. Access was possible via a door on the northern elevation.

Plate 5: North-west corner of B7

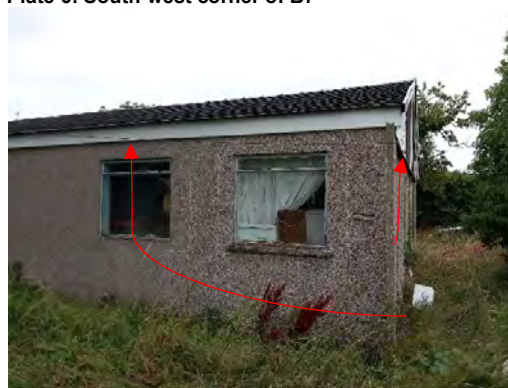
Plate 6: South-west corner of B7

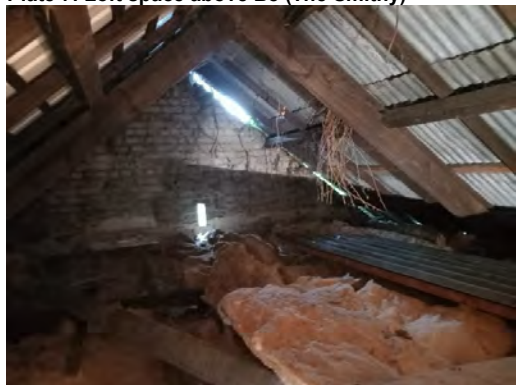
- 5.11 Access was possible inside the Smithy. The structure is used as a combination of a forge, a woodworking business and a crafting business. Two loft spaces are present, both of which are accessible via hatches in the main part of the structure to the north, and via the small square structure to the south-west. Loft spaces are not boarded, but have been laid with fibreglass insulation between ceiling joists. No roof lining was noted.

Plate 7: Loft space above B8 (The Smithy)

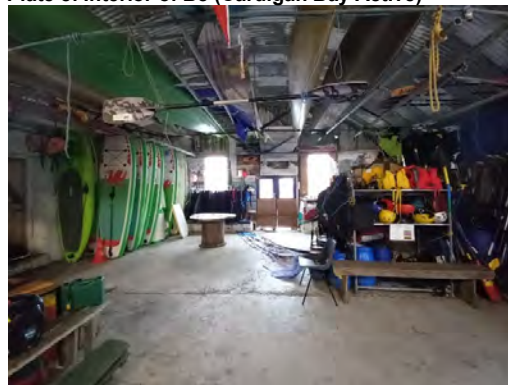
- 5.12 The Smithy directly abuts the Cardigan Bay Active unit on the Smithy's southern elevation. Cardigan Bay Active is a structure built in a combination of brick, stone and corrugated metal sheeting. The unit is covered by a curved roof, laid with curved metal sheeting. Access was possible via a sliding door on the west elevation, with windows and other doors present on the western, southern and eastern elevations.
- 5.13 Inside, the unit is a single space modified to house various pieces of watersports equipment available for rental. No loft space is present.

Plate 8: Interior of B8 (Cardigan Bay Active)

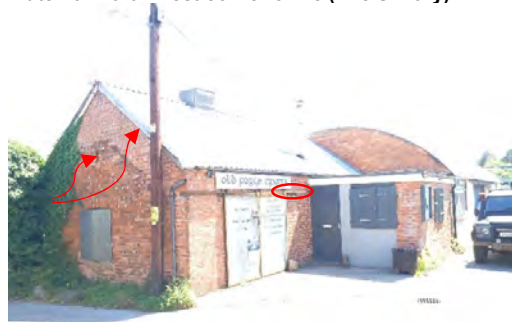
- 5.9 Building 8 (B8) is situated at NGR SN 17917 45961 at 8m AOD.
- 5.10 The Smithy is a rectangular structure situated on a north-south position, built in brick with a pitched roof covered with corrugated metal sheeting. A metal chimney or vent is present centrally along the ridge, with a metal, cylindrical flue protruding from the western roof pitch. Barge boards and fascia boards are timber, no soffit is present. At the south-west corner, a small, square structure also built in brick is noted to form part of the Smithy building. This square structure has a flat roof covered in glass-reinforced plastic (GRP), a strong yet light polyester resin that is reinforced using chopped strand mat glass fibres that form a GRP laminate. Access was possible via metal sliding doors on the west elevation. Doors and windows elsewhere are present on the northern gable end of the Smithy and north and west elevations of the small square structure.

Plate 10: North-west corner of B8 (The Smithy)

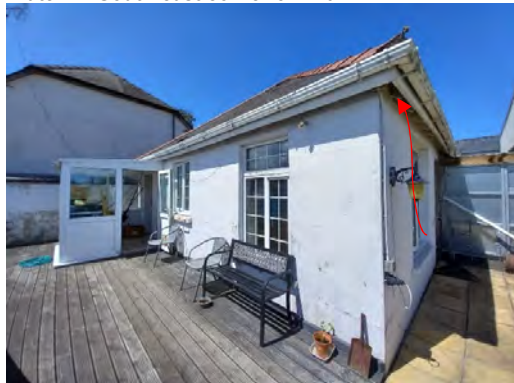
- 5.14 Building 10 (B10) is situated at NGR SN 17875 45927 at 8m AOD.
- 5.15 Sandwiched between two light industrial units, the Presbytery is a detached, square structure covered with a pyramidal roof, laid with slate composite tiles and clay ridge tiles. It appears to be built in modern concrete blockwork, with associated roof coverings such as barge boards and soffits formed from a combination of timber and uPVC. Windows are double-glazed and set in uPVC frames. A double glazed, uPVC-panelled porch stands to the front, on the northern elevation. A small conservatory is present to the rear, at the southern elevation, where a small enclosed garden overlooks the Afon Teifi.
- 5.16 Inside, a loft space is absent with the upstairs rooms having vaulted ceilings. It is currently used as a residential dwelling.

| Feature | Live bats? | Evidence of bats? | Potential for bats to be present? | Further detail | Level of potential to support roosting bats | Additional survey required? | Number of surveyors recommended |
|---|---|---|---|---|---|---|---|
| B10 | X | X | ✓ | <ul style="list-style-type: none"> <li>gaps between soffit and wall on all elevations;</li> <li>small gaps underneath ridge tiles on southern and northern elevations where mortar is missing.</li> </ul> | Moderate | Two (2) | Two (2) |

Plate 11: South-east corner of B10

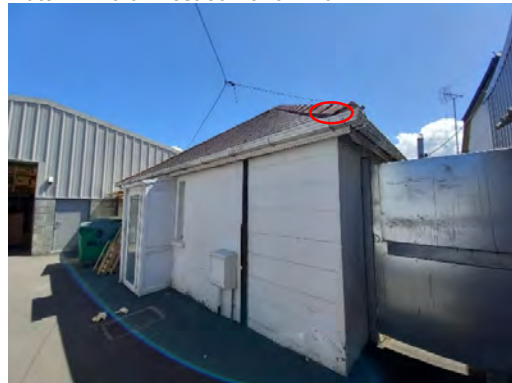
Plate 12: North-west corner of B10

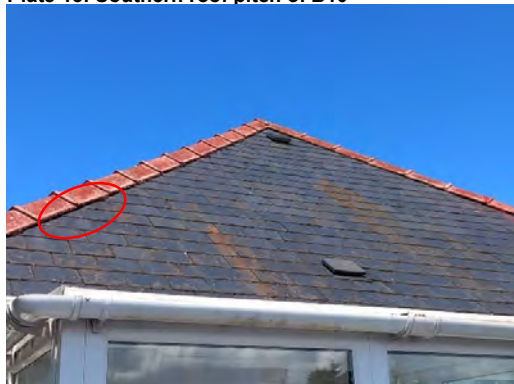
Plate 13: Southern roof pitch of B10

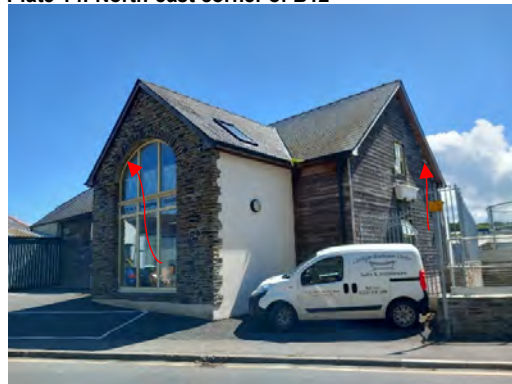
- 5.17 Building 12 (B12) is situated at NGR SN 17859 45916 at 8m AOD.
- 5.18 Riverside Showrooms is an active business positioned on the banks of the Afon Teifi. It is essentially a rectangular structure positioned on an east/west position, with two cross-gabled sections projecting to the north and south toward the western end of the building. The entirety of the building is clad in overlapping timber boards, and the roof is pitched and laid with slate along with clay ridge tiles. The cross-gabled sections are laid with the same materials. Soffits, fascia boards and barge boards are timber, with doors and window frames formed from uPVC aside from the street-side, north-facing cross gable end which is almost entirely glazed, and set in timber frames. Access around the building for external inspection was difficult, due to the proximity of the Afon Teifi.

Plate 14: North-east corner of B12

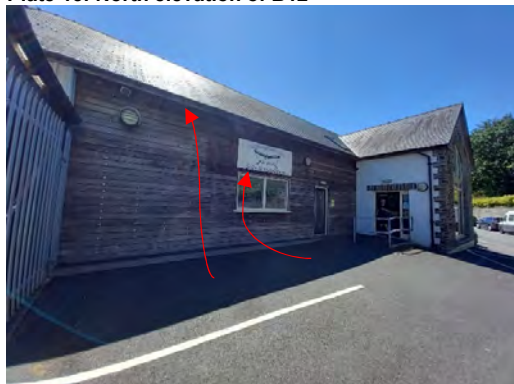
Plate 15: North elevation of B12

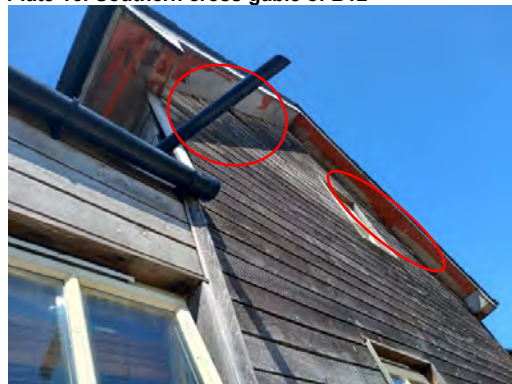
Plate 16: Southern cross-gable of B12

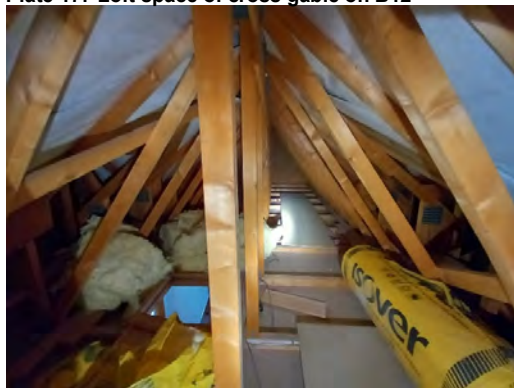
- 5.19 Inside, the ground floor is given over to the bathroom showroom, with the upper floor set aside for office and storage spaces, which are largely empty. A loft space is present that connects the two cross-gabled roof sections, with the remainder of the building being vaulted. The loft space is not boarded and has no fibreglass insulation laid between the joists. The trussed rafter arrangement that supports the roof is a key feature of the loft space, and a breathable/modern lining membrane is visible above the rafters and below the slates.

Plate 17: Loft space of cross gable on B12

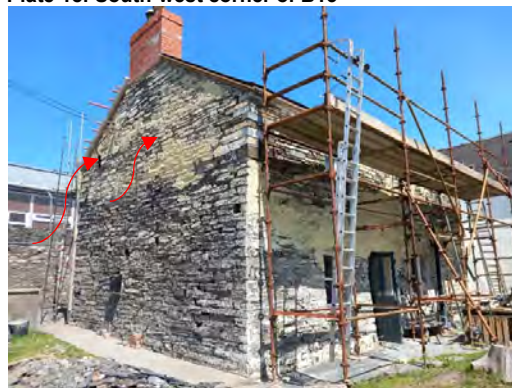
- 5.20 Building 13 B13 is situated at NGR SN 18018 46014 at 5m AOD.
- 5.21 6 Church Street is a detached property set on an east/west orientation. It is a rectangular dwelling, covered with a pitched roof. At the time of survey, the majority of the dwelling had no roof as it was in the process of being re-laid. The owner of the property is living on site whilst renovation works are carried out. The dwelling is built in stone and is rendered on the north elevation with a Canterbury spar render. Windows and doors are present on both the north and south elevations. Associated roof features, such as fascia boards, barge boards and soffits were absent at the time of survey. A newly-repaired brick chimney stands on the western gable end.

Plate 18: South-west corner of B13

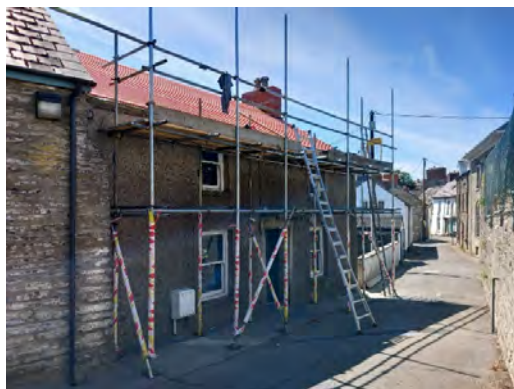
Plate 19: North elevation of B13

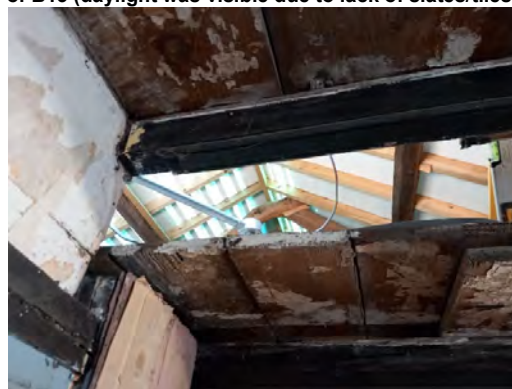
- 5.22 Internal access was possible, and due to the ongoing renovation works it was possible to view the underside of the rafters and battens from the first floor, where a breathable/modern roofing membrane was observed. No loft space was present on account of this.

Plate 20: View of underside of roof battens and rafters of B13 (daylight was visible due to lack of slates/tiles)

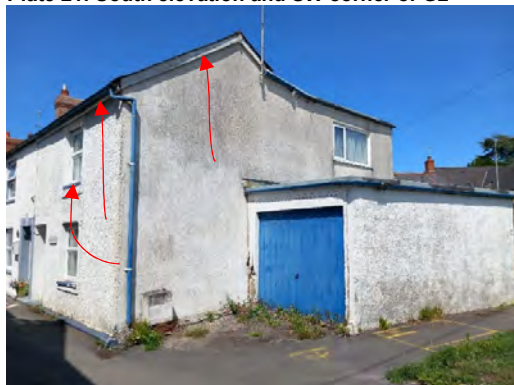
5.24 River View, which is the southernmost property of group G2 is positioned on a north-south orientation, owing to its association with the Gloster Row terrace of houses which runs north-south. It appears to originally have had a simple, slate-covered pitched roof with a southerly gable end: a southern gable end is still present although a large, full-height extension is situated on the east elevation. This is a largely flat-roofed extension, including a garage that abuts the southern gable end. The property is almost entirely clad in painted pebbledash render. Doors and windows are set in uPVC frames, are double-glazed and are on all elevations. The full-height extension is covered with GRP and appears to support metal rainwater goods.

Plate 21: South elevation and SW corner of G2

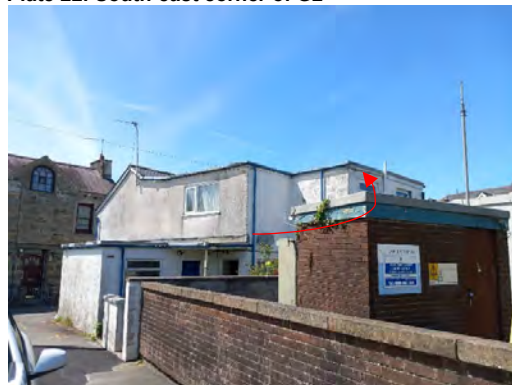
Plate 22: South-east corner of G2

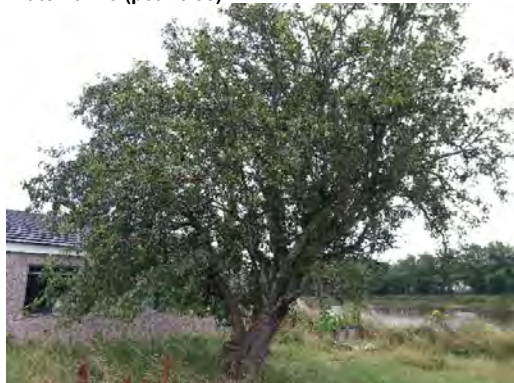
5.27 The pear tree (*Malus sp.*) is located within the grassed enclosure and grows in proximity to the Scout hut (B7). It is approximately 5m in height and is a mature specimen, with a main trunk that grows at a 45° angle and a secondary trunk that grows in the opposite direction. At approximately 1m in height, the main trunk splits into multiple secondary trunks that form the main canopy of the tree. Semi-ripe fruits were growing at the time of survey. The tree appeared to be in good health, with no dead limbs and no dead leaves noted to be still attached to the tree.

Plate 23: T3 (pear tree)

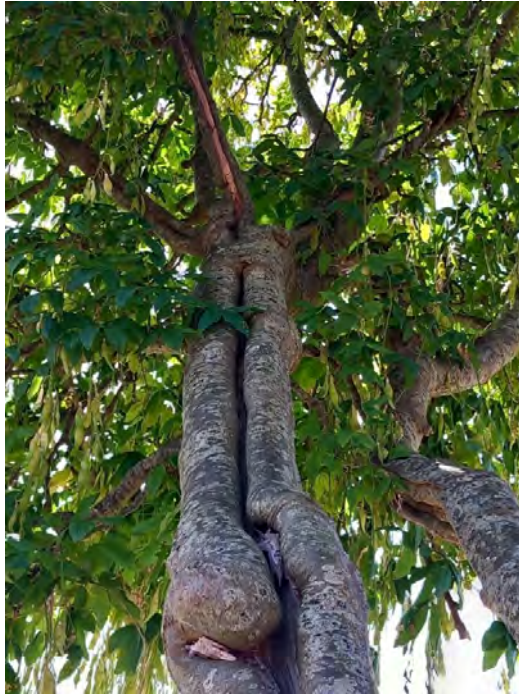
5.29 The laburnum tree (*Laburnum anagyroides*) is positioned at the south-western corner of the Gloster Row car park. It is approximately 3m in height and appears to be a semi-mature specimen. The tree grows at an approximate 20° angle toward the river. The main trunk splits into two secondary trunks at approximately 1.5m in height. The tree appears to be in declining health with a long split in the bark that runs from the ground up to the tip of both secondary trunks, exposing the heart of the tree. This split does not appear to be recent, as either side of the trunk has swollen.

| Feature | Live bats? | Evidence of bats? | Potential for bats to be present? | Further detail | Level of potential to support roosting bats | Additional survey required? | Number of surveyors recommended |
|---|---|---|---|---|---|---|---|
| T4 | X | X | X | <ul style="list-style-type: none"> <li>long crack from floor level to the full height of branches, showing heart of the tree. Very small opening present at the top of the crack leading into the tree trunk, however this was inspected and no bats were found to be present. The cavity in question is extremely narrow. Slugs and woodlice were also present within these cavity, indicating the damp nature of them.</li> </ul> | Low | None* | - |

Plate 24: Swollen crack on T4 (common laburnum)

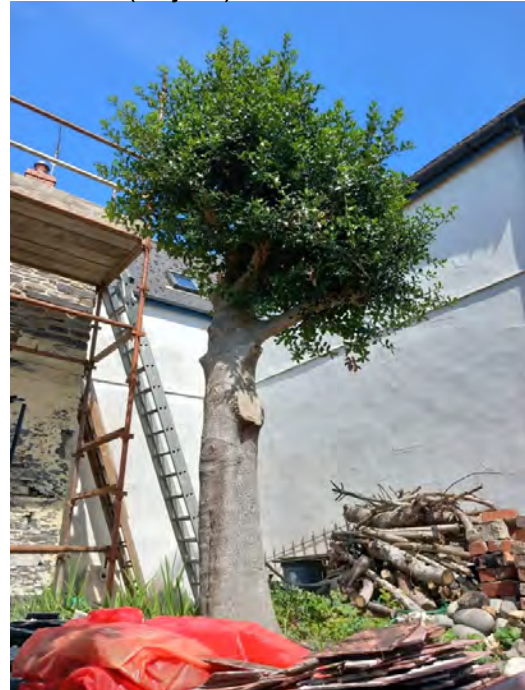
5.31 T5, the mature holly tree stands approximately 5m in height and is essentially a monolithic specimen that is still alive. It appears to have undergone recent extreme pollarding, with the tree trunk appearing to have been topped at a height of 5m. Very small and stubby radial branches are still present and still have healthy leaves, giving the tree its appearance of a lollipop with a very thick stem. It appears to be in good health, with no cavities or tears in the bark.

Plate 25: T5 (holly tree)

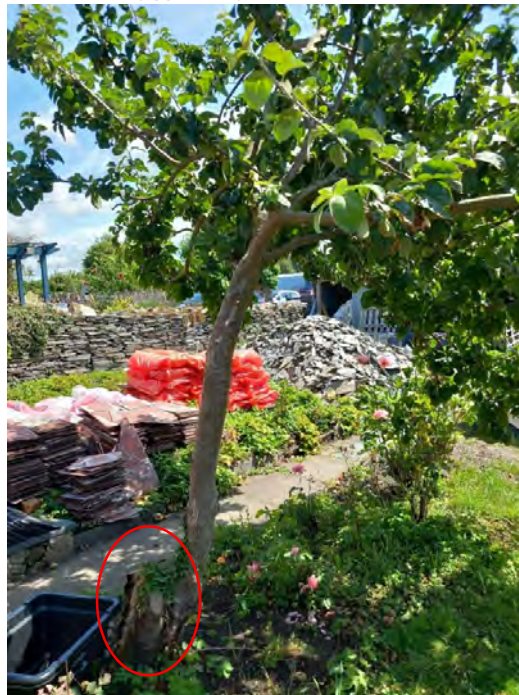
5.32 TN8, the mature apple tree stands at a height of approximately 4m and consists of a single, thin stem that supports the spreading canopy that reaches an approximate radius of 2m. The tree appears to be in good health, with no cavities or tears in the bark that could be observed. It is important to note that the tree used to have a second, possibly larger stem, although this has recently been removed: a large stub is noted at the base of the tree.

Plate 26: TN8 (apple tree)
