CSL19053 – Filter papers ex Aberthaw

CSL ID	Sample Description	Date sampled	Date received
19-1873	Rail Loop filter	Aug-19	05/11/2019
19-1874	Quarry North filter #1	Sept-19	05/11/2019
19-1875	Quarry North filter #2	Sept-19	05/11/2019

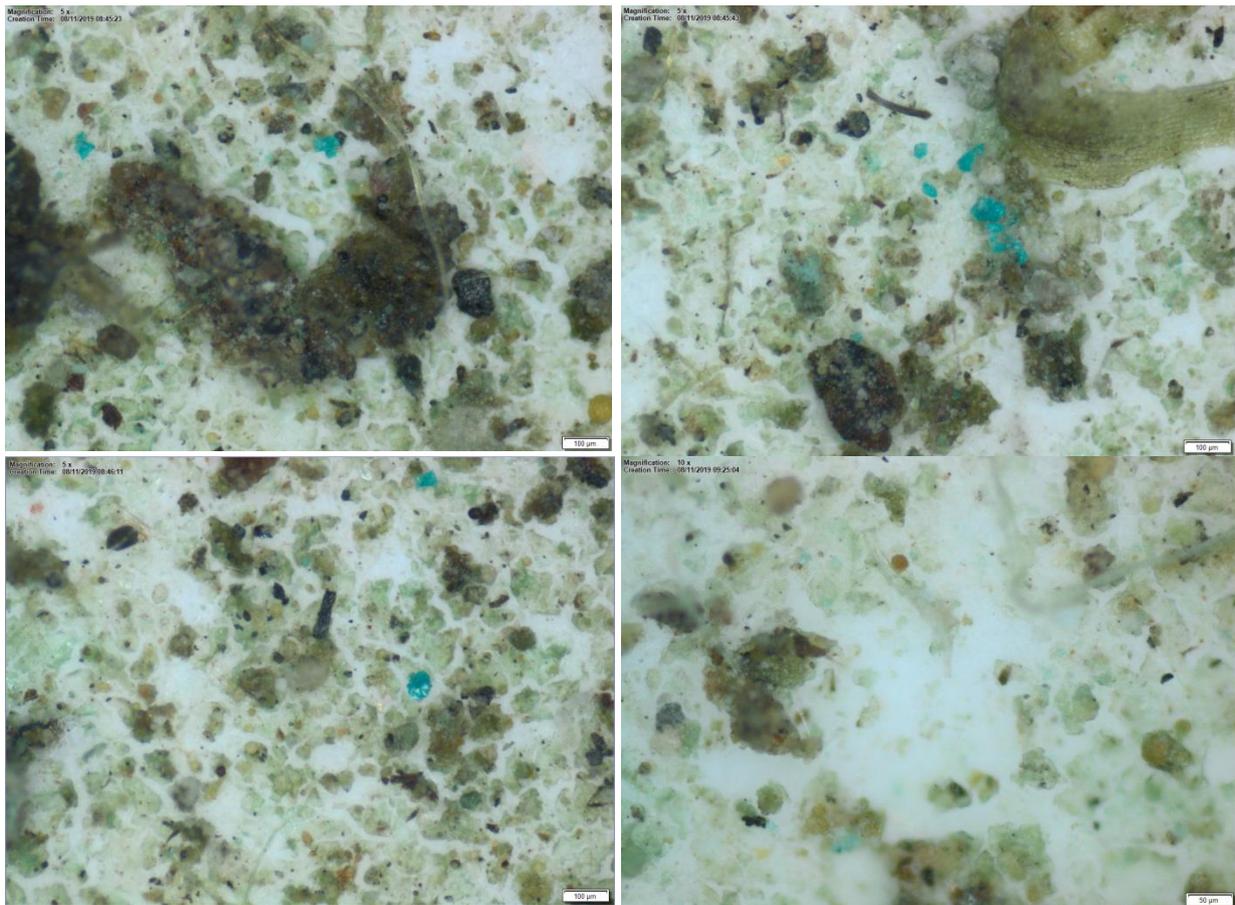
19-1873 Rail Loop 08-19

A small amount of blue crystalline material along with a number of dark brown/green coloured plaques could be seen on the filter paper. Very few cenospheres were observed on the filter paper when inspected with the light microscope.

Microscopic examination of this filter suggests the deposition is blue copper sulphate (likely from environmental solutions) and plant matter. Very few cenospheres were observed. The appearance of this filter is consistent with those seen previously from this sample point, with the same findings eg 18-579 Rail Loop ex Feb 2018.

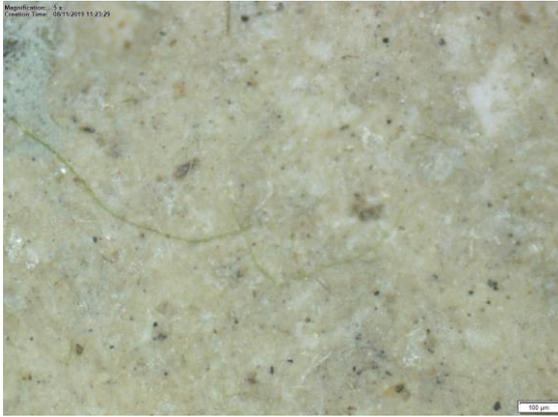
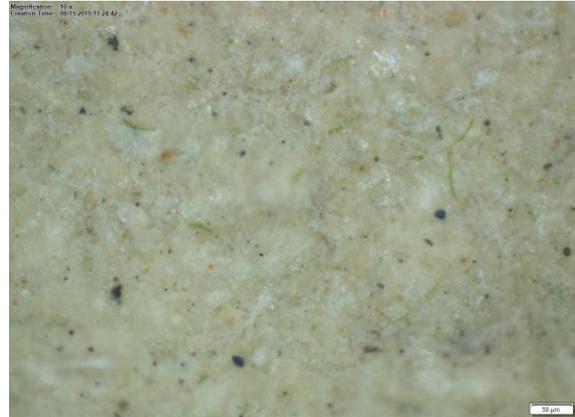
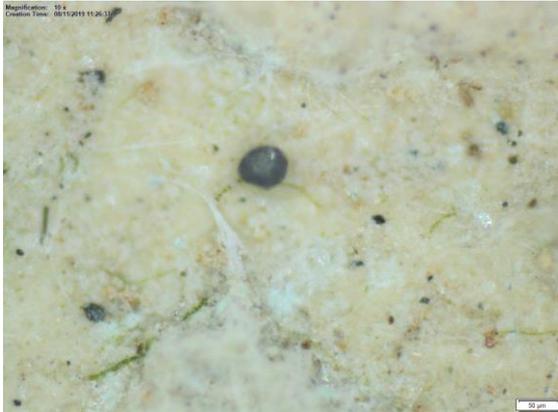
19-1874 Quarry North 09-19 #1

The majority of deposition appeared to be grainy sand coloured material, with some fibres and green plant like material present. Very few cenospheres were observed on the filter papers when inspected with the light microscope.

Microscopic examination of the filters ex Quarry North suggests that the deposition is predominantly dirt/dust and plant matter. Very few cenospheres were observed on the filter paper. Appearance of the filter is consistent with sample 19-001 ex Quarry North November 2018 and indicates the majority of residual material is possibly sand/dust.
