Pump Test Report and Assessment

Greenway Poultry,

Date:	October 2019	
Revision:	1	
Project Number:	HYG649	
Document Reference:	HYG649 R 191004 PM Pump Test Report and Assessment	
Document File Path:	\\Hydrogeo-nas422\hyg-projects\HYG649 Greenway Poultry Ltd\Reports\Full Report\HYG649 R 191004 PM Pump Test Report and Assessment.docx

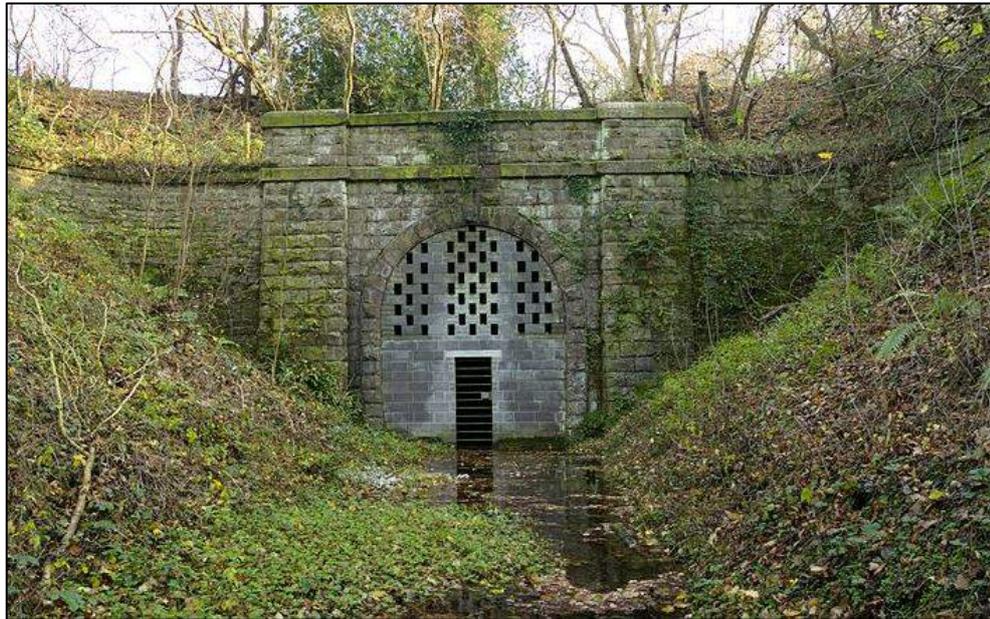
Figure 1-2 Talylyn Tunnel western portal

The disused tunnel, Talylyn Tunnel, is approximately 600m in length and opened in 1816 as part of the Brecon to Hay tramway. The tramway was widened to take trains in the 1860s, and the tunnel remained operational until 1964. At the time of closure the tunnel was the oldest railway tunnel in regular use, and when constructed it was the longest tunnel in the United Kingdom.

Field conductivity measurements made of the watercourse to the north of the abstraction borehole indicate that it is moderately mineralized. It is known that the watercourse is fed by groundwater issues from the disused Tallylyn Tunnel.
