CROWNHILL TOPSOIL PRELIMINARY GROUND AND SURFACE WATER RISK ASSESSMENT REV1 - 2020

Unit 1009, Caerwent Army Training Estate,
Caerwent

Title	Crownhill Topsoil – Groundwater Risk Assessment		
Location	Unit 1009 Caerwent Army Training Estate		
Document Ref	Groundwater Risk Assessment CH017	Issue / Revision: Draft for Comment	00
File reference	CH007		
Date	19/06/18		
Prepared by	David Findon	Signature

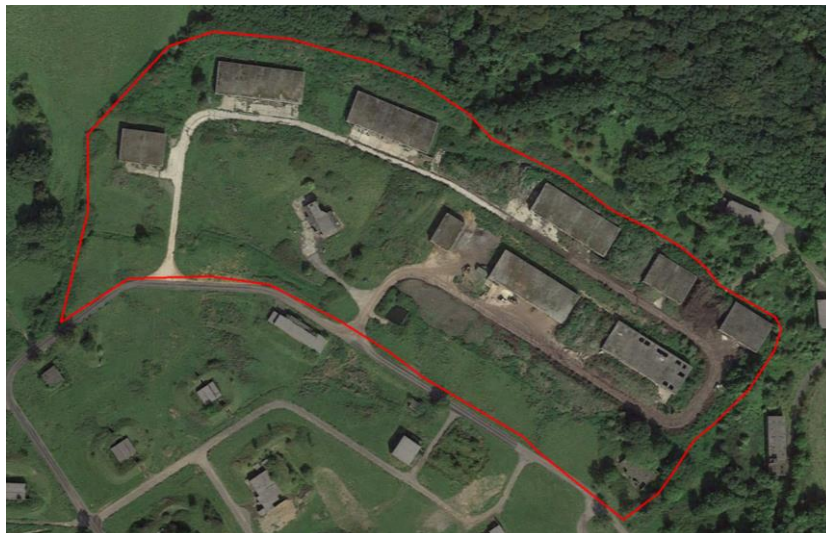
FIGURE 1: SITE LAYOUT

The site is located at Unit 1009 within the Caerwent Army Training Estate. The site occupies an area of around 6ha in the north west of the estate. There are a number of brick and concrete built buildings within the boundary of the site which have previously been used for compost production. This site is a combination of hard covered and permeable areas within the secure confines of the Army Training Estate. The site is secure against unauthorised access with all traffic entering and leaving the site passing through a manned security barrier.

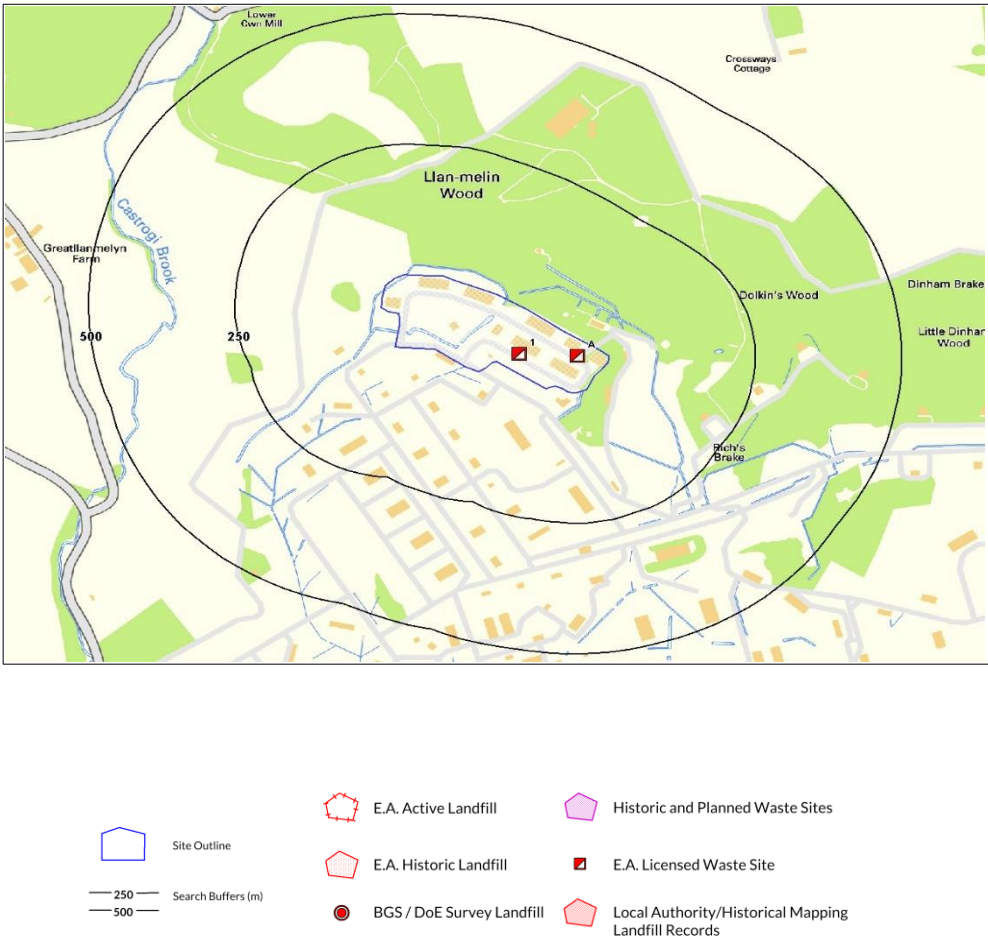
FIGURE 5: WASTE SITES

The data search returned 4 waste treatment licenses for the Wormtech composting facility on site. No other waste treatment, transfer or disposal sites were identified within 500m of the site.

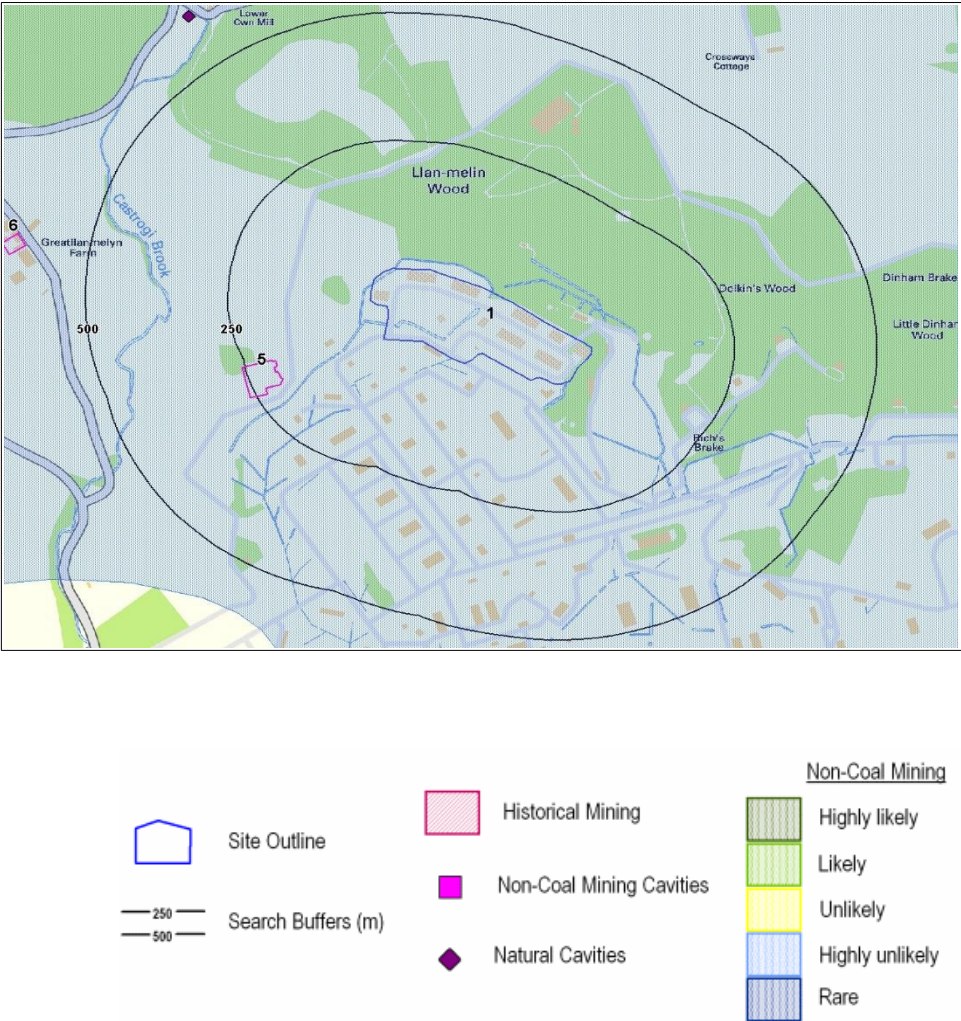
FIGURE 6: HISTORICAL MINING

The Groundsure report identified two historic mining areas within 1000m of the site. The first was located 193m south west of the site. The second was 612m to the west of the site. Both records were from 1902 and do not specify mining type.

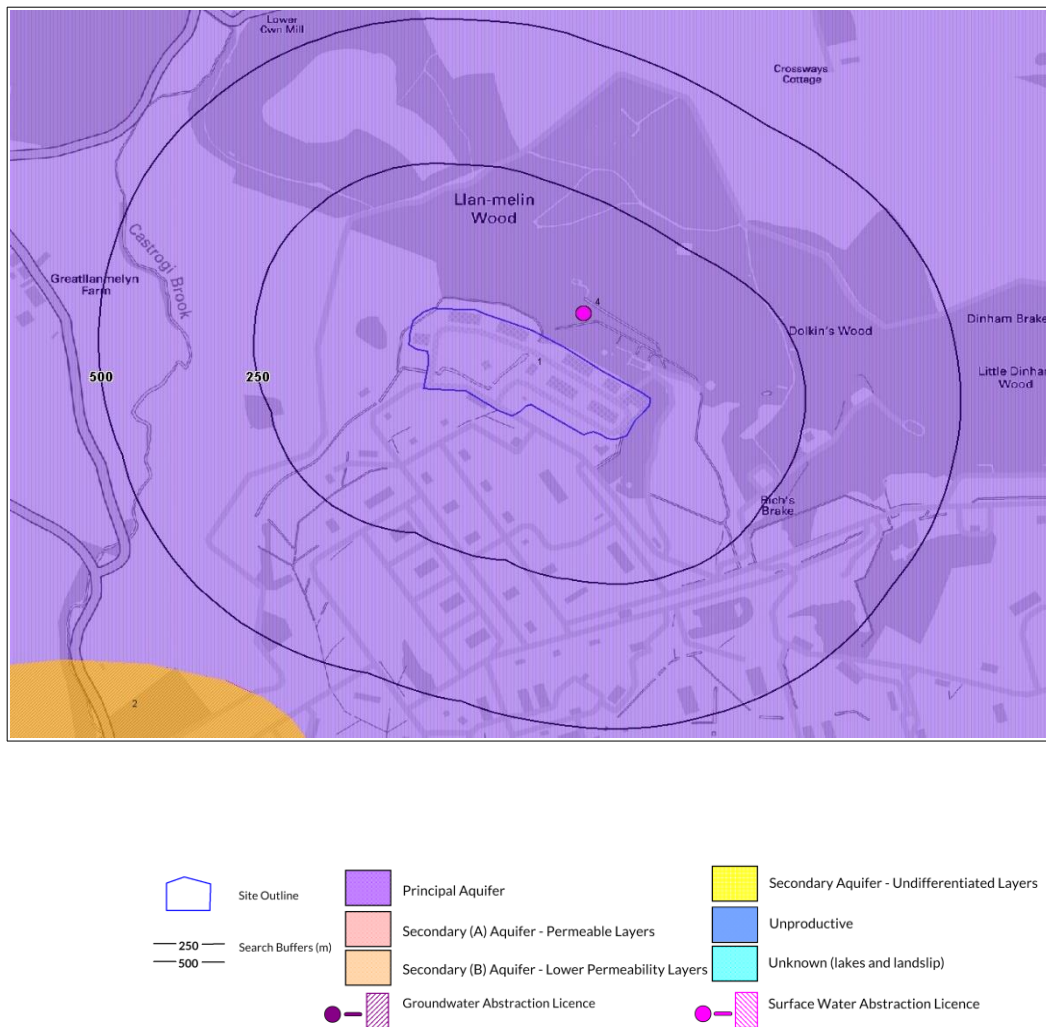
FIGURE 10: AQUIFERS PRESENT IN UNDERLYING GEOLOGY

The bedrock has a high level of permeability. It has been designated as a “Principle Aquifer” by the data search, which is defined as “Geology of high intergranular and/or fracture permeability, usually providing a high level of water storage and may support water supply/river base flow on a strategic scale. Generally principal aquifers were previously major aquifers”. This principle aquifer forms part of the source protection zone (SPZ1) for the Severn Tunnel Great Spring Abstraction at Sudbury.

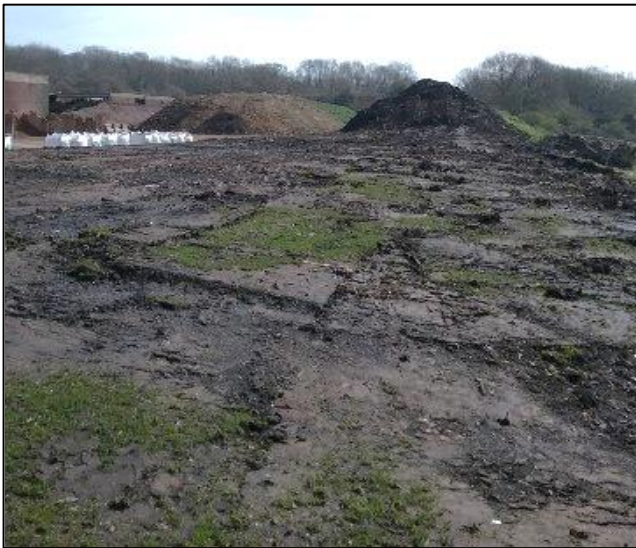
Plate Ref.	Description of Features	Photographs of Features
1	Stockpiles identified in 2013 as A10 and A11 (see 2014 LQA for locations) south of Buildings 1009 and 1008 respectively have been moved. The ground here has been seeded with grass by CTL and was starting to germinate and grow at the time of the site visit in April 2016.

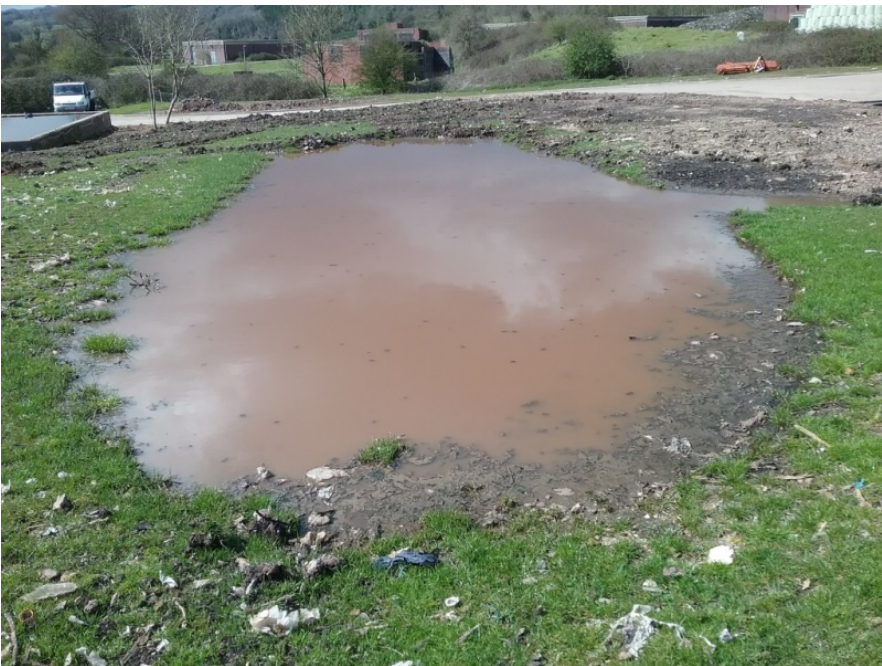
2	The former small leachate collection pit immediately east of the emergency water supply has been infilled and a new shallow sediment settlement pond created, purportedly at the request of NRW. This settlement pond is unlined and collected run-off either soaks to ground or overflows the pond and flows south and west over surrounding ground. The settlement pond was sampled as SW202.

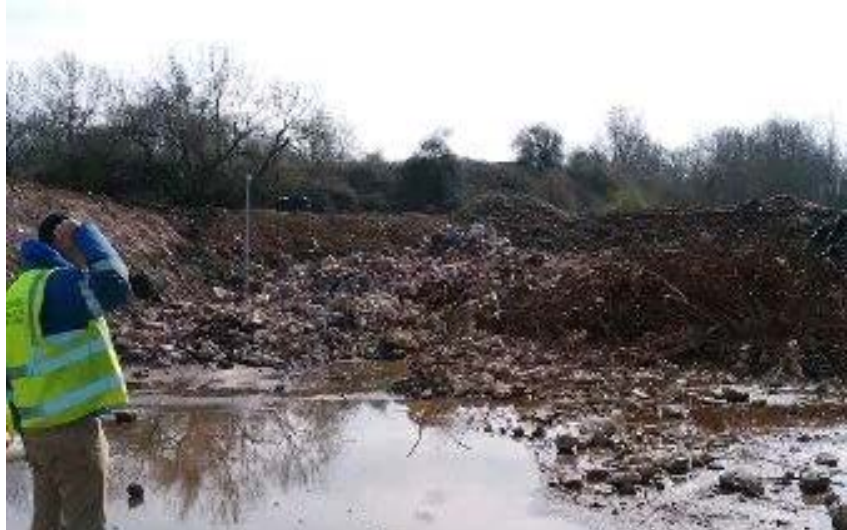
Plate Ref.	Description of Features	Photographs of Features
3	<p>Building 1007, formerly damaged by fire, has been demolished by CTL. The demolition rubble (Stockpile A12 - centre of plate) and steel reinforcement (Stockpile A13 – right of plate) remained on site in April 2016 but were planned to be recycled in the near future.</p>

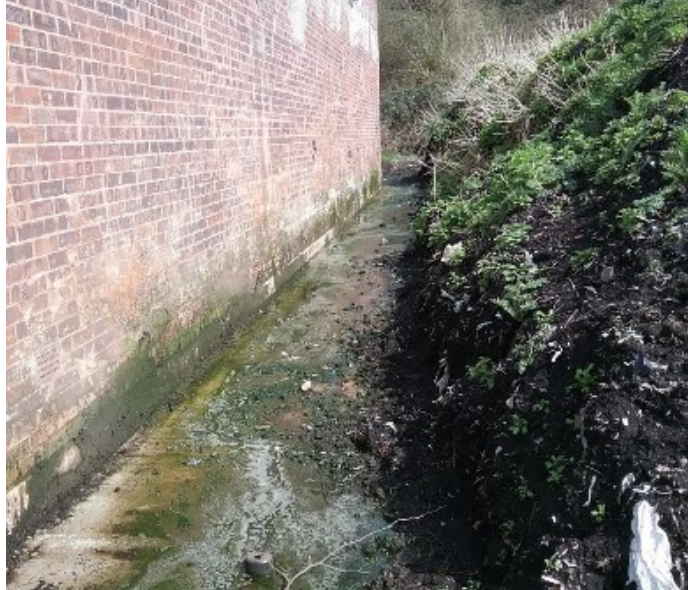
4	<p>Green wastes formerly piled against building walls have been re-profiled in most areas and there is now a small walkway, approx.. 1m wide between waste piles and the buildings. CTL's director has stated that leachate from the green waste was having detrimental effects on the brickwork mortar.</p>

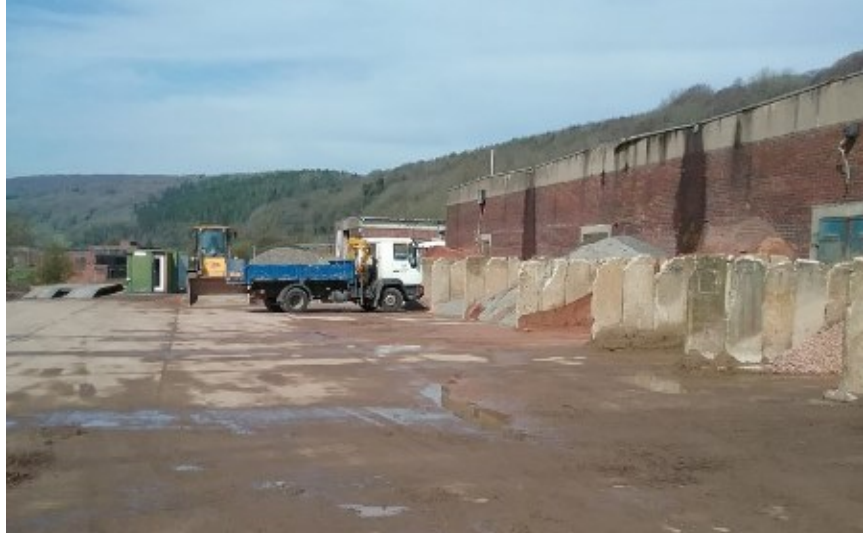
Plate Ref.	Description of Features	Photographs of Features
6	The CTL site accepts waste soils and demolition materials of various types and recycles these as secondary aggregates, soil and topsoil.

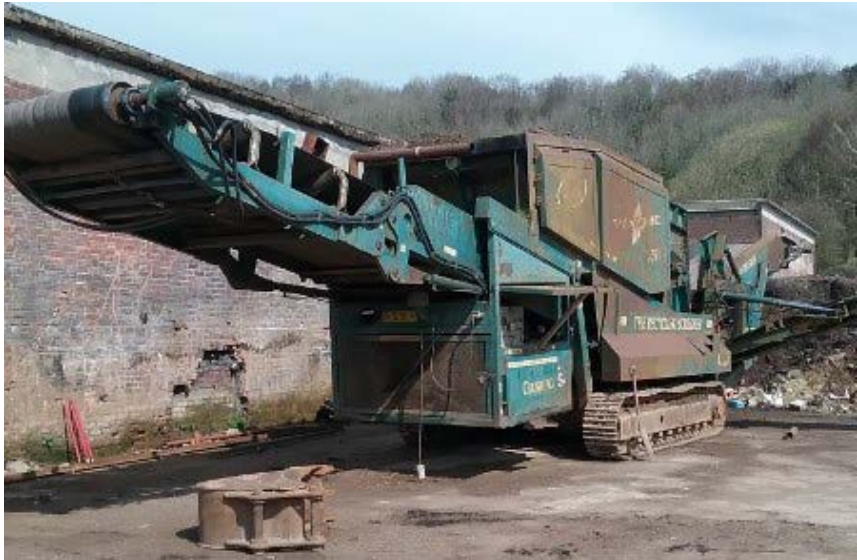
7	A crusher-screener is used to process sub-soils, green wastes and demolition materials by separating the fine and coarse fractions.

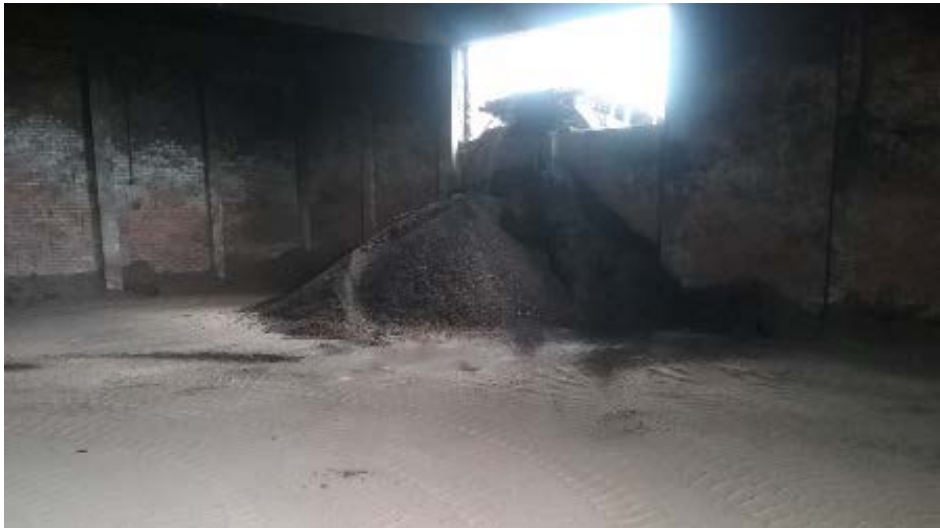
8	A large hole has been cut into the side of Building 1008 in order to deposit processed materials directly from the crusher/screener into the interior of the building. This is of particular use for topsoil as it helps maintain moisture content closer to optimum.

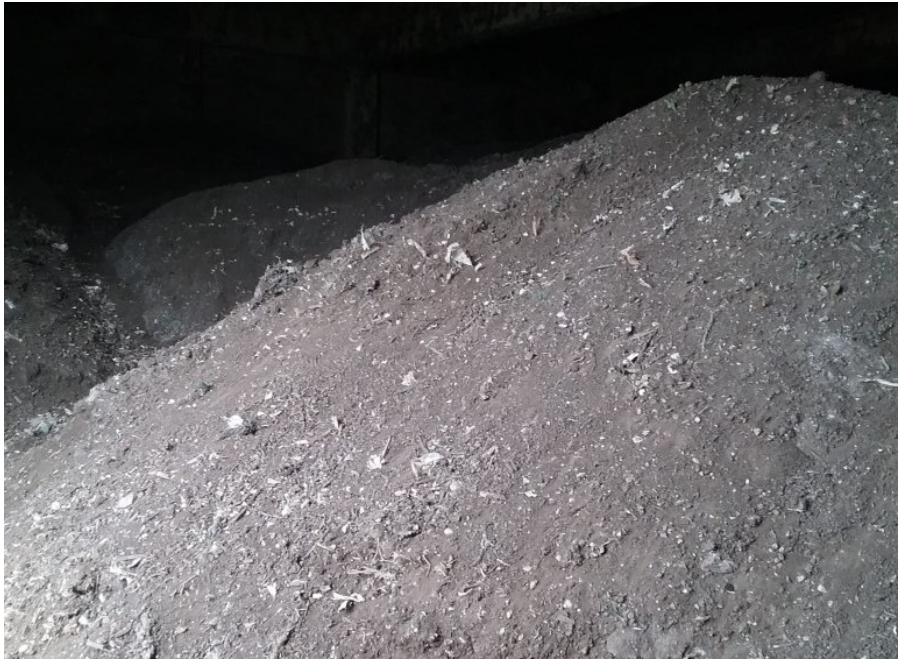
Plate Ref.	Description of Features	Photographs of Features
11	Close up view of part treated green waste.

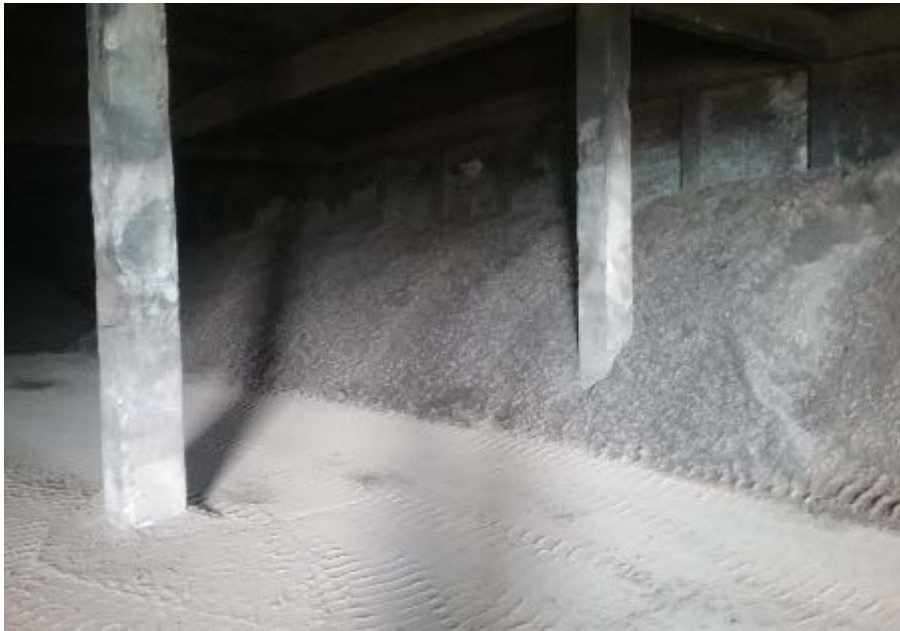
A close-up photograph showing a large pile of dark, moist, and crumbly material, likely treated green waste, under artificial lighting.
12	During the site visit on 27 th March the interior of Building 1008 had started to fill up with topsoil, indicating that some topsoil processing had been undertaken in the preceding fortnight. These soils were not able to be included in the photogrammetric survey but their total volume is estimated to be approximately 220 m ³ .

A photograph showing the interior of a building, identified as Building 1008, which is filled with a large volume of topsoil. The soil is piled up against the walls and floor, with concrete pillars visible in the foreground.

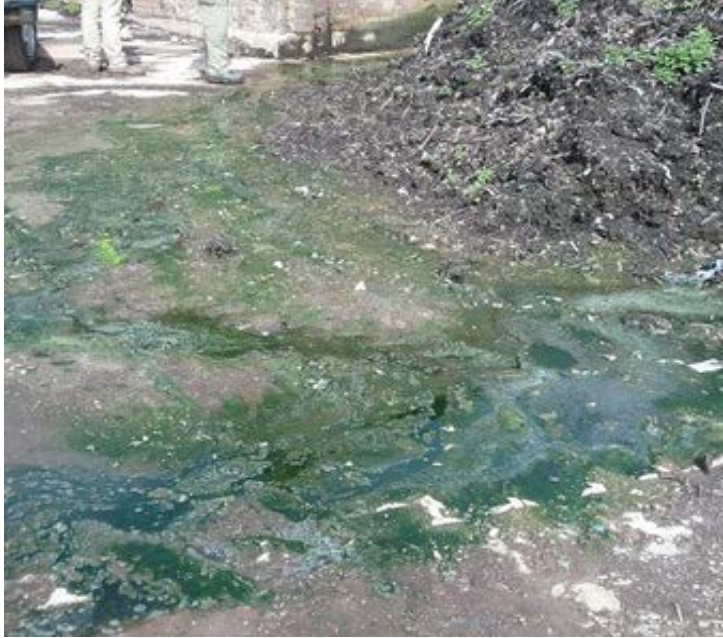
Plate Ref.	Description of Features	Photographs of Features
19	Leachate being generated from Stockpile A5.

A photograph showing a large, dark, and wet stockpile of material on the right side of the frame. In the foreground, there is a patch of ground covered in green, slimy leachate that has seeped out from the base of the stockpile. The leachate has a thick, gelatinous appearance.
20	Leachate derived from Stockpile A4 between Buildings 1002 and 1003. Leachate runs along road and soaks into the verge adjacent to Building 1002 or evaporates.

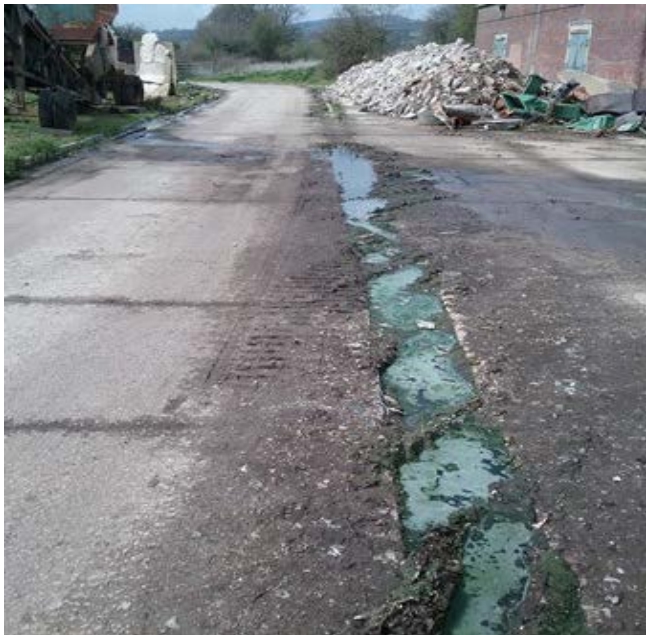
A photograph showing a paved road with a large, dark, and wet leachate spill running along its edge. The leachate is dark and has a thick, gelatinous appearance. In the background, there are buildings and a large pile of debris or rubble.

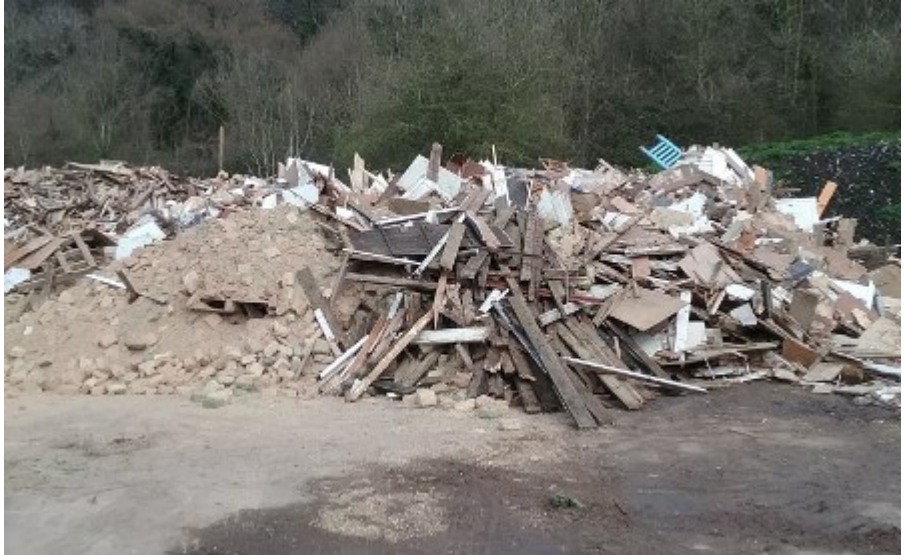
Plate Ref.	Description of Features	Photographs of Features
21	Stockpile A7. CTL also process waste wood and timber on site – turning it into wood chip.

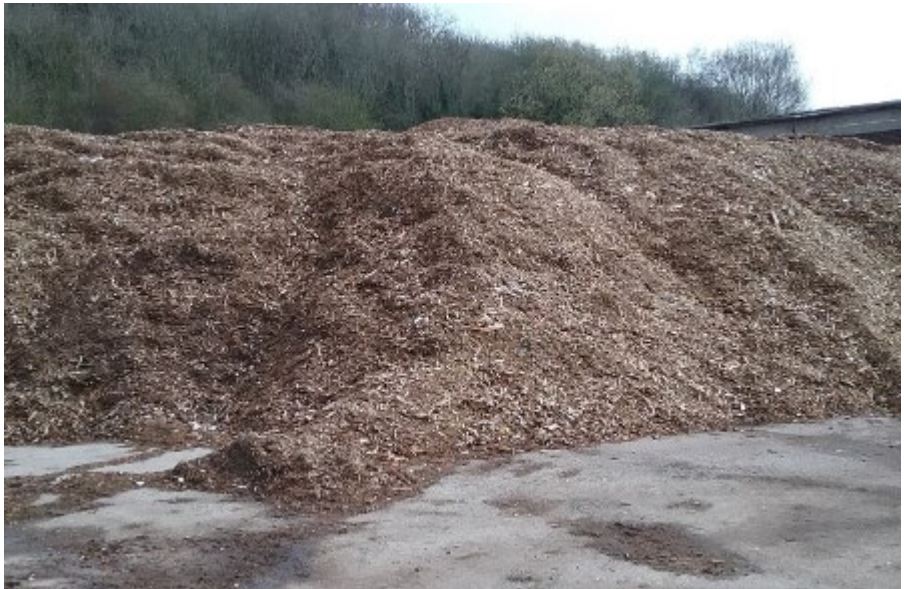
22	Stockpile A1. Chipped wood stored in a pile located between Buildings 1003 and 1004. No significant sign of leachate was observed around the wood chip pile.

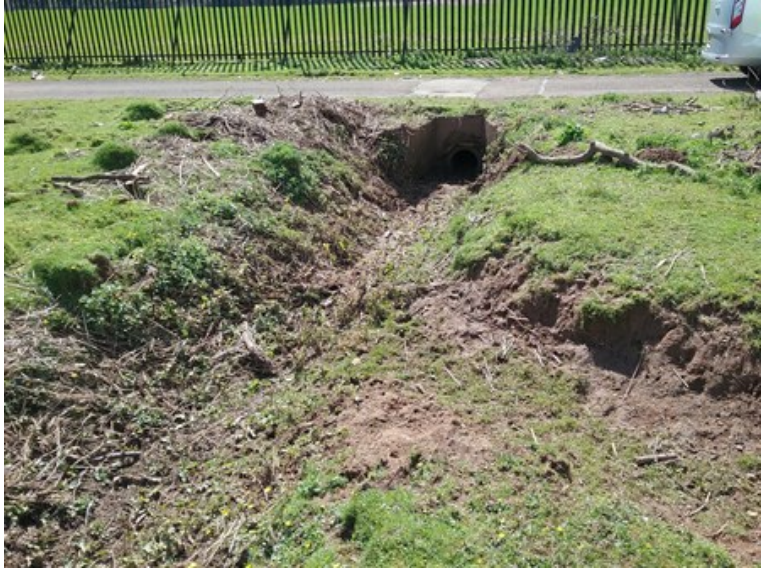
Plate Ref.	Description of Features	Photographs of Features
28	SW102 – dry at the time of the site visits

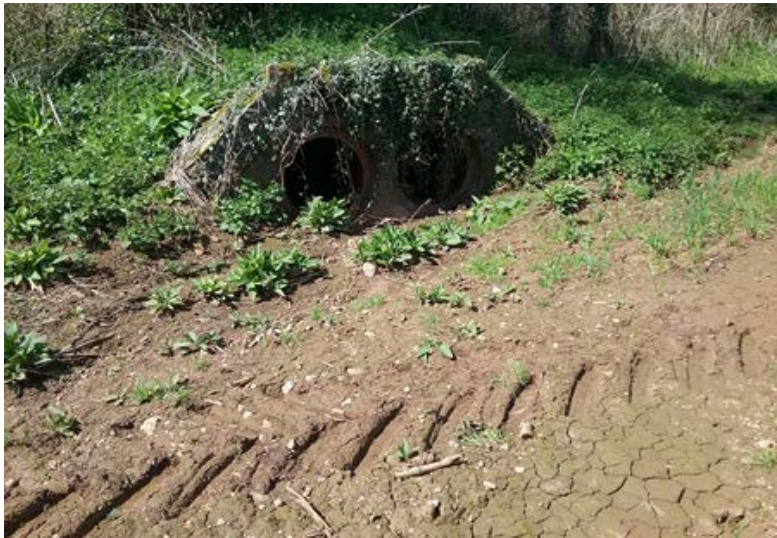
29	View of the Field Culvert. The field was dry at the time of the site visits.

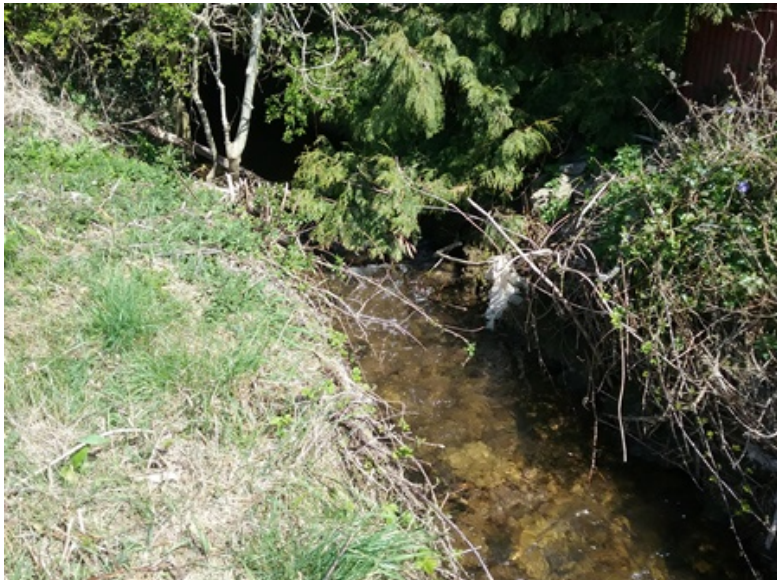
30	View of SW104 at the downstream side of the culvert on the Cas Troggy. The water was clear and had a moderate flow.
