DTE Caerwent: Former Wormtech Area LQA2 Addendum

Defence Infrastructure Organisation

Environmental Monitoring at DTE Caerwent

B2355900 | 1

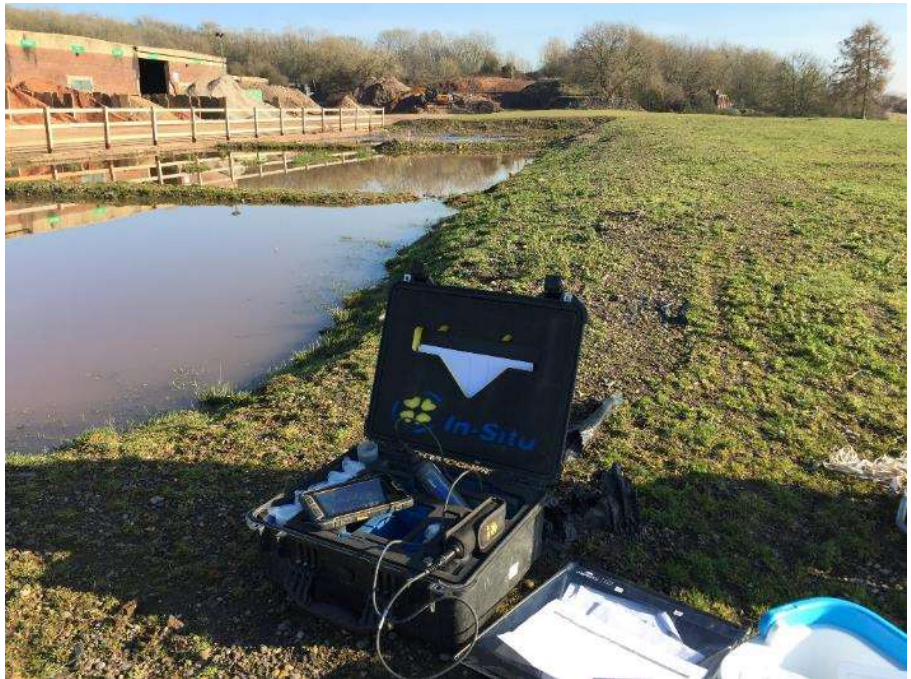
Plate Ref.	Description of Features	Photograph of Features
1	Stockpiles identified in 2013 as A10 and A11 (see 2014 LQA ¹ for locations) south of Building 1008 were removed prior to the 2017 walkover. The location is now a grassed verge with lined attenuation ponds. Plastics and other debris were noted in the topsoil of this grassed area, primarily to the east in the vicinity of the Wormtech stockpiles.

Improvements were observed to drainage at the site since 2017, with the creation of attenuation ponds (Plates 1 & 2) and existing drainage channels cleared of waste and vegetation. Runoff is now directed into these channels rather than allowed to freely drain across the site. The efficiency of this could not be assessed due to the dry

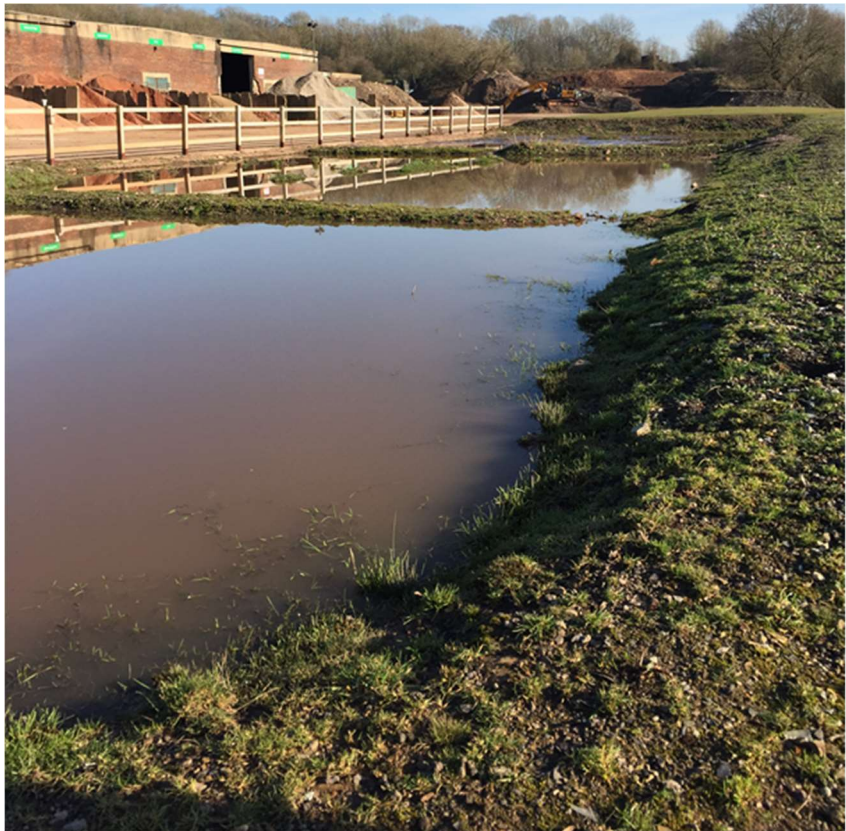
Plate Ref.	Description of Features	Photograph of Features
2	<p>The former small leachate collection pit immediately east of the emergency water supply is now a 50m x 15m attenuation pond with 2 No. raised separators, lined with 1mm high density polyethylene (HDPE). Depth of the ponds is unknown although it appears to be shallow at a maximum of approximately 40cm. During the 2017 visit, it was noted these ponds were unlined and have since been lined at NRW's request.</p> <p>It is unclear how leachate or runoff generated within the site would reach the attenuation ponds. Collected run-off would then overspill the attenuation ponds once they reach capacity and drain east via a gully into a ditch.</p> <p>The attenuation pond was sampled as SW202.</p>

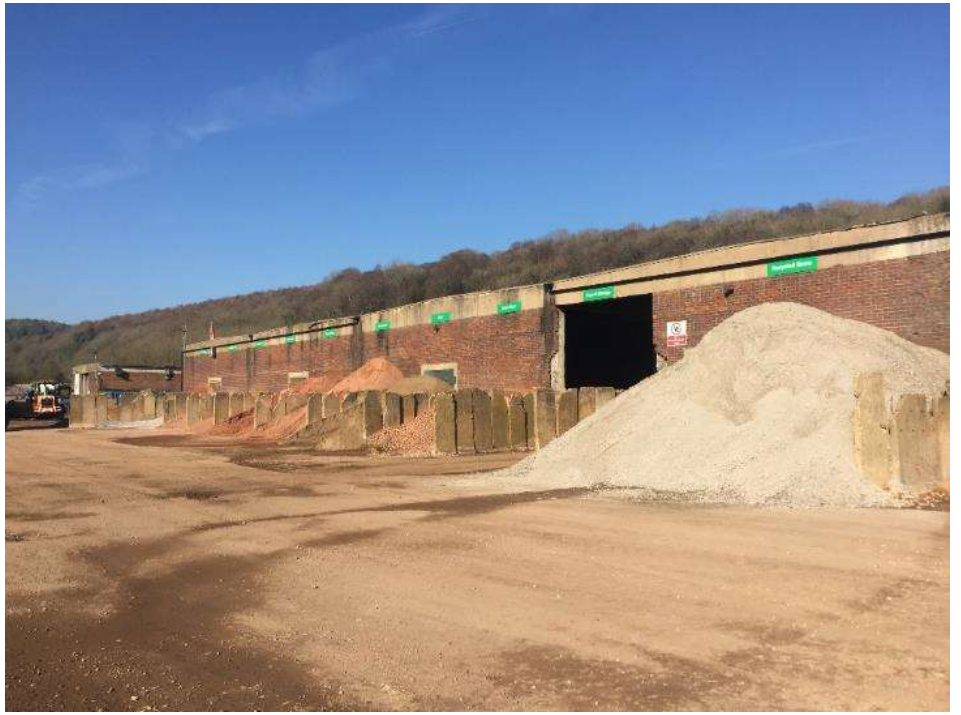
Plate Ref.	Description of Features	Photograph of Features
5	CTL resells imported aggregate which is stored in temporary bays outside Building 1008.

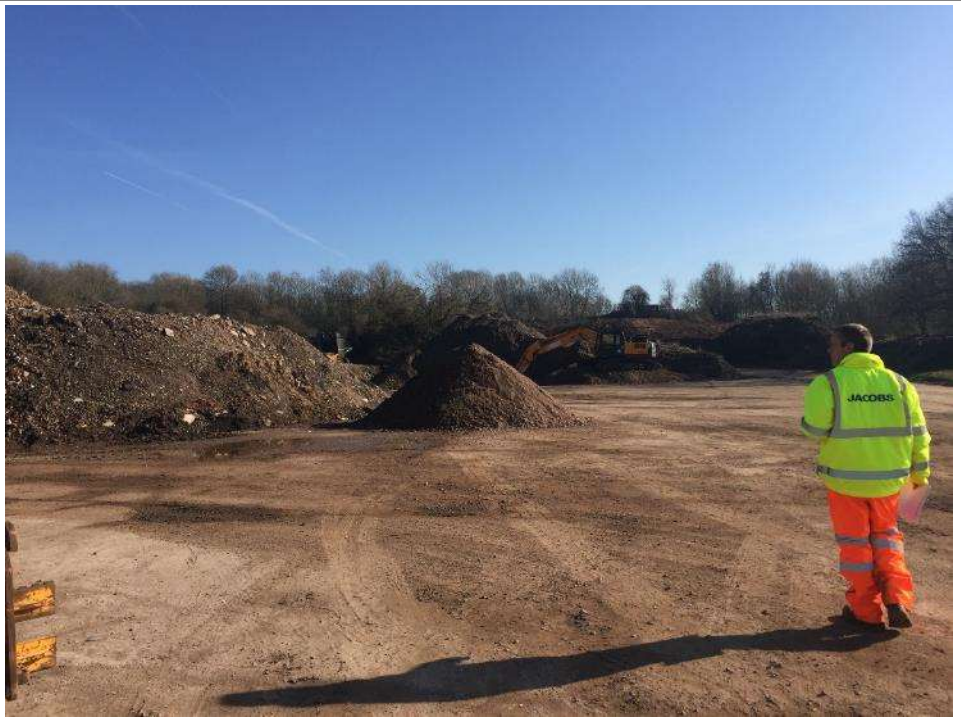
6	<p>The CTL site has stockpiles of waste soils and demolition materials, most of which precedes the EP revocation.</p> <p>Demolition materials present on site have been sourced from demolition of buildings and material crushing within DTE Caerwent, and subsequently stored within the CTL boundary.</p>

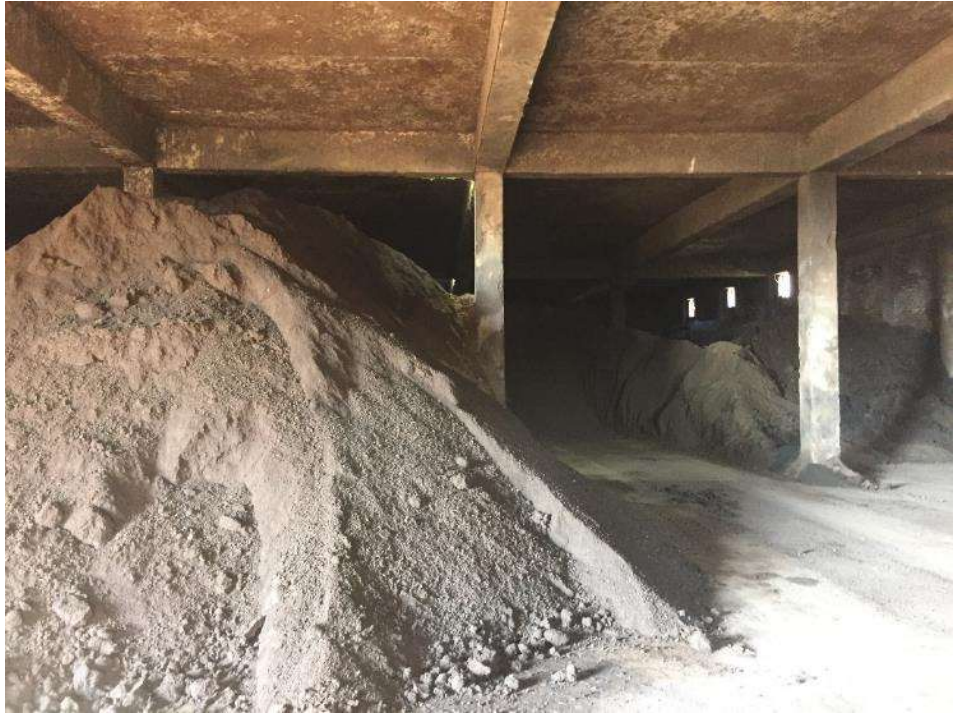
Plate Ref.	Description of Features	Photograph of Features
7	Building 1008 contains topsoil which predates the revocation of CTL's EP. It is understood that this is still being sold from the site. It is noted that this topsoil has not been produced from the former Wormtech materials on site. The building is approximately 50% full of this material.

There appears to be a significantly lower volume of waste and aggregate stored at the CTL site in general, attributed to the revocation of the EP resulting in cessation of CTL's onsite material processing. One stockpile of processed topsoil was observed in Building 1008, which is noted to pre-date the EP revocation and is currently being sold (Plates 7 & 8).

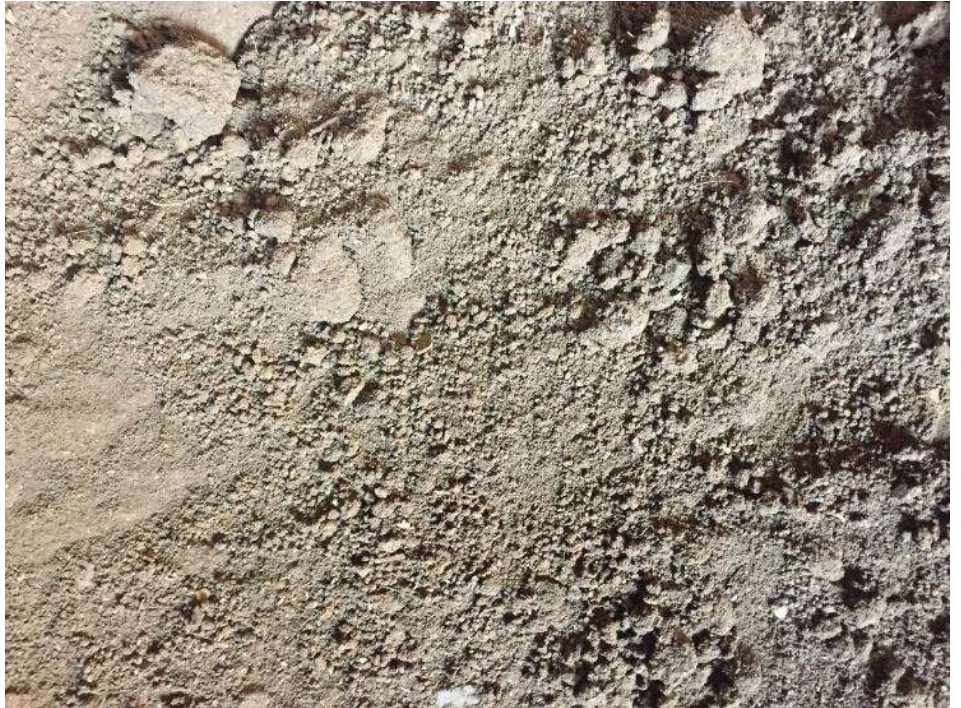
8	Close-up view of finished topsoil material shown in Plate 7. There is no evidence of bagging of this material for sale.

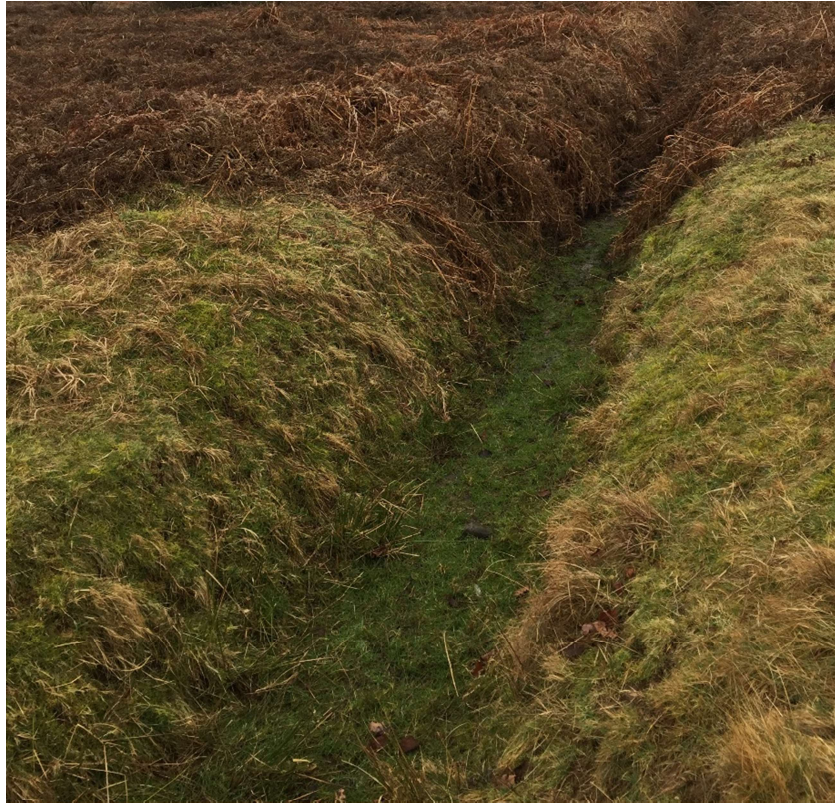
Plate Ref.	Description of Features	Photograph of Features
15	View of SW105, down-gradient of FWA, looking southwards. Ditch was observed as being dry and vegetated.

Downstream of the FWA, drainage ditches within the central area of DTE Caerwent were all dry and monitoring points could not be sampled (SW105, SW201 and SW102). These ditches meet the drains connected to the FWA, approximately 340 m north-north-east of SW102. Inspection of these drainage ditches found them all to be dry and as a result there was no flow observed into the Cas Troggy brook from DTE Caerwent.

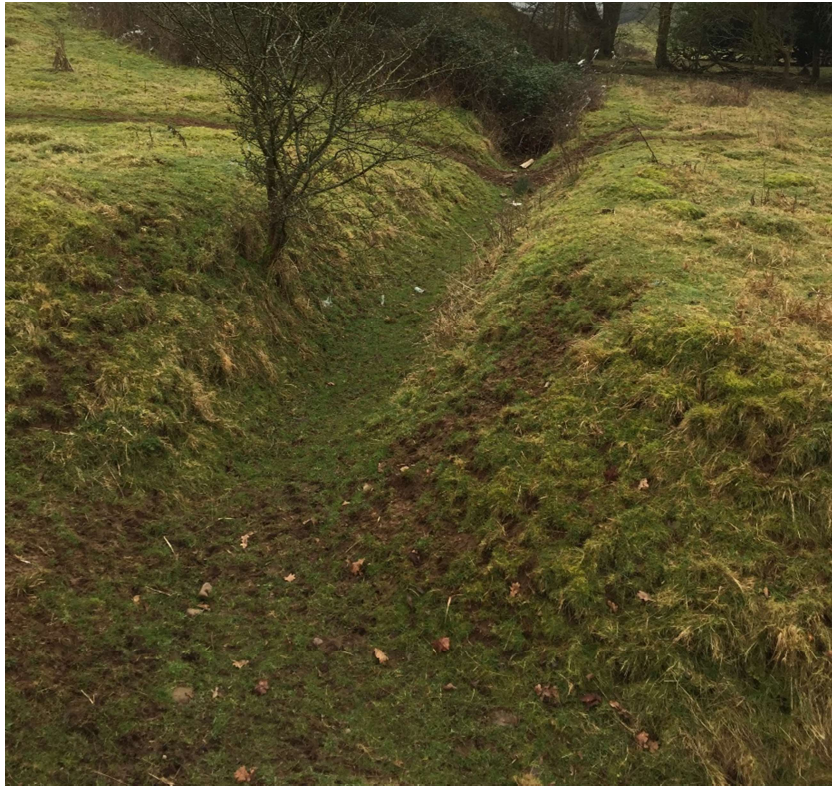
16	SW201, down-gradient of FWA, looking south. The furthest downstream point within this drainage ditch. The ditch was observed as being dry and vegetated.

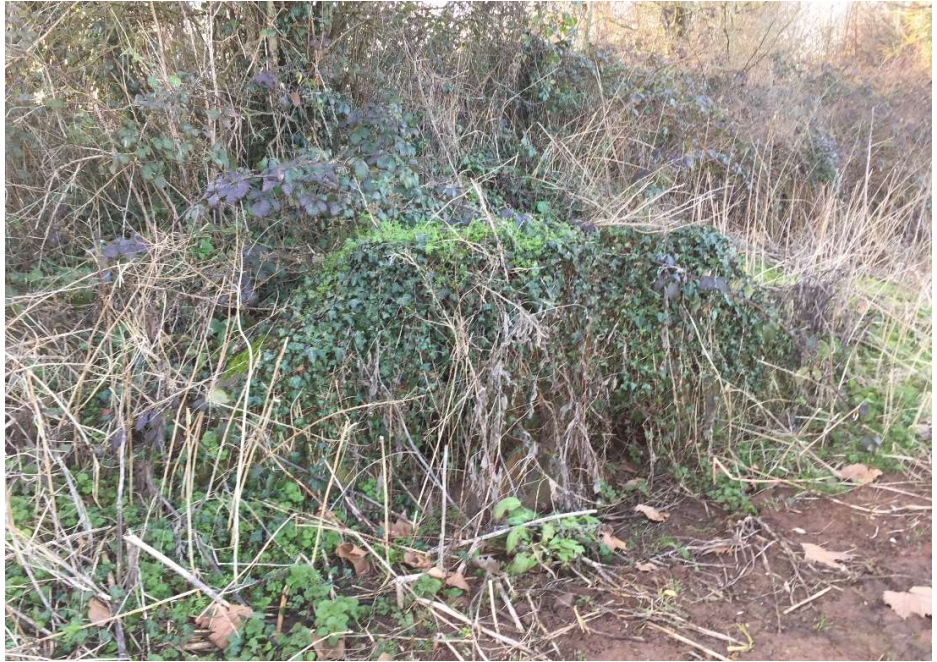
Plate Ref.	Description of Features	Photograph of Features
19	View of the Field Culvert. The field was dry at the time of the site visit and the culvert heavily overgrown.

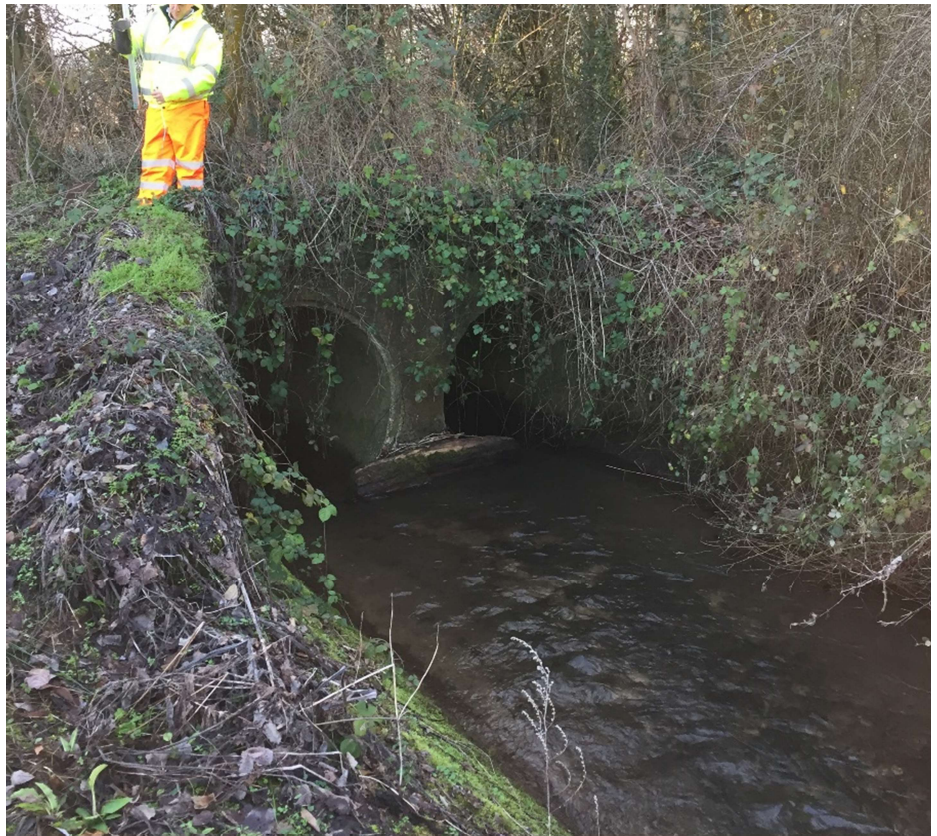
20	View of SW103 at the upstream side of the culvert on the Cas Troggy, looking south. The water was clear and had a moderate flow.

The Cas Troggy brook (SW103 and SW104) had a moderate flow, with low suspended sediments and an absence of odour, sheen or foam noted at both sampling locations.

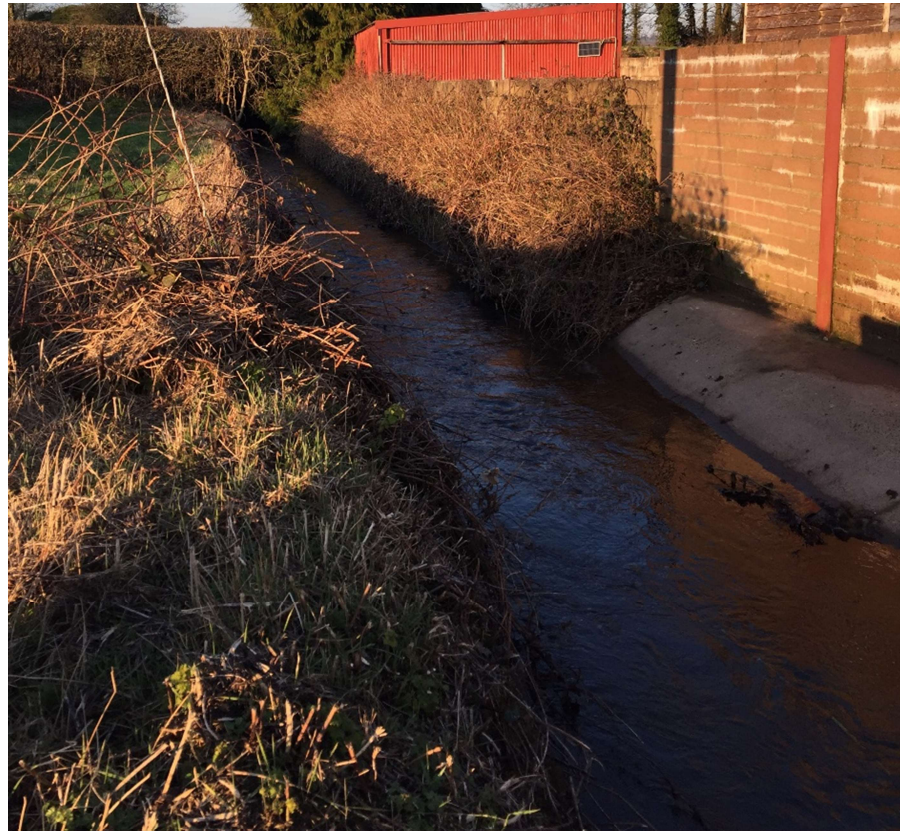
Plate Ref.	Description of Features	Photograph of Features
21	View of SW104 at the downstream side of the culvert on the Cas Troggy, looking north. The water was clear and had a moderate flow.

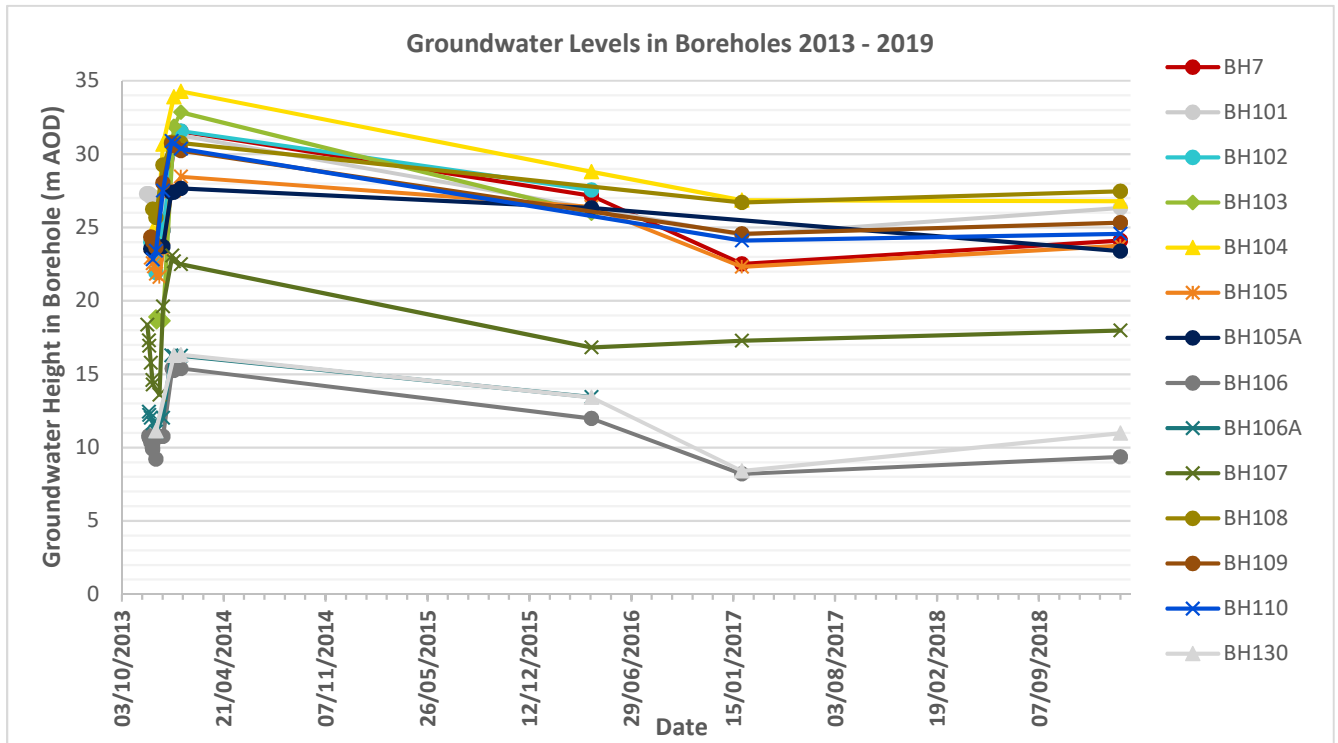
Figure 4.1: Comparison of recorded groundwater levels in boreholes from 2013.

Figure 4.1 shows changes in groundwater heights between the 2013 and 2014 LQA monitoring period and 2016 – 2019 monitoring rounds. The maxima and minima groundwater heights are provided in Table 4.4. BH108 to BH110 are located on the central landfill area, outside of the FWA monitoring zone and have been included to provide information on groundwater depth. This information indicates that groundwater levels during 2019 monitoring are at or just above their lowest recorded height. The levels recorded in BH104 and BH107 were significantly above minimum values for the period 2013 – 2017, but still below historical maxima. Existing groundwater levels are attributed to the dry winter 2018 – 2019 season preceding the recent monitoring.

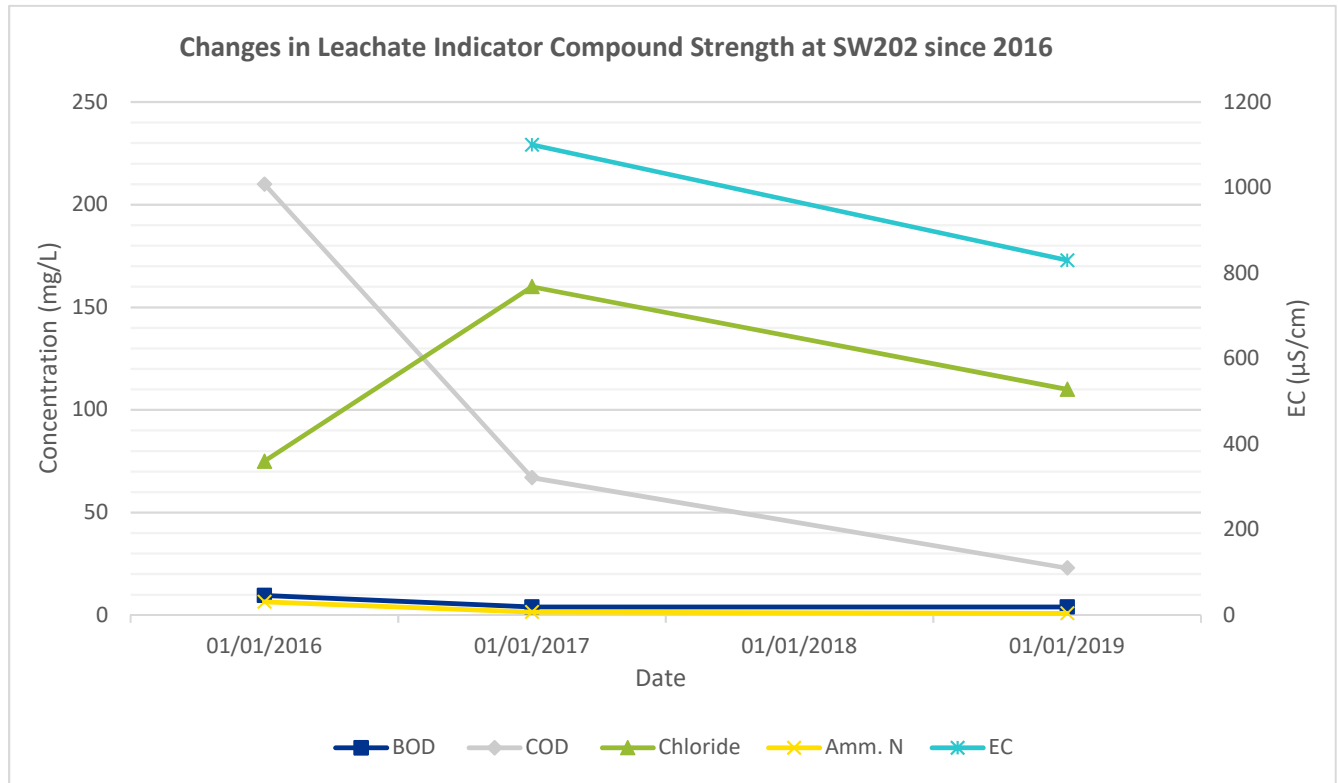
Figure 4.2: Leachate indicator compound concentrations at SW202 since 2016

Figure 4.2 below shows the variation in concentrations of key leachate indicator compounds at SW202, an attenuation pond within the FWA, since 2016. No earlier monitoring data are available as the attenuation pond from which this sample is taken, was constructed by CTL in 2016. Due to the preceding dry weather conditions resulting in low rainfall prior to the site visit, there was no flow within the drainage network within or outside of the FWA. As such, no downstream drainage trend can be evaluated.

Figure 4.2 shows a decline in leachate indicator compounds within SW202 between 2016 - 2019, excluding chloride concentration which increased between 2016 – 2017. Since 2017, BOD has been below the LOD.

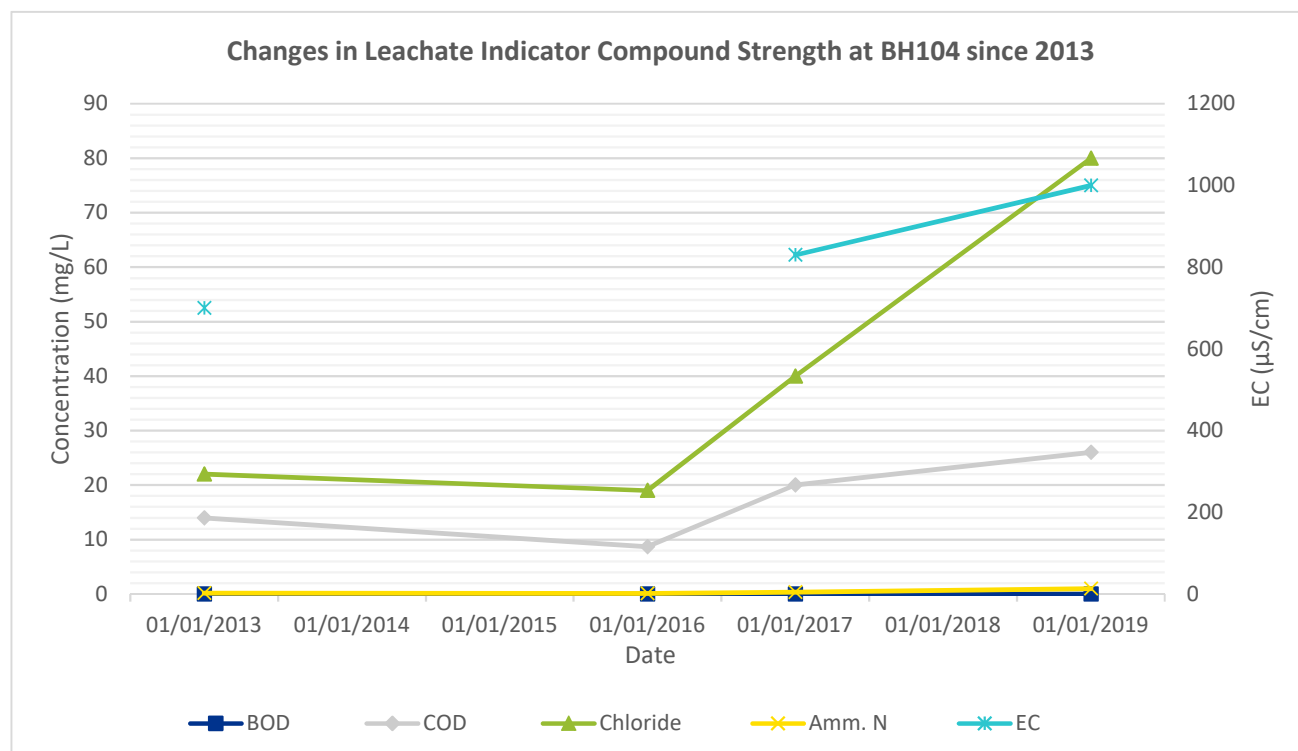
Figure 4.3: Changes in leachate indicator compound concentrations in BH104 since 2013

Concentrations of metals within FWA groundwater samples are markedly reduced in comparison to previous monitoring rounds, and are below the EQS. Only iron exceeded the DWS in three boreholes, with the highest concentration recorded in BH104. No determinand values exceed those observed during the 2017 monitoring round, with the majority having decreased by a factor of 10 since.

Concentrations of leachate indicator compounds in other boreholes within the FWA (BH105, BH105A and BH101) are lower than those identified within BH104 during 2019 monitoring, and are generally lower than previous monitoring rounds.
