# NANTYCAWS LANDFILL

**Landfill Surface Emissions Survey 2019**  
**Prepared for: CWM Environmental**

SLR Ref: 402.00610.00033  
Version No: V01  
January 2020

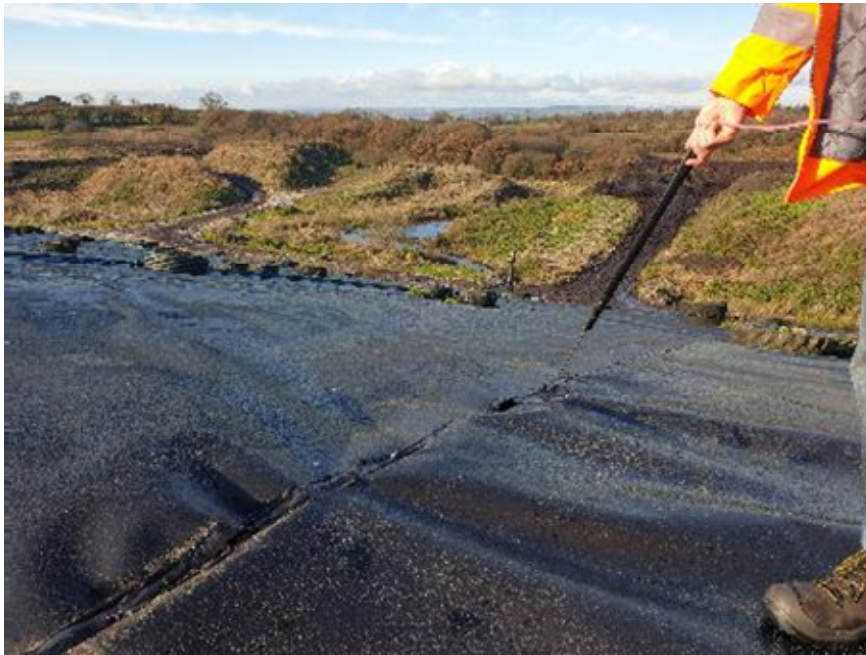
Photo 1: Cap Exceedance #1

| Ref | Grid Reference (NGR) | Maximum Concentration (ppm) | Exceedance Information |
|---|---|---|---|
| Cap1 | 246934, 217536 | >5000 | Near Well #1006 |

| Reference | Remediation undertaken | Maximum Concentration (ppm) |
|---|---|---|
| Cap 1 | Extrusion weld | 0 |

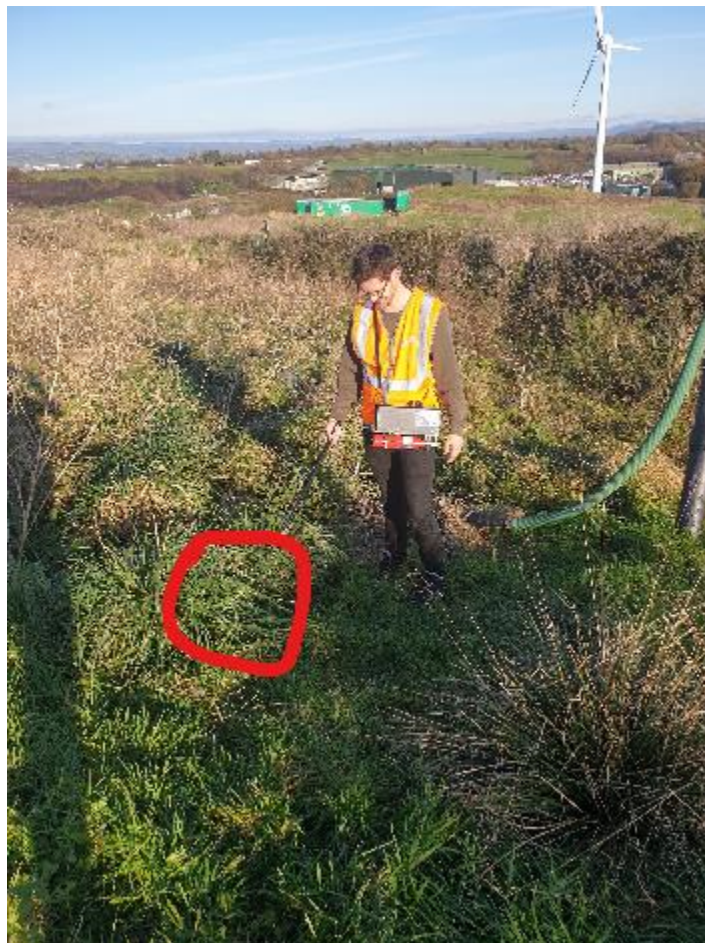
Photo 2: Cap Exceedance #2

| Ref | Grid Reference (NGR) | Maximum Concentration (ppm) | Exceedance Information |
|---|---|---|---|
| Cap2 | 246922, 217431 | >5000 | Near Well #0906 |

| Reference | Remediation undertaken | Maximum Concentration (ppm) |
|---|---|---|
| Cap 2 | Extrusion weld | 0 |

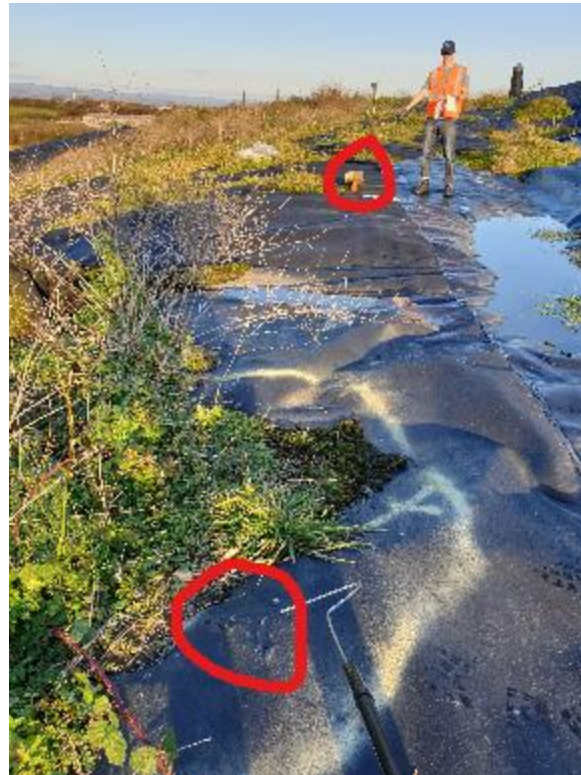
Photo 3: Cap Exceedance #3 and #4

| Ref | Grid Reference (NGR) | Maximum Concentration (ppm) | Exceedance Information |
|---|---|---|---|
| Cap 3 | Area of<br>246841, 217444 | >5000 | Near Well# 1410 |
| Cap 4 | | >5000 | Near Well #1410 |

| Reference | Remediation undertaken | Maximum Concentration (ppm) |
|---|---|---|
| Cap 3 | Extrusion weld | 50 |
| Cap 4 | Extrusion weld | 0 |

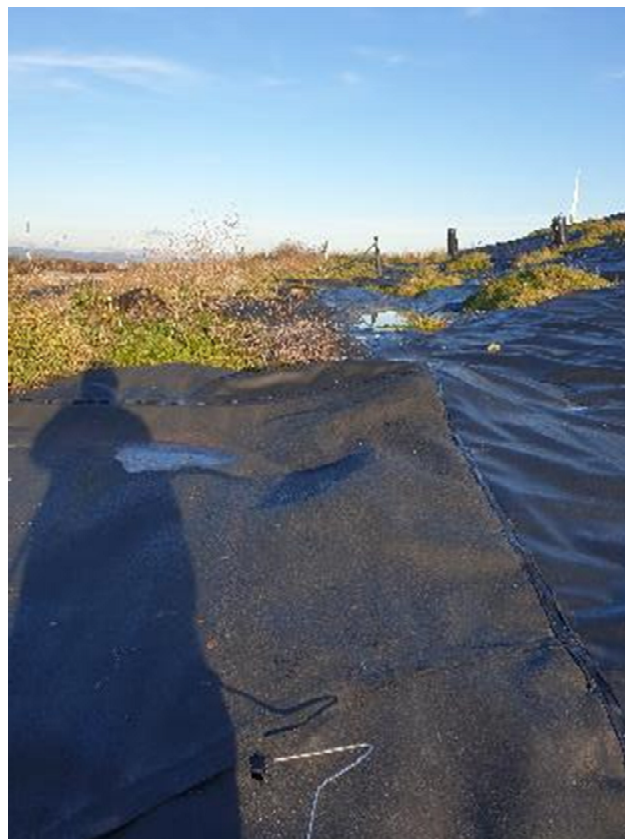
Photo 4: Cap Exceedance #5

| Ref | Grid Reference (NGR) | Maximum Concentration (ppm) | Exceedance Information |
|---|---|---|---|
| Cap 5 | | >5000 | Near Well #1410 |

| Reference | Remediation undertaken | Maximum Concentration (ppm) |
|---|---|---|
| Cap 5 | Extrusion weld | 5 |

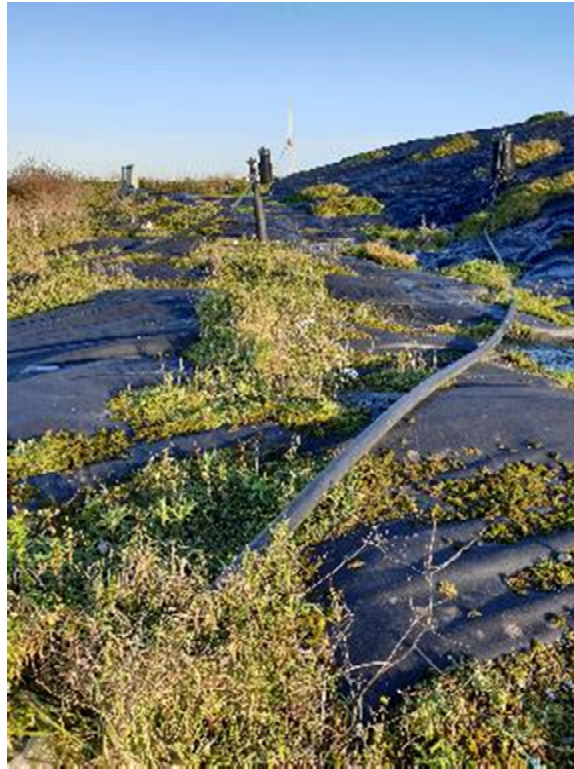
Photo 5: Cap Exceedance #6

| Ref | Grid Reference (NGR) | Maximum Concentration (ppm) | Exceedance Information |
|---|---|---|---|
| Cap 6 | | 400 | Near Well #1410 |

| Reference | Remediation undertaken | Maximum Concentration (ppm) |
|---|---|---|
| Cap 6 | Extrusion weld | 40 |

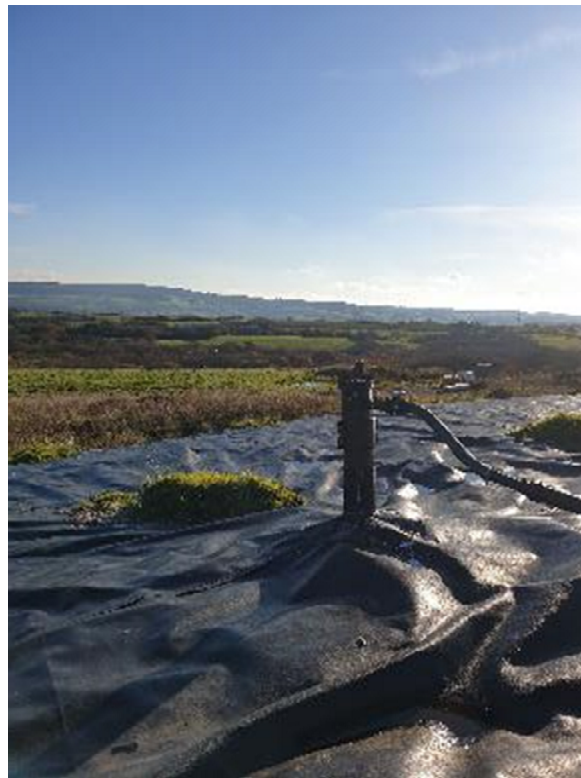
Photo 6: Feature #1 (1206)

| Ref | Grid Reference (NGR) | Maximum Concentration (ppm) | Exceedance Information |
|---|---|---|---|
| F1 | 246894, 217385 | >5000 | Rip in Seam of Base, Well 1206 |

| Reference | Remediation undertaken | Maximum Concentration (ppm) |
|---|---|---|
| Feature 1 | Extrusion weld | 0 |

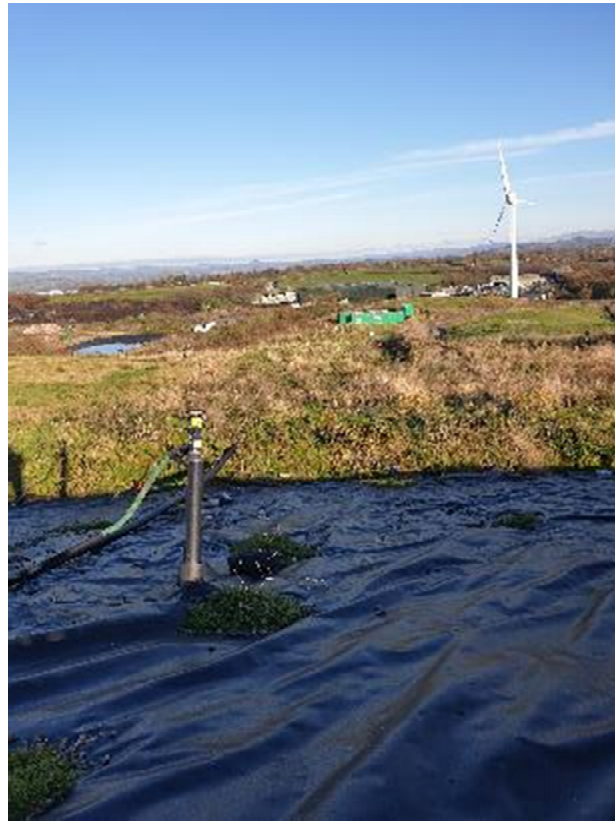
Photo 7: Feature #2

| Ref | Grid Reference (NGR) | Maximum Concentration (ppm) | Exceedance Information |
|---|---|---|---|
| F2 | 246910, 217428 | >5000 | No Reference on Feature, Source = Collar Seal |

| Reference | Remediation undertaken | Maximum Concentration (ppm) |
|---|---|---|
| Feature 2 | Extrusion weld | 100 |

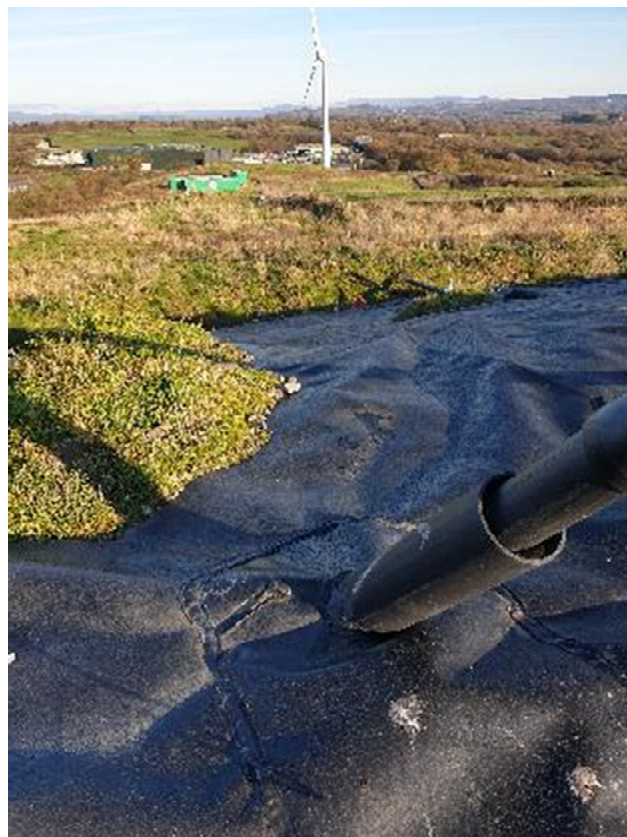
Photo 8: Feature #3

| Ref | Grid Reference (NGR) | Maximum Concentration (ppm) | Exceedance Information |
|---|---|---|---|
| F3 | 246900, 217439 | 1000 | No Reference on Feature, Source = Collar Seal |

| Reference | Remediation undertaken | Maximum Concentration (ppm) |
|---|---|---|
| Feature 3 | Extrusion weld | 0 |

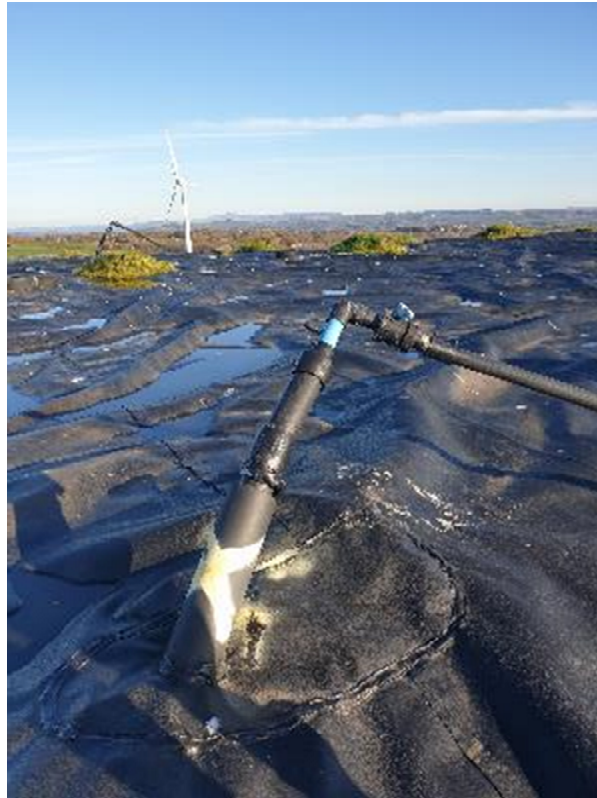
Photo 9: Feature #4

| Ref | Grid Reference (NGR) | Maximum Concentration (ppm) | Exceedance Information |
|---|---|---|---|
| F4 | 246881, 217430 | 1000 | No Reference on Feature, Source = Collar Seal |

| Reference | Remediation undertaken | Maximum Concentration (ppm) |
|---|---|---|
| Feature 4 | Extrusion weld | 50 |

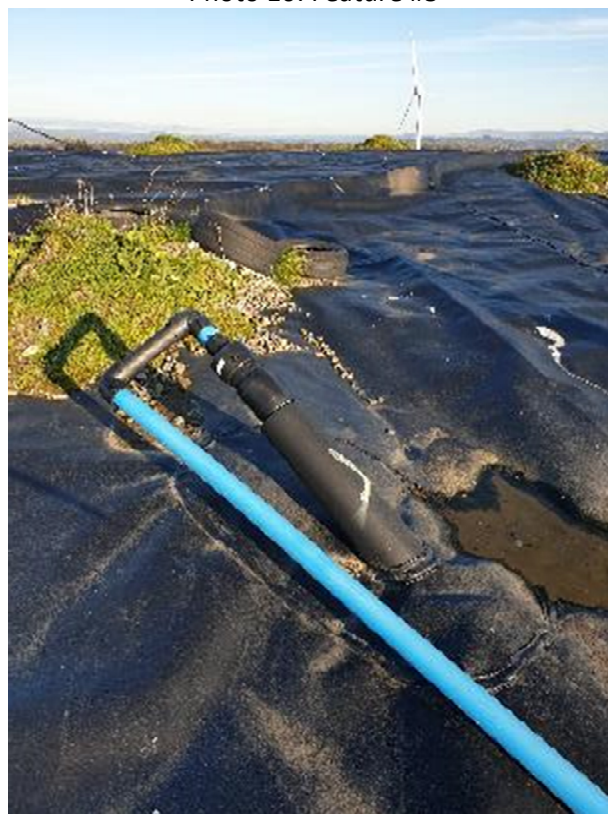
Photo 10: Feature #5

| Ref | Grid Reference (NGR) | Maximum Concentration (ppm) | Exceedance Information |
|---|---|---|---|
| F5 | 246884, 217418 | >5000 | No Reference on Feature, Source = Collar Seal |

| Reference | Remediation undertaken | Maximum Concentration (ppm) |
|---|---|---|
| Feature 5 | Extrusion weld | 0 |

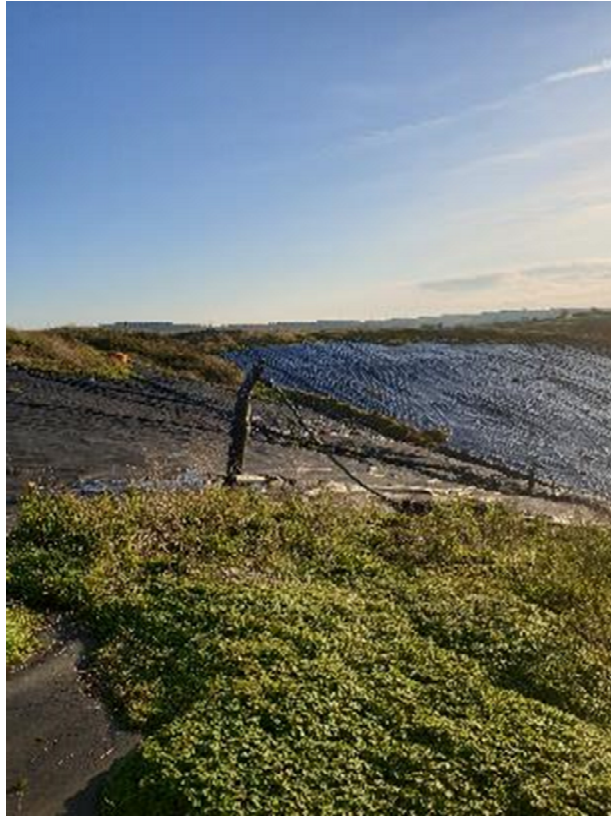
Photo 11: Feature #6

| Ref | Grid Reference (NGR) | Maximum Concentration (ppm) | Exceedance Information |
|---|---|---|---|
| F6 | 246825, 217424 | >5000 | No Reference on Feature, Base of Well |

| Reference | Remediation undertaken | Maximum Concentration (ppm) |
|---|---|---|
| Feature 6 | Extrusion weld | 900 |

Concentrations recorded at feature 6 and feature 8 remained elevated but did not exceed the relevant criteria. These features are to be further looked at by CWM to ensure they don't deteriorate further and remain below the relevant criteria.

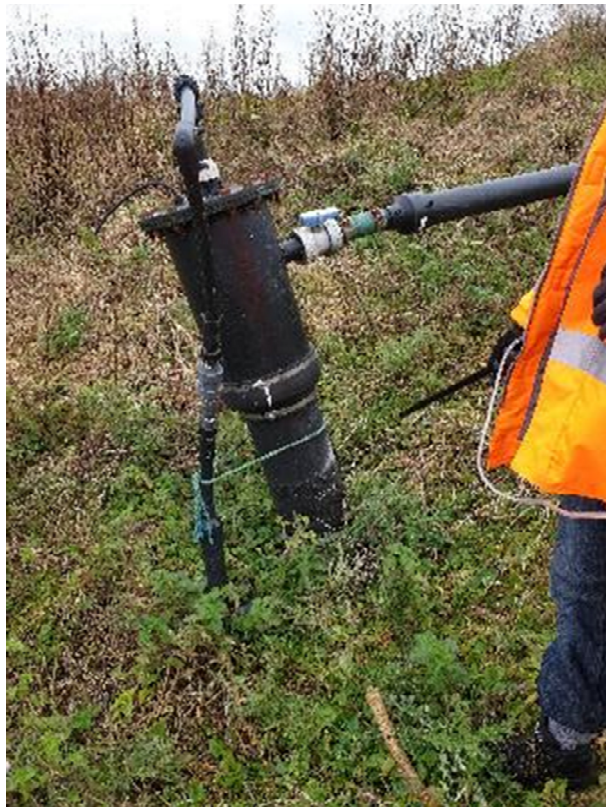
Photo 12: Feature #7

| Ref | Grid Reference (NGR) | Maximum Concentration (ppm) | Exceedance Information |
|---|---|---|---|
| F7 | 246922, 217203 | >5000 | Well NYCL0010, Base of Well |

| Reference | Remediation undertaken | Maximum Concentration (ppm) |
|---|---|---|
| Feature 7 | Extrusion weld | 0 |

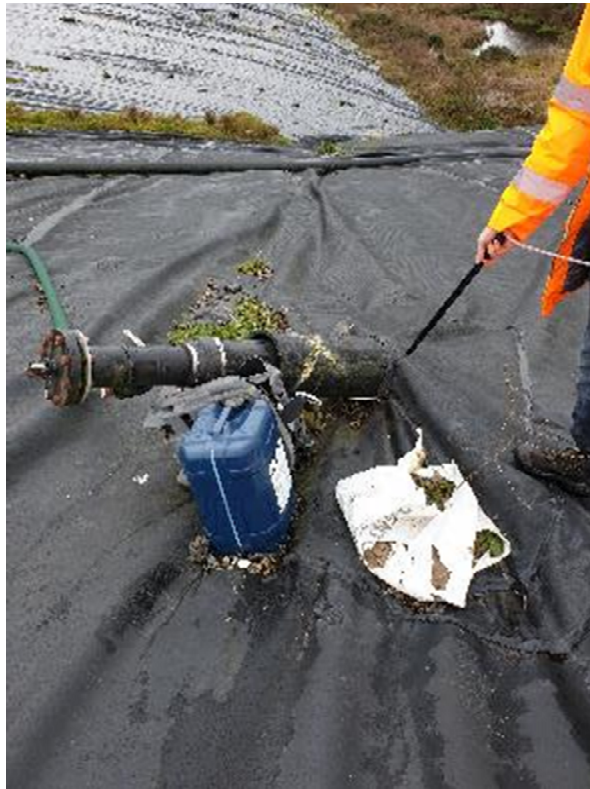
Photo 13: Feature #8

| Ref | Grid Reference (NGR) | Maximum Concentration (ppm) | Exceedance Information |
|---|---|---|---|
| F8 | 246848, 217380 | >5000 | No Reference on Feature, located between Wells 1407 & 1412 |

| Reference | Remediation undertaken | Maximum Concentration (ppm) |
|---|---|---|
| Feature 8 | Extrusion weld | 500 |
