**MORFA NON-  
HAZARDOUS LANDFILL,  
PORT TALBOT**

**PERMIT BV7311IE**

**2019 Annual Review of  
Environmental  
Monitoring**

*Report Number 1965r1v1d0220*

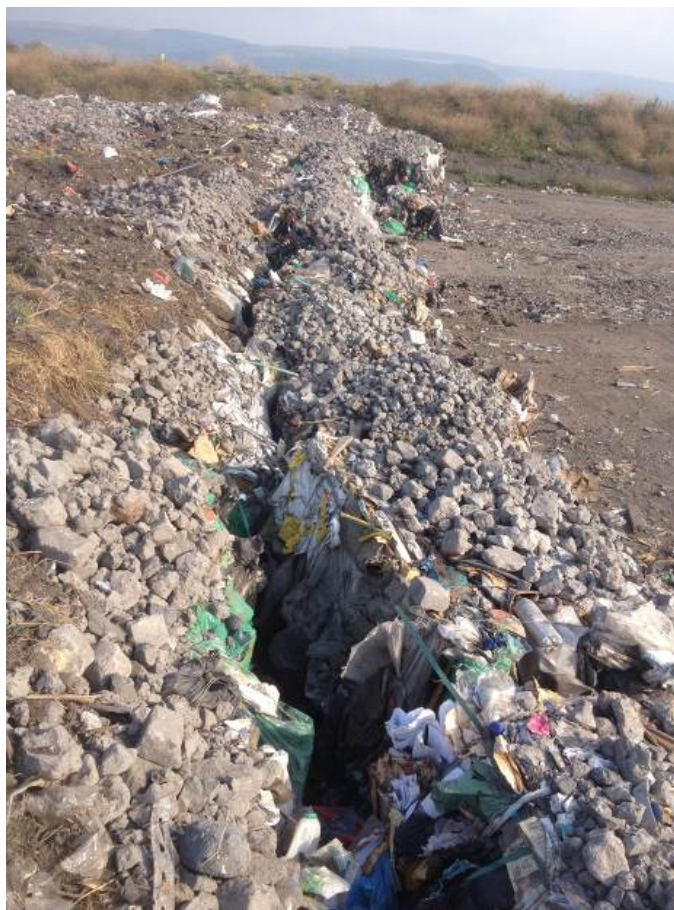
**Plate 4-1 Gaps between bales in bio cell**

The integrity of the internal gas monitoring wells in bio-cells A and B is inspected monthly. There are no problems with this aspect of the monitoring network although the vents, which are open to the atmosphere, are not designed for monitoring. Consequently, the data being gathered is influenced by atmospheric processes and dilution. Some monitoring points in the bio-cell are also difficult / impossible to safely access due to dense growth of buddleia and because the bales are sometimes separated by large gaps. Consequently, not all wells can be routinely safely accessed.

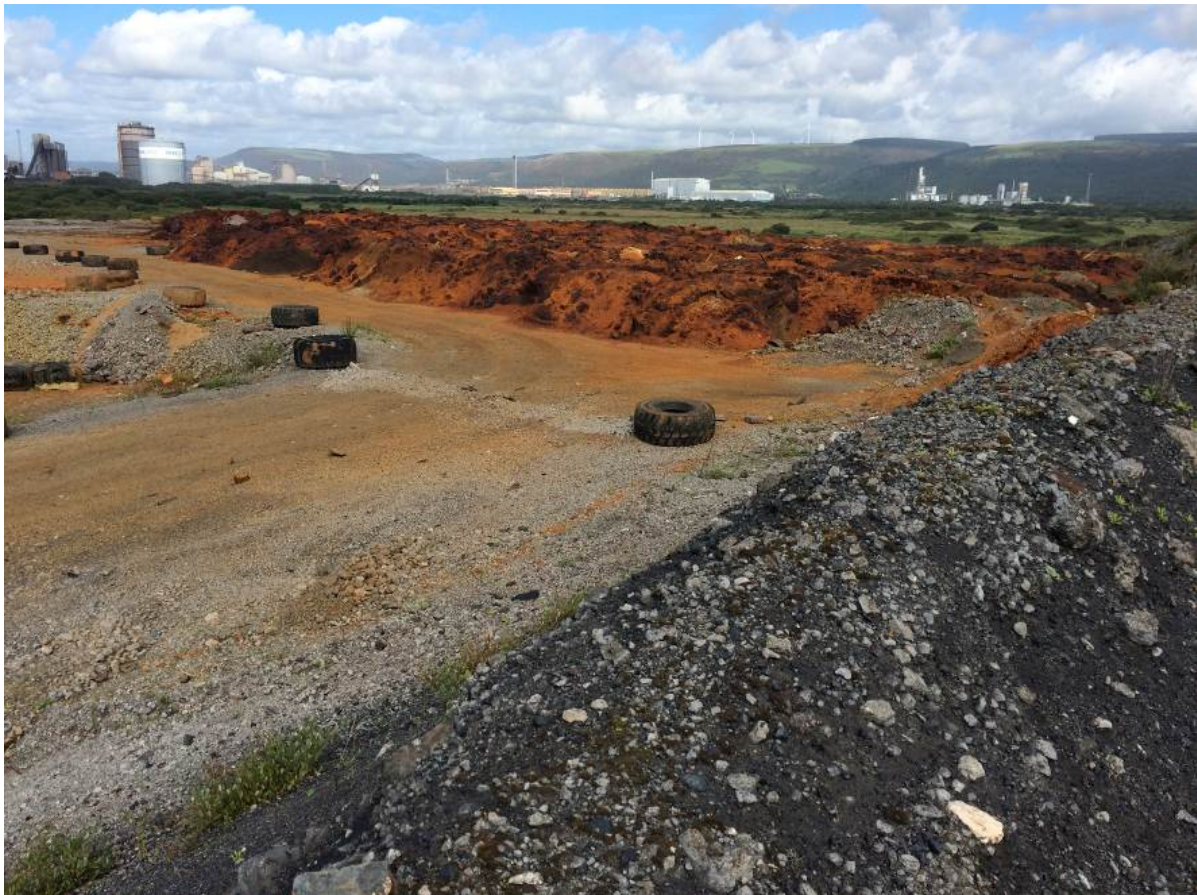
Since October 2008, hot mill sludge (HMS) filter cake generated by the steelworks has been landfilled in Bio Cell B. This process has subsequently continued at a rate of approximately 500 - 700 tonnes/month. In accordance with Improvement Condition 1 of the Variation Notice this prompted the monthly monitoring of Benzo(a)pyrene (BaP) on samples collected from sump L6. In September 2010 this data was reviewed by Geotechnology to establish whether BaP control levels were required (see report 993r1v1d0910). As the data showed that BaP was not detected in the leachate, control levels were not considered to provide additional environmental protection. Benzo(a)pyrene has continued to be present in leachate below the analytical detection limit.

**Plate 6-1 View North over MNHL Cell 2. Note dominance of iron rich filter cake**

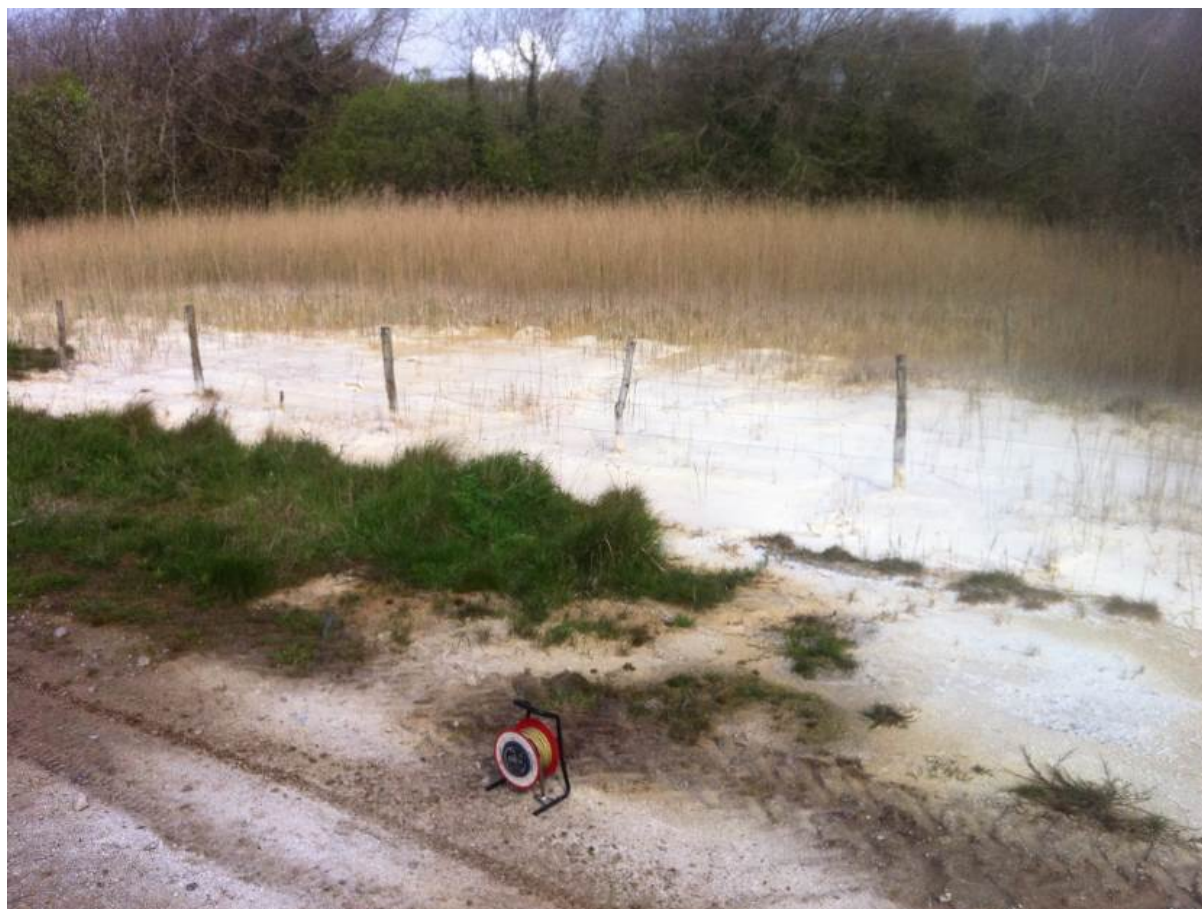
sometimes exposed. Wider dispersion and leaching of these previously accumulated precipitates and groundwater has been previously observed in response to changes in shallow groundwater levels. NRW has approved the covering of these areas with site won sand to limit direct access.

**Plate 6-3 Accumulation of secondary precipitates adjacent to MCL  
(between BH17 and P12)**

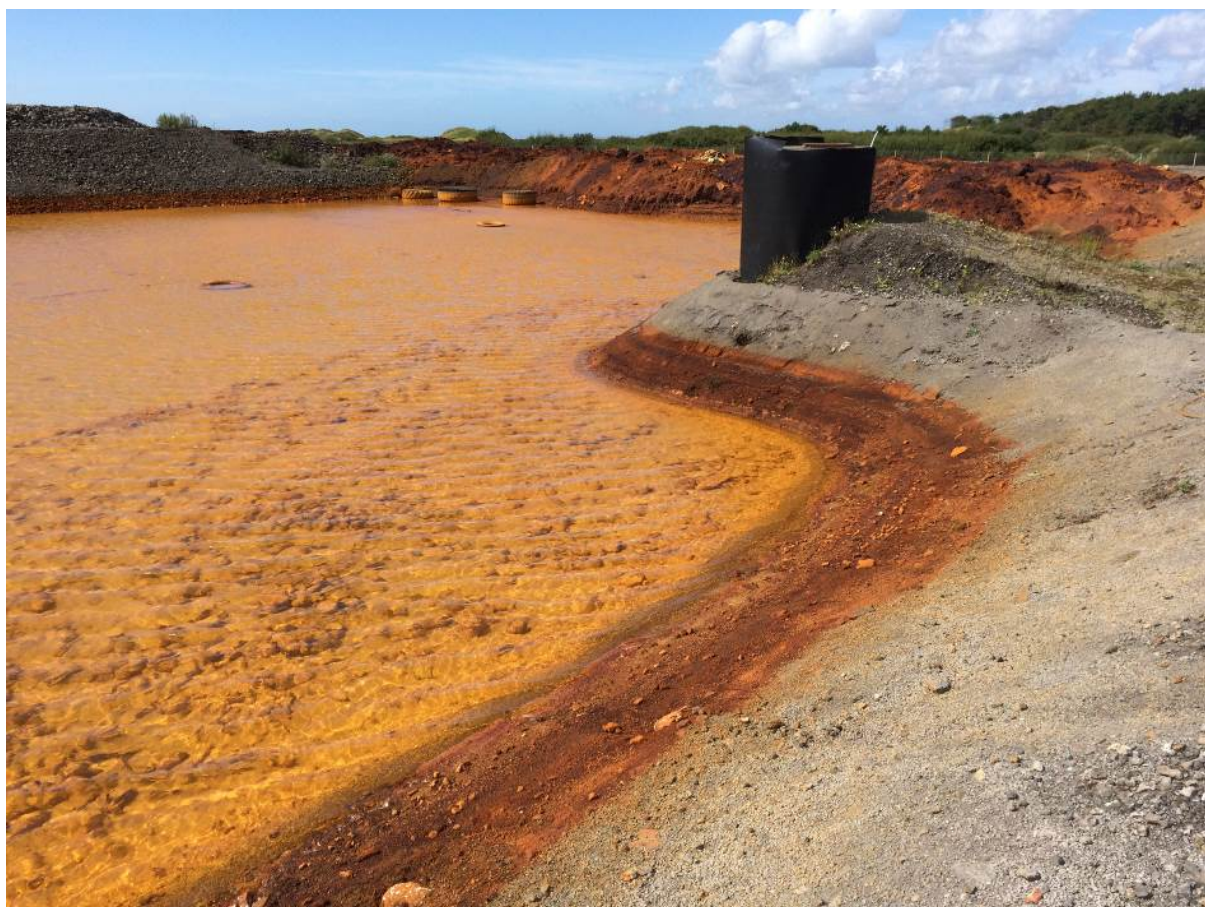
Filter cake (EWC code 11 01 10) has been placed into Cells 1 and 2 (with leachate draining to sumps L7 and L8) at a rate of approximately 500 - 800t/month since the start of monitoring. Produced by the lime neutralisation of acidic ferrous chloride and pickling solutions at the cold mill effluent treatment plant, the waste principally comprises iron oxyhydroxide chloride phases, calcium chloride, iron chloride and mixed oxides. Within the landfill, the soluble components of the waste are leached by infiltration. This process is suspected to be the source of the elevated levels of chloride and calcium. As the waste becomes buried and less oxygenated, the oxyhydroxide iron phases may also start to undergo changes. Some may start to age and crystallise, forming more stable iron oxide phases and some may undergo reductive dissolution in anaerobic conditions that may be

present in parts of the landfill. This latter process could potentially release iron into the leachate along with other trace metals adsorbed to the iron precipitates.

**Plate 8-1 Cell 2 leachate sump L8. Note staining due to iron.**

This latter process was previously considered to be occurring within Cell 2 at L8, as iron significantly increased in concentration from <1mg/l to over 1000 mg/l during the latter part of 2012 and was elevated on several occasions during 2013. At the same time, the leachate sampled at sump L8 was found to be green in colour and the laboratory measured pH variable over a relatively brief time i.e. dropping from over pH 11 to pH 4 and then returning to pH 11 within 12 weeks (see chart below). Similar patterns were observed during 2014, 2015 and 2016. During 2017 no such patterns were observed but in 2018, very acidic pH levels were sometime reported but iron levels remained low. The pH variations may be a consequence of the acid / neutralising components of the waste. In 2019. These variations were less pronounced.
