# **Marine Ecological Surveys at Hafan y Môr, Gwynedd**

Baseline review to inform proposed breakwater development

February 2017

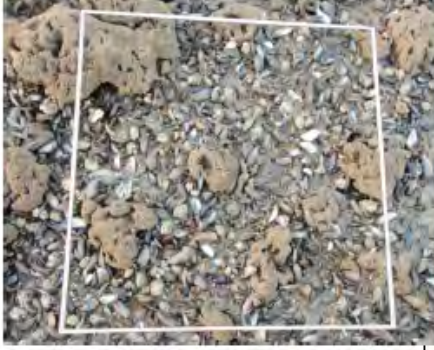
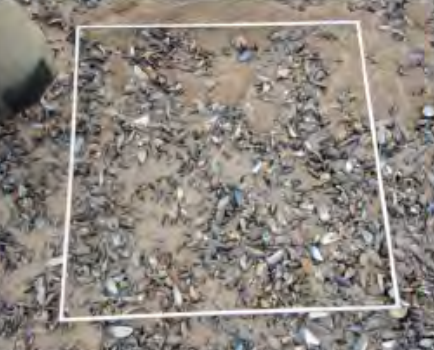
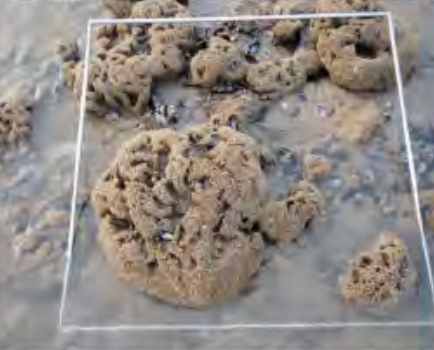
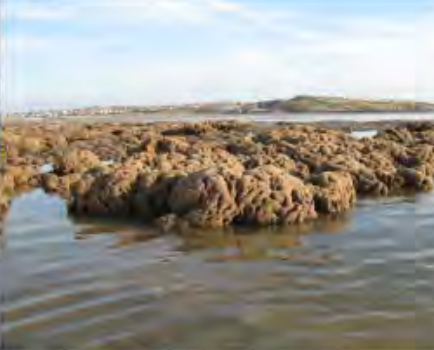
| <b>Formation Type</b> | | | |
|---|---|---|---|
| <b>Patchy</b> | <b>Sheet</b> | <b>Hummock</b> | <b>Reef</b> |
| Small crusts or mounds which are less than 30 cm <sup>2</sup> | Flat crust which are greater than 30 cm <sup>2</sup> | Raised mound which are greater than 30 cm <sup>2</sup> | Large mounds which are greater than 1 m <sup>2</sup> |

Image 4. *Sabellaria alveolata* classification guide

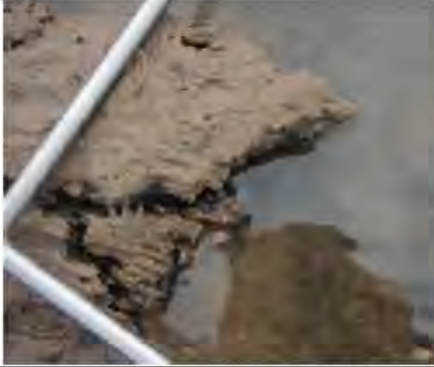
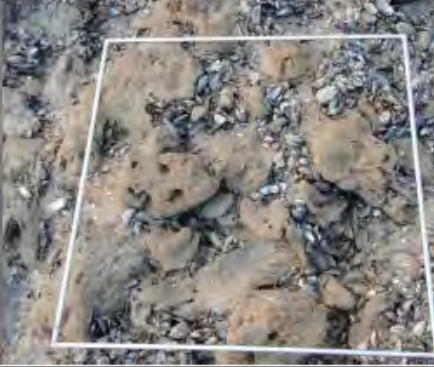
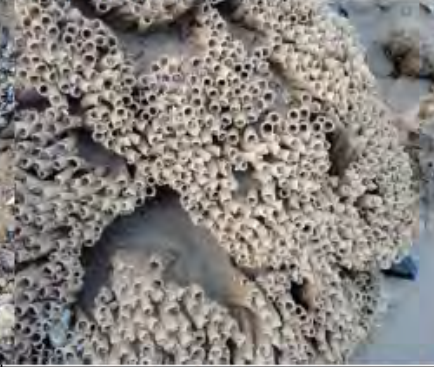
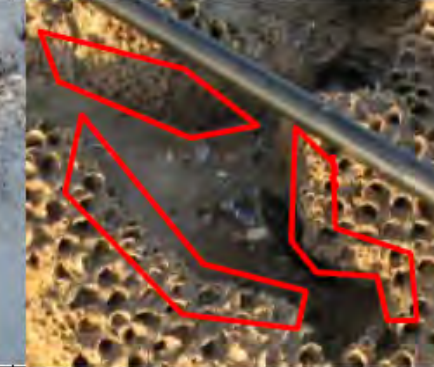
| <b>Formation Type</b> | | | |
|---|---|---|---|
| <b>Dead</b> | <b>Worn Apertures</b> | <b>Crisp Apertures</b> | <b>Newly Settled</b> |
| Tubes have merged into a block of sediment. If a piece of reef is detached from the substratum. | There has been no clear new growth/ tube building. The apertures can still be seen. The tubes are still attached to the substratum. | New growth of tubes can be seen, the apertures are crisp and will have a fine wall. Tend to be a lighter sandy colour compared with worn reef. | Very small apertures between 1 mm and 4 mm. Usually found around the larger, older apertures as shown above. |

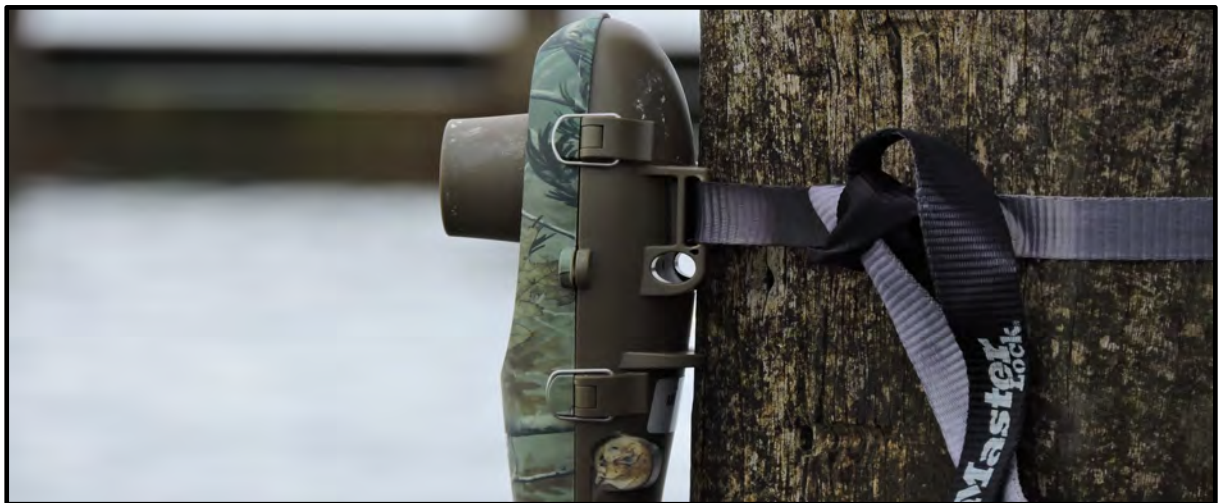
**Image 5.** The static time-lapse camera in position at Hafan y Môr

In addition, a static time-lapse camera was also set up on the shoreline over a 12 h period to help understand tidal movement within the area and record observations of shoreline usage by birds and visitors. The camera took photos of the foreshore every 10 seconds throughout daylight hours (Image 5).

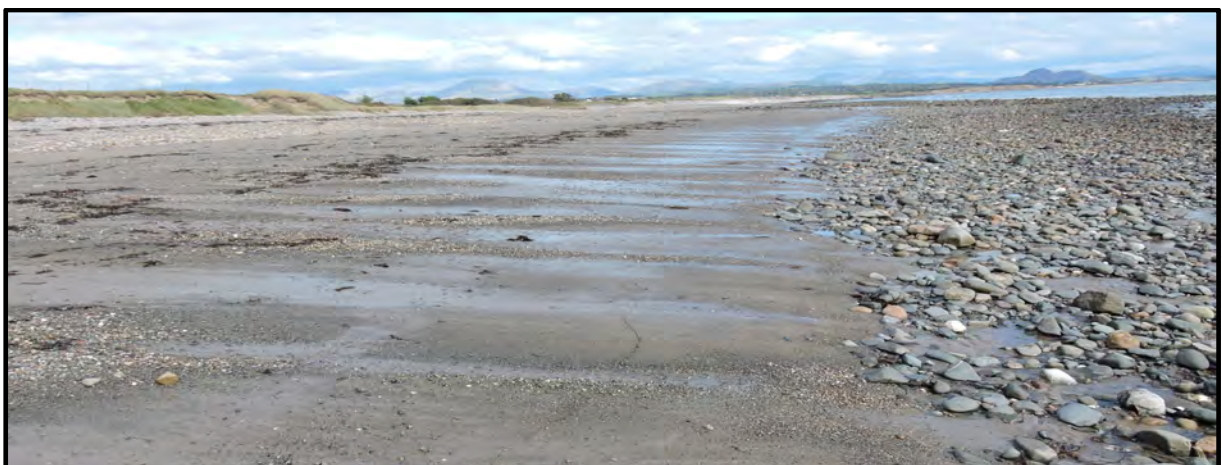
Image 9. View of the upper shore habitats looking towards Hafan y Môr holiday park

The top of the upper foreshore below the high water mark consists of barren shingle, pebbles and cobble (LS.LCS.Sh.BarSh Barren littoral shingle) as shown in Image 9.

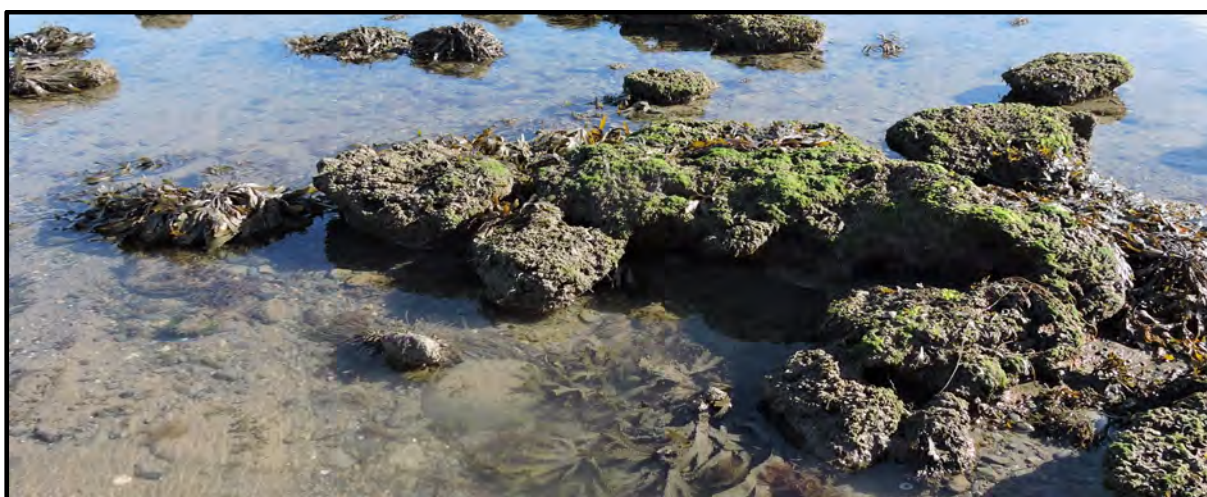
**Image 11.** View of honeycomb worm *Sabellaria alveolata* reef on the mid-shore

The mid-shore habitat was found to predominantly consist of boulder and cobble fields with a zone of LR.FLR.Eph.BLitX (Barnacles and *Littorina* spp. on unstable eulittoral mixed substrata) on the upper section of the boulder field and a zone of LR.LLR.F.Fves.X (*Fucus vesiculosus* on mid eulittoral mixed substrata) on the lower section. The habitat and species recorded was similar to that recorded on the mid-shore further east nearer the Afon Wen River Mouth (Section 3.2.2). The honeycomb worm *S. alveolata* was commonly recorded encrusting the boulders in this area (Figure 4). The *S. alveolata* structures generally consisted of flat (sheet) crusts or patchy mounds (Appendix A).

Several patches were also observed in which more notable biogenic growth had occurred (Image 11 and Appendix B).

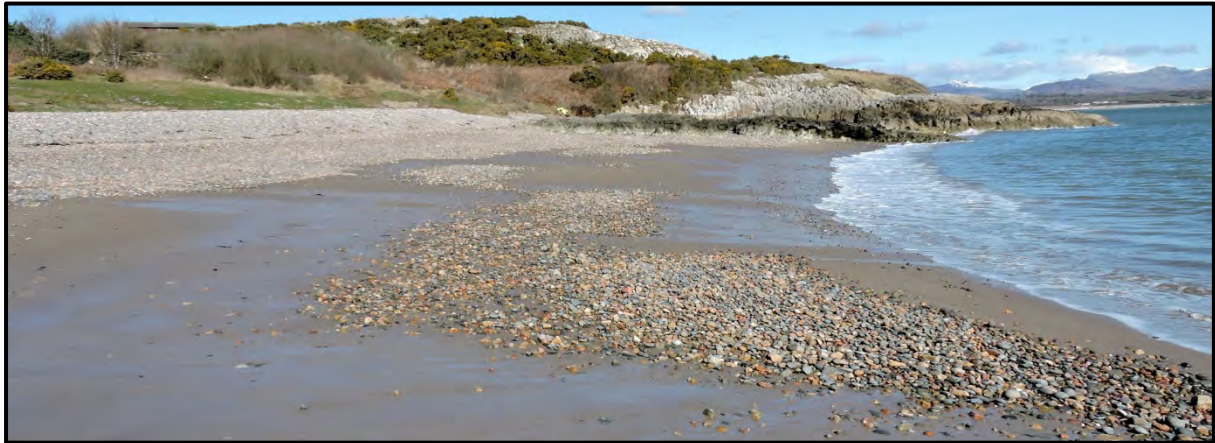
Image 15. Upper shore habitat on Porth Fechan beach

The upper foreshore of Porth Fechan beach consisted of barren shingle (LS.LCS.Sh.BarSh: Barren littoral shingle) (Image 15). Lichen zonation was observed along the rocky headlands (LR.FLR.Lic.YG: Yellow and grey lichens on supralittoral rock and LR.FLR.Lic.Ver.Ver: *Verrucaria maura* on very exposed to very sheltered upper littoral fringe rock). Below this zone, *Pelvetia canaliculata* and barnacles on moderately exposed littoral fringe rock (LR.MLR.BF.PelB) were present.

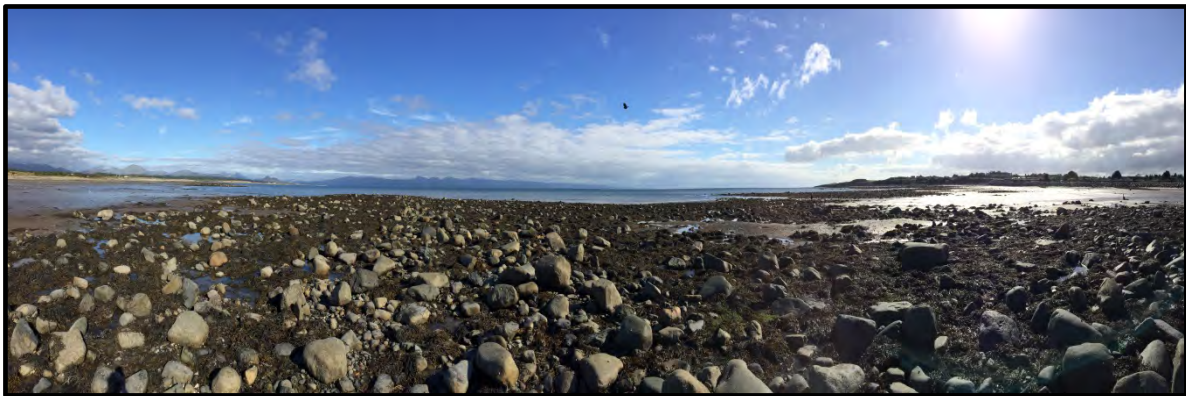
**Image 16.** Habitat looking seaward from the toe of the larger proposed breakwater structure

The footprint of the larger proposed breakwater structure primarily overlaps with littoral sand and barren shingle habitat. These habitats are generally impoverished and of low biodiversity (Image 16). The toe of the breakwater overlaps with boulder habitat with patches of encrusting *S. alveolata* attached to the rocks. The nearest large area of distinct biogenic reef structure is located approximately 50 m away.

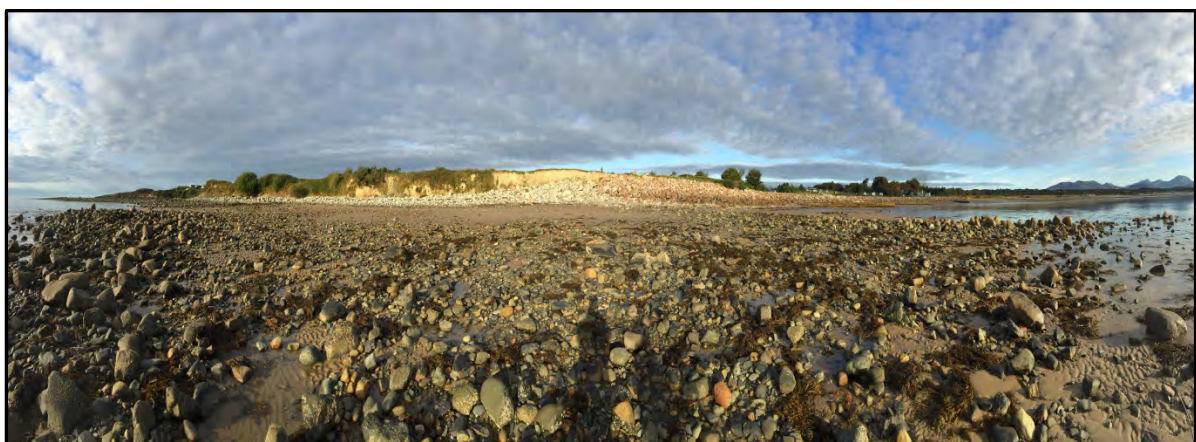
**Image 17.** Habitat looking landward from toe of smaller proposed breakwater structure

The footprint of the smaller breakwater structure overlaps with sand and upper shore boulder habitat. *S. alveolata* was not recorded in the footprint with nearest area of biogenic reef located approximately 30 m away (Image 17). Notable under boulder communities were present on the lower shore below the breakwater in this area.

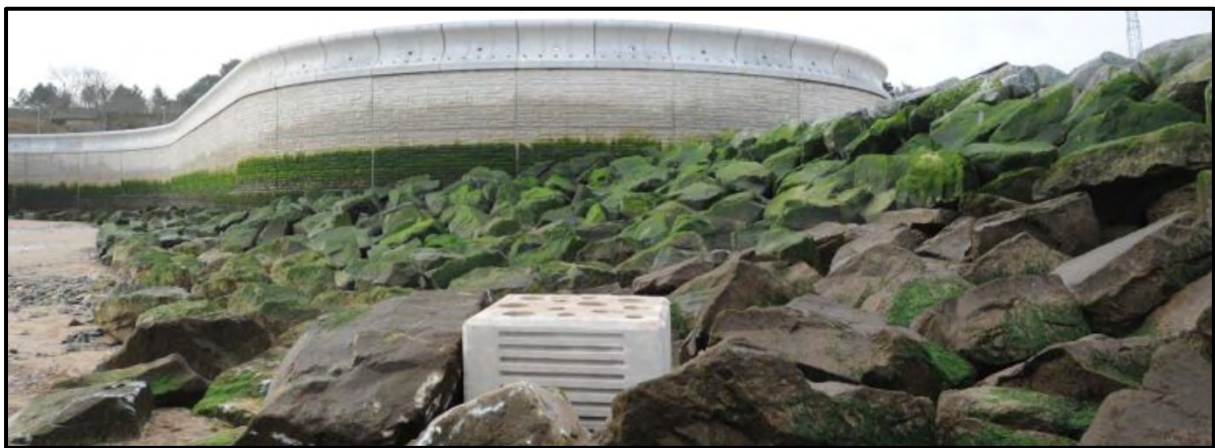
**Image 18.** Bioblock positioned within rock armouring at Colwyn Bay

- **Pre-cast 'Bioblock' (Colwyn Bay, Conwy):** Following a principle similar to the Plymouth work, a 6 tonne pre-cast concrete cube (or 'Bioblock') with dimensions of 1.5x1.5x1.1 m was introduced to the rock armouring at Colwyn Bay in February 2012 (see Image 18). During the casting process a variety of micro-habitat features were introduced including rock pools and crevices varying diameters, depths and alignments. Monitoring of the 'Bioblocks' found they consistently supported greater species richness than adjacent boulders. Functional groups represented on the feature included algae, barnacles, shrimps, annelids, crabs, ctenophores and gastropods whilst those represented on the adjacent boulders included algae, barnacles and crabs (Firth *et al.*, 2014).

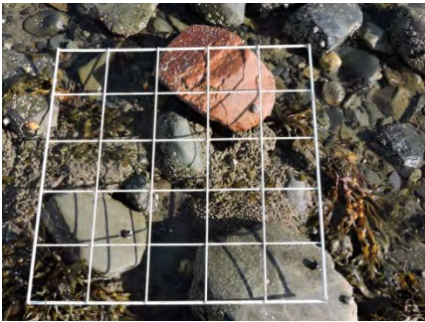
| Quadrat Number | Quadrat Image | Total <i>Sabellaria</i> (%) | Formation (%) | | | | Development/Health (%) | | | |
|---|---|---|---|---|---|---|---|---|---|---|
| Q2 | | 30 | 100 | | | | | 30 | 70 | |

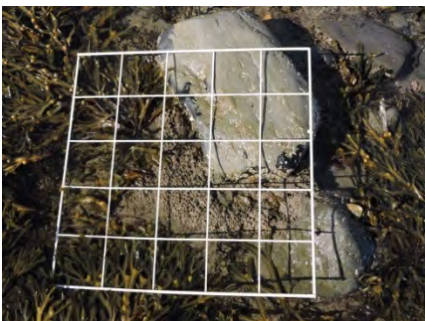
| Quadrat Number | Quadrat Image | Total <i>Sabellaria</i> (%) | Formation (%) | | | | Development/Health (%) | | | |
|---|---|---|---|---|---|---|---|---|---|---|
| Q3 | | 65 | | 100 | | | | 20 | 80 | |

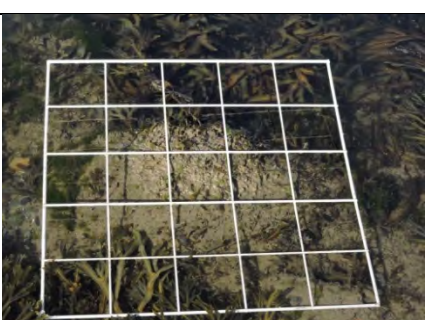
| Quadrat Number | Quadrat Image | Total <i>Sabellaria</i> (%) | Formation (%) | | | | Development/Health (%) | | | |
|---|---|---|---|---|---|---|---|---|---|---|
| Q9 | | 90 | | 100 | | | | | 60 | 40 |

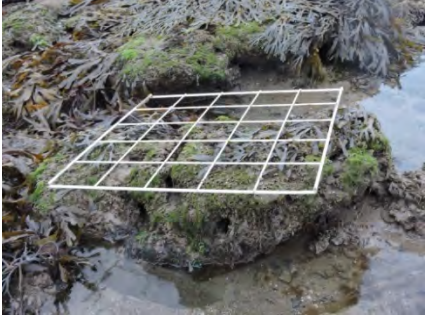
| Quadrat Number | Quadrat Image | Total <i>Sabellaria</i> (%) | Formation (%) | | | | Development/Health (%) | | | |
|---|---|---|---|---|---|---|---|---|---|---|
| Q10 | | 65 | | | | 100 | | 60 | 40 | |

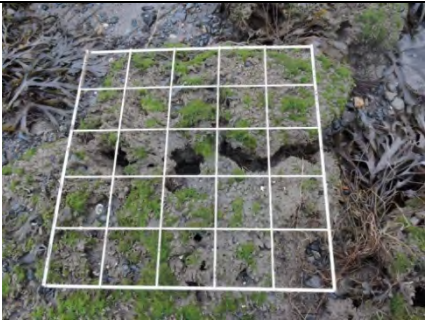
| Quadrat Number | Quadrat Image | Total <i>Sabellaria</i> (%) | Formation (%) | | | | Development/Health (%) | | | |
|---|---|---|---|---|---|---|---|---|---|---|
| Q11 | | 95 | | | | 100 | | 60 | 40 | |

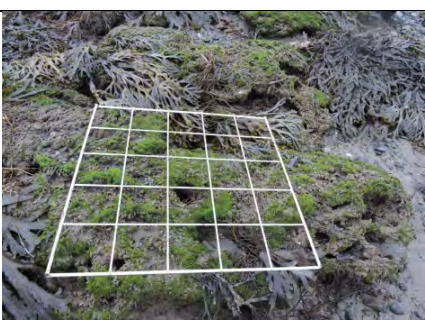
| Quadrat Number | Quadrat Image | Total <i>Sabellaria</i> (%) | Formation (%) | | | | Development/Health (%) | | | |
|---|---|---|---|---|---|---|---|---|---|---|
| Q13 | | 95 | | | | 100 | | 70 | 30 | |

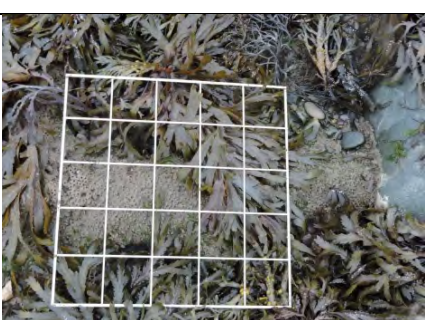
| Quadrat Number | Quadrat Image | Total <i>Sabellaria</i> (%) | Formation (%) | | | | Development/Health (%) | | | |
|---|---|---|---|---|---|---|---|---|---|---|
| Q14 | | 50 | 100 | | | | 20 | 80 | | |

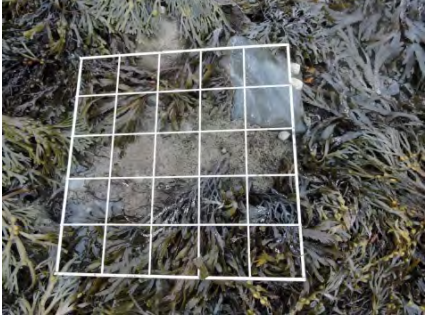
| Quadrat Number | Quadrat Image | Total <i>Sabellaria</i> (%) | Formation (%) | | | | Development/Health (%) | | | |
|---|---|---|---|---|---|---|---|---|---|---|
| Q15 | | 50 | 100 | | | | | | 100 | |

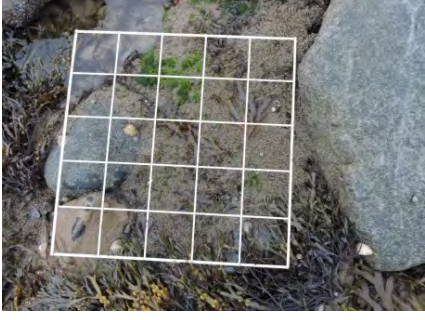
| Quadrat Number | Quadrat Image | Total <i>Sabellaria</i> (%) | Formation (%) | | | | Development/Health (%) | | | |
|---|---|---|---|---|---|---|---|---|---|---|
| Q17 | | 65 | | 100 | | | | 50 | 50 | |

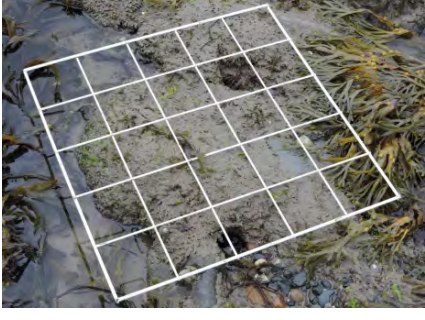
| Quadrat Number | Quadrat Image | Total <i>Sabellaria</i> (%) | Formation (%) | | | | Development/Health (%) | | | |
|---|---|---|---|---|---|---|---|---|---|---|
| Q18 | | 90 | | 100 | | | | | 100 | |

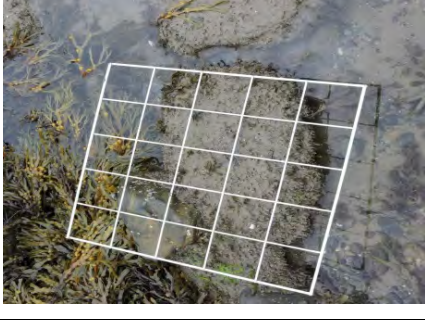
| Quadrat Number | Quadrat Image | Total <i>Sabellaria</i> (%) | Formation (%) | | | | Development/Health (%) | | | |
|---|---|---|---|---|---|---|---|---|---|---|
| Q19 | | 85 | | 100 | | | | 10 | 90 | |

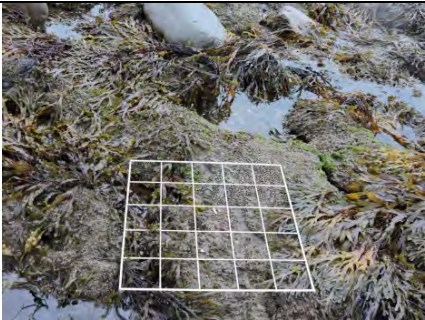
| Quadrat Number | Quadrat Image | Total <i>Sabellaria</i> (%) | Formation (%) | | | | Development/Health (%) | | | |
|---|---|---|---|---|---|---|---|---|---|---|
| Q21 | | 95 | | 100 | | | | | 100 | |

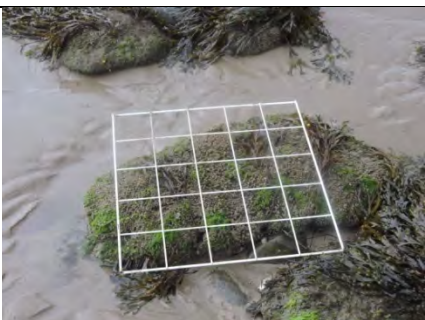
| Quadrat Number | Quadrat Image | Total <i>Sabellaria</i> (%) | Formation (%) | | | | Development/Health (%) | | | |
|---|---|---|---|---|---|---|---|---|---|---|
| Q22 | | 90 | 100 | | | | | 30 | 70 | |

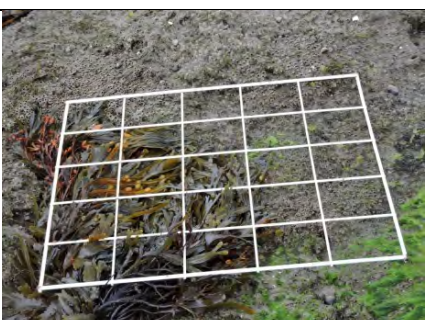
| Quadrat Number | Quadrat Image | Total <i>Sabellaria</i> (%) | Formation (%) | | | | Development/Health (%) | | | |
|---|---|---|---|---|---|---|---|---|---|---|
| Q23 | | 100 | | | | 100 | 10 | 75 | 15 | |
