**Barmouth Viaduct Refurbishment  
Water Framework Directive  
Assessment**

| Document Information | | | |
|---|---|--|---|
| Project | Barmouth Viaduct Refurbishment | | |
| Title | Water Framework Directive Assessment | | |
| Document Ref | EV200213.WFD.001 | Issue / Revision | 0.1 |

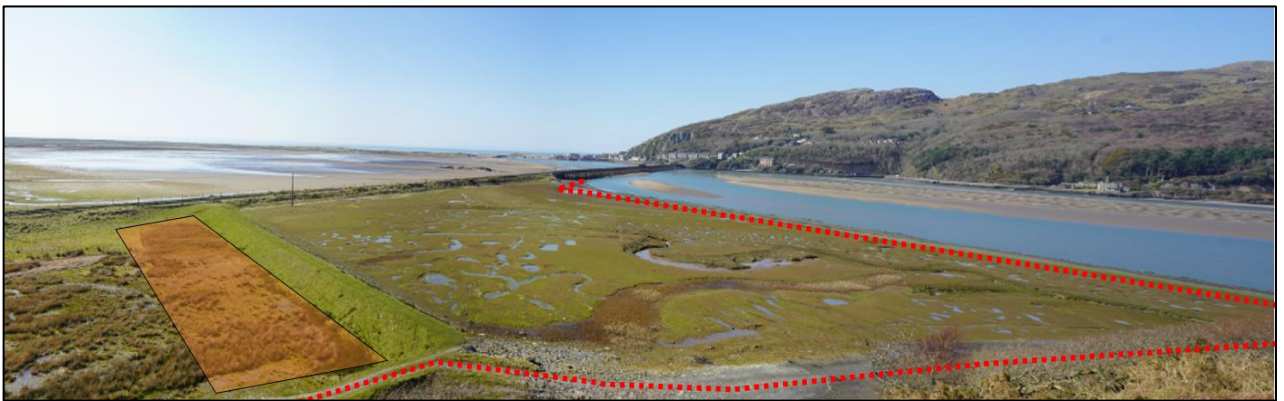
- 6.1.4 Much of the existing road leading up to the shale bank is of modern design with a geotextile membrane present in its construction (appears to be Terram 1000 from observation). Therefore, it is likely this section of road/track is robust enough to carry the limited traffic proposed to undertake the refurbishment.

*Figure 10: Access route to estuary.*

- 6.1.5 There is a low spot within the shale bank which allows water from the estuary to enter the saltmarsh during high tides. The bed / invert level of this will be recorded prior to the commencement of works, to ensure this level is retained for the duration of the contract. This drainage feature (highlighted in figure 12b next page) will not be modified as a preferred option. Although this is not a lagoon feature it is integral to the gradual drainage of the salt marsh habitat.

- 6.1.6 Consequently, if movement of vehicles begins to degrade it's function as a drainage route, a temporary crossing will be installed using locally sourced shale and drainage piping or channels installed to the same level as the measured bed / invert level, to maintain the current flow of water while allowing continued vehicle movement outside of the salt marsh habitat.

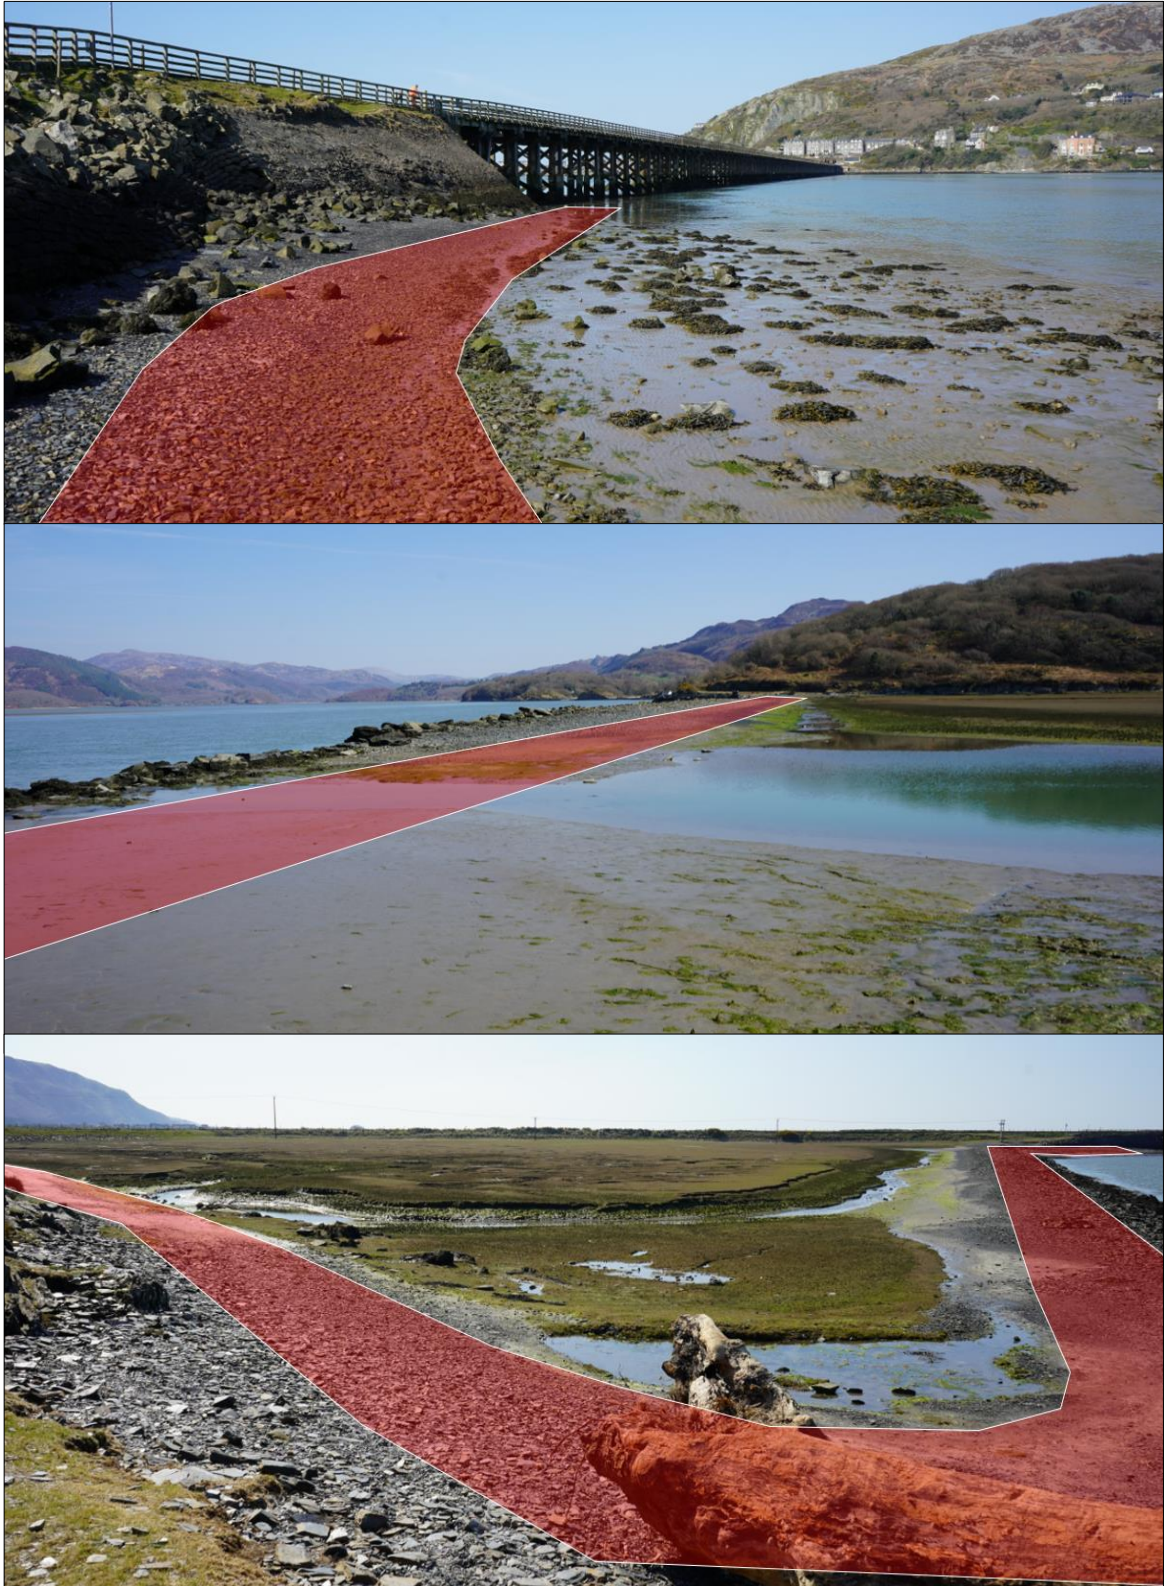
**Figure 11: Caption in descending order A, B, C of access route.**

- 6.1.7 Where possible, the existing shale present along the bank would be used to create any necessary modification to limit or even eliminate the need for importing new material. If any materials are imported, they will be laid on a geotextile separation layer to aid their removal on the completion of the works.

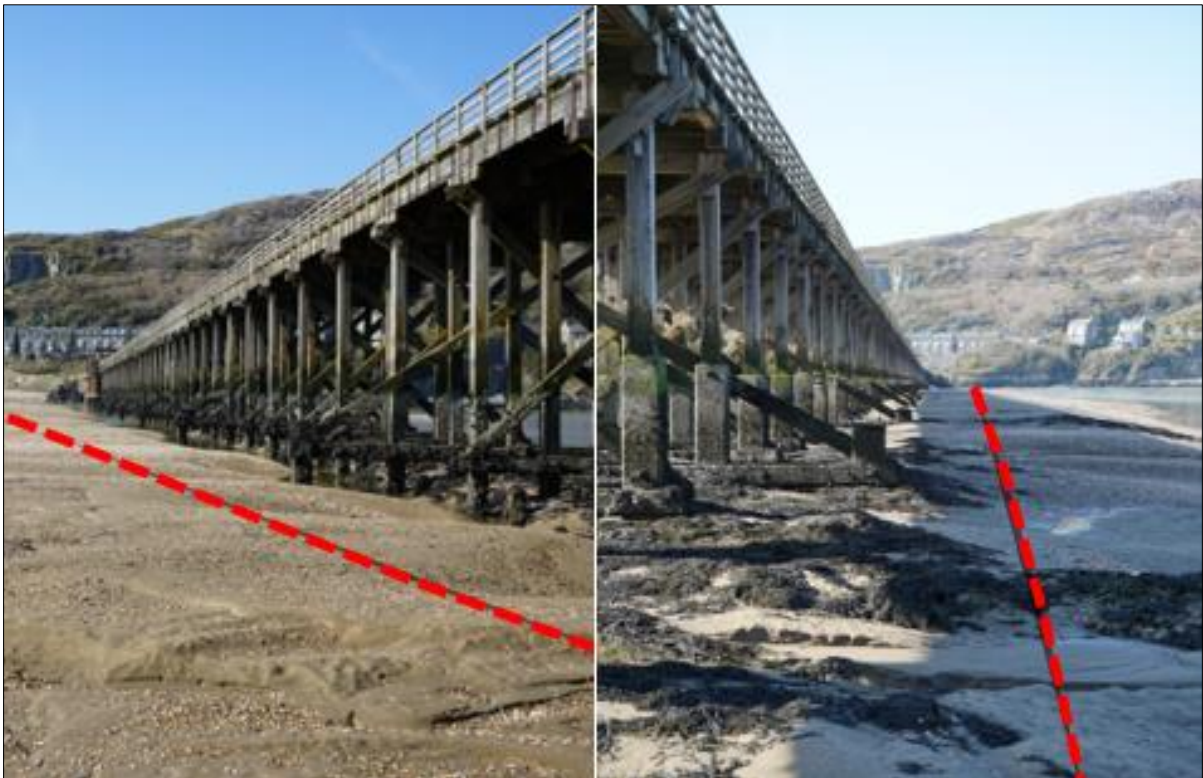
**Figure 12: Vehicle Route either side of the structure.**

- 6.2.1 Phase I of the project is set to occur over 6 months and Phase II occurring over 7 months in total. However, this represents the entire project durations, activities within the estuary itself will be over a shorter period, as January 2021 involves de-mobilisation.
- 6.2.2 The spacing between the viaduct piers close to the solid sea defence at the start of the timber bridge (Morfa south) is wide enough to allow plant/vehicles to move beneath the structure and access both sides of the Viaduct (see figure 13) without the need to add an additional access route along the salt marsh habitat to the west of the rail.

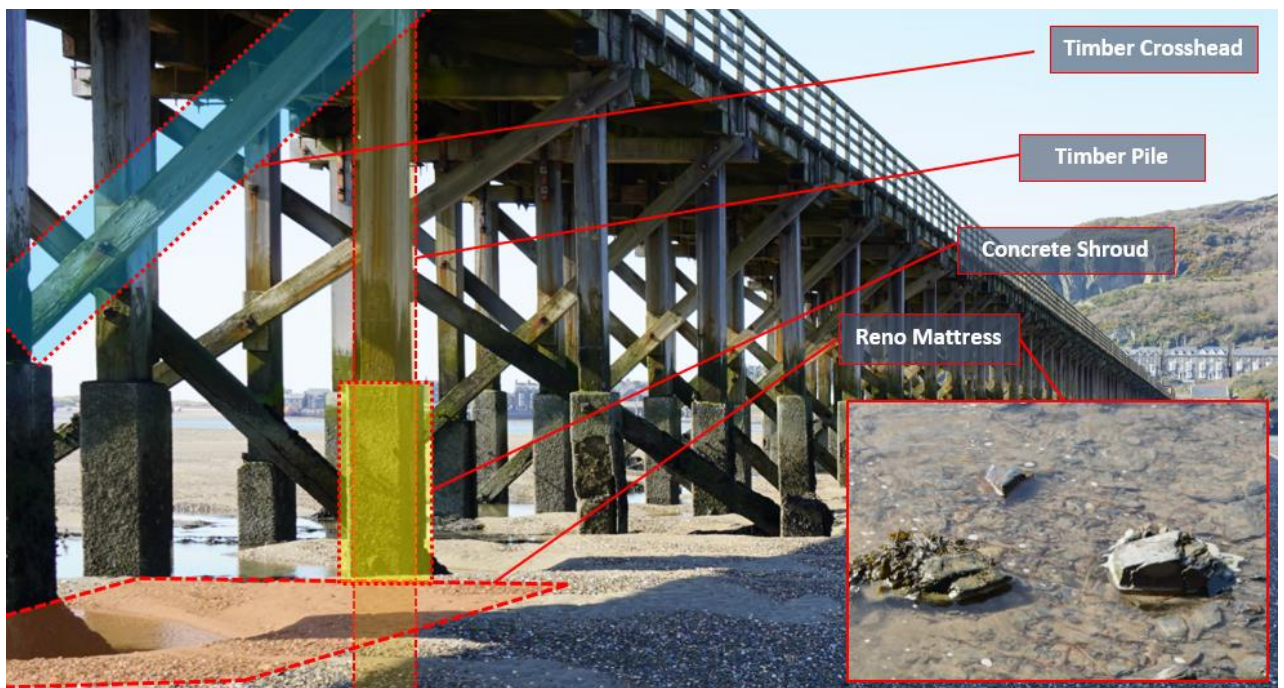
**Figure 13: Illustration of individual timber structure supporting components.**

- 6.2.10 The replacement timber will be Greenheart hardwood which is naturally resistant to shipworm attack and degradation. Thus, it does not require intensive chemical protection to be used in a marine environment.

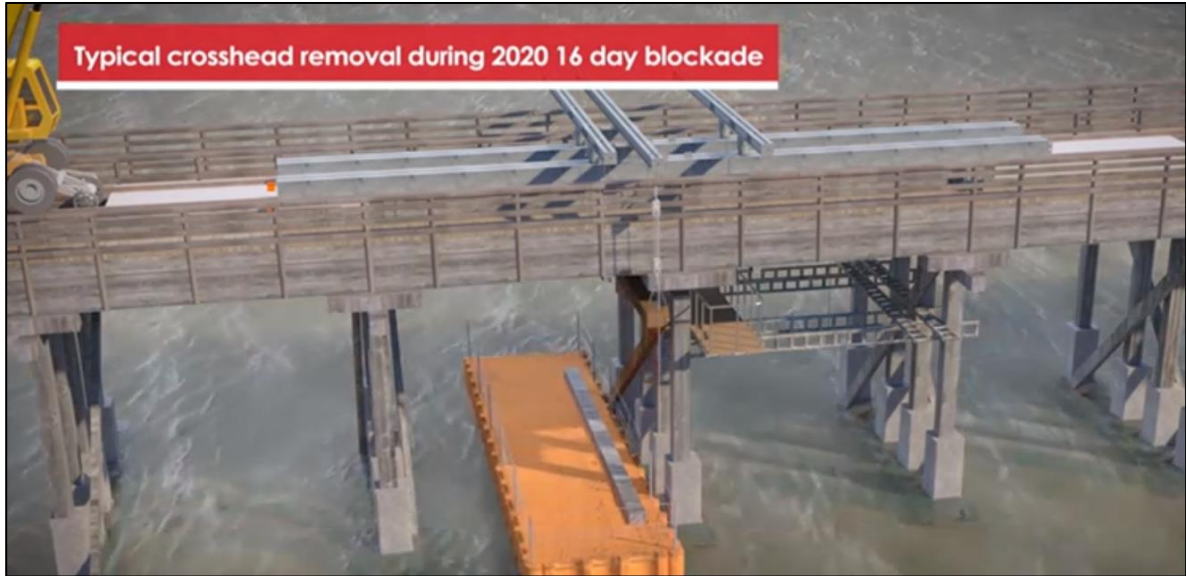
**Figure 15: Cross head replacement process, supported by RRV & Barge.**

- 6.2.16 Additional preparation works include the replacement of crosshead supports (see figure 16, next page) of the timber frame of the piers. This process will also be largely undertaken during low tide conditions.

- 6.2.18 A jack up barge will not be required for the project as this need has been eliminated through novel design approaches, including upper structure lifts using a trestle propping method (essentially using the rail either side of an individual section as supports to lift the centre and access a bridge feature requiring replacement).
