## Barmouth Viaduct

## Habitat Regulations Assessment

| Document Information | | | |
|---|---|---|---|
| Project | Barmouth Viaduct Refurbishment | | |
| Title | Habitat Regulations Assessment | | |

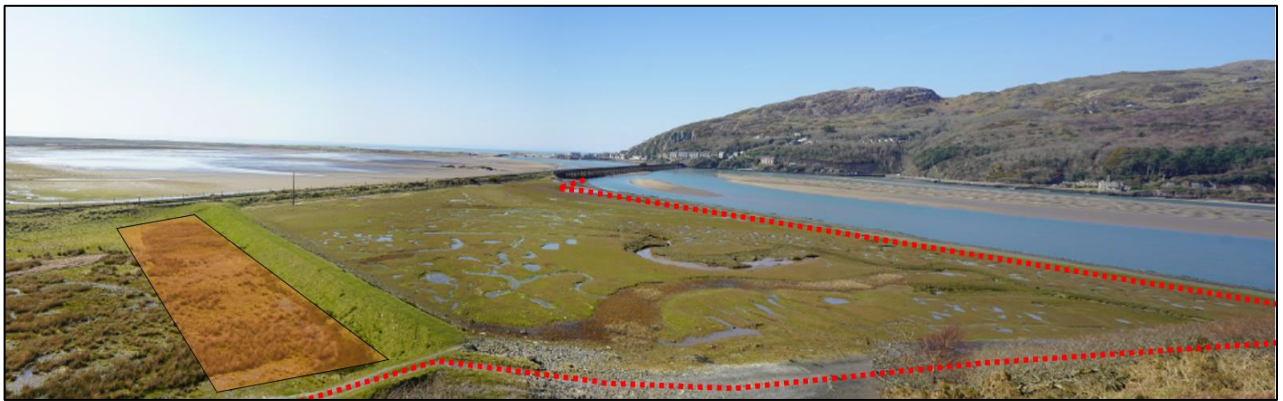
*Figure 11: Access route to estuary.*

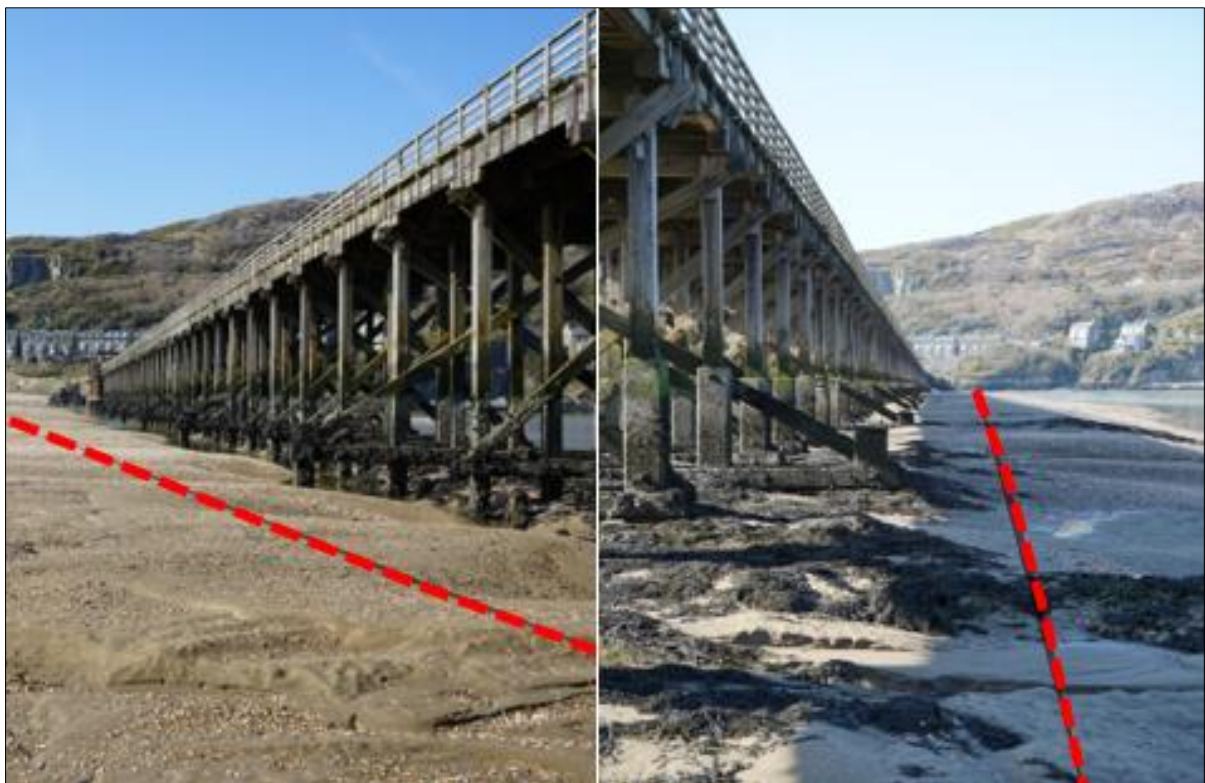
**Figure 13: Vehicle Route either side of the structure.**

- 4.5.3 The spacing between the viaduct piers close to the solid sea defence at the start of the timber bridge (Morfa south) is wide enough to allow plant and vehicles to move beneath the structure and access both sides of the Viaduct (see figure 13) without the need to add an additional access route along the salt marsh habitat to the west of the rail.

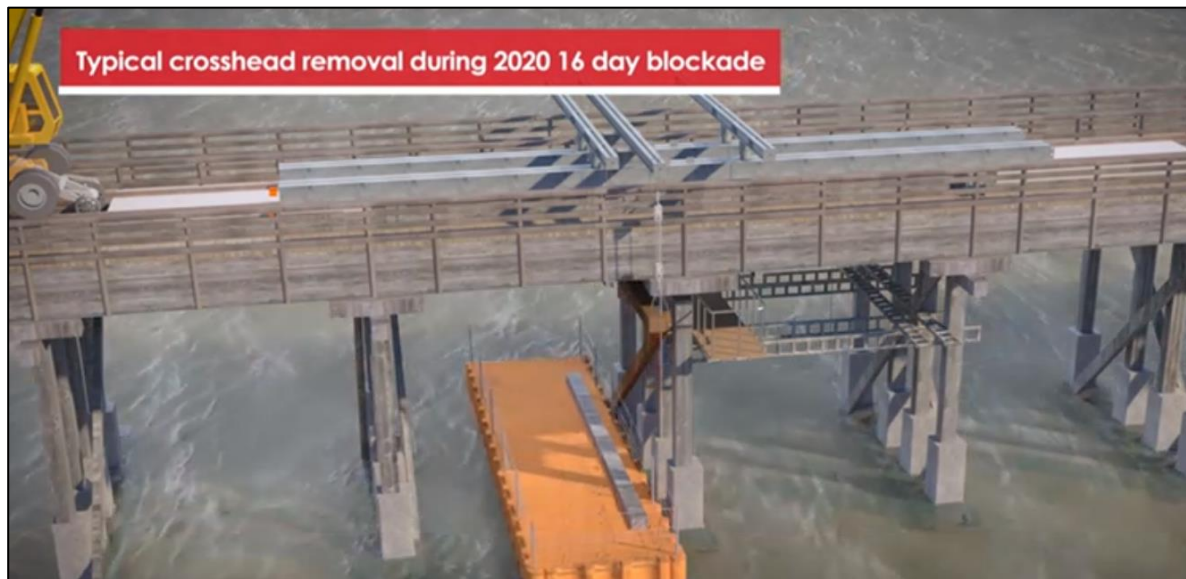
**Figure 16: Cross head replacement process, supported by RRV & Barge.**

- 4.5.17 Additional preparation works include the replacement of crosshead supports (see figure 16, next page) of the timber frame of the piers. This process will also be largely undertaken during low tide conditions.
