Report No: AC2020/ENV/01  
January 2020

REVIEW OF ENVIRONMENTAL MONITORING  
UNDERTAKEN AT THE  
BRYN PICA LANDFILL SITE DURING THE PERIOD  
JAN 19 – DEC 19

Amgen Cymru  
Bryn Pica Landfill Site  
Llwydcoed  
Aberdare  
CF44 0BX

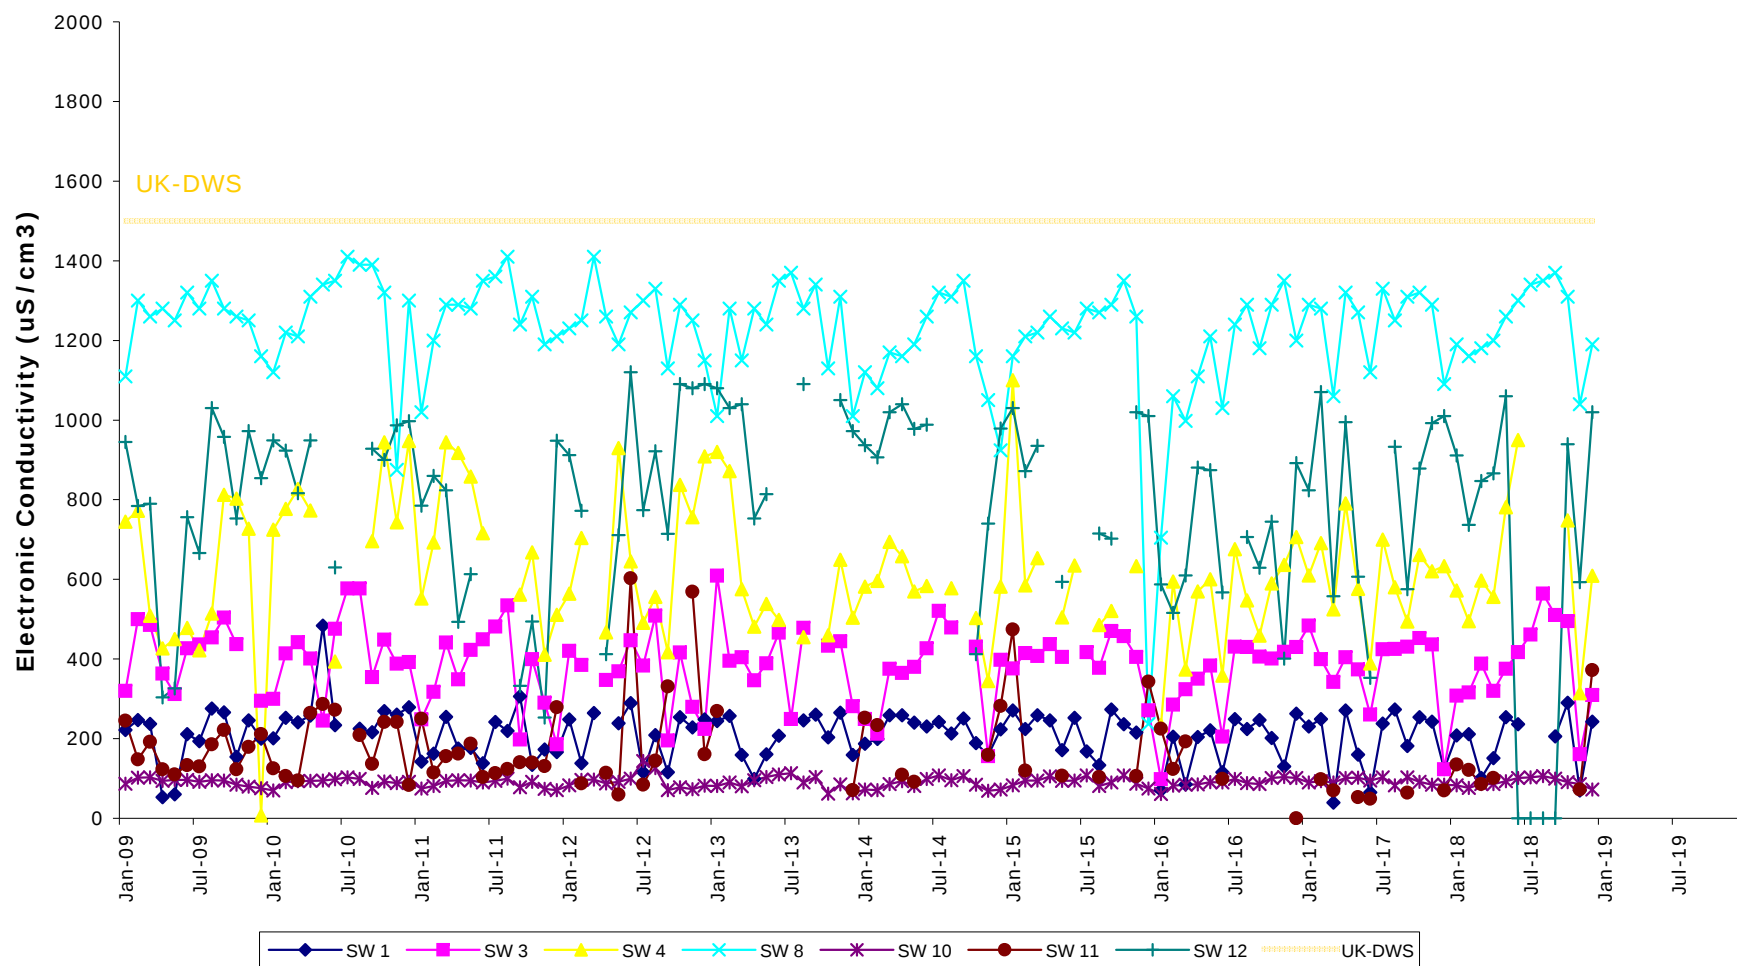
**Lab analysis of Electronic Conductivity levels in surface water sampled by Amgen Cymru at the Bryn Pica Landfill Site during the period Jan 2009 - Dec 2019.**
