**Garth Isaf Farm
Efail Isaf,
Pontypridd,
Rhondda Cynon Taff
CF38 1SN**

SITE CONDITION REPORT (Inc. HISTORICAL FILL)

**Concerning the use of recovered material from Inert/Non-Hazardous Construction
Waste**

Reference Number RJPH WAST-004 HIST

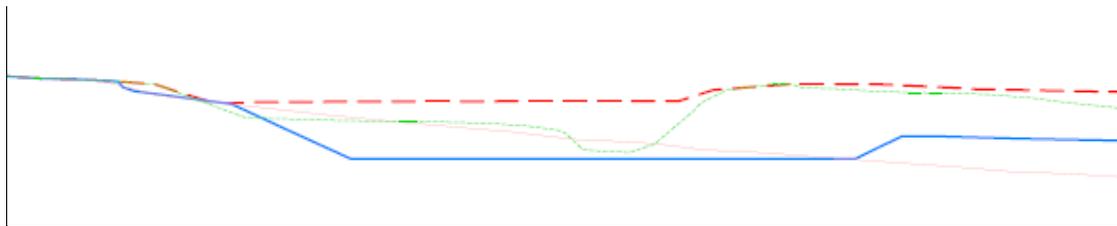
Figure 1: Blue line is 2003 design, Red dotted line is revised design for 2018 application, Green line is as existing 2018

This change has been discussed with RCT Planning and it has been agreed that the area can be viewed as isolated from the 2003 consent and included in the new 2018 application. This application has been submitted and, at time of writing, is under consideration via planning reference 18/1030/10. Notwithstanding the above, the area has also been included in the Ground Contamination Report under the historical fill aspect and so any material placed has been considered as part of the existing site conditions.

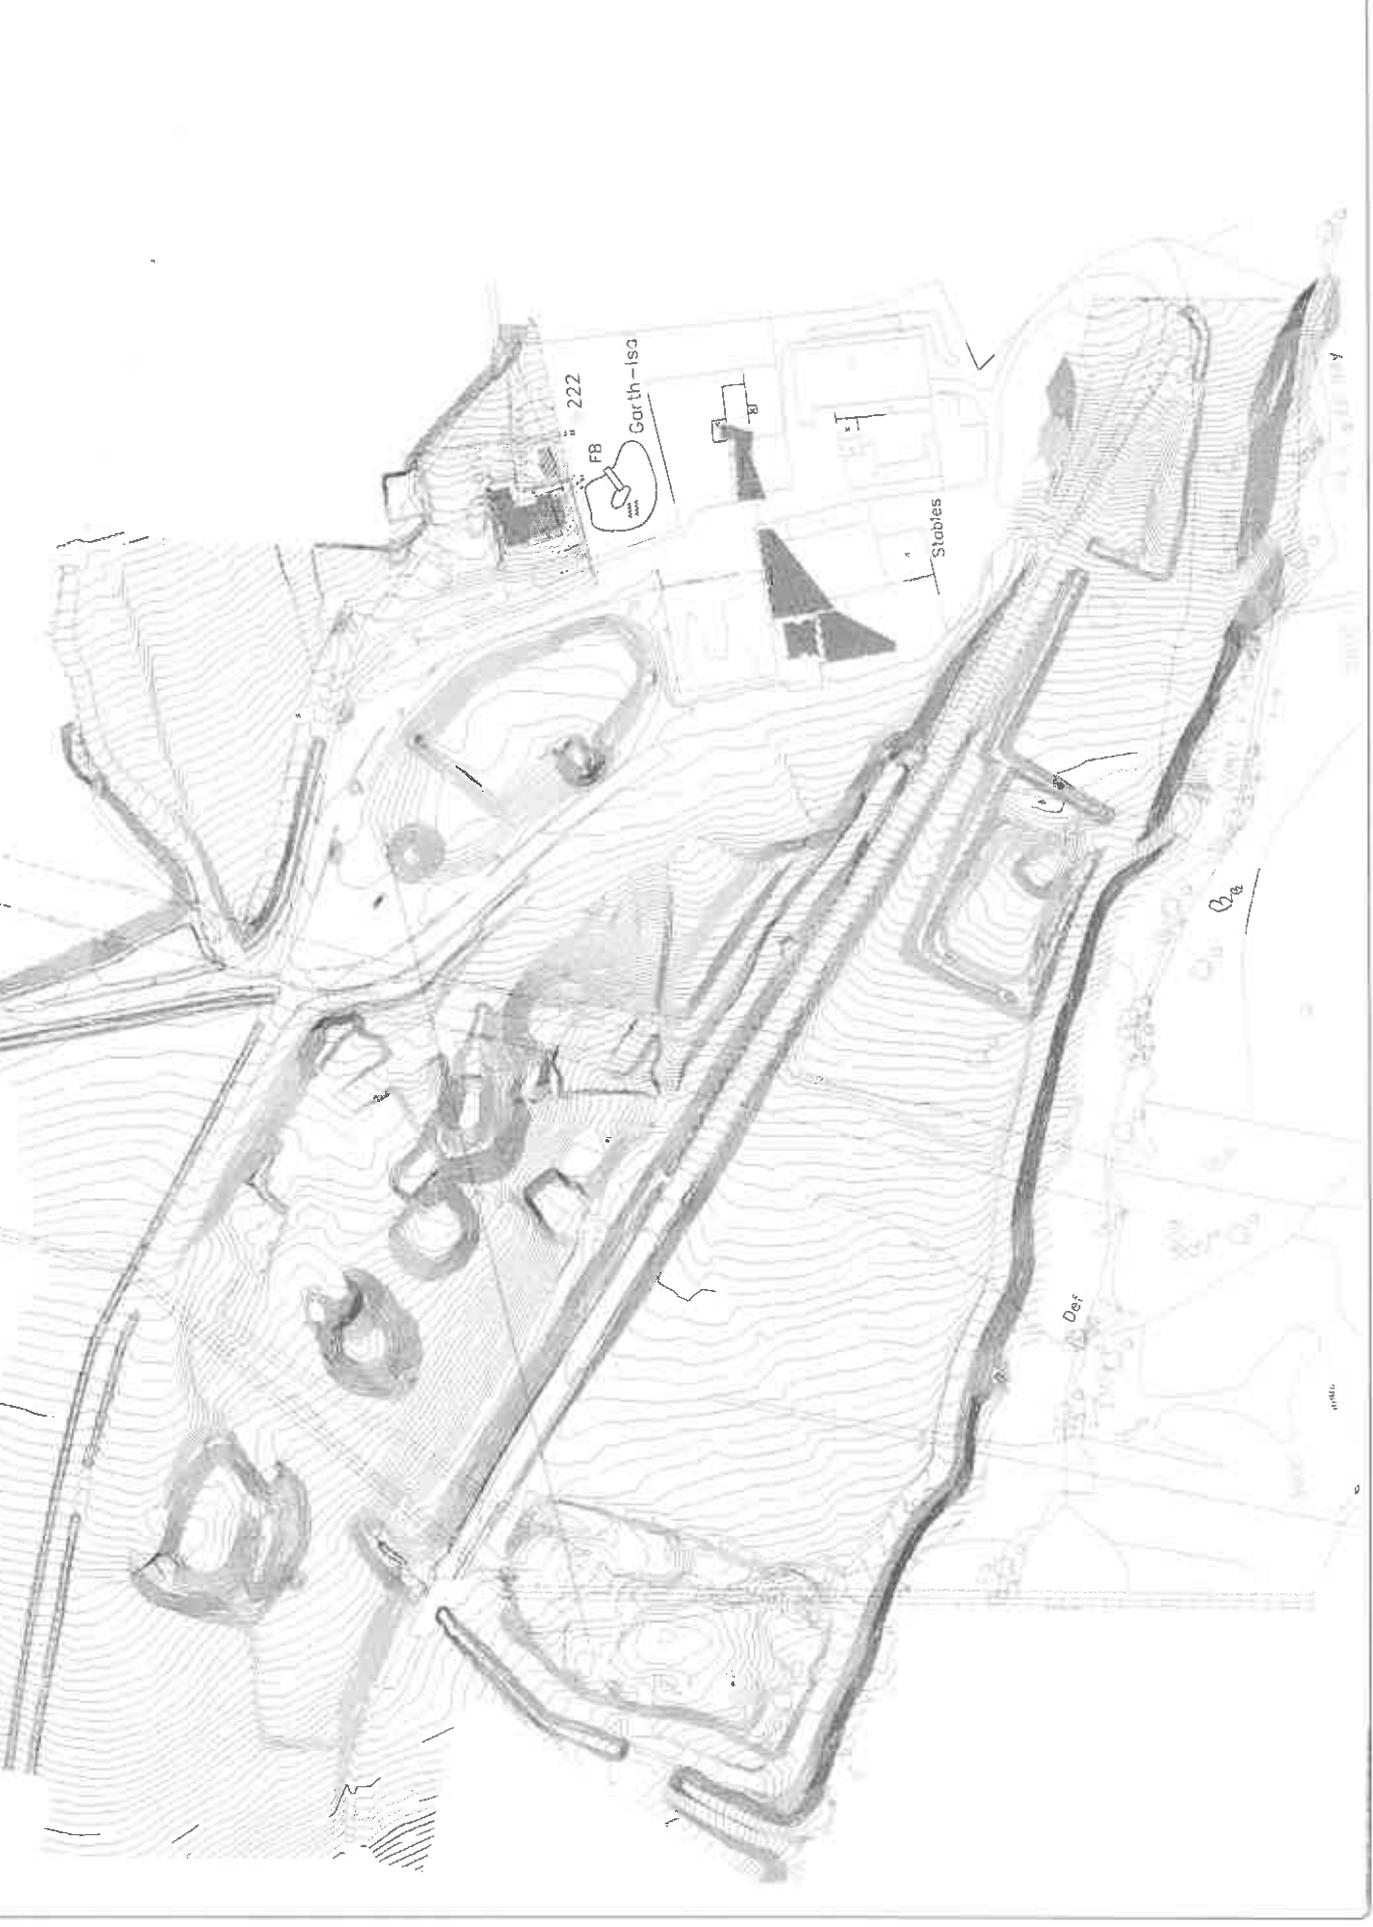
FOR INFORMATION	
CDGray 1000 North 10th Street Portland, Oregon 97228 503.281.1318 www.cdgray.com	
DATE	D.H. JONES
PROJECT	GARTH ISAF FARM EPHRAIM, OR
EXISTING SITE LAYOUT	
SCALE	AS SHOWN
DATE	01
BY	B

SURFACE LEVEL DATA

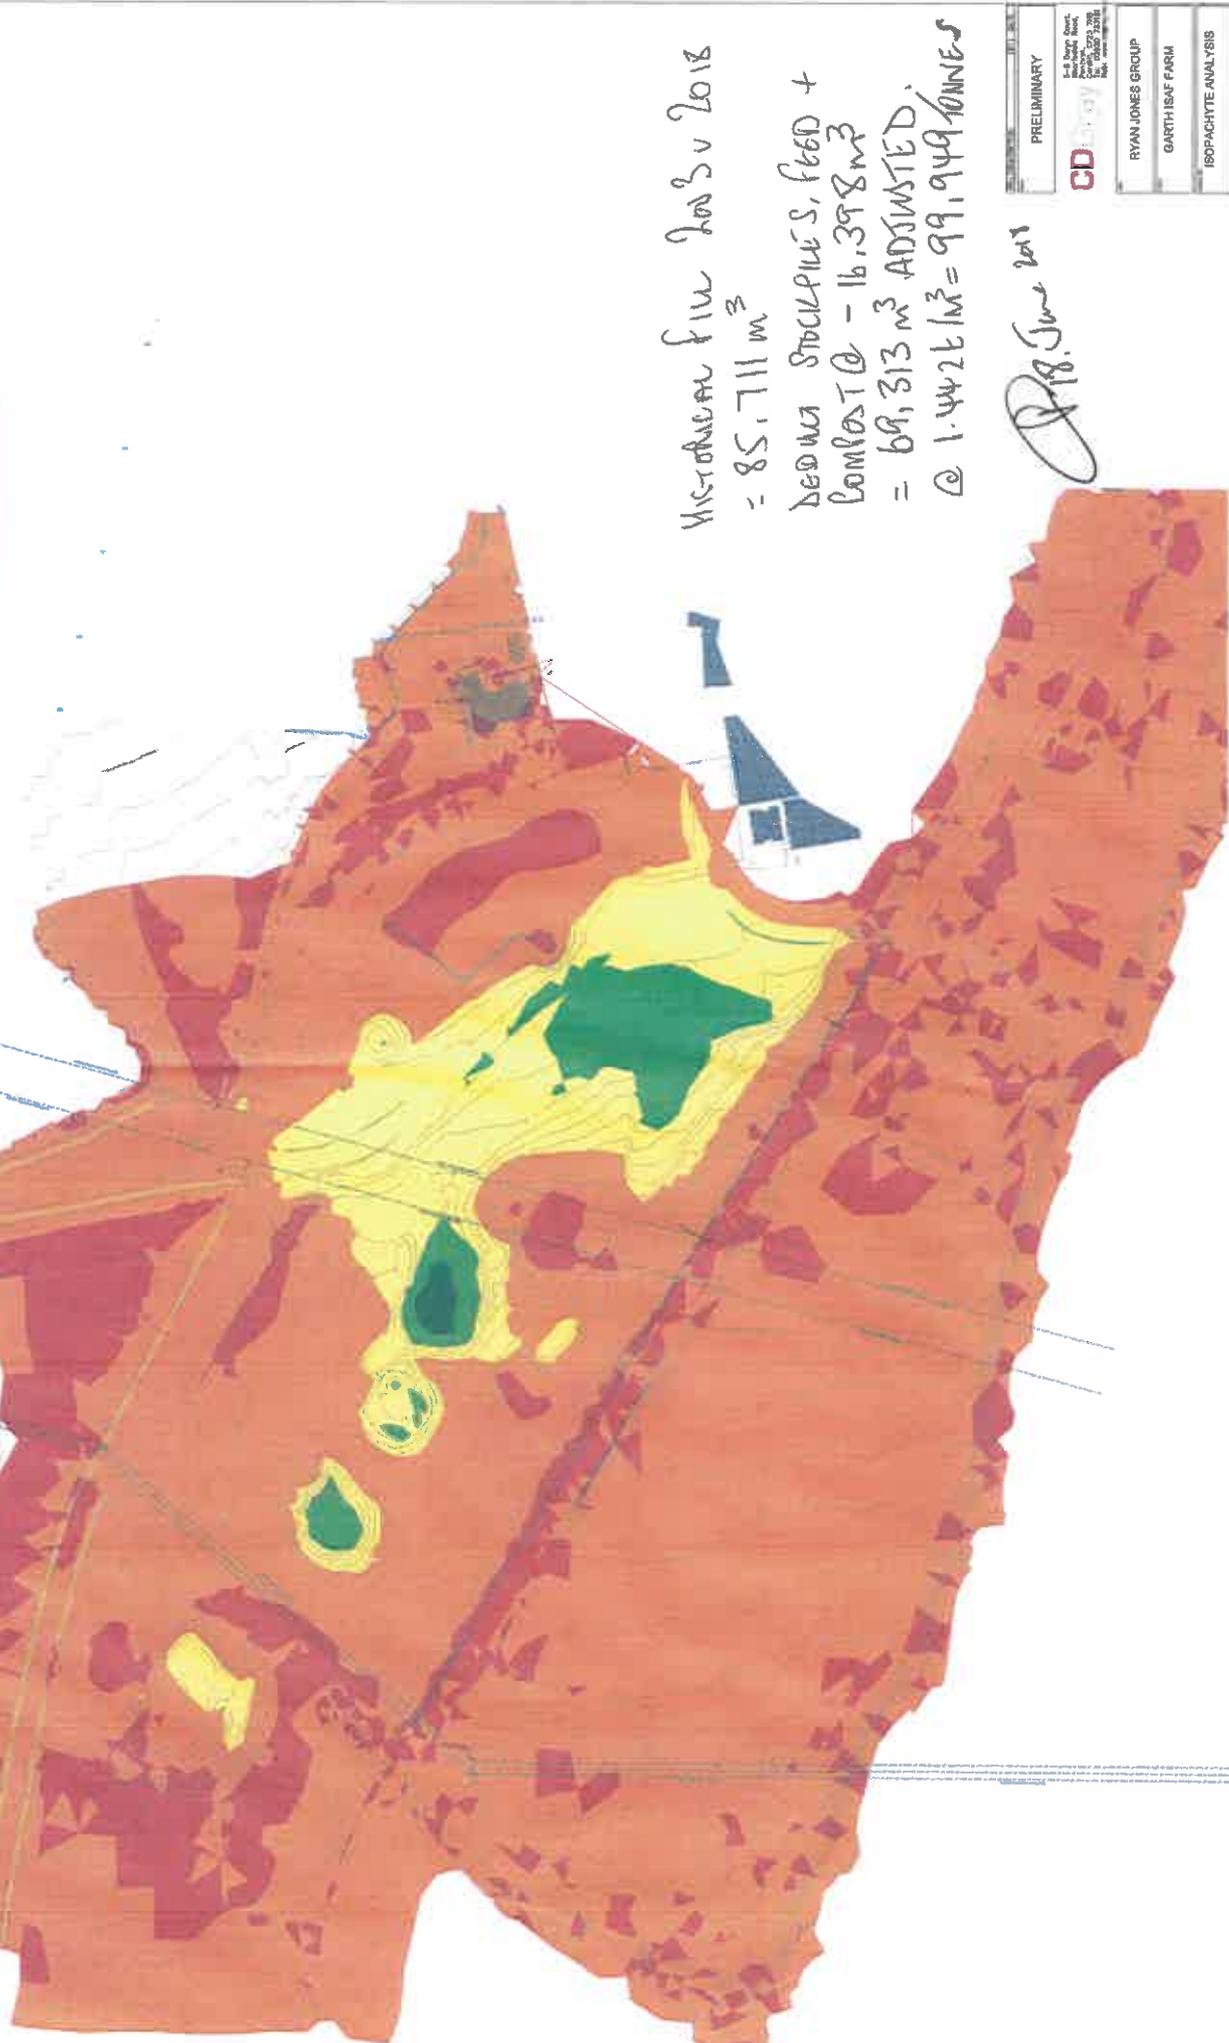
PRELIMINARY
CD
RYAN JONES GROUP
GARTH ISAF FARM
ISO-MACHYTE ANALYSIS
DATE: 18/06/2018
BY: R. JONES
SCALE: 1:500
P1

VICTORIAN FILL 2003 v 2018
 = 85,711 m³
 BEDDING STOCKPILES, FEED +
 COMPOST @ - 16,398 m³
 = 69,313 m³ ADJUSTED.
 @ 1.442 t/m³ = 99,949 TONNES

To establish quantities relating to the historical fill, an isopachyte exercise, to compare the existing ground survey of circa 2003 and a similar survey completed in 2017-18, was completed by CD Gray & Associates, who are professional consulting and design engineers.

The exercise shows the depths of fill in various areas of the site and calculates the difference in between the surfaces as m³. The exercise generated a volume of some 85,711 m³ of material had been placed during the period between the surveys, however, this included temporary stockpiles that when removed, leaves an adjusted volume of some 69,313 m³.

Using a conversion factor of 1.442 tonnes per m³ from BS 648³, this generated an estimated tonnage of 99,949 tonnes of recovered waste as being placed to site during the referred period.
