# SHOTTON MILL

## Noise Investigation

PROJECT NO. 70065921

DATE: FEBRUARY 2020

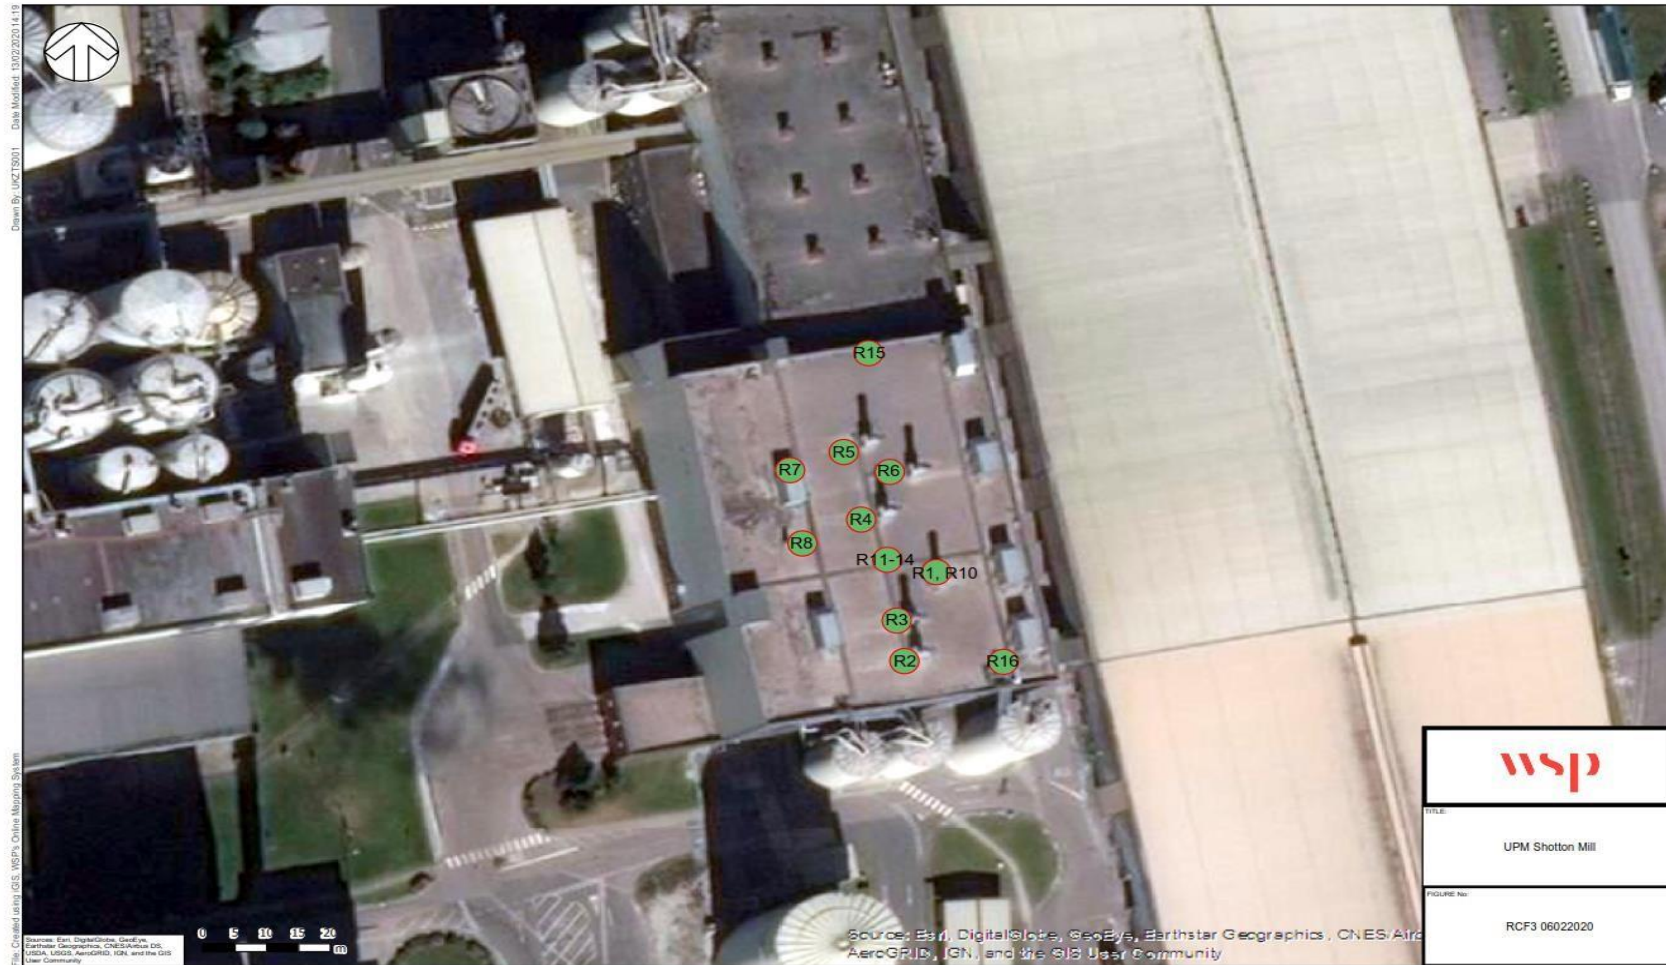
## SITE LOCATION PLAN [REDACTED]

A plan showing the measurement locations ML1-ML3, and on-site measurements, together with the general location of the UPM site relative to [TEXT REDACTED] dwelling is included in Appendix B.
