**Port of Mostyn Ltd.**

## **Overview of Maintenance Dredge and Disposal**

Report to accompany Progress Note 48; June 2019

| Document History and Authorisation | | |
|---|---|---|
| <b>Document ref</b> | R.3230TN | |

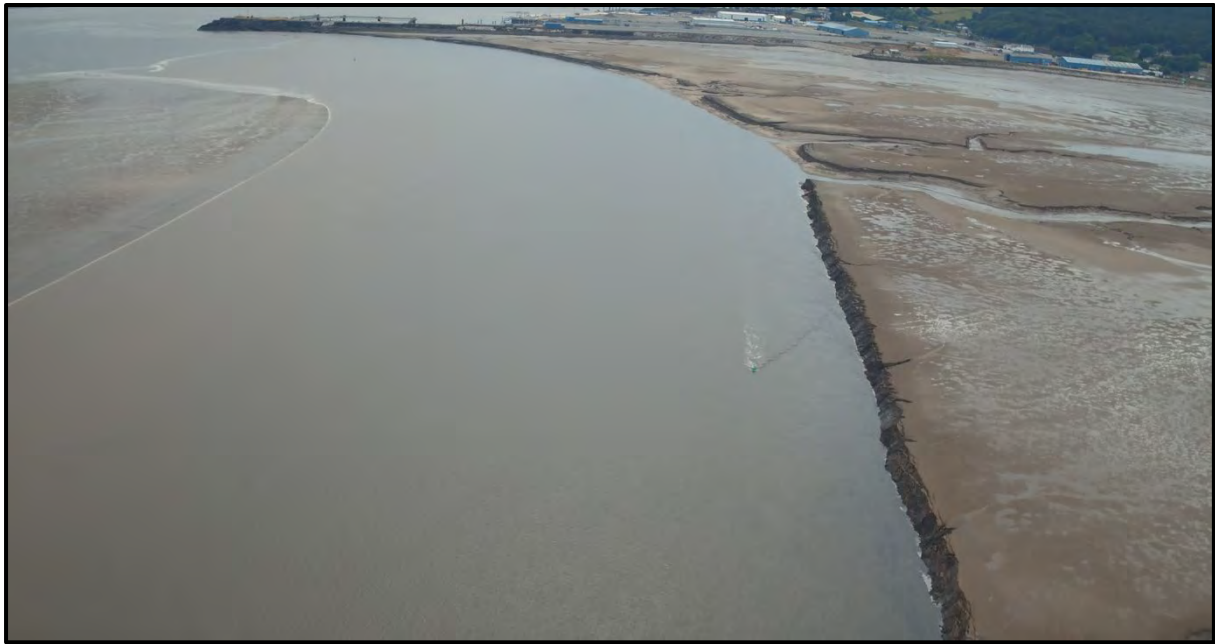
For example, it was useful for describing the steepened edge of the migrating Mostyn Channel (Image 1) as well as the distribution of surface sand over the southern Mostyn Bank (Image 2), which may have influenced Site B3 during the surveys.

**Image 1.** View south towards Port of Mostyn along the western edge of Mostyn Channel

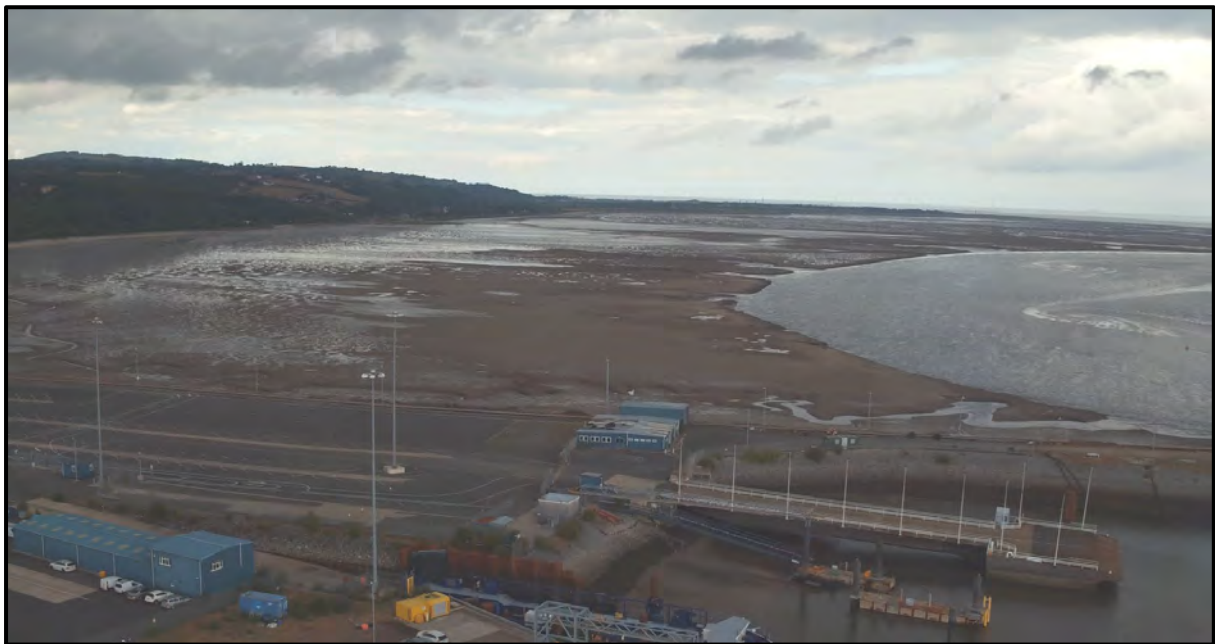
**Image 2.** View north from Port of Mostyn along the southern part of Mostyn Bank
