**Silent Valley Landfill, Waste
Transfer Station**

Site condition report

2015/9363

Issue 1 | 17 April 2015

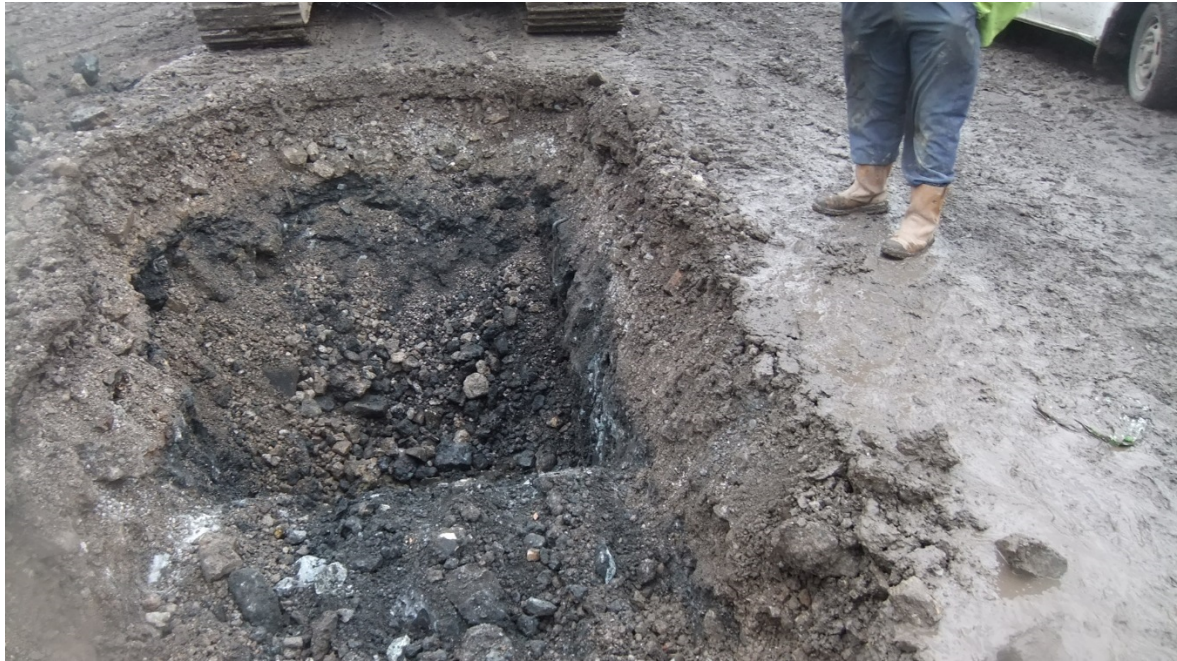
<table><tr><th>Trial pit location</th><th>Depth of sample</th><th>Evidence of contamination</th></tr><tr><td rowspan="2">TP01</td><td>0.6m</td><td>Presence of slag in black soil matrix.</td></tr><tr><td>1.2m</td><td>Presence of slag in black soil matrix.</td></tr></table>

Photograph 1 – Trial pit TP1

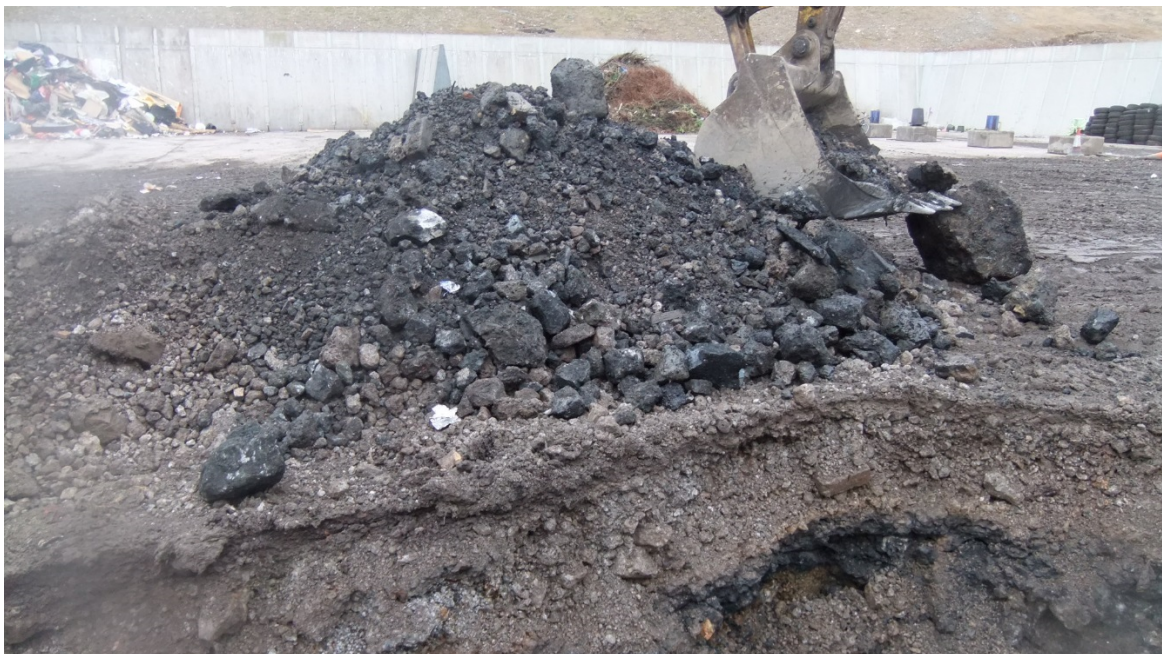
Photograph 2 – Trial pit TP1 (arising)

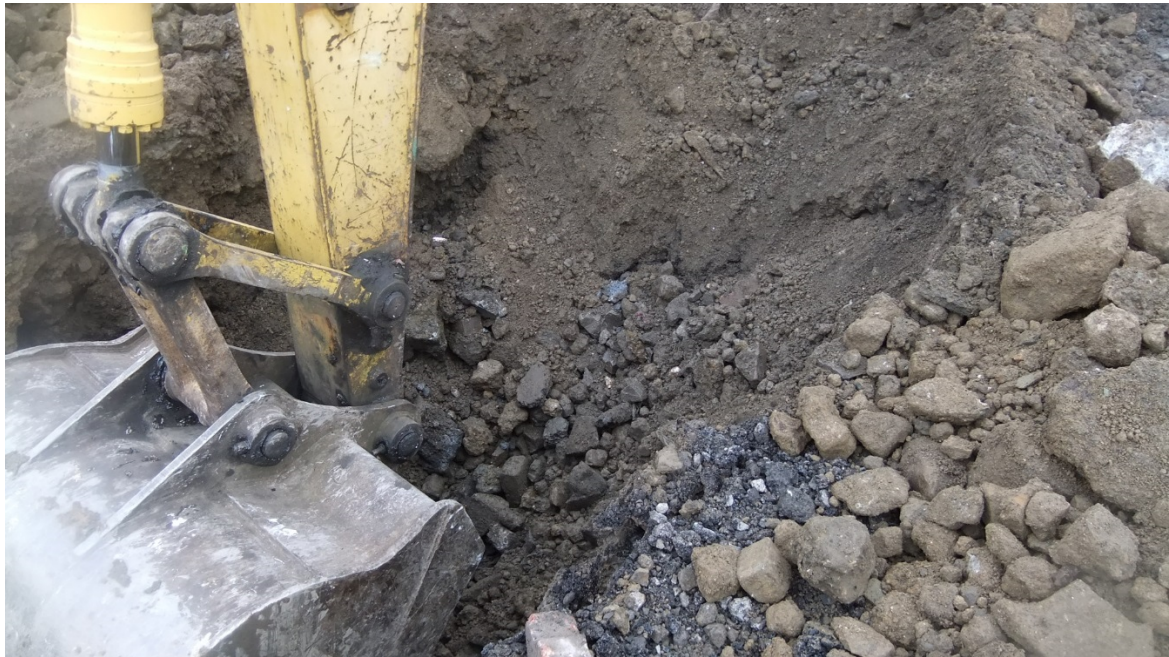
<table><tr><th>Trial pit location</th><th>Depth of sample</th><th>Evidence of contamination</th></tr><tr><td rowspan="5">TP2</td><td>0.25m</td><td rowspan="3">Presence of slag, bricks and fragments of metal, timber, plastic and tin. (stratum as above)</td></tr><tr><td>2.5m</td><td>Presence of slag, bricks, timber, metal, wires in black soil matrix. Strong hydrocarbon odour.</td></tr><tr><td>2.7m</td><td>Presence of slag. Strong hydrocarbon odour. Presence of slag, bricks, timber, plastic, metal and cloth in black soil matrix. Strong hydrocarbon odour.</td></tr></table>

Photograph 3 – Trial pit TP2

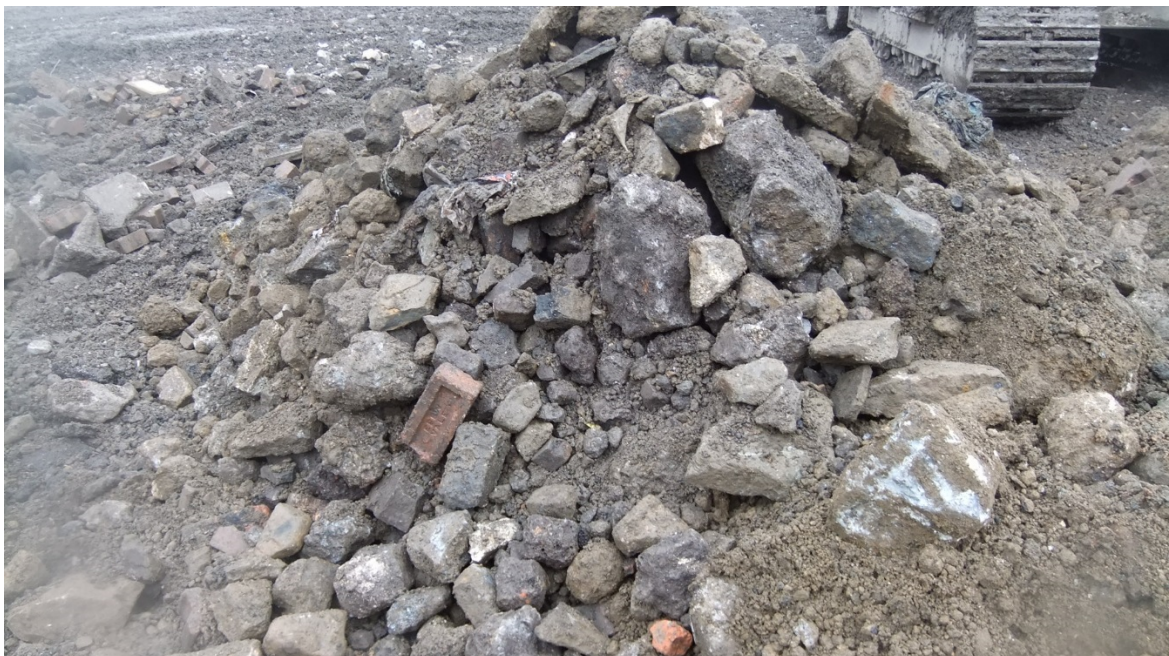
Photograph 4 – Trial pit TP2 (arisings)

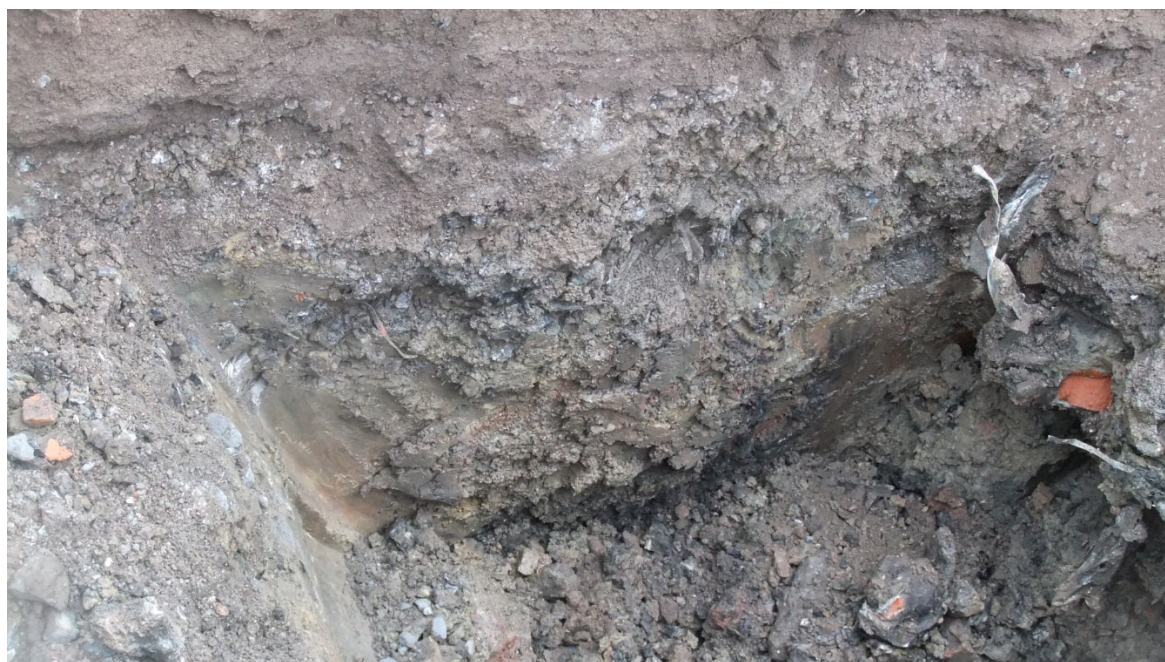
<table><tr><th>Trial pit location</th><th>Depth of sample</th><th>Evidence of contamination</th></tr><tr><td rowspan="4">TP3</td><td>0.3m</td><td rowspan="2">Presence of slag, bricks, plastic, timber, tiles, clothes, construction rubble.</td></tr><tr><td>1.9m</td><td>Presence of slag and bricks. Strong hydrocarbon odour.</td></tr><tr><td>2.4m</td><td>Presence of slag, bricks, construction rubble, plastic in black soil matrix. (stratum as above)</td></tr></table>

Photograph 5 – Trial pit TP3

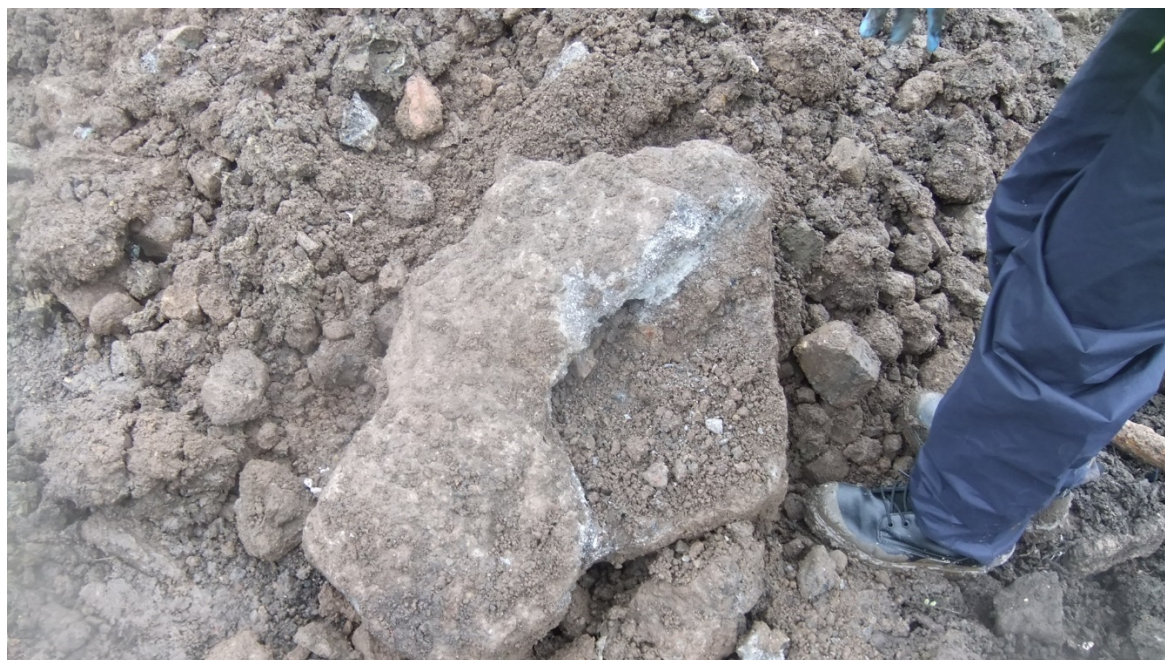
Photograph 6 – Trial pit TP3 (arisings)

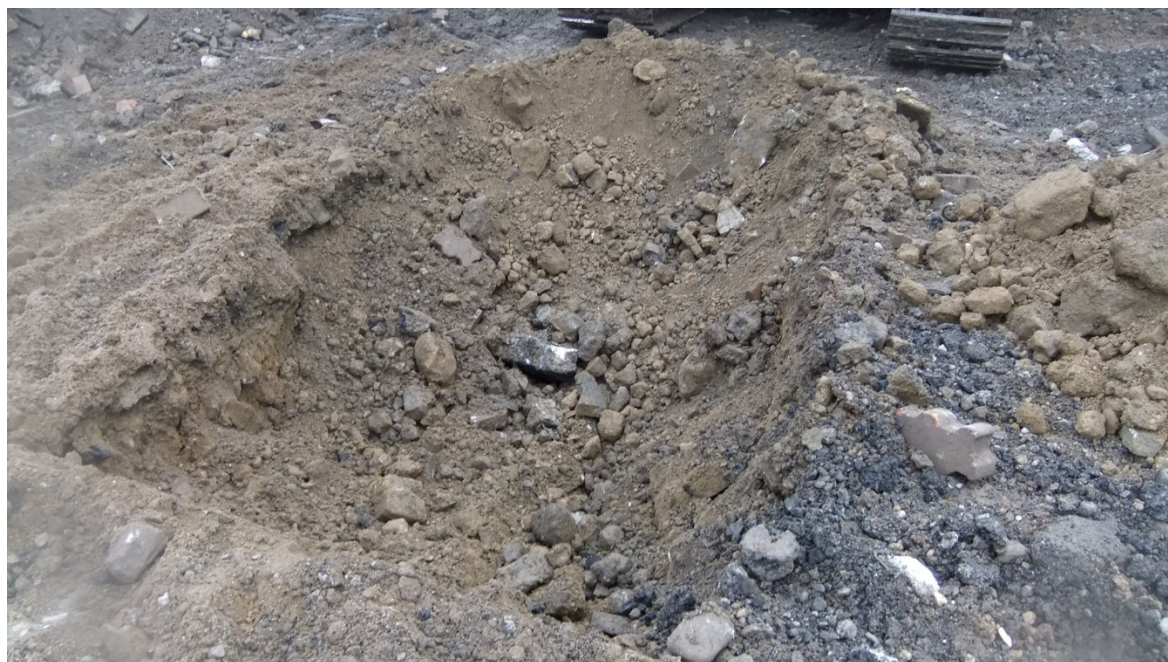
<table><tr><th>Trial pit location</th><th>Depth of sample</th><th>Evidence of contamination</th></tr><tr><td rowspan="2">TP4</td><td>0.6m</td><td>Presence of slag, bricks, construction rubble, plastic and metal. Hydrocarbon odour</td></tr><tr><td>1.2m</td><td>Presence of slag. Hydrocarbon odour.</td></tr></table>

Photograph 7 – Trial pit TP4

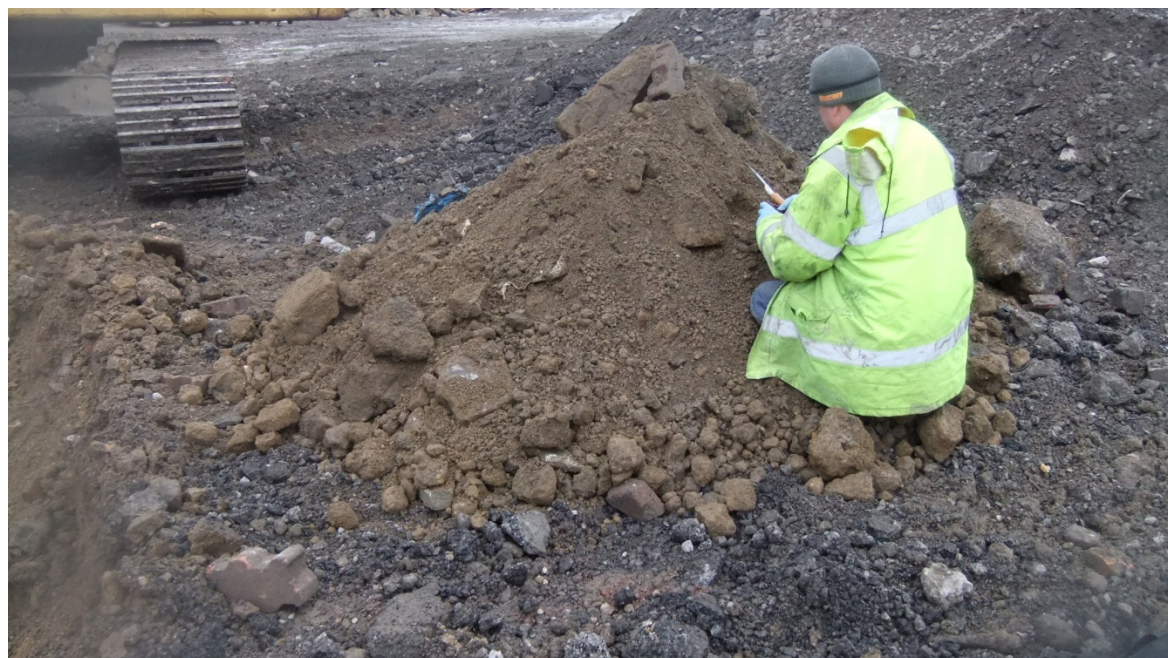
Photograph 8 – Trial pit TP4 (arising)
