Cefas Report TR492 Hinkley Point Cardiff Grounds (LU110) post-disposal bathymetric survey and grab sample analyses (Marine Licence 12/45/MLv1)

BEEMS Technical Report	TR492
BEEMS Technical Report Title	Hinkley Point Cardiff Grounds (LU110) post-disposal bathymetric survey and grab sample analyses (Marine Licence 12/45/MLv1)
Sub-Contract Report Original Title:	CS0555_Cardiff Grounds Survey_V4
Sub-Contractor	Titan Environmental Surveys Limited
Summary of Purpose & Value to BEEMS	
<p>Installation of the intake and outfall heads for the Hinkley Point C (HPC) nuclear power station, requires dredging works to prepare the seabed, and subsequent disposal of the dredged material. Consent to carry out this dredge was granted by the Marine Management Organisation in marine licence L/2013/00178/4, as amended (MMO, 2017). Permission to dispose of this material in disposal area LU110 (Cardiff Grounds) was granted in Natural Resources Wales in marine licence 12/45/MLv1 (NRW, 2018). To satisfy the conditions of marine licence 12/45/MLv1 (NRW 2018), pre- and post-disposal monitoring requirements were agreed with NRW and are detailed in BEEMS Technical Report TR429. To meet pre-disposal monitoring r

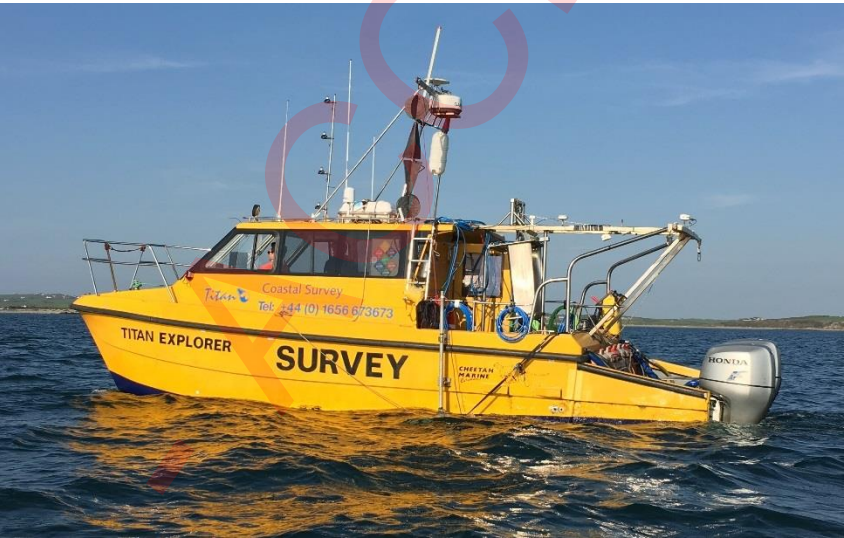
Figure 2.1 The MV Titan Explorer

The MV Titan Explorer (Figure 2.1) was used as the survey platform. The vessel's particulars are:

Length overall	:	9.7m
Beam	:	2.9m
Draught	:	0.8m
Engines	:	2 x 150bhp
Certification	:	MCA Category 2 (60 miles from safe haven)

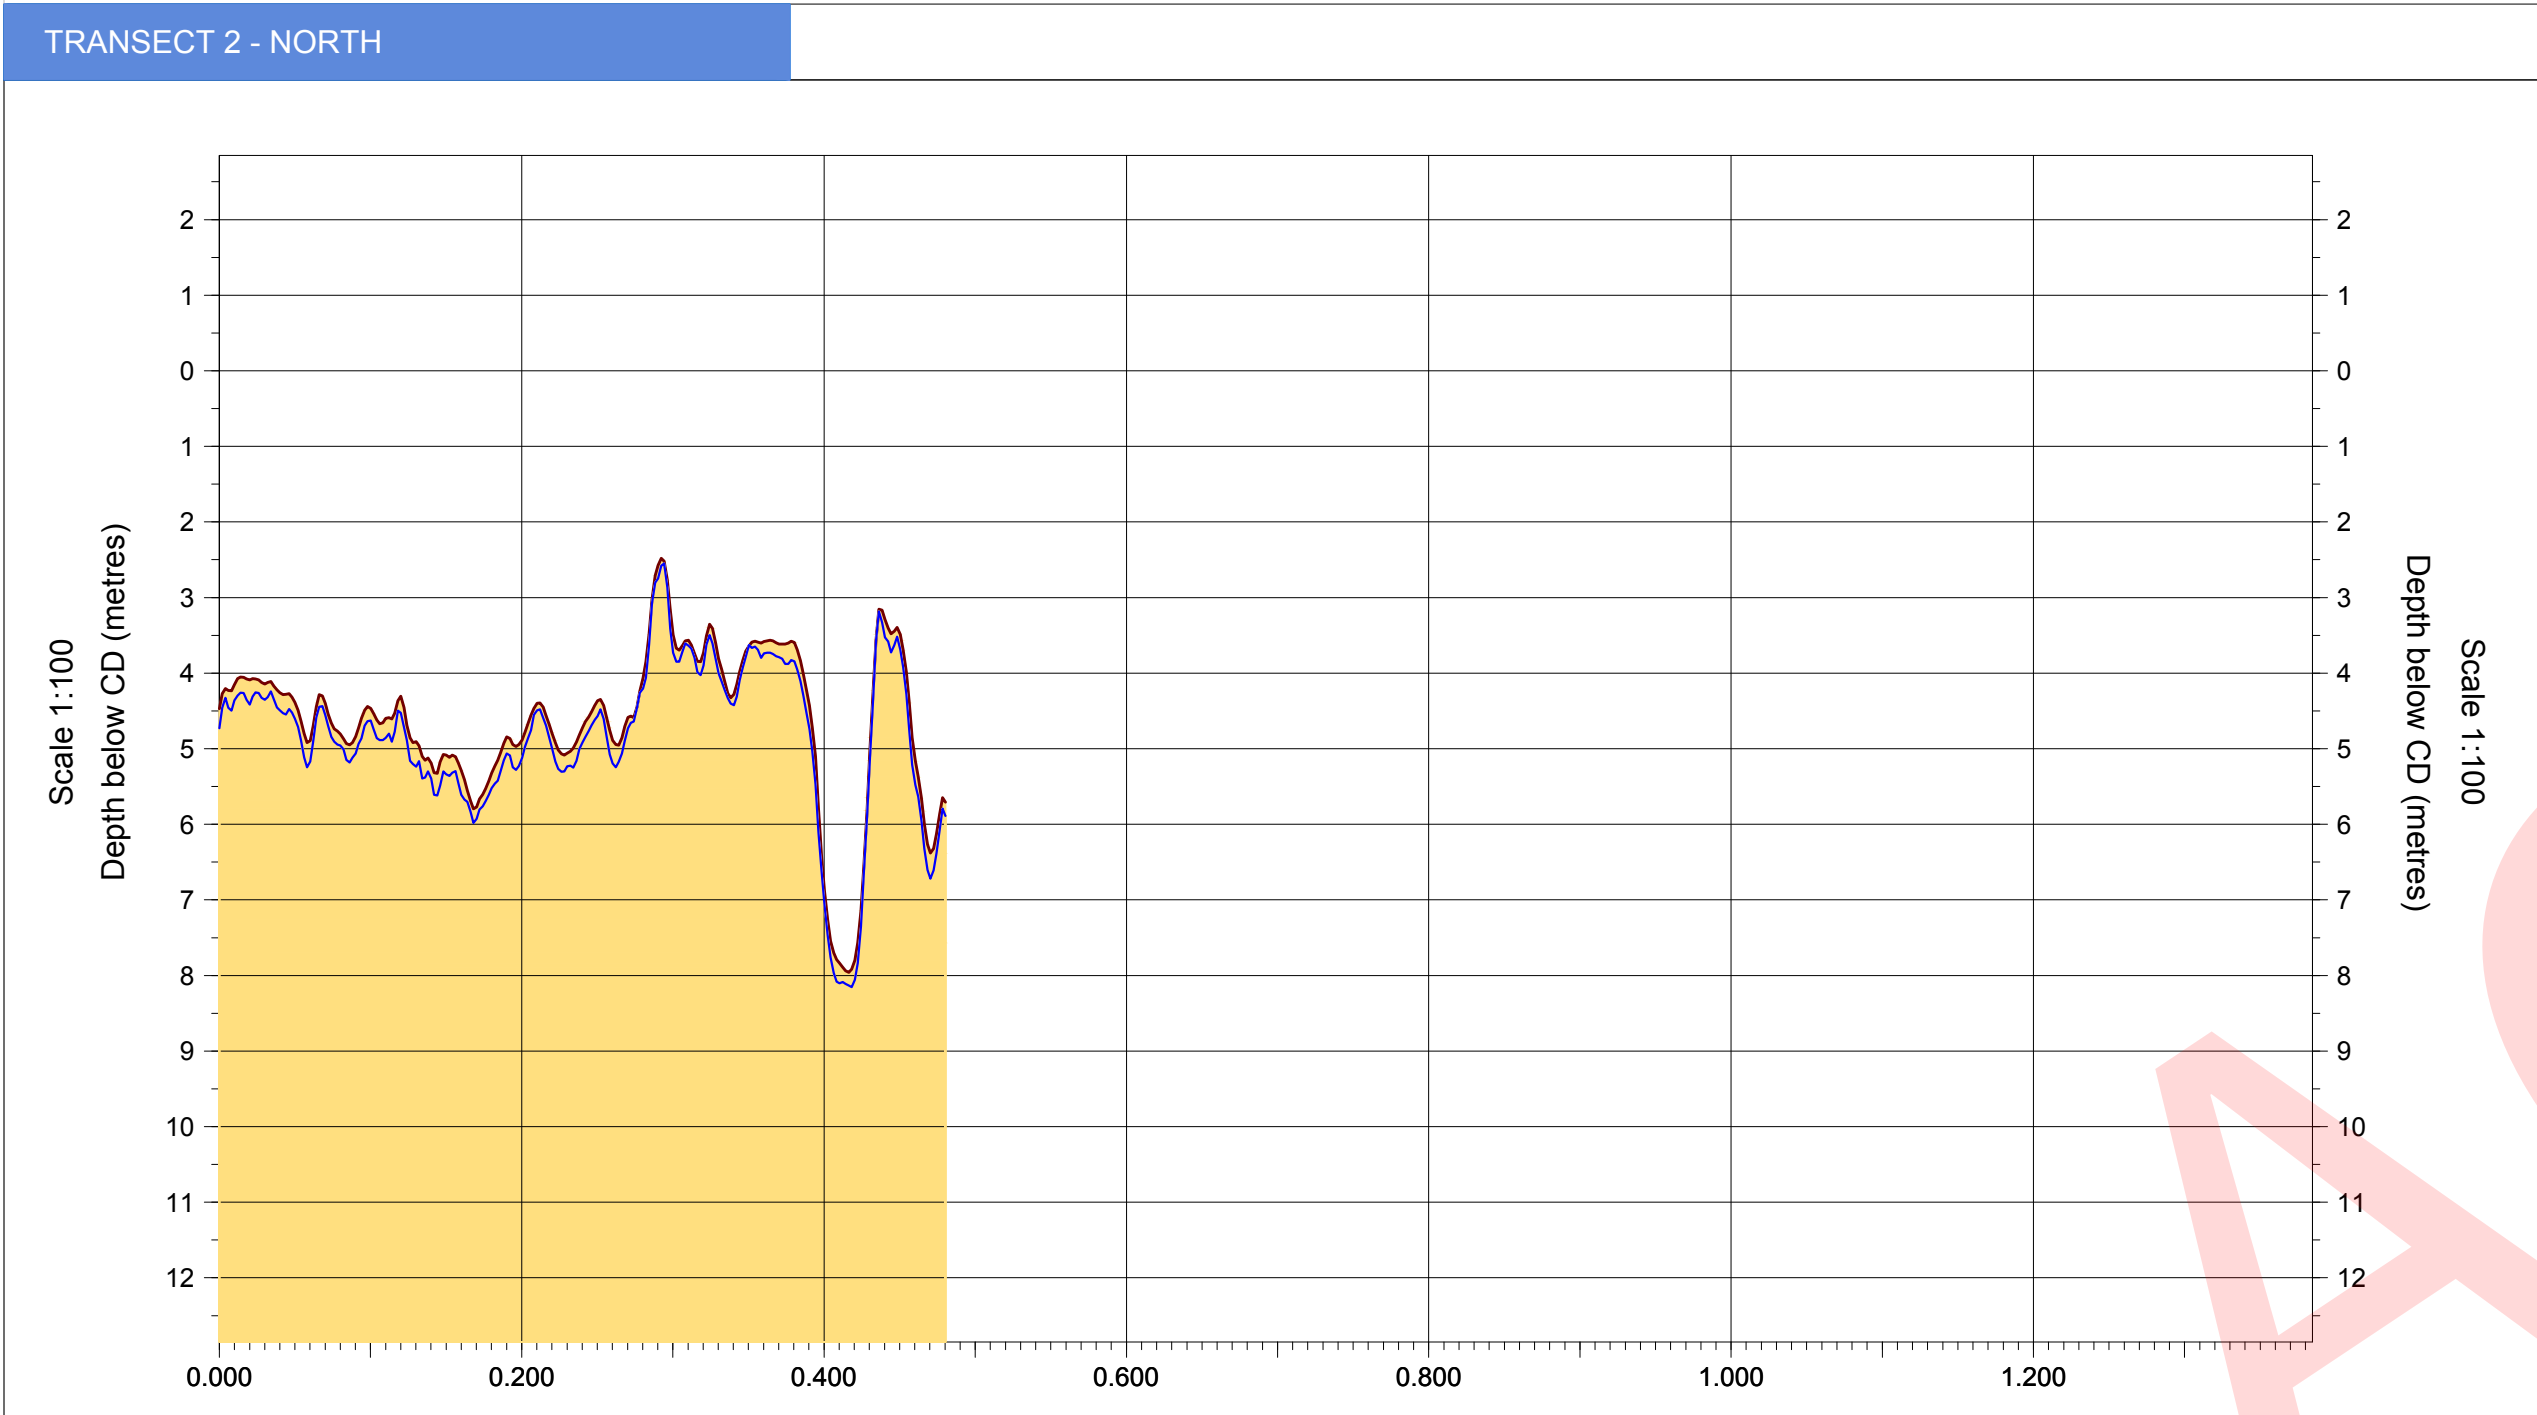
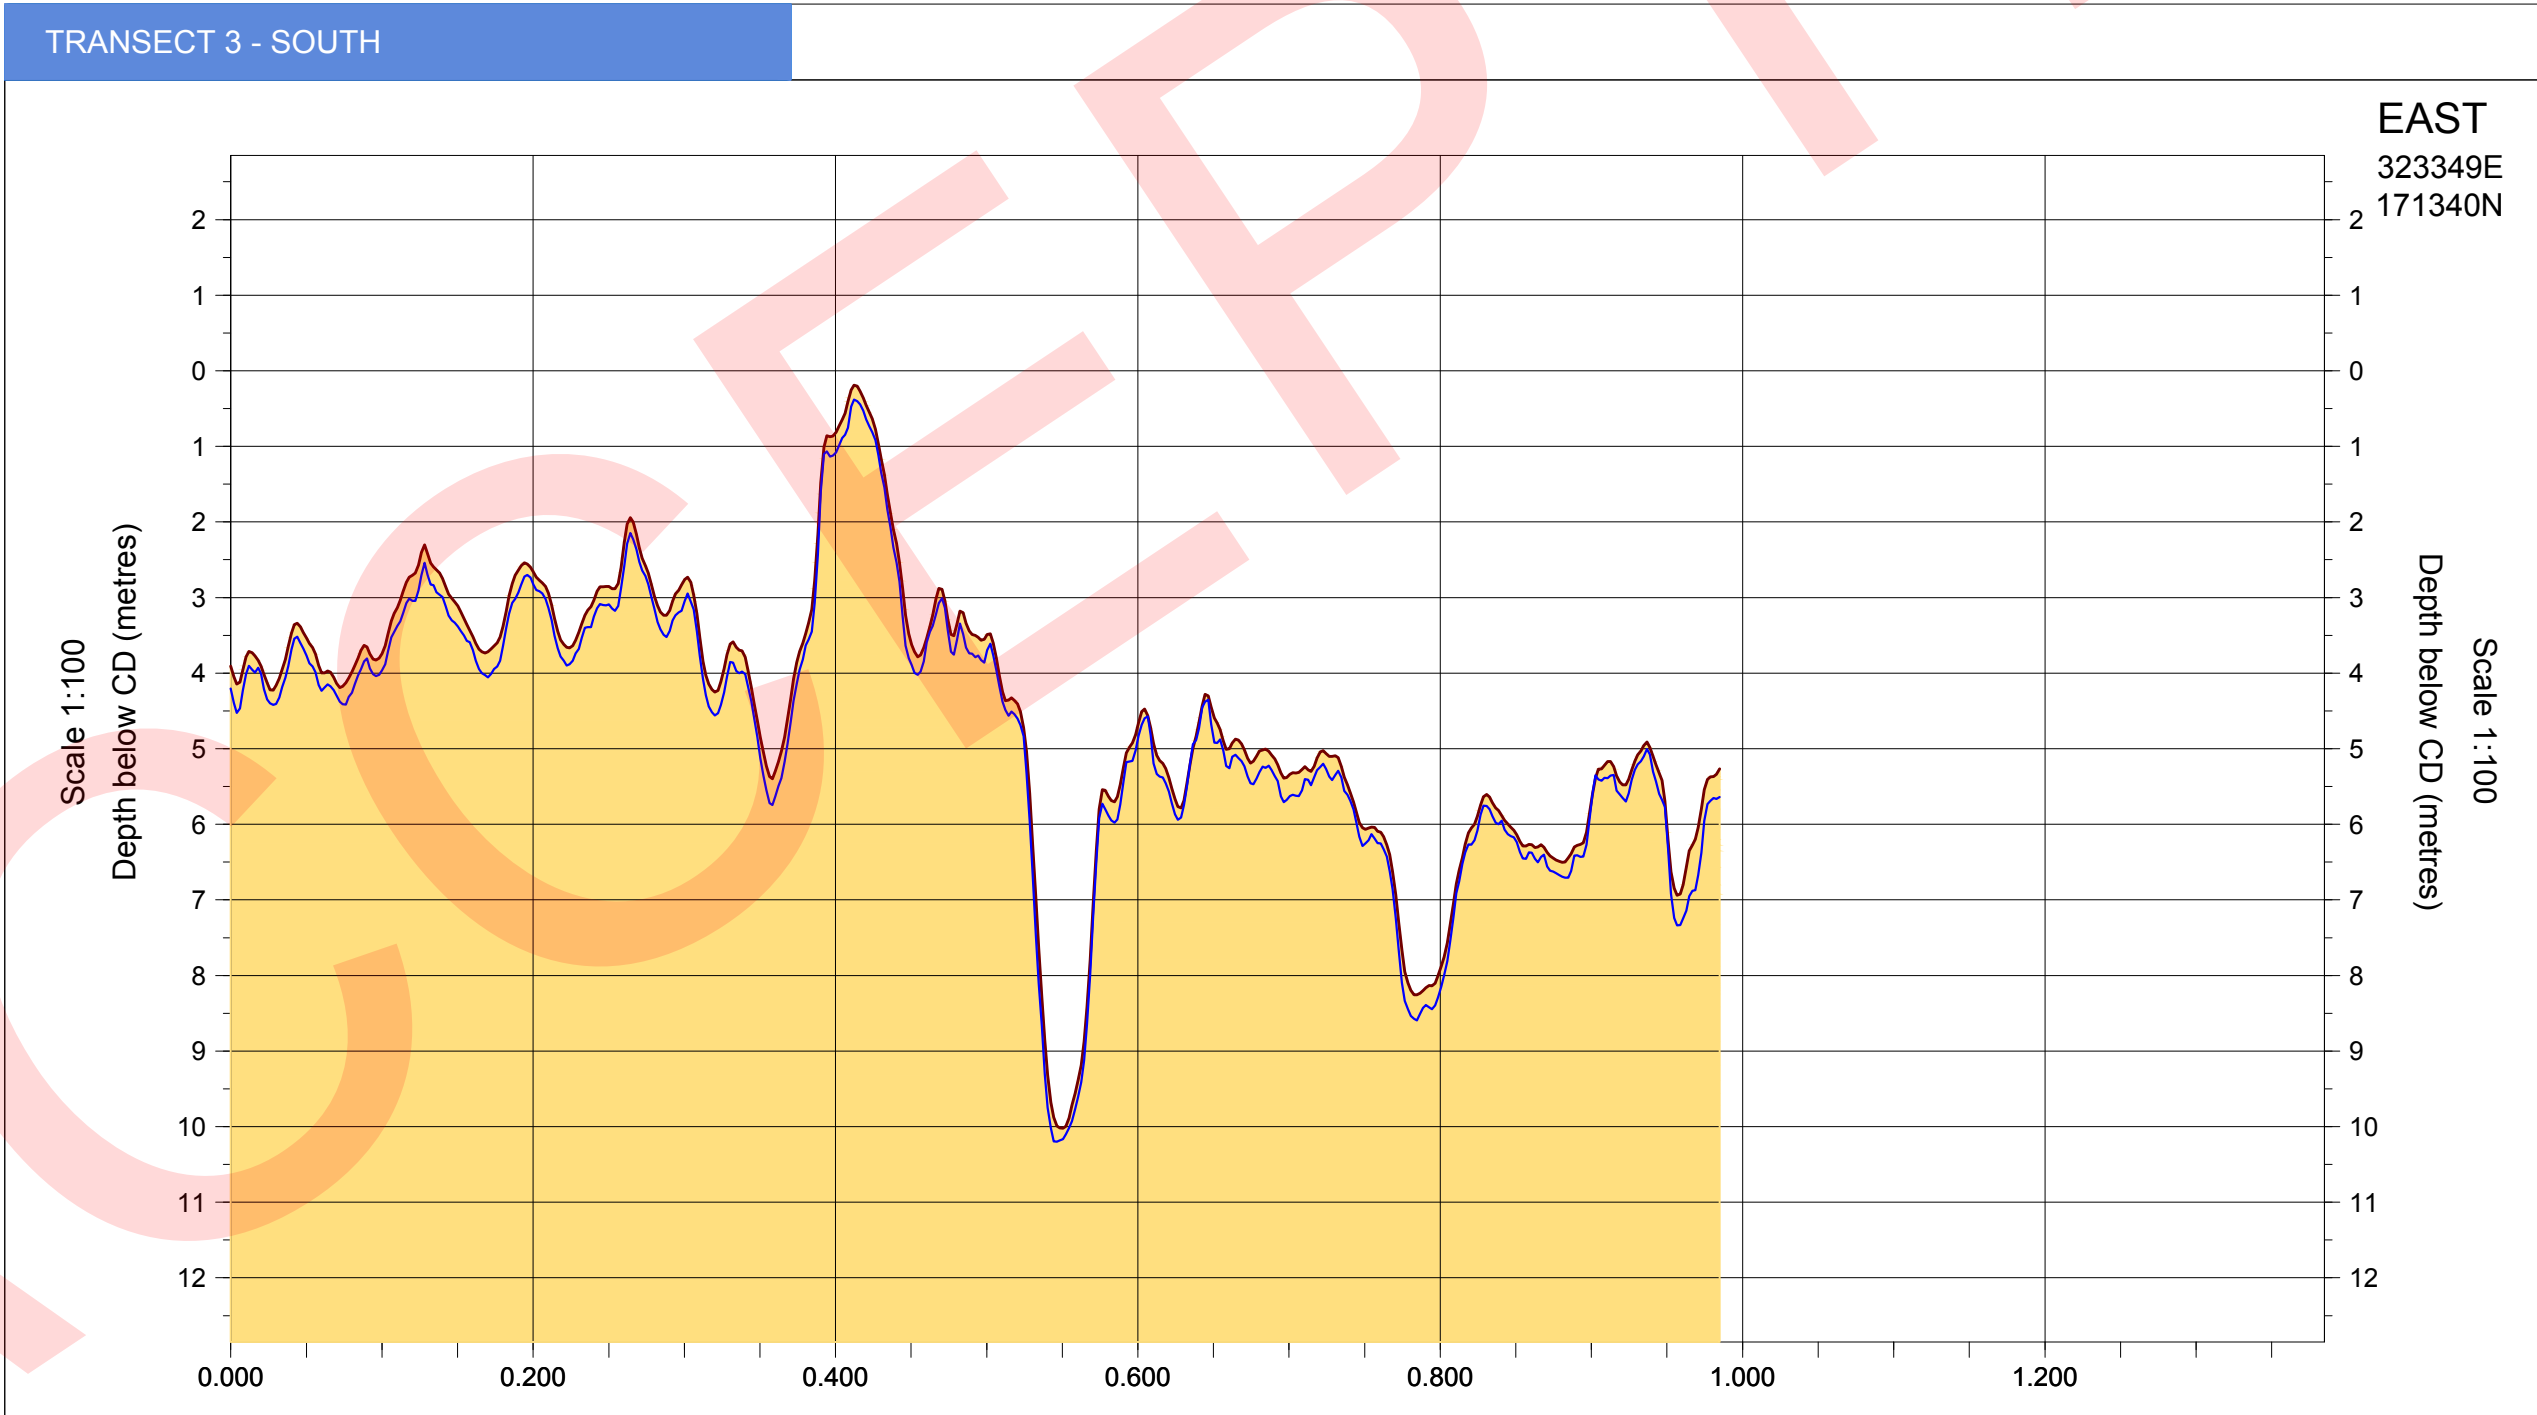
B.4 BATHYMETRY TRANSECTS

- All Depths are reduced to Chart Datum (CD) using PPK tides and the Vertical Offset Reference Frame (VORF) model.
- The longitudinal profile has been produced from the bathymetry DTM produced in 2018 and 2019.
- Following detailed analysis, the depths from the 2019 transects have been increased by 8.5cm.

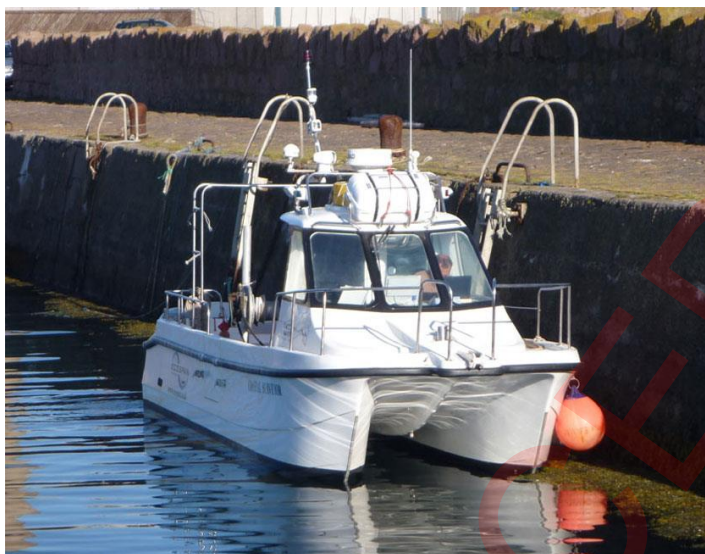
Figure 1: Ecospan RV Coastal Surveyor

Operations: Cefas conducted grab sampling operations from Ecospan's RV Coastal Surveyor, 7.9 m twin engine Sea Cheetah catamaran, an MCA Category 3 workboat (Figure 1). Survey works were supported by Marine Science Services (MSS).

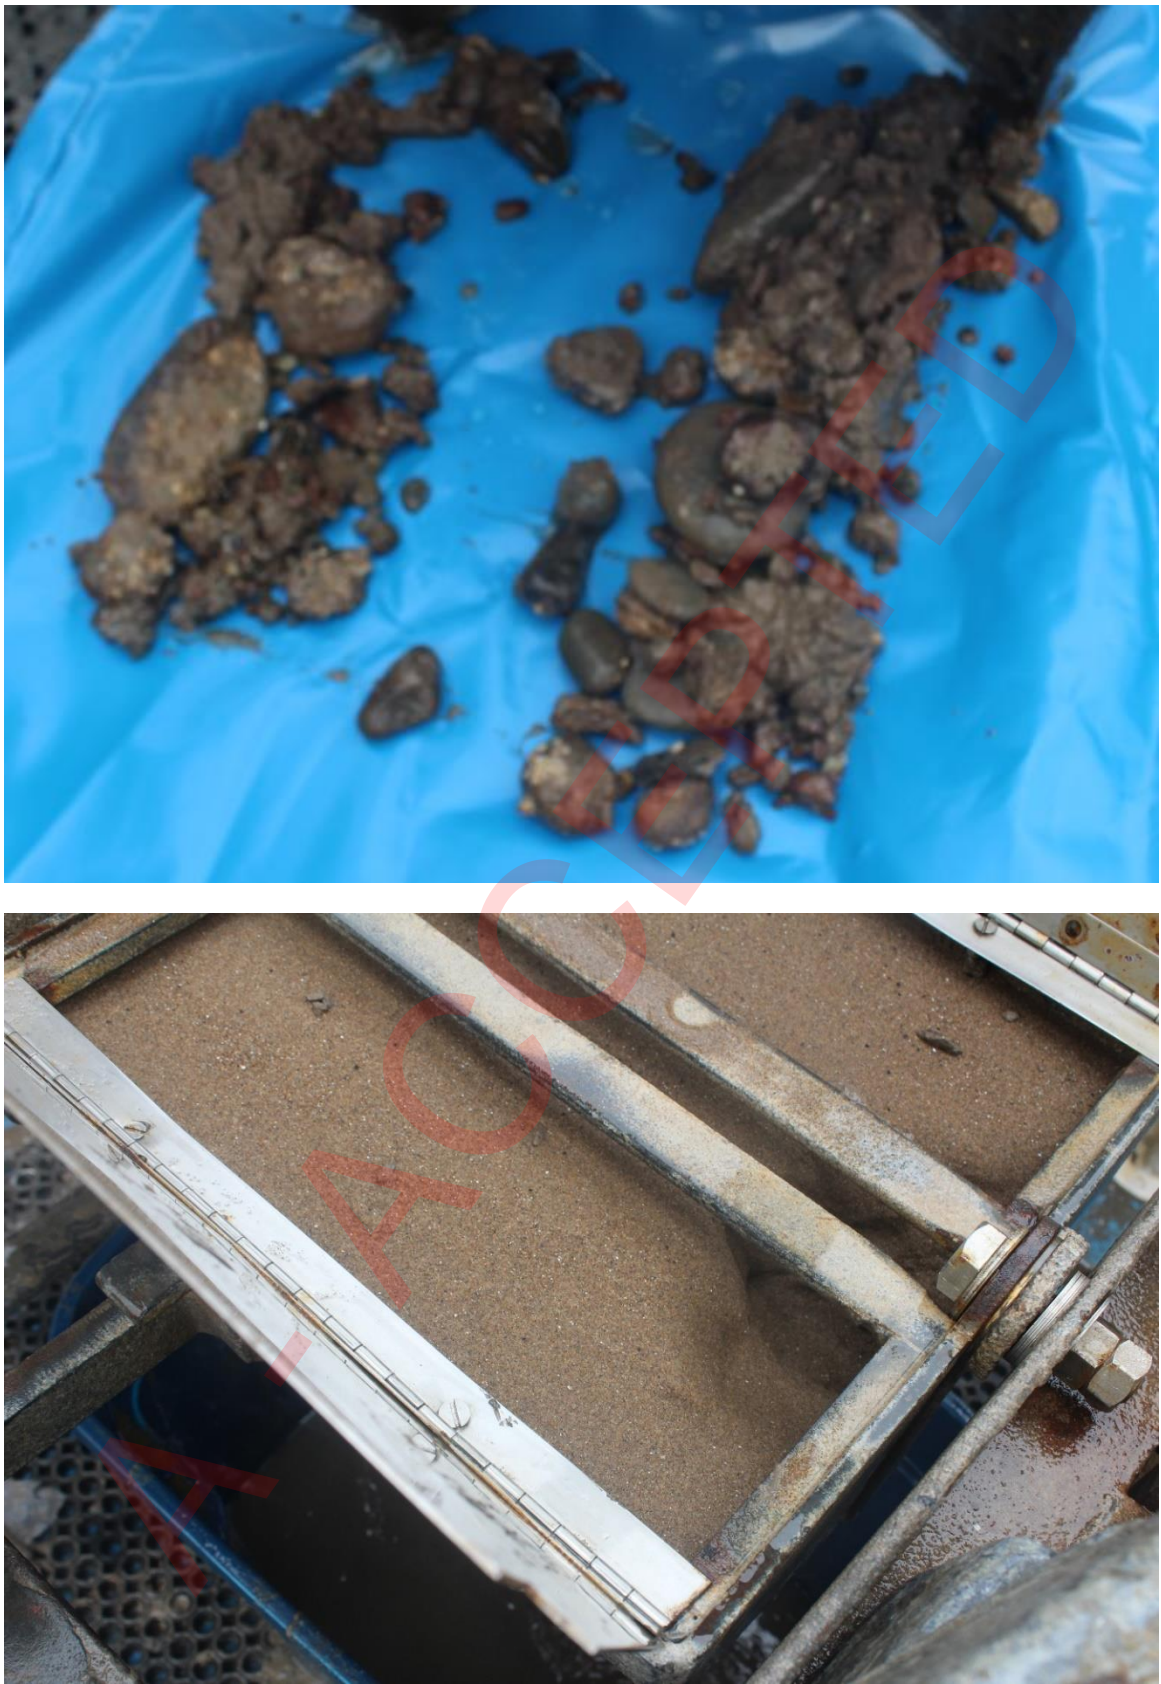
Figure 2: S7 sample (top panel) and S12 sample (bottom panel) collected 24th June 2019. Note that unfortunately camera issues led to blur in the S7 photograph.

Sampling: Two additional grab samples were collected from Cardiff Grounds at the locations specified in Table 1. The grab sample from station S12 was collected with a 0.1 m³ day grab. The grab sample from station S7 was collected with a Van Veen grab, as the day grab was unsuccessful due to the presence of coarse material.

Results: Upon survey completion, samples were transported to the Cefas Lowestoft sedimentology laboratory for particle size analysis (PSA). Upon completion of analysis, results will be reported to NNB GenCo in accordance with monitoring requirements. Photographs of the grab samples taken during the survey are shown in Figure 2.
