DOCUMENT TITLE	Cefas Report TR492 Hinkley Point Cardiff Grounds (LU110) post-disposal bathymetric survey and grab sample analyses (Marine Licence 12/45/MLv1)															EMPLOYER REVISION	08
-----------------------	--	--	--	--	--	--	--	--	--	--	--	--	--	--	--	--------------------------	----

BEEMS Technical Report	TR492
BEEMS Technical Report Title	Hinkley Point Cardiff Grounds (LU110) post-disposal bathymetric survey and grab sample analyses (Marine Licence 12/45/MLv1)
Sub-Contract Report Original Title:	CS0555_Cardiff Grounds Survey_V4
Sub-Contractor	Titan Environmental Surveys Limited
Summary of Purpose & Value to BEEMS	
<p>Installation of the intake and outfall heads for the Hinkley Point C (HPC) nuclear power station, requires dredging works to prepare the seabed, and subsequent disposal of the dredged material. Consent to carry out this dredge was granted by the Marine Management Organisation in marine licence L/2013/00178/4, as amended (MMO, 2017). Permission to dispose of this material in disposal area LU110 (Cardiff Grounds) was granted by Natural Resources Wales in marine licence 12/45/MLv1 (NRW, 2018). To satisfy the conditions of marine licence 12/45/MLv1 (NRW 2018),

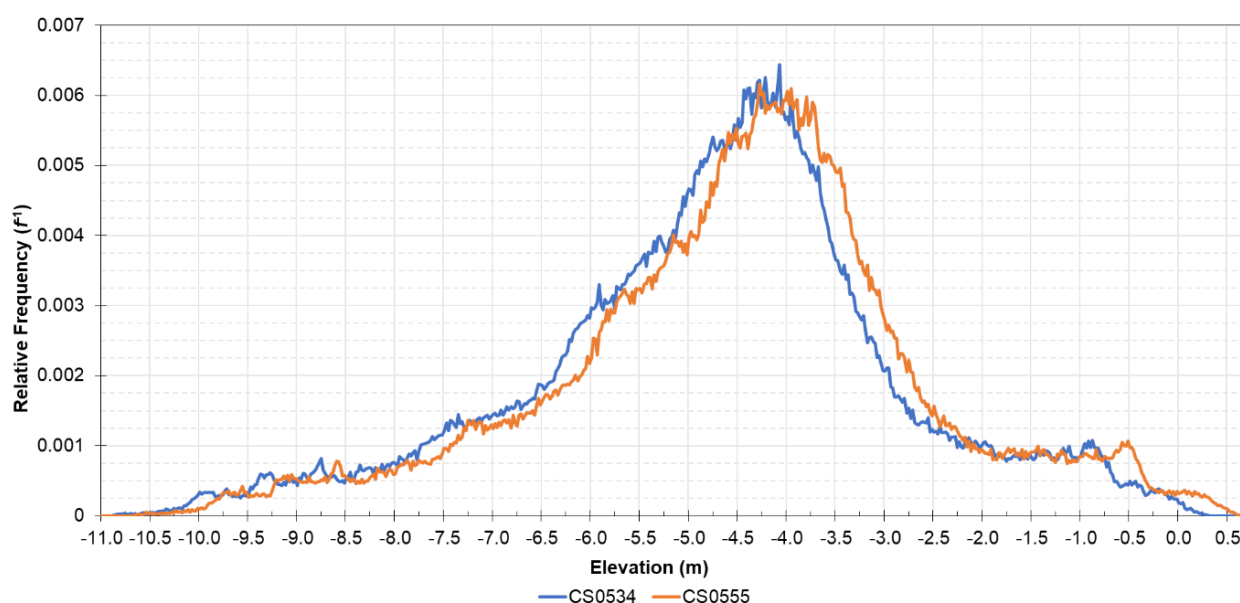
Figure 1: Cumulative water depth plot for the CS0534 (pre-disposal) and CS0555 (post-disposal) bathymetric surveys.

Following discussions with NRW, the residual survey offset (which remained once Titan's report had been updated to remove the +0.085 m antenna offset) was further investigated by Cefas. For bathymetric surveys CS0534 (pre-disposal) and CS0555 (post-disposal), a histogram of the relative distributions of water depth was produced (bin size of 0.02 m) (Figure 1). The arithmetic mean of the water depths across Cardiff Grounds only (i.e., excluding the survey buffer) are -4.737 m and -4.496 m for CS0534 and CS0555 respectively. Direct comparison of these mean values results in a vertical offset between the surveys of 0.241 m.

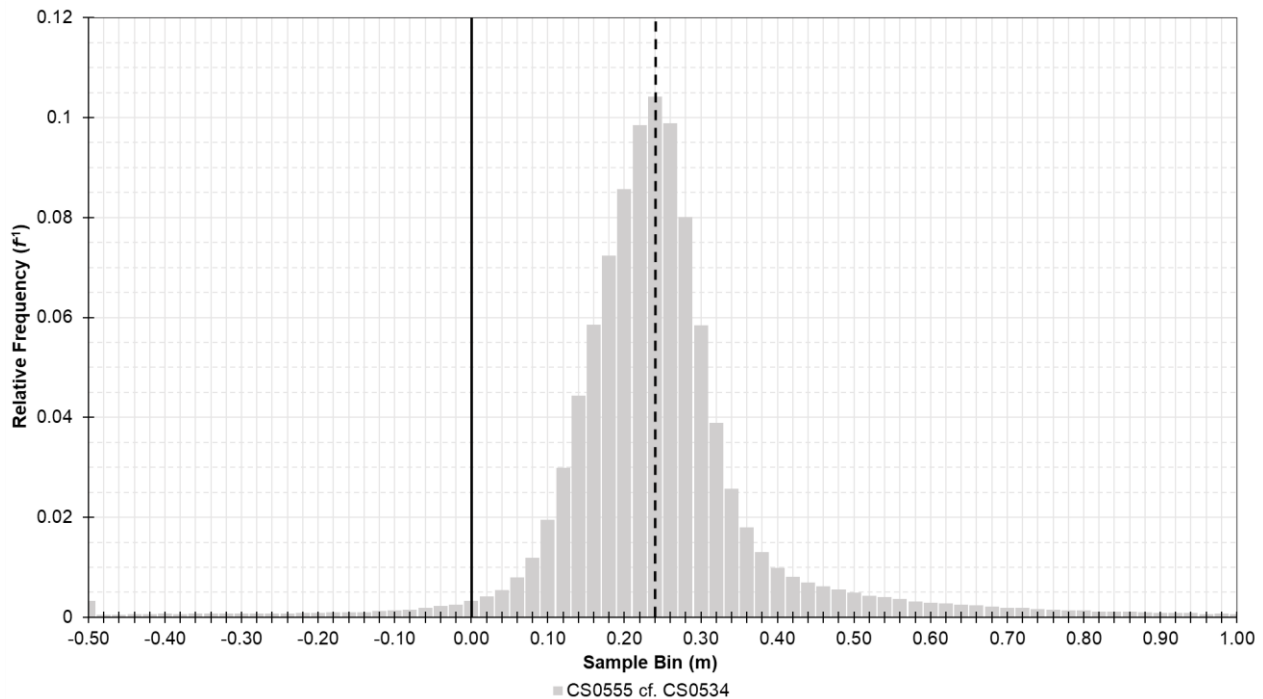
Figure 2: Histogram of residual differences, derived by subtracting CS0534 (pre-disposal) from CS0555 (post-disposal).

To further validate and demonstrate the vertical offset, a difference analysis was undertaken, assuming CS0534 to be vertically ‘correct’ and comparing it with survey CS0555 on a node by node basis. A histogram of the residual differences between the two bathymetric surveys is presented in Figure 2. The difference analysis again yields a residual mean value of +0.24 m (dashed black line (Figure 2)).

If the residual differences presented in Figure 2 were due to a real event (i.e., disposal activities and/or natural sediment processes, rather than survey artefact), the distribution of residuals and the residual mean value would be expected to vary, if the area over which they were calculated was changed (i.e., the residual offset would not be uniformly distributed across the site). To assess this, a gate filter was applied to survey CS0555 (post-disposal), such that it excluded areas where “real” changes were deemed to have occurred. “Real” changes were defined as any change greater than +0.50 m and less than 0.00 m (i.e., changes in the bed elevation about the offset of approximately ± 0.25 m). The resultant “mask” (Figure 3) was used to repeat the above difference analysis (i.e., residual differences were calculated for areas highlighted green in Figure 3). Again, the difference analysis yields a residual mean value of 0.24 m (Figure 4). The consistency between the results implies that the +0.24 m vertical offset is due to survey artefact, rather than any disposal activity and/or natural processes.

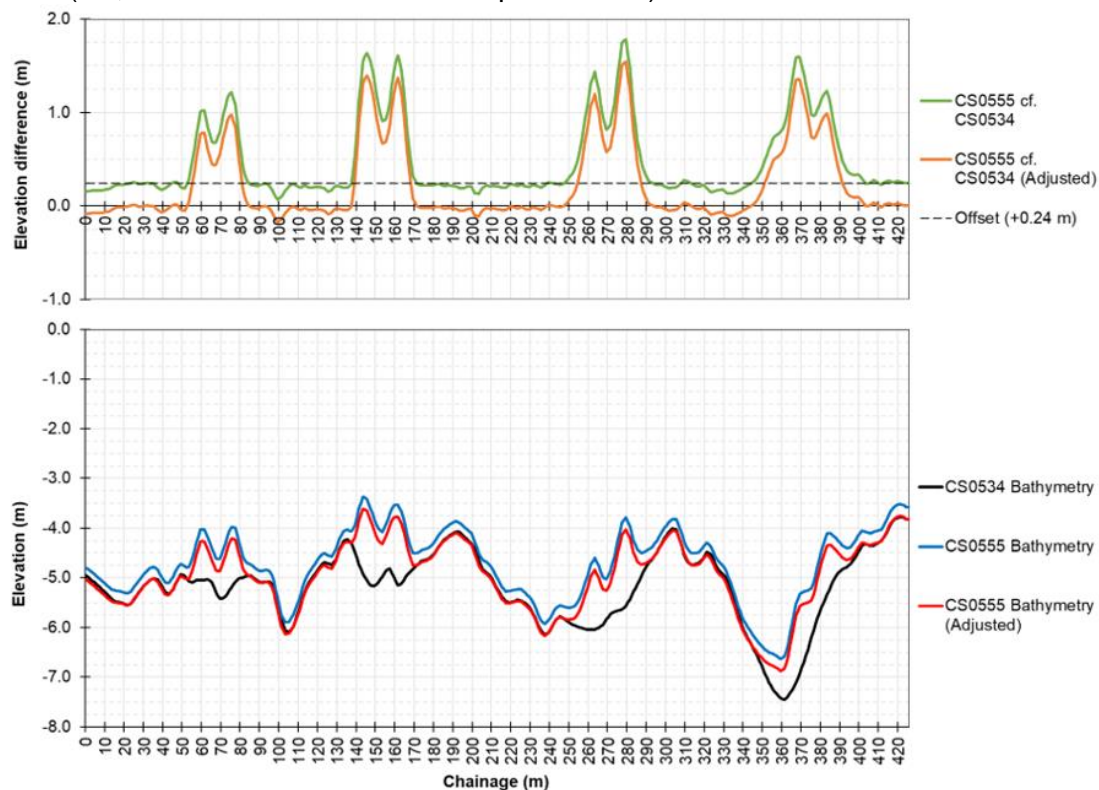
Figure 8: Bed level changes along "Transect 01" (shown in Figure 6 and Figure 7), including both "unadjusted" and "adjusted" elevations (chainage originates in the south of "Transect 01", progressing north).

Elevation differences and bathymetry along "Transect 01" are presented in Figure 8. In the top panel, the elevation differences between the CS0534 (pre disposal) survey and the "unadjusted" (green line) and "adjusted" (orange line) CS0555 (post disposal) survey, clearly identify changes in the bed level associated with the four disposal events, whilst the 0.24 m offset is apparent in areas outside of these disposal events. In the bottom panel, the bathymetry of the CS0534 (pre-disposal) (black line) survey and the "unadjusted" (blue line) and "adjusted" (red line) CS0555 (post disposal) survey along "Transect 01" is presented. Again, following subtraction of the 0.24 m offset, comparison of the CS0534 (pre disposal) (black line) survey and the "adjusted" (red line) CS0555 (post disposal) survey, clearly identifies the four disposal events whilst showing good agreement in areas where patterns of erosion and accretion would only be expected due to natural processes (i.e., there is no evidence of a disposal event).

This analysis clearly shows a systematic offset of 0.24 m between the pre- and post- disposal bathymetric surveys. Following subtraction of this offset, the resultant erosion and fill and resultant net volume change across Cardiff Grounds (Table 5). In summary, there has been a minor net increase in sediment volume of only 103 m³ across the site between the pre- and post- disposal surveys, consistent with the understanding that this site is dispersive.

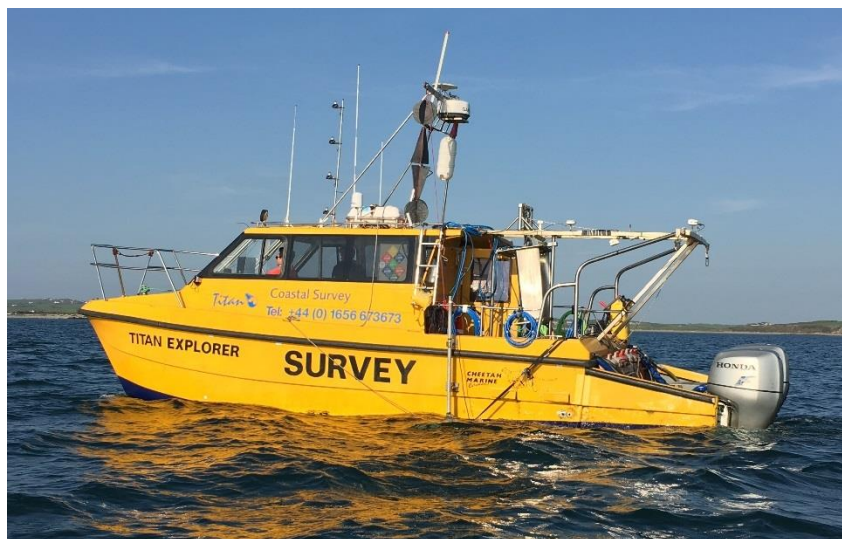
Figure 2.1 The MV Titan Explorer

The MV Titan Explorer (Figure 2.1) was used as the survey platform. The vessel's particulars are:

Length overall	:	9.7m
Beam	:	2.9m
Draught	:	0.8m
Engines	:	2 x 150bhp
Certification	:	MCA Category 2 (60 miles from safe haven)

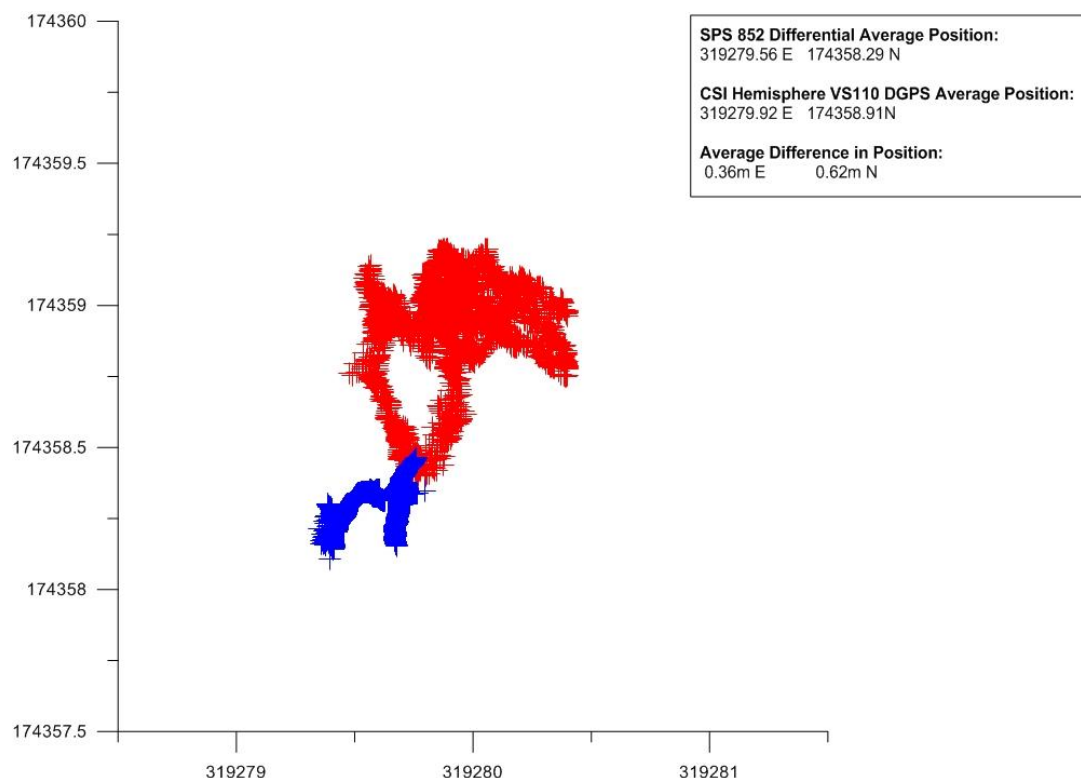
Figure 5.1 Navigation Static Verification Scatter Plot

A navigation calibration was carried out on 09/04/2019, whilst the vessel was alongside in Mermaid Quay Marina, Cardiff. GPS antenna positions were logged for approximately 1.5 hours enabling a comparison of the positions derived from the primary and secondary navigation systems. The positions derived from the two systems had an average difference in position of 0.36m in Easting and 0.62m in Northing, (see Figure 5.1). Further information can be found in Appendix A.2.

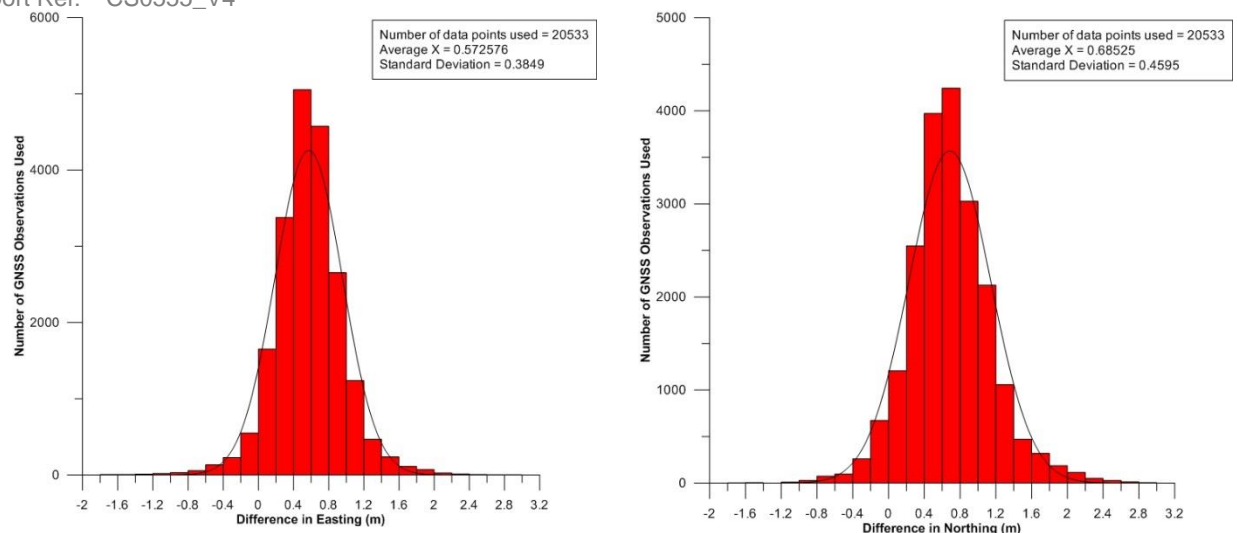
Figure 5.2 Comparison of Eastings and Northings between the Primary and Secondary Navigation Systems

During the survey, comparisons were made between the primary and secondary navigation systems. Analysis produced average differences of 0.573m in easting and 0.685m in northing between the two systems confirming the accuracy of the primary navigation system.

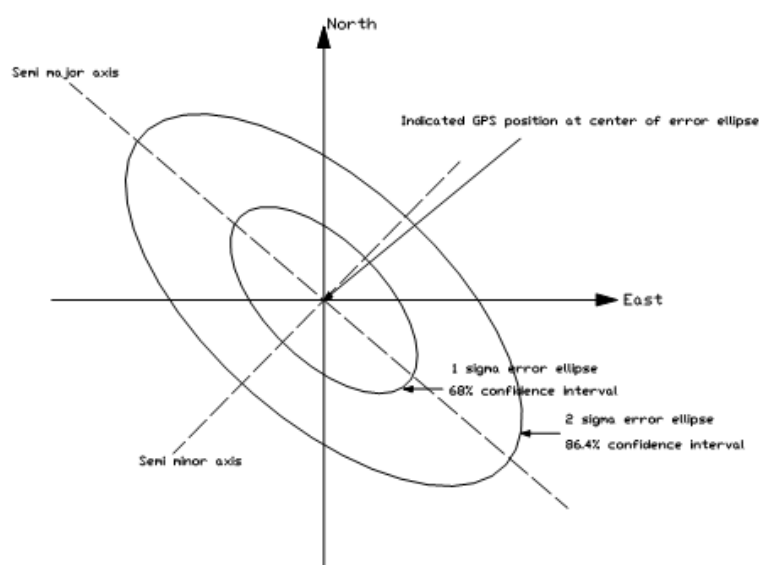
Figure 5.3 Schematic Diagram of a Two-Sigma Error Ellipse

Throughout the survey GPS quality figures were logged for each fix. These figures were processed and presented in tabulated form to enable positional verification. Sigma figures are generated for the North, East and Up axes. Each individual sigma display was a probability estimate of how close the actual position was to the GPS displayed position. Given the sigma values for a position fix, it is possible to construct an error ellipse; this is a graphical representation of the position fix, displaying the indicated GPS position at the centre of the ellipse with the relevant sigma error ellipse centred on this position (Figure 5.3). The 1-sigma error ellipse represented the probability that a position fix was within 68% of the indicated position and the two-sigma error ellipse represented the chance of a position fix being within 86.4% of the indicated position.

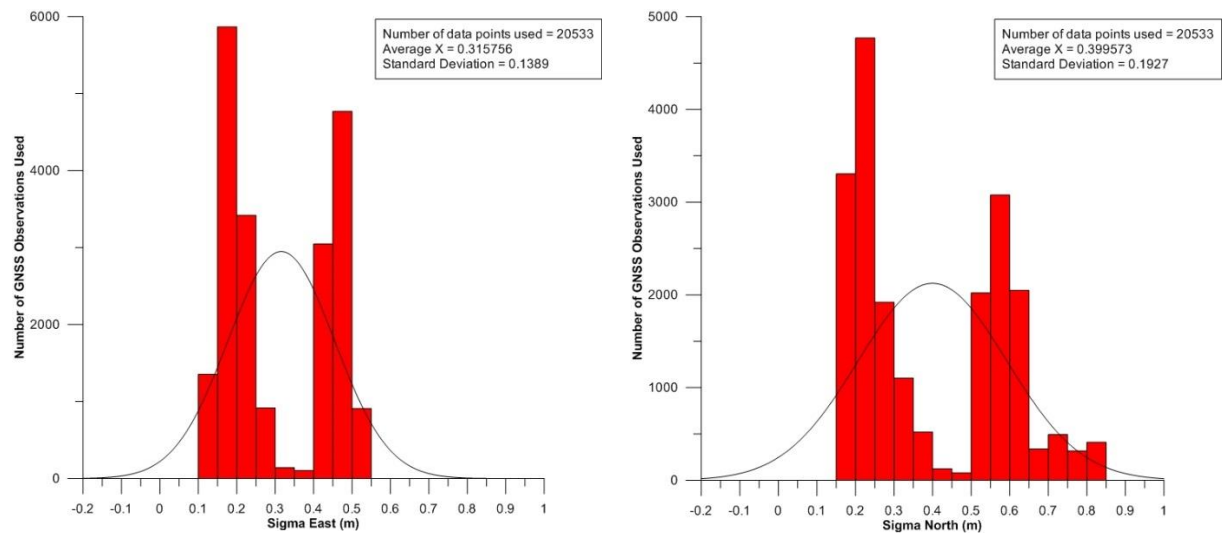
Figure 5.4 Primary Navigation, Sigma East and Sigma North.

Figure 5.4 below displays histograms of the Sigma East and Sigma North values recorded for the primary navigation during the survey. Average Sigma East and North values were recorded as 0.32m and 0.40m respectively.

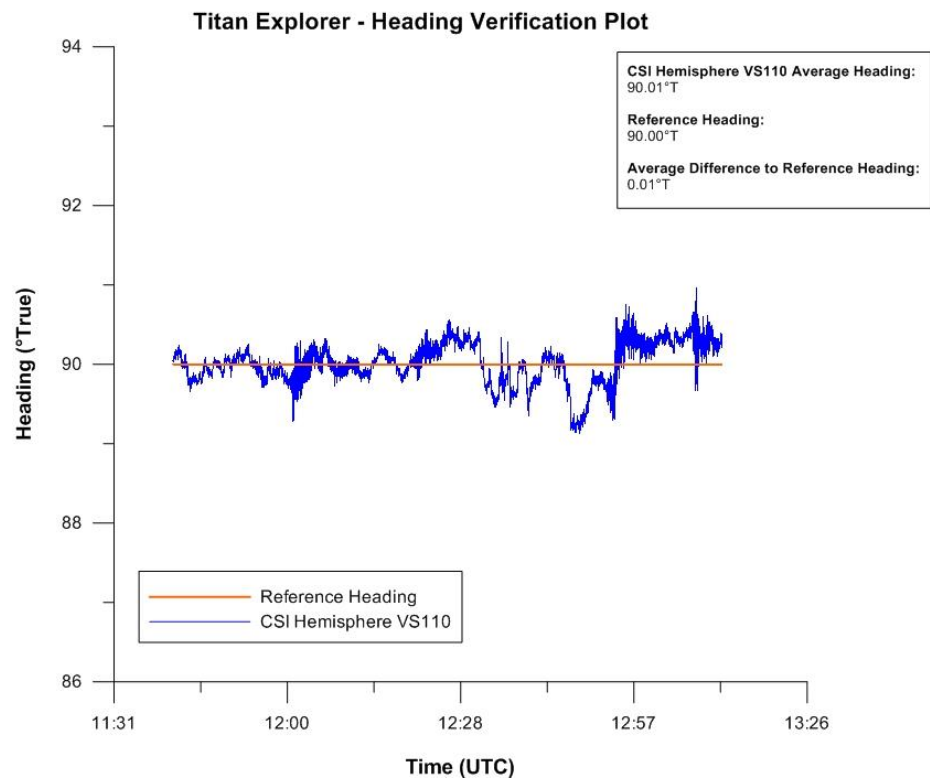
Figure 5.5 Heading Verification Plot

A heading calibration was conducted alongside the navigation calibration. This enabled a direct comparison of the primary heading system against the known heading of the berth, see Figure 5.5. Further information can be found Appendix A.3.

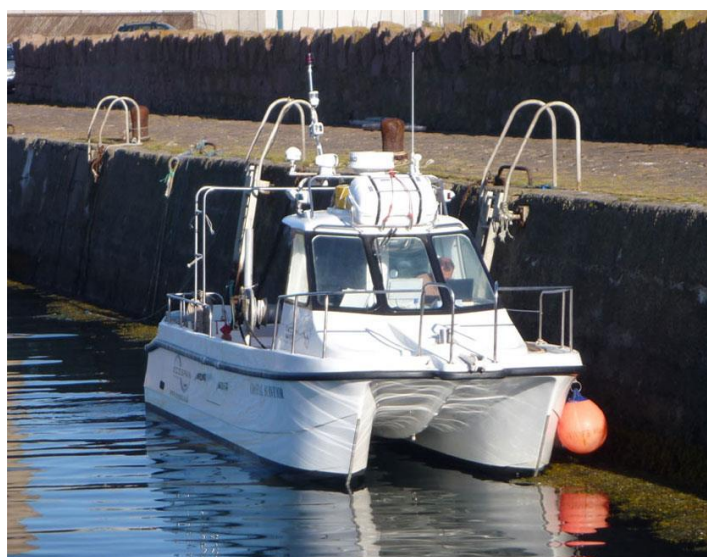
Figure 1: Ecospan RV Coastal Surveyor

Operations: Cefas conducted grab sampling operations from Ecospan's RV Coastal Surveyor, 7.9 m twin engine Sea Cheetah catamaran, an MCA Category 3 workboat (Figure 1). Survey works were supported by Marine Science Services (MSS).

Sampling: Two additional grab samples were collected from Cardiff Grounds at the locations specified in Table 1. The grab sample from station S12 was collected with a 0.1 m³ day grab. The grab sample from station S7 was collected with a Van Veen grab, as the day grab was unsuccessful due to the presence of coarse material.

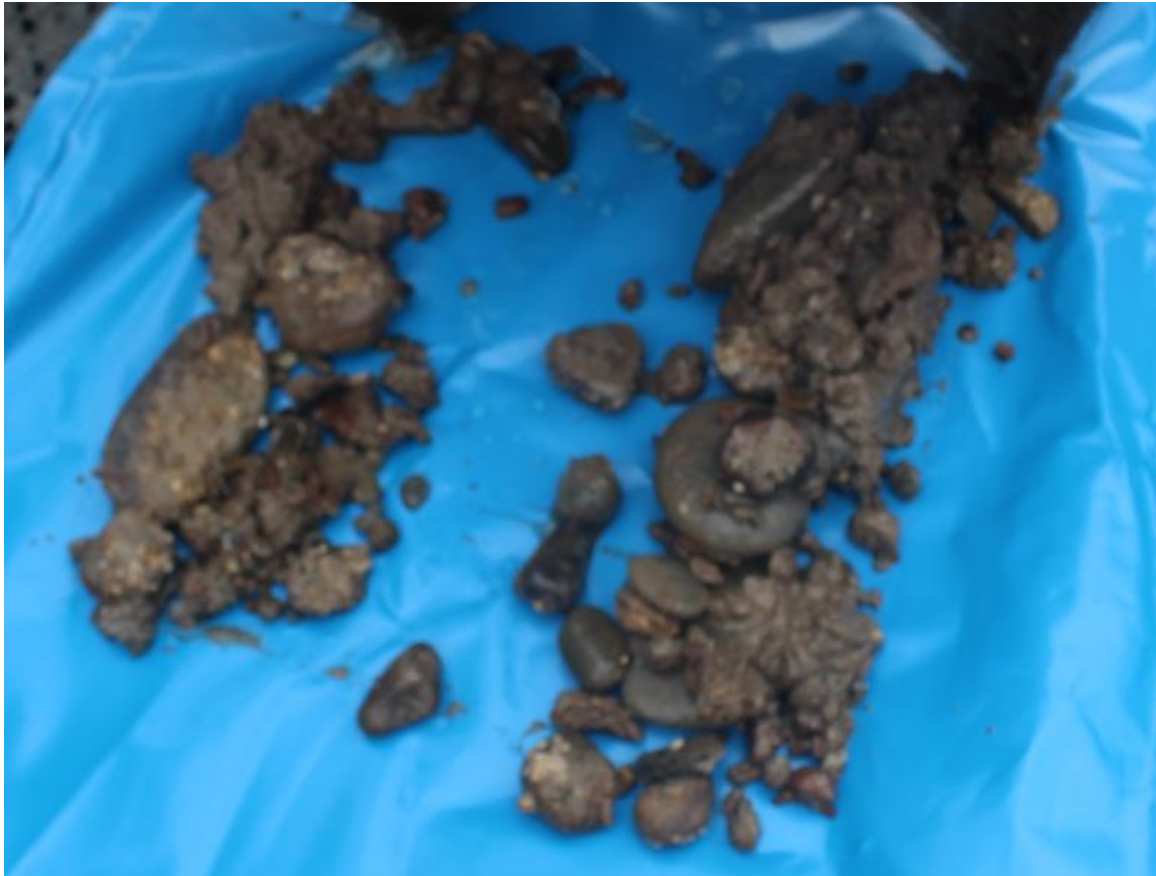
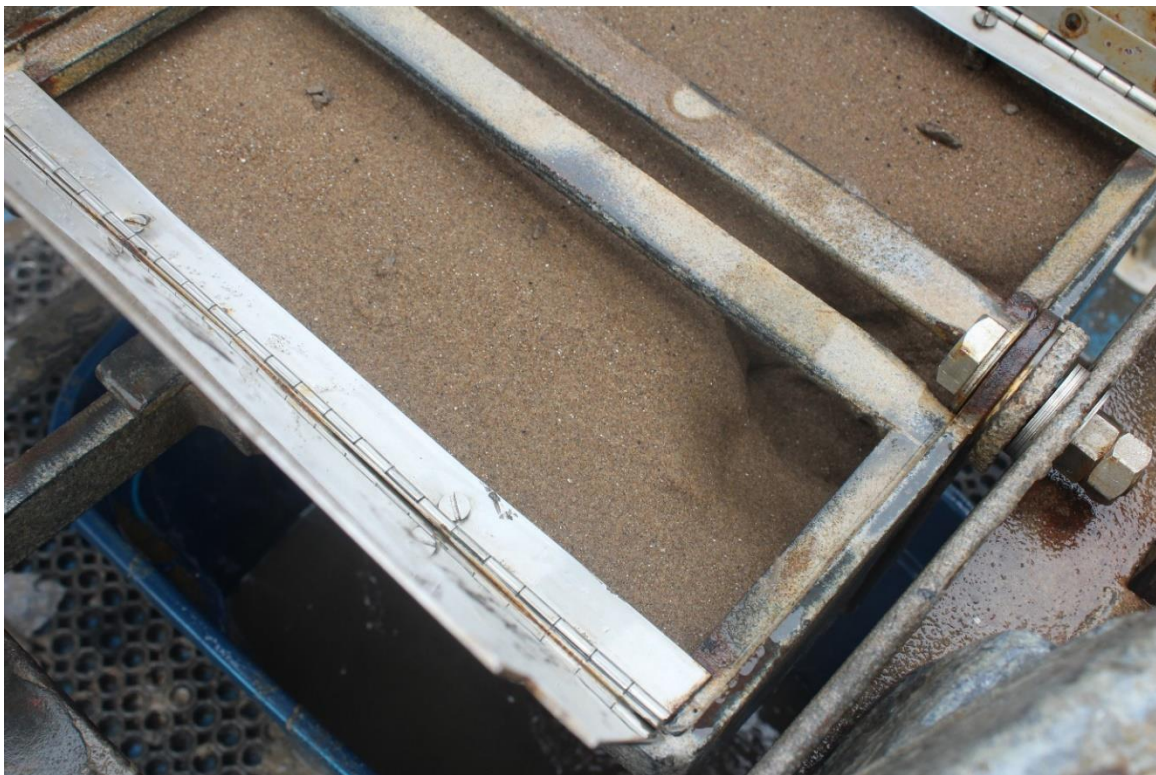
Figure 2: S7 sample (top panel) and S12 sample (bottom panel) collected 24th June 2019. Note that unfortunately camera issues led to blur in the S7 photograph.

Results: Upon survey completion, samples were transported to the Cefas Lowestoft sedimentology laboratory for particle size analysis (PSA). Upon completion of analysis, results will be reported to NNB GenCo in accordance with monitoring requirements. Photographs of the grab samples taken during the survey are shown in Figure 2.
