DOCUMENT TITLE		Cefas Report TR492 Hinkley Point Cardiff Grounds (LU110) post-disposal bathymetric survey and grab sample analyses (Marine Licence 12/45/MLv1)														EMPLOYER REVISION				03			
-----------------------	--	--	--	--	--	--	--	--	--	--	--	--	--	--	--	--------------------------	--	--	--	----	--	--	--

BEEMS Technical Report	TR492
BEEMS Technical Report Title	Hinkley Point Cardiff Grounds (LU110) post-disposal bathymetric survey and grab sample analyses (Marine Licence 12/45/MLv1)
Sub-Contract Report Original Title:	CS0555_Cardiff Grounds Survey_V2
Sub-Contractor	Titan Environmental Surveys Limited

Project:
Cardiff Grounds Survey

Description
Bathymetry and Grab Sampling

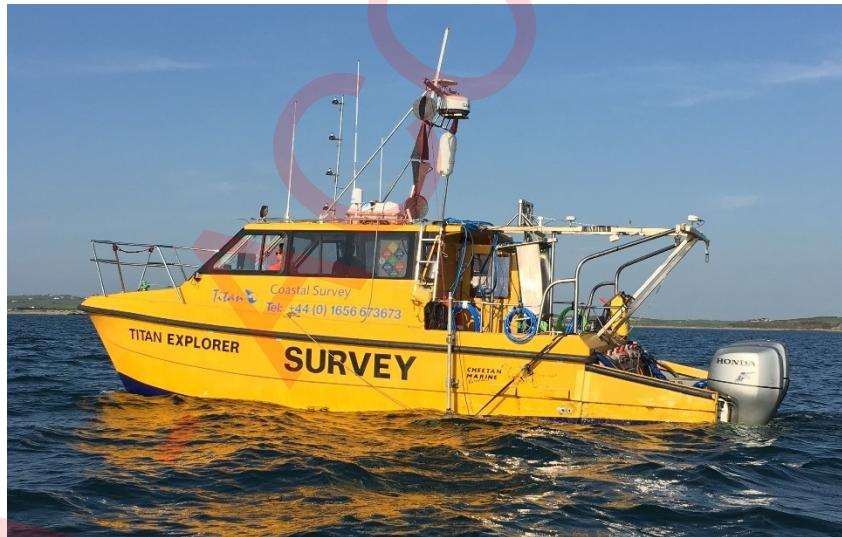
Figure 2.1 The MV Titan Explorer

The MV Titan Explorer (Figure 2.1) was used as the survey platform. The vessel's particulars are:

Length overall : 9.7m
Beam : 2.9m
Draught : 0.8m
Engines : 2 x 150bhp
Certification : MCA Category 2 (60 miles from safe haven)

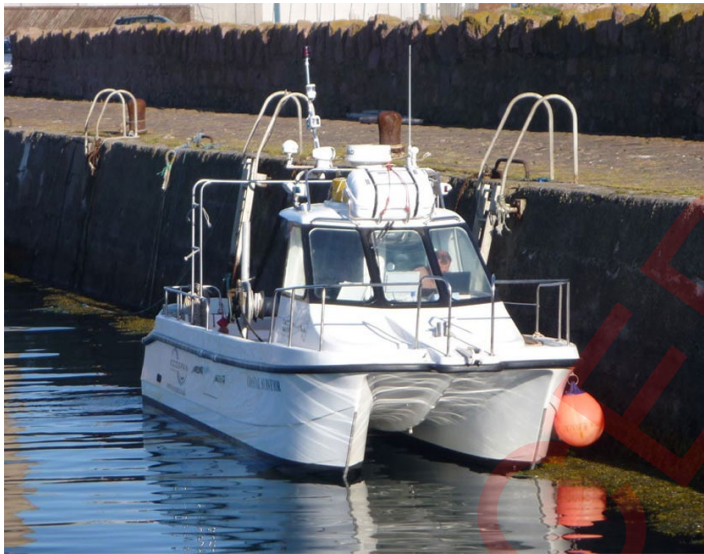
Figure 1: Ecospan RV Coastal Surveyor

Operations: Cefas conducted grab sampling operations from Ecospan's RV Coastal Surveyor, 7.9 m twin engine Sea Cheetah catamaran, an MCA Category 3 workboat (Figure 1). Survey works were supported by Marine Science Services (MSS).

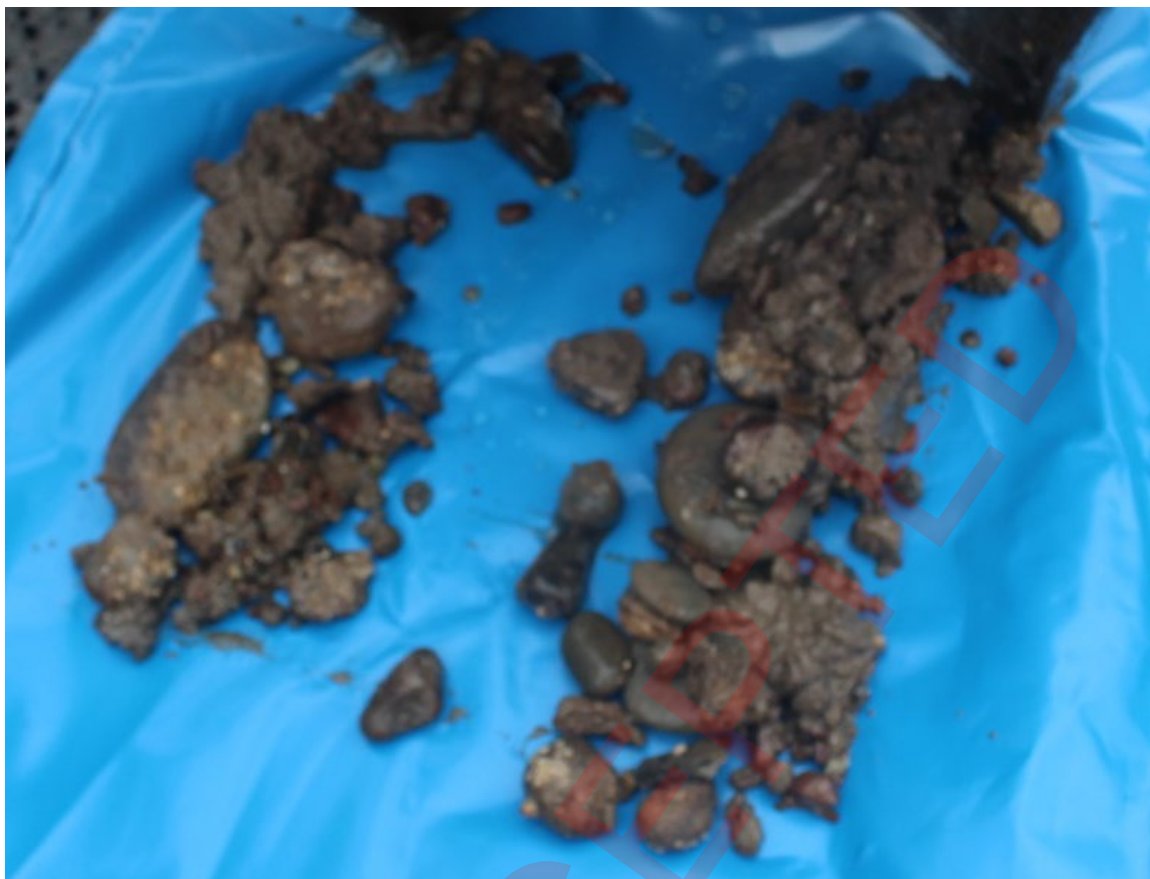
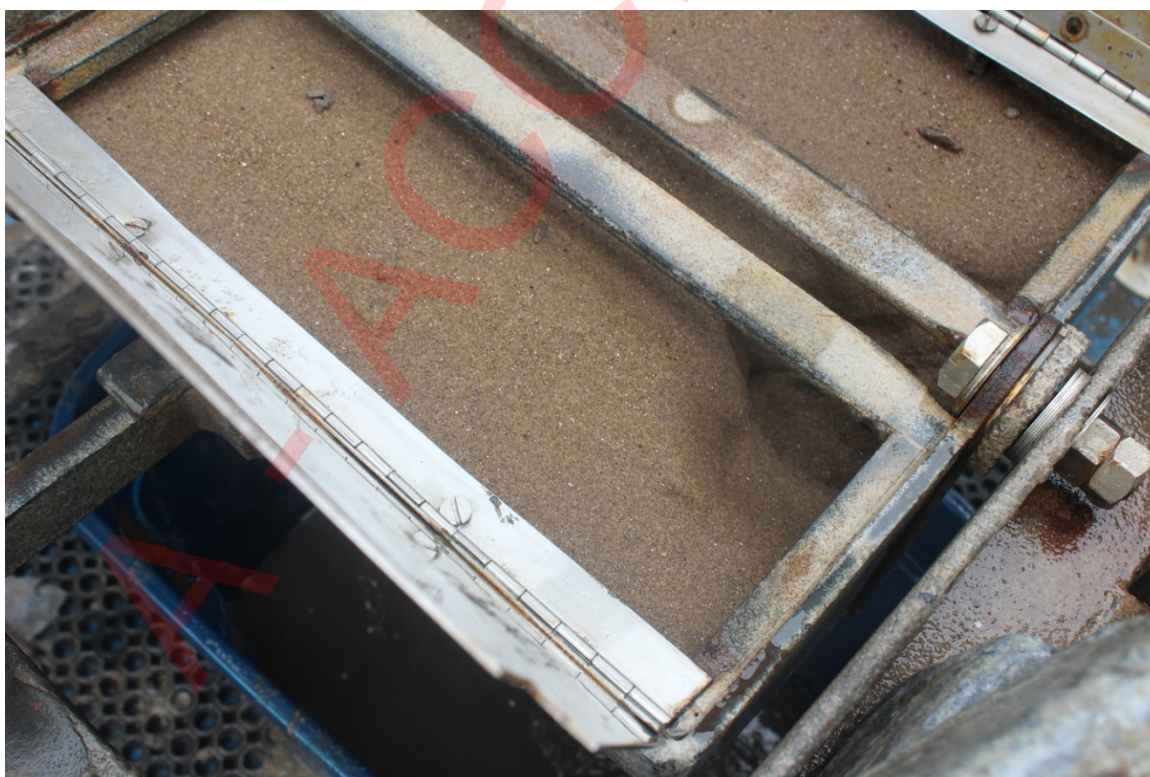
Sampling: Two additional grab samples were collected from Cardiff Grounds at the locations specified in Table 1. The grab sample from station S12 was collected with a 0.1 m³ day grab. The grab sample from station S7 was collected with a Van Veen grab, as the day grab was unsuccessful due to the presence of coarse material.

Figure 2: S7 sample (top panel) and S12 sample (bottom panel) collected 24th June 2019. Note that unfortunately camera issues led to blur in the S7 photograph.

Results: Upon survey completion, samples were transported to the Cefas Lowestoft sedimentology laboratory for particle size analysis (PSA). Upon completion of analysis, results will be reported to NNB GenCo in accordance with monitoring requirements. Photographs of the grab samples taken during the survey are shown in Figure 2.
