## **Lamby Way annual report January 2019 – December 2019**

**With reference to section 4.2 of Lamby Way Landfill site permit Variation  
notice UP3130MA of permit JP3239ST**

# **Lamby Way Landfill Site**

### **2019 Annual Report as per Schedule 4.2 sub section 4.2.1**

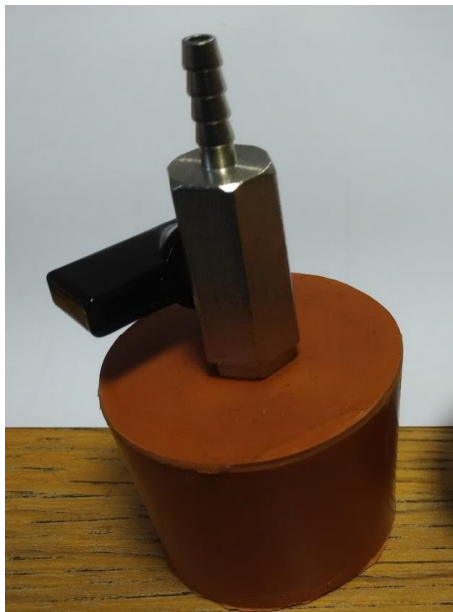
1. Maintenance overhaul of all perimeter gas sampling points. Six valves/well heads were replaced and all surrounding vegetation was cleared around the sampling points to allow easier access.
2. Vegetation clearing – Several sampling locations were in danger of being lost due to plant growth, predominantly C1, C2, C3, C4 and C5. These areas were stripped back and access is now considerably easier. Also Gas monitoring points G13 – G20 have undergone maintenance and new sampling taps have been installed on all Gas monitoring that required them (10 total). See below.

3. Gas monitoring points G20 and G21 have had new brick chambers built around them to protect them as they are outside the perimeter.
4. Submersible field pumps in MH4 and MH22 have been replaced for like for like pumps to improve reliability to the LTP.
5. LTP maintenance tender has been put out to the market for renewal. Specification has been passed to NRW for review. New tender to begin in February 2020.
