Appendix 1 – Kingspan Environmental Limited (KEL).
Site Visit reports 1, 2 and 3.

Customer Service Report

Customer Name: Caerphilly County Borough Council
Customer Address: Tir Y Berth Depot C/O Unit B6
New Road

Product: BioDisc BA Gravity

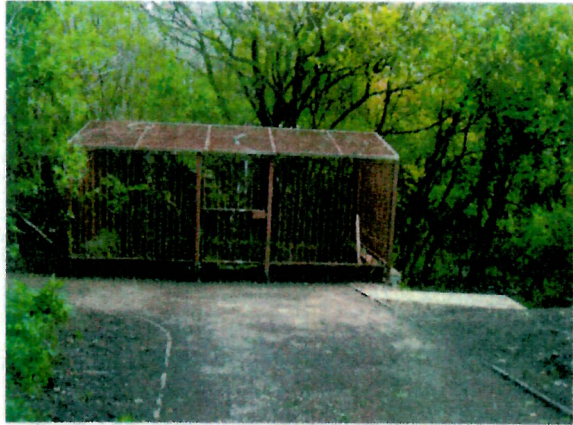
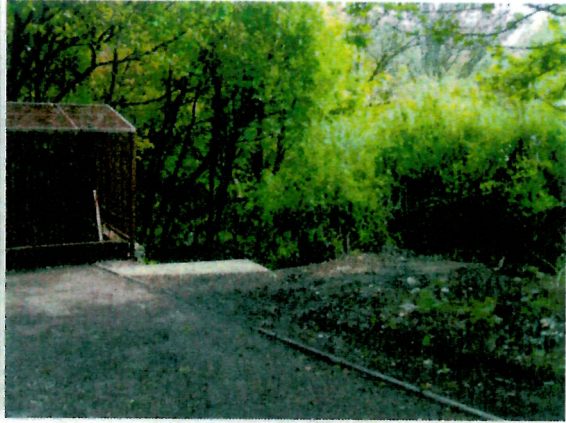
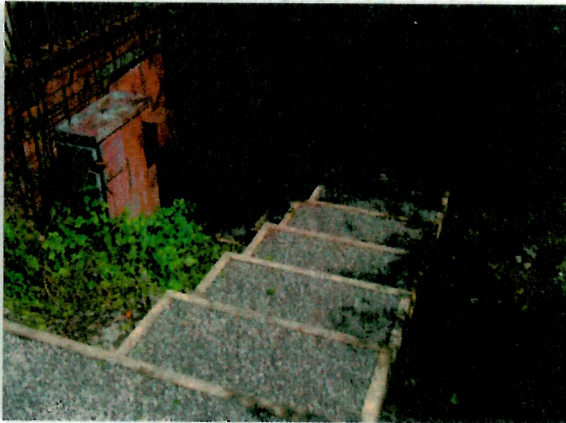
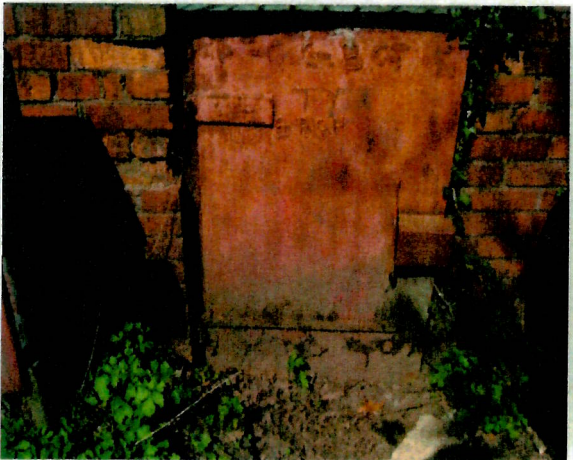
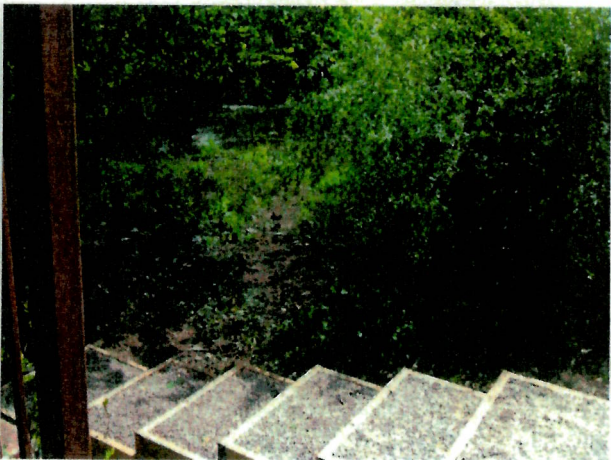
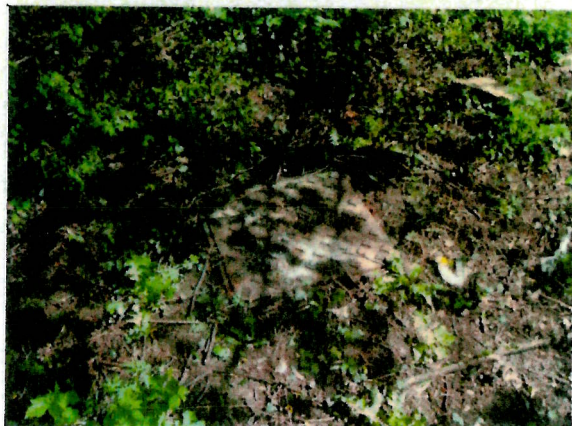
APPENDIX 1 - Improvement of access to water treatment plant and waters edge

Call in contractor to discuss costs for providing easier access to bio-disc	27/4/2015	Martyn Bishop AL Landscapes	Contractor advised to proceed with works
Check if works have been carried out to a satisfactory condition	19/5/2015	Martyn Bishop Rob Lewis	Works carried out to a very good standard providing easier access to treatment plant. SEE PHOTOGRAPHS APPENDIX 1 ON NEXT PAGES
Check course for evidence of pollution	19/5/2015	Martyn Bishop Rob Lewis	No evidence of pollution at time of visit. SEE PHOTOGRAPHS APPENDIX 2 ON NEXT PAGES
Servicing of bio-disc	15/6/2015	Martyn Bishop	Contacted Lucille Fletcher, procurement to set up with Keeprocess. E-mail confirmation received
View waste disposal company emptying bio-disc	17/5/2015	Martyn Bishop	The contractor had emptied the bio-disc before they could be monitored on site. However MB checked the glass filling tube and it showed 2000 gallons of waste, the driver informed he had cleaned out the sludge and water. The location where the waste is taken was also discussed, see document at front of file.

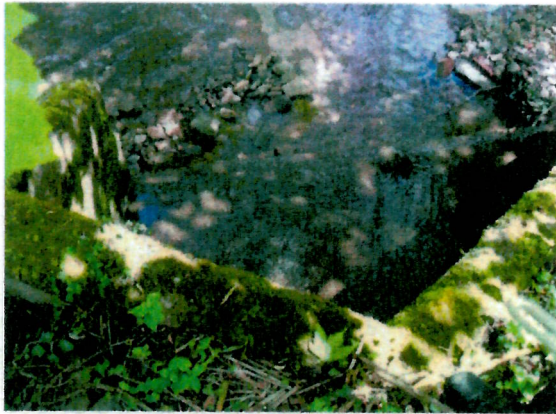
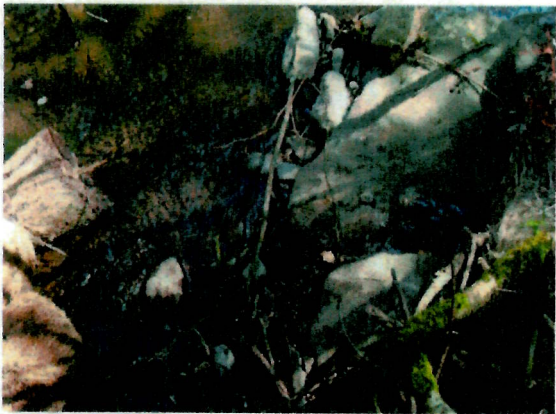
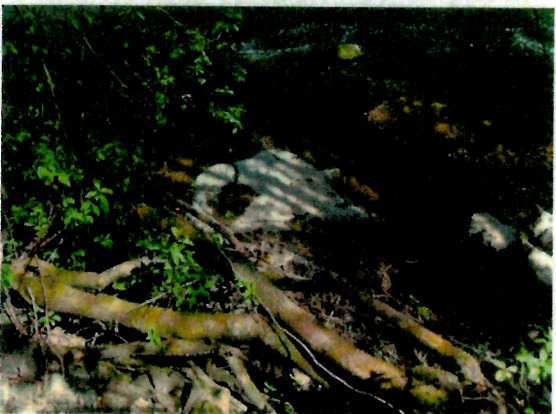
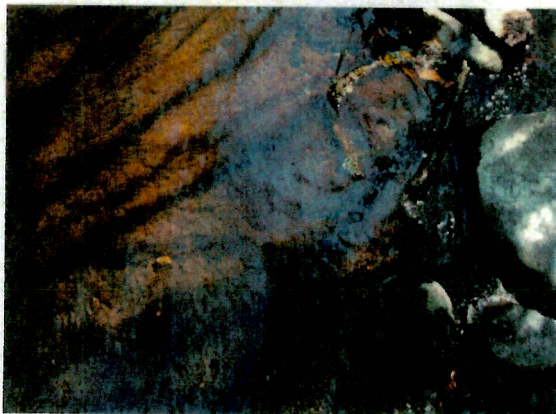
APPENDIX 2 - Water course check for pollution

ACTION	DATE & TIME	CARRIED OUT BY	RESULT
Maintenance of Bio-disc	26/1/2015	Kee Services	No issues found
De-sludge Bio-disc	20/3/2015 14:00 to 15:00	Mayglothing Waste Ltd	<ul style="list-style-type: none"> ♣ Emptied 2000 gallons ♣ Waste Transfer Note: 0017475 ♣ Checked bio-disc turning
Monitor access to bio-disc	23/4/2015	Paul Smythe Martyn Bishop Rob Lewis	<ul style="list-style-type: none"> ♣ Discussed providing better access to the bio-disc. ♣ Checked disc turning
Tried to identify outlet from bio-disc	23/4/2015	Paul Smythe Martyn Bishop Rob Lewis	Unable to locate outlet due to overgrowth
Obtain dye to trace outlets	23/4/2015	Martyn Bishop	Dye obtained from Highways Section (Culverts) Michelle Johnson
To identify where the outlets are located	24/4/2015	Martyn Bishop & Highways Representative	Dye placed in water whereby discovering the outlet into the Rhymney river and marked on drawings. The manhole was sprayed white to identify location. There is only one outlet into the Rhymney river for both the bio-disc and storm water, the bio-disc links into the storm water outlet.
