| Client name & address: | Newport City Council, Docksway Disposal Site, Newport, NP20 2NS | | |
| Scope of works: | Background testing around asbestos cell Sample locations: 1 - lagoon, 2 - <i>Scott Pallets</i> , 3 - cell 5 ridge, 4 - asbestos clay bund | | |

Appendix 1. Site plan

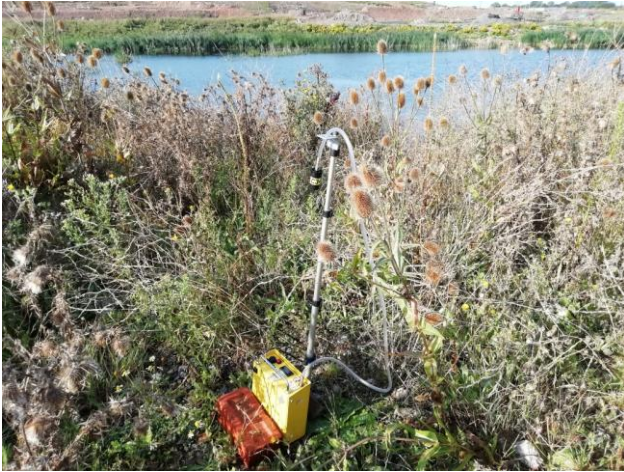
1. Sample 1, lagoon

| Sample ref | Pump ID | Cowl ID | Time on | Time off | Duration (mins) | Flow rate (litres/min) | | Volume (litres) | Fibres | Fields | Airborne fibre concentration (f/ml) | Limit of quantification (f/ml) | Reported result (f/ml) |
|---|---|---|---|---|---|---|---|---|---|---|---|---|---|
| 1 | SP1 | C34 | 0904 | 1002 | 58 | 10.0 | 10.0 | 580 | 1.0 | 200 | 0.000 | 0.01 | < 0.01 |

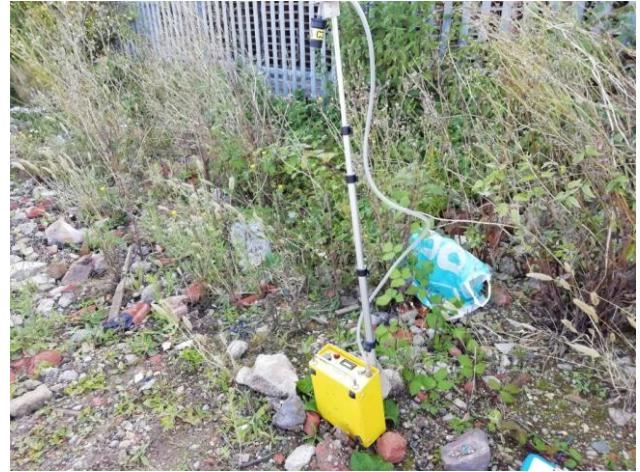
2. Sample 2, Scott Pallets

| Sample ref | Pump ID | Cowl ID | Time on | Time off | Duration (mins) | Flow rate (litres/min) | | Volume (litres) | Fibres | Fields | Airborne fibre concentration (f/ml) | Limit of quantification (f/ml) | Reported result (f/ml) |
|---|---|---|---|---|---|---|---|---|---|---|---|---|---|
| 2 | SP3 | C35 | 0907 | 1004 | 57 | 10.0 | 10.0 | 570 | 1.0 | 200 | 0.000 | 0.01 | < 0.01 |

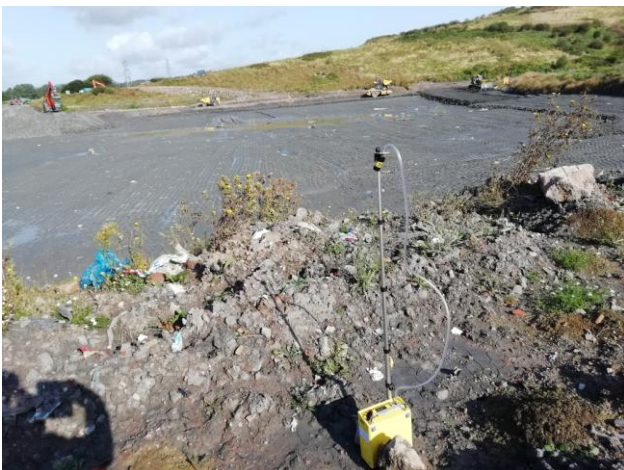
3. Sample 3, cell 5 ridge

| Sample ref | Pump ID | Cowl ID | Time on | Time off | Duration (mins) | Flow rate (litres/min) | | Volume (litres) | Fibres | Fields | Airborne fibre concentration (f/ml) | Limit of quantification (f/ml) | Reported result (f/ml) |
|---|---|---|---|---|---|---|---|---|---|---|---|---|---|
| 3 | SP4 | C36 | 0913 | 1008 | 55 | 10.0 | 10.0 | 550 | 0.0 | 200 | 0.000 | 0.01 | < 0.01 |

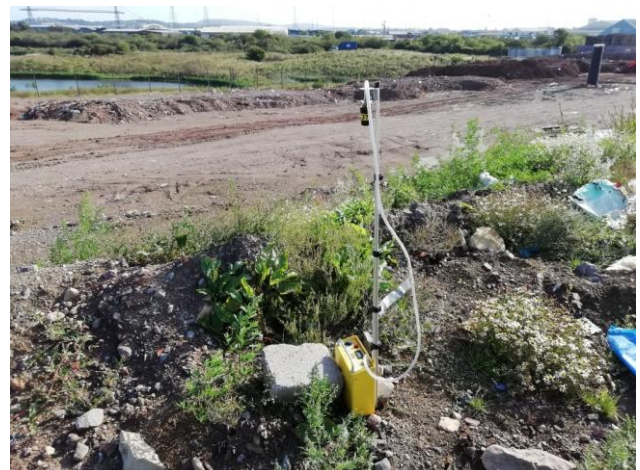
4. Sample 4, asbestos clay bund

| Sample ref | Pump ID | Cowl ID | Time on | Time off | Duration (mins) | Flow rate (litres/min) | | Volume (litres) | Fibres | Fields | Airborne fibre concentration (f/ml) | Limit of quantification (f/ml) | Reported result (f/ml) |
|---|---|---|---|---|---|---|---|---|---|---|---|---|---|
| 4 | SP7 | C37 | 0917 | 1011 | 54 | 10.0 | 10.0 | 540 | 1.5 | 200 | 0.001 | 0.01 | < 0.01 |
